Pueblo de Cochiti Green Infrastructure Concept Design

Improving Stormwater Management and Water Quality in the Community while Preserving Cultural History

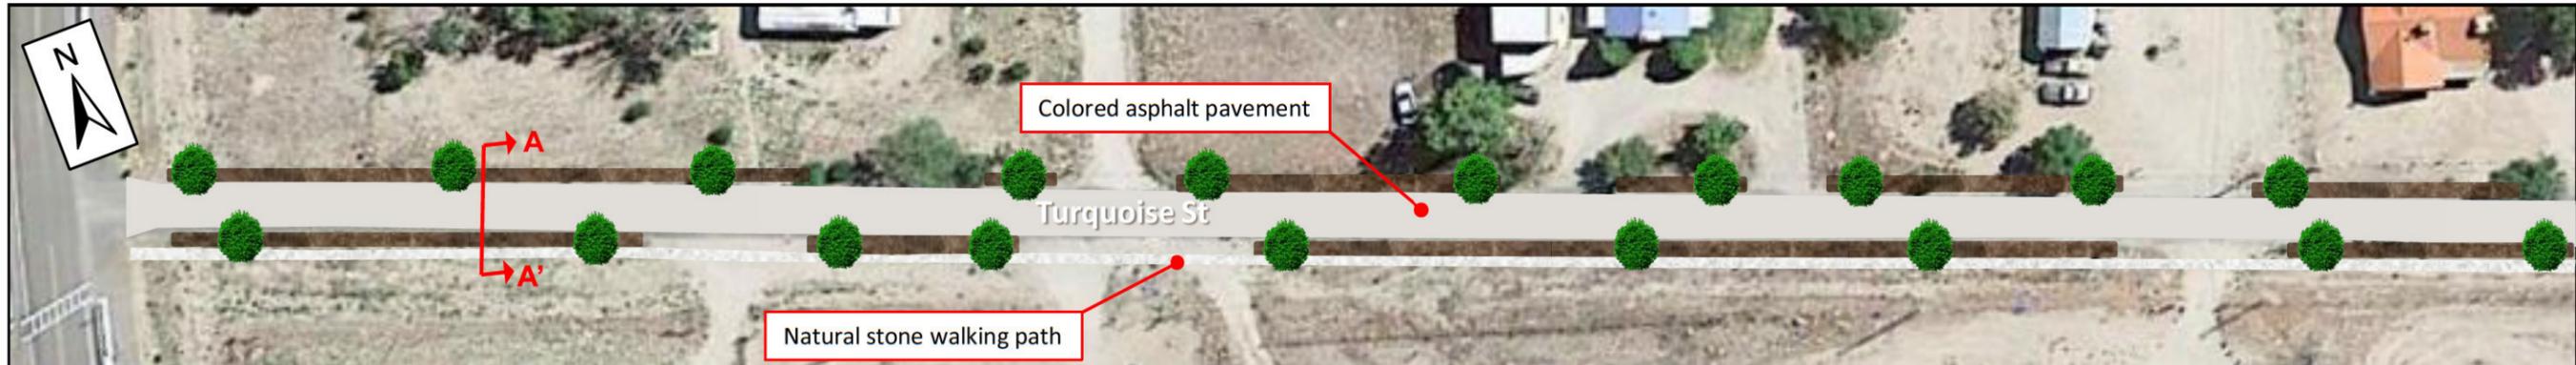
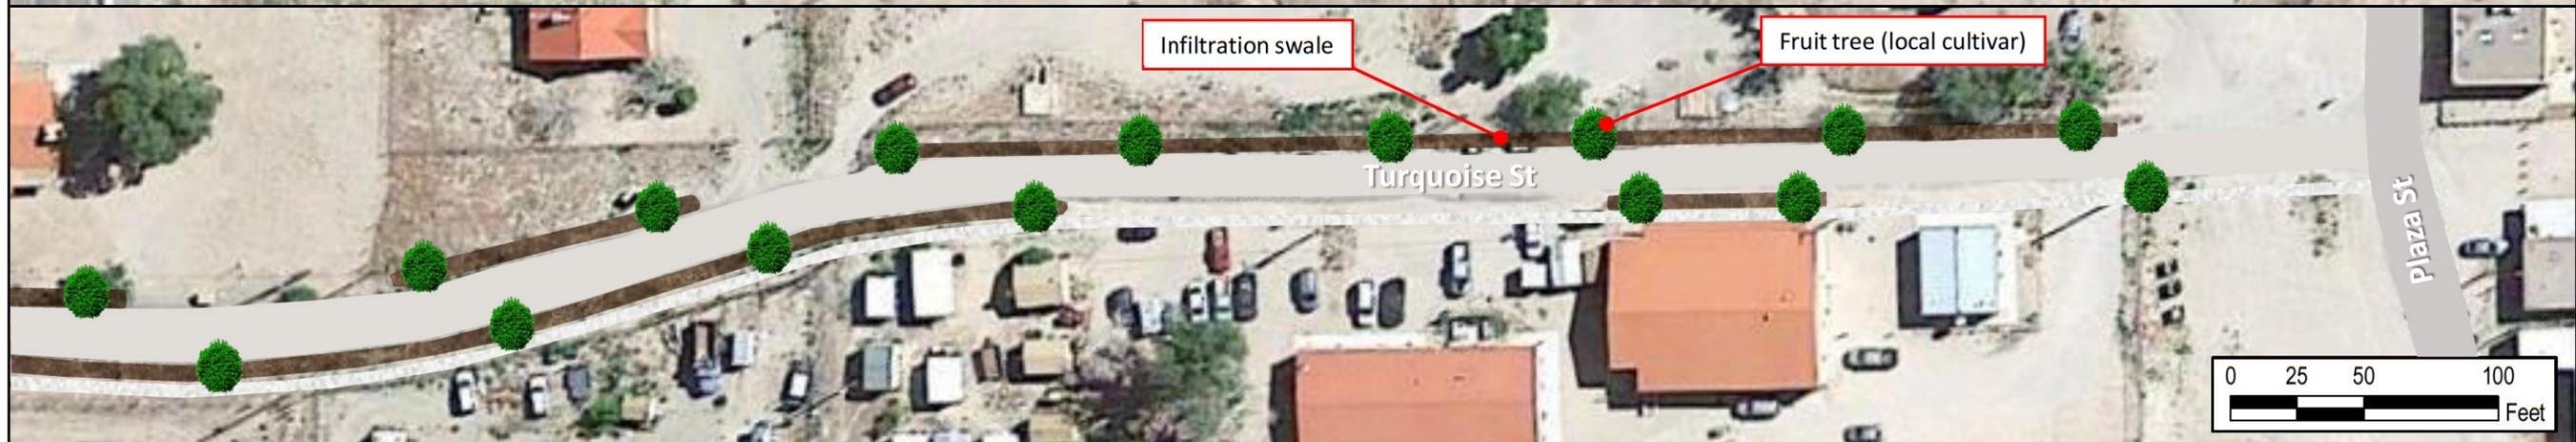
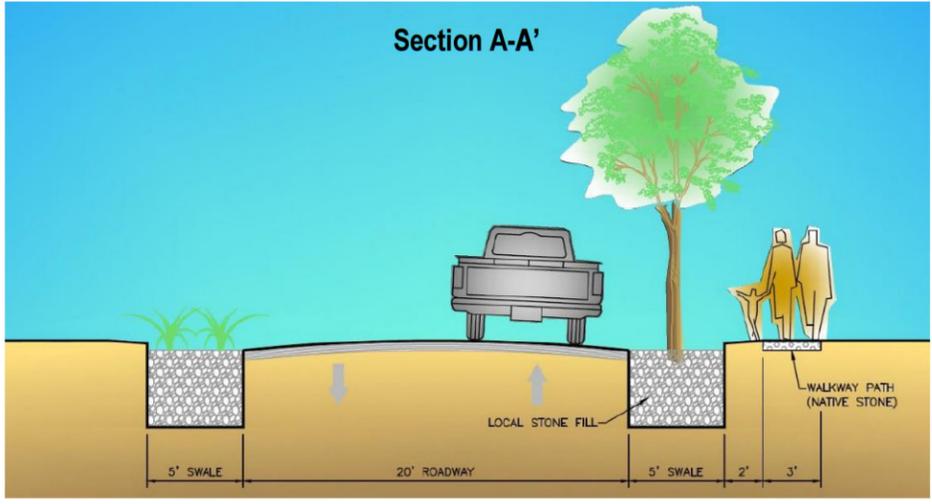
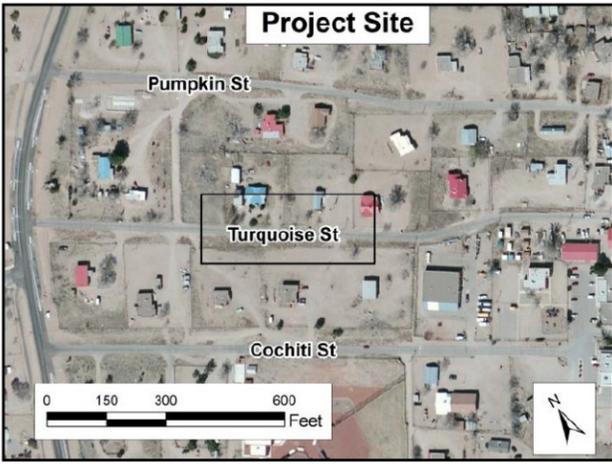
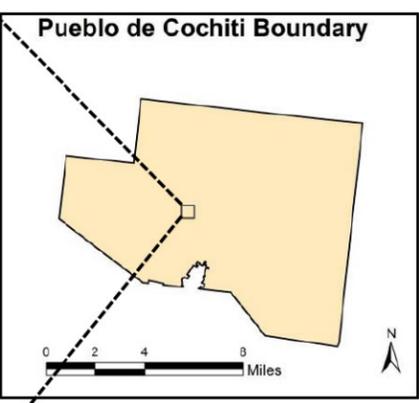
PUEBLO DE COCHITI, NEW MEXICO
 GREEN INFRASTRUCTURE CONCEPTUAL PLAN
 SITE: TURQUOISE STREET

Proposed Green Infrastructure Description: Proposed improvements to the roadway will include incorporation of infiltration swales along both sides of the roadway designed to capture and infiltrate roadway runoff. The swales will be partially filled with local native stone and planted with local fruit tree cultivars to utilize the captured runoff. A 3 ft wide stone walking path will be included on the southern side of the roadway.

SS = Stormwater Swale, ST = Street Trees
 *Green Infrastructure characteristics are based on field observations and GIS data resources available at the time of conceptual design analysis. Note that final design characteristics will be dependent on a detailed site survey and could vary slightly from conceptual design characteristics.

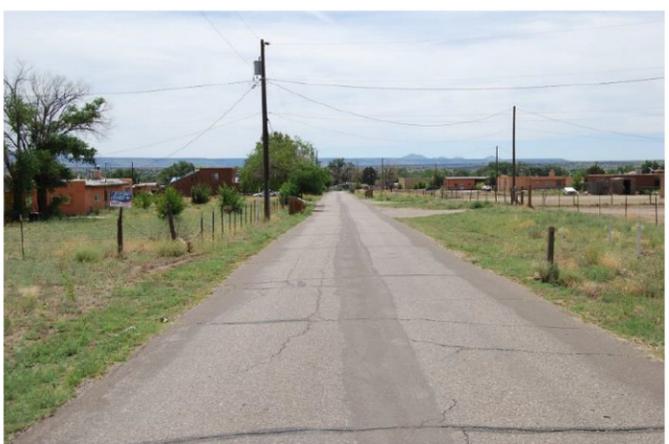
Current Street View (Facing Southeast)

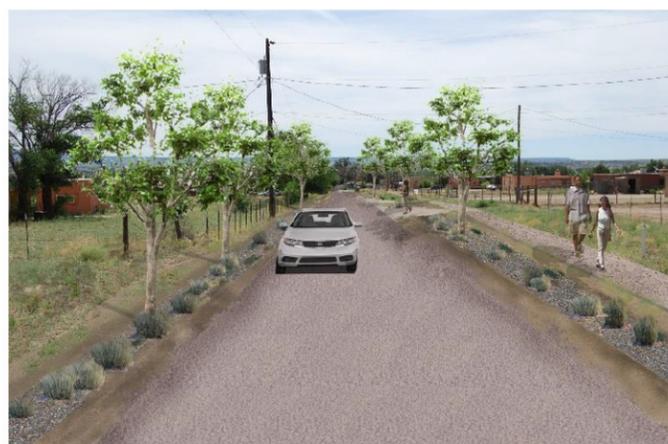
Conceptual Green Street Rendering (Facing Southeast)
