**SITE-WIDE PROJECT WORK PLAN-PART I  
PART 1: SITE-WIDE BACKGROUND REPORT  
PRUDHOE BAY FACILITY, ALASKA**

**ADMINISTRATIVE ORDER ON CONSENT:  
RCRA-10-2007-0222**

**Date: January 28, 2008**

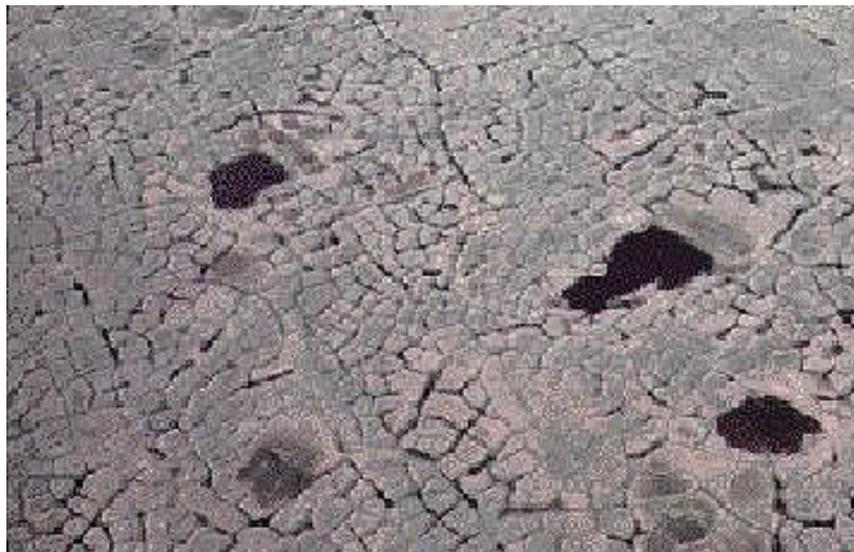
**FIGURE 7.** The permafrost that underlies the Coastal Plain of the Alaskan Arctic and the seasonal frost action at the land's surface has generated the polygonally patterned ground that is common throughout much of the area. Courtesy D. R. Klein, USGS

which determine vegetation composition (Figure 7) (Walker and Acevedo, 1987:11). Arctic tundra communities occur in dry, moist, and wet soil conditions and are represented by a low diversity of plant species and low plant biomass.

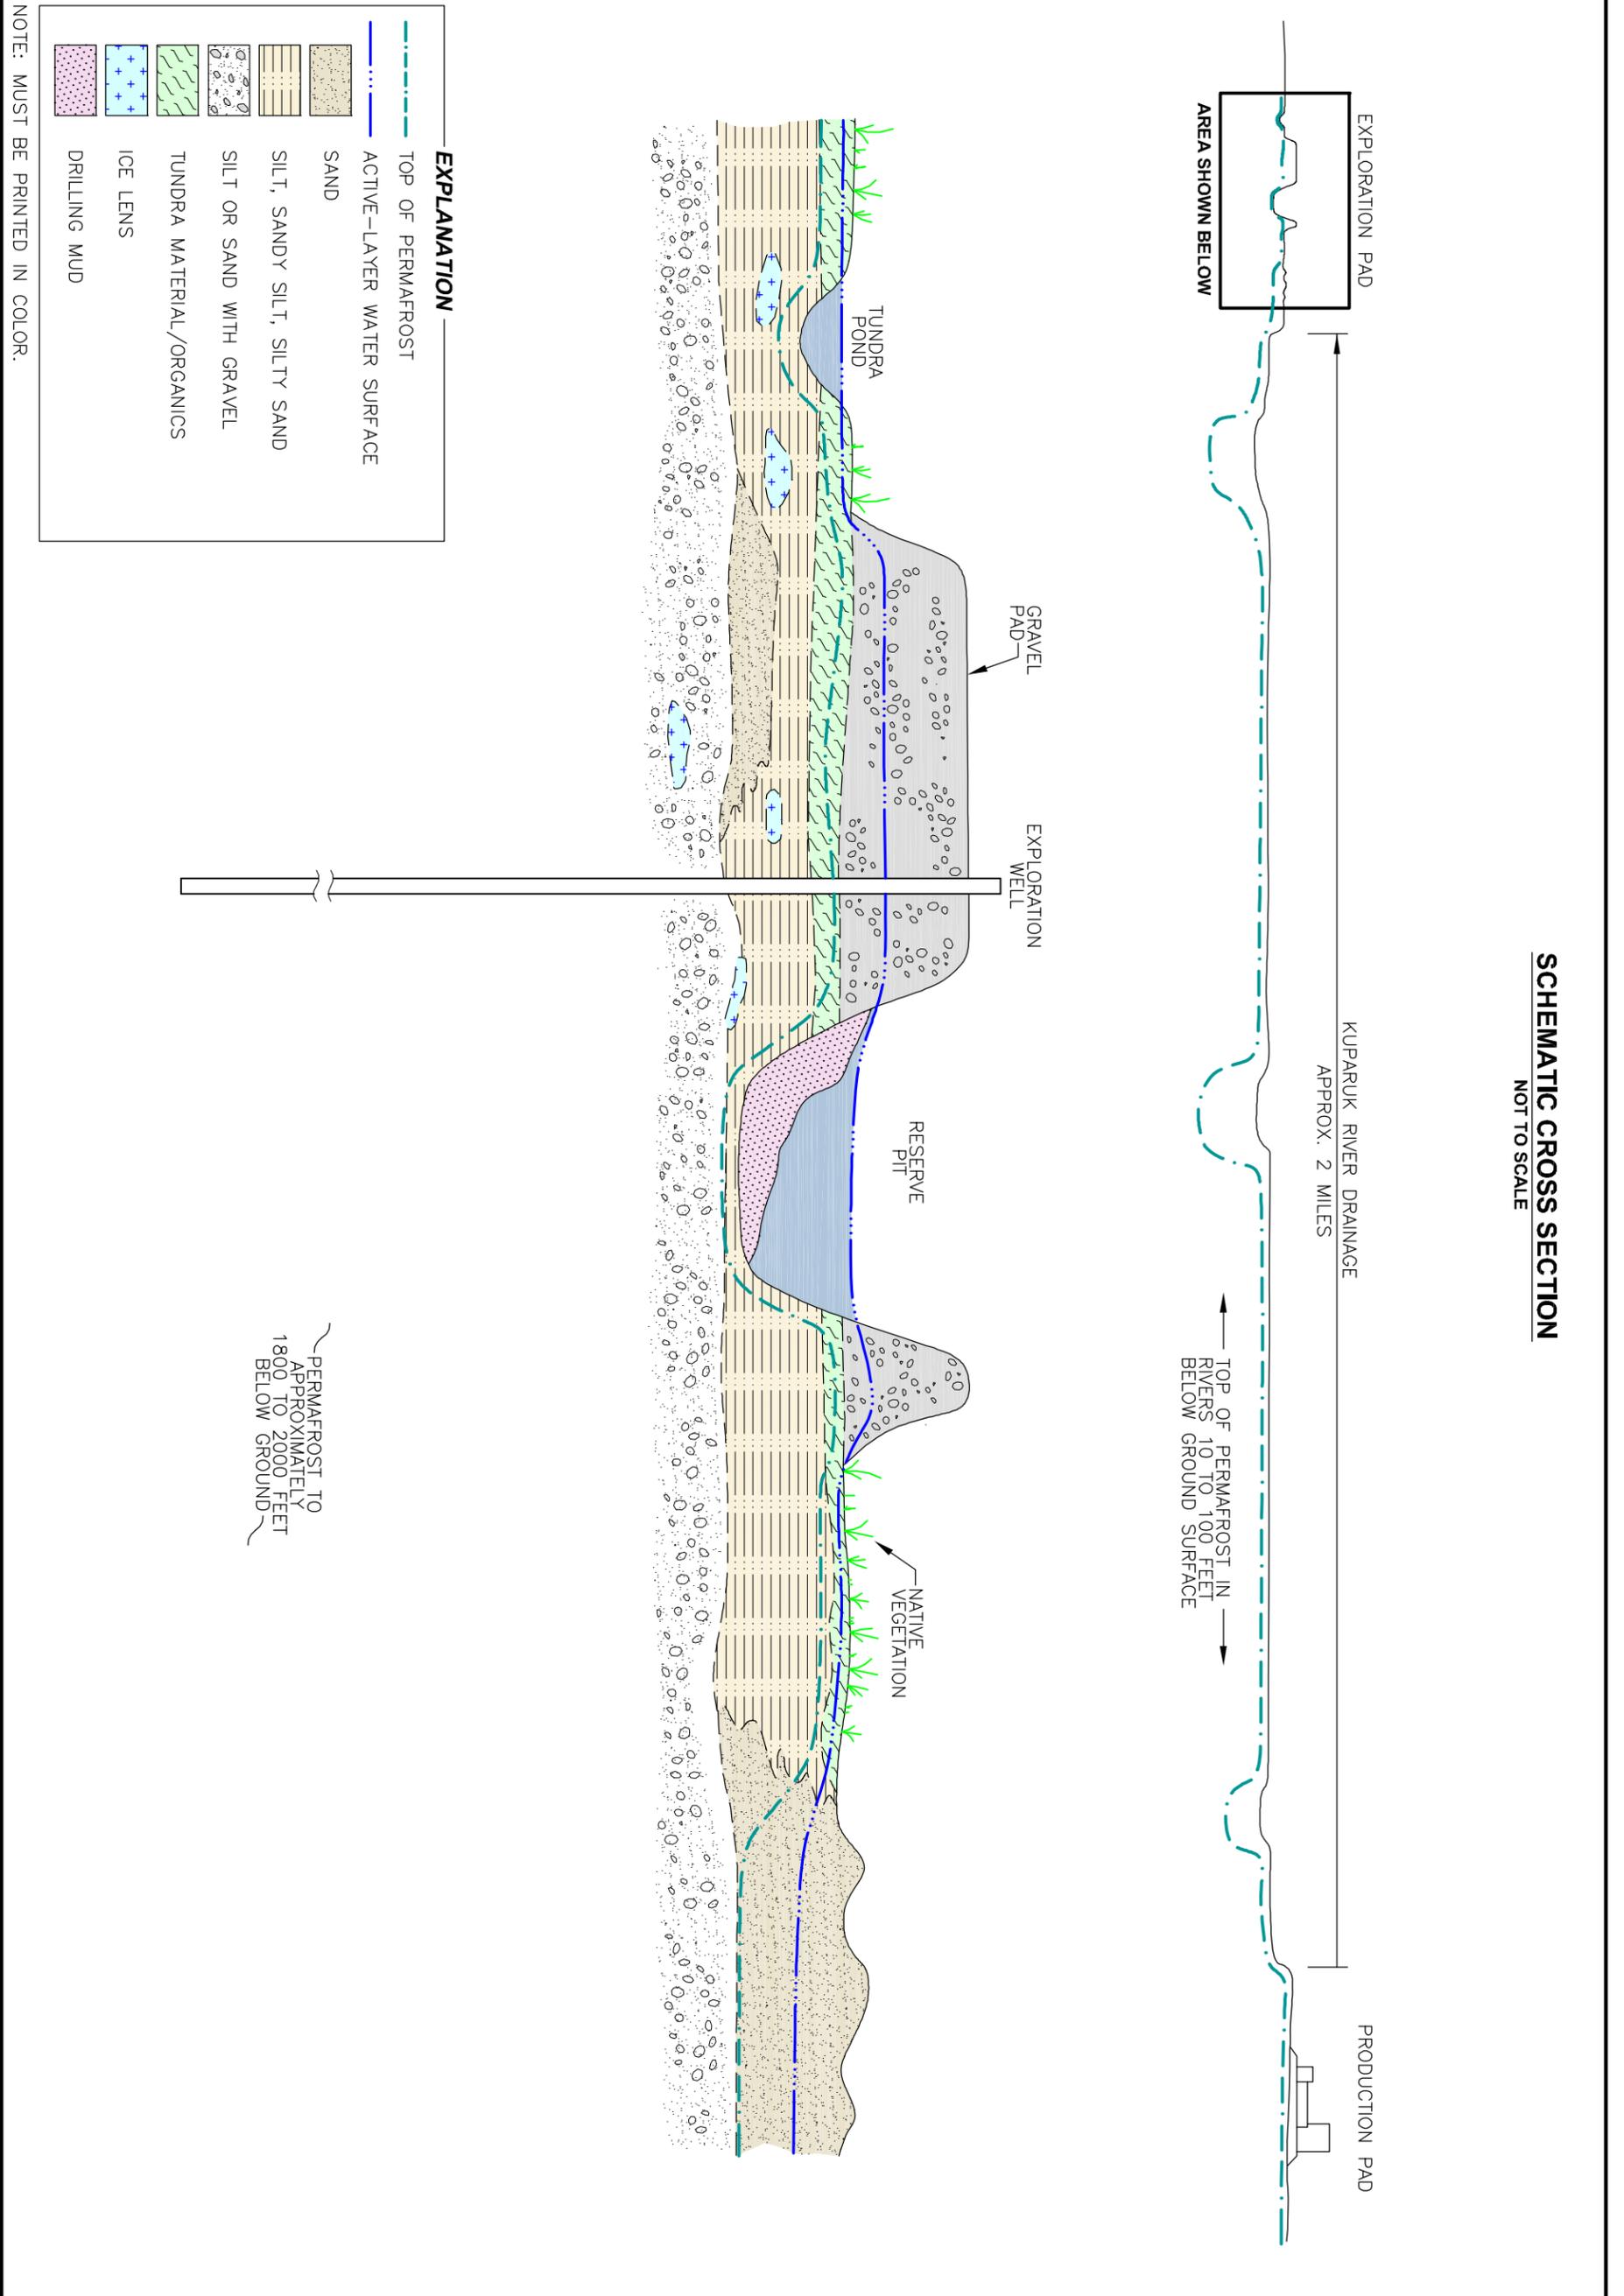
FIGURE  
**5**

**SCHEMATIC CROSS SECTION OF SHALLOW SOIL STRATIFICATION**

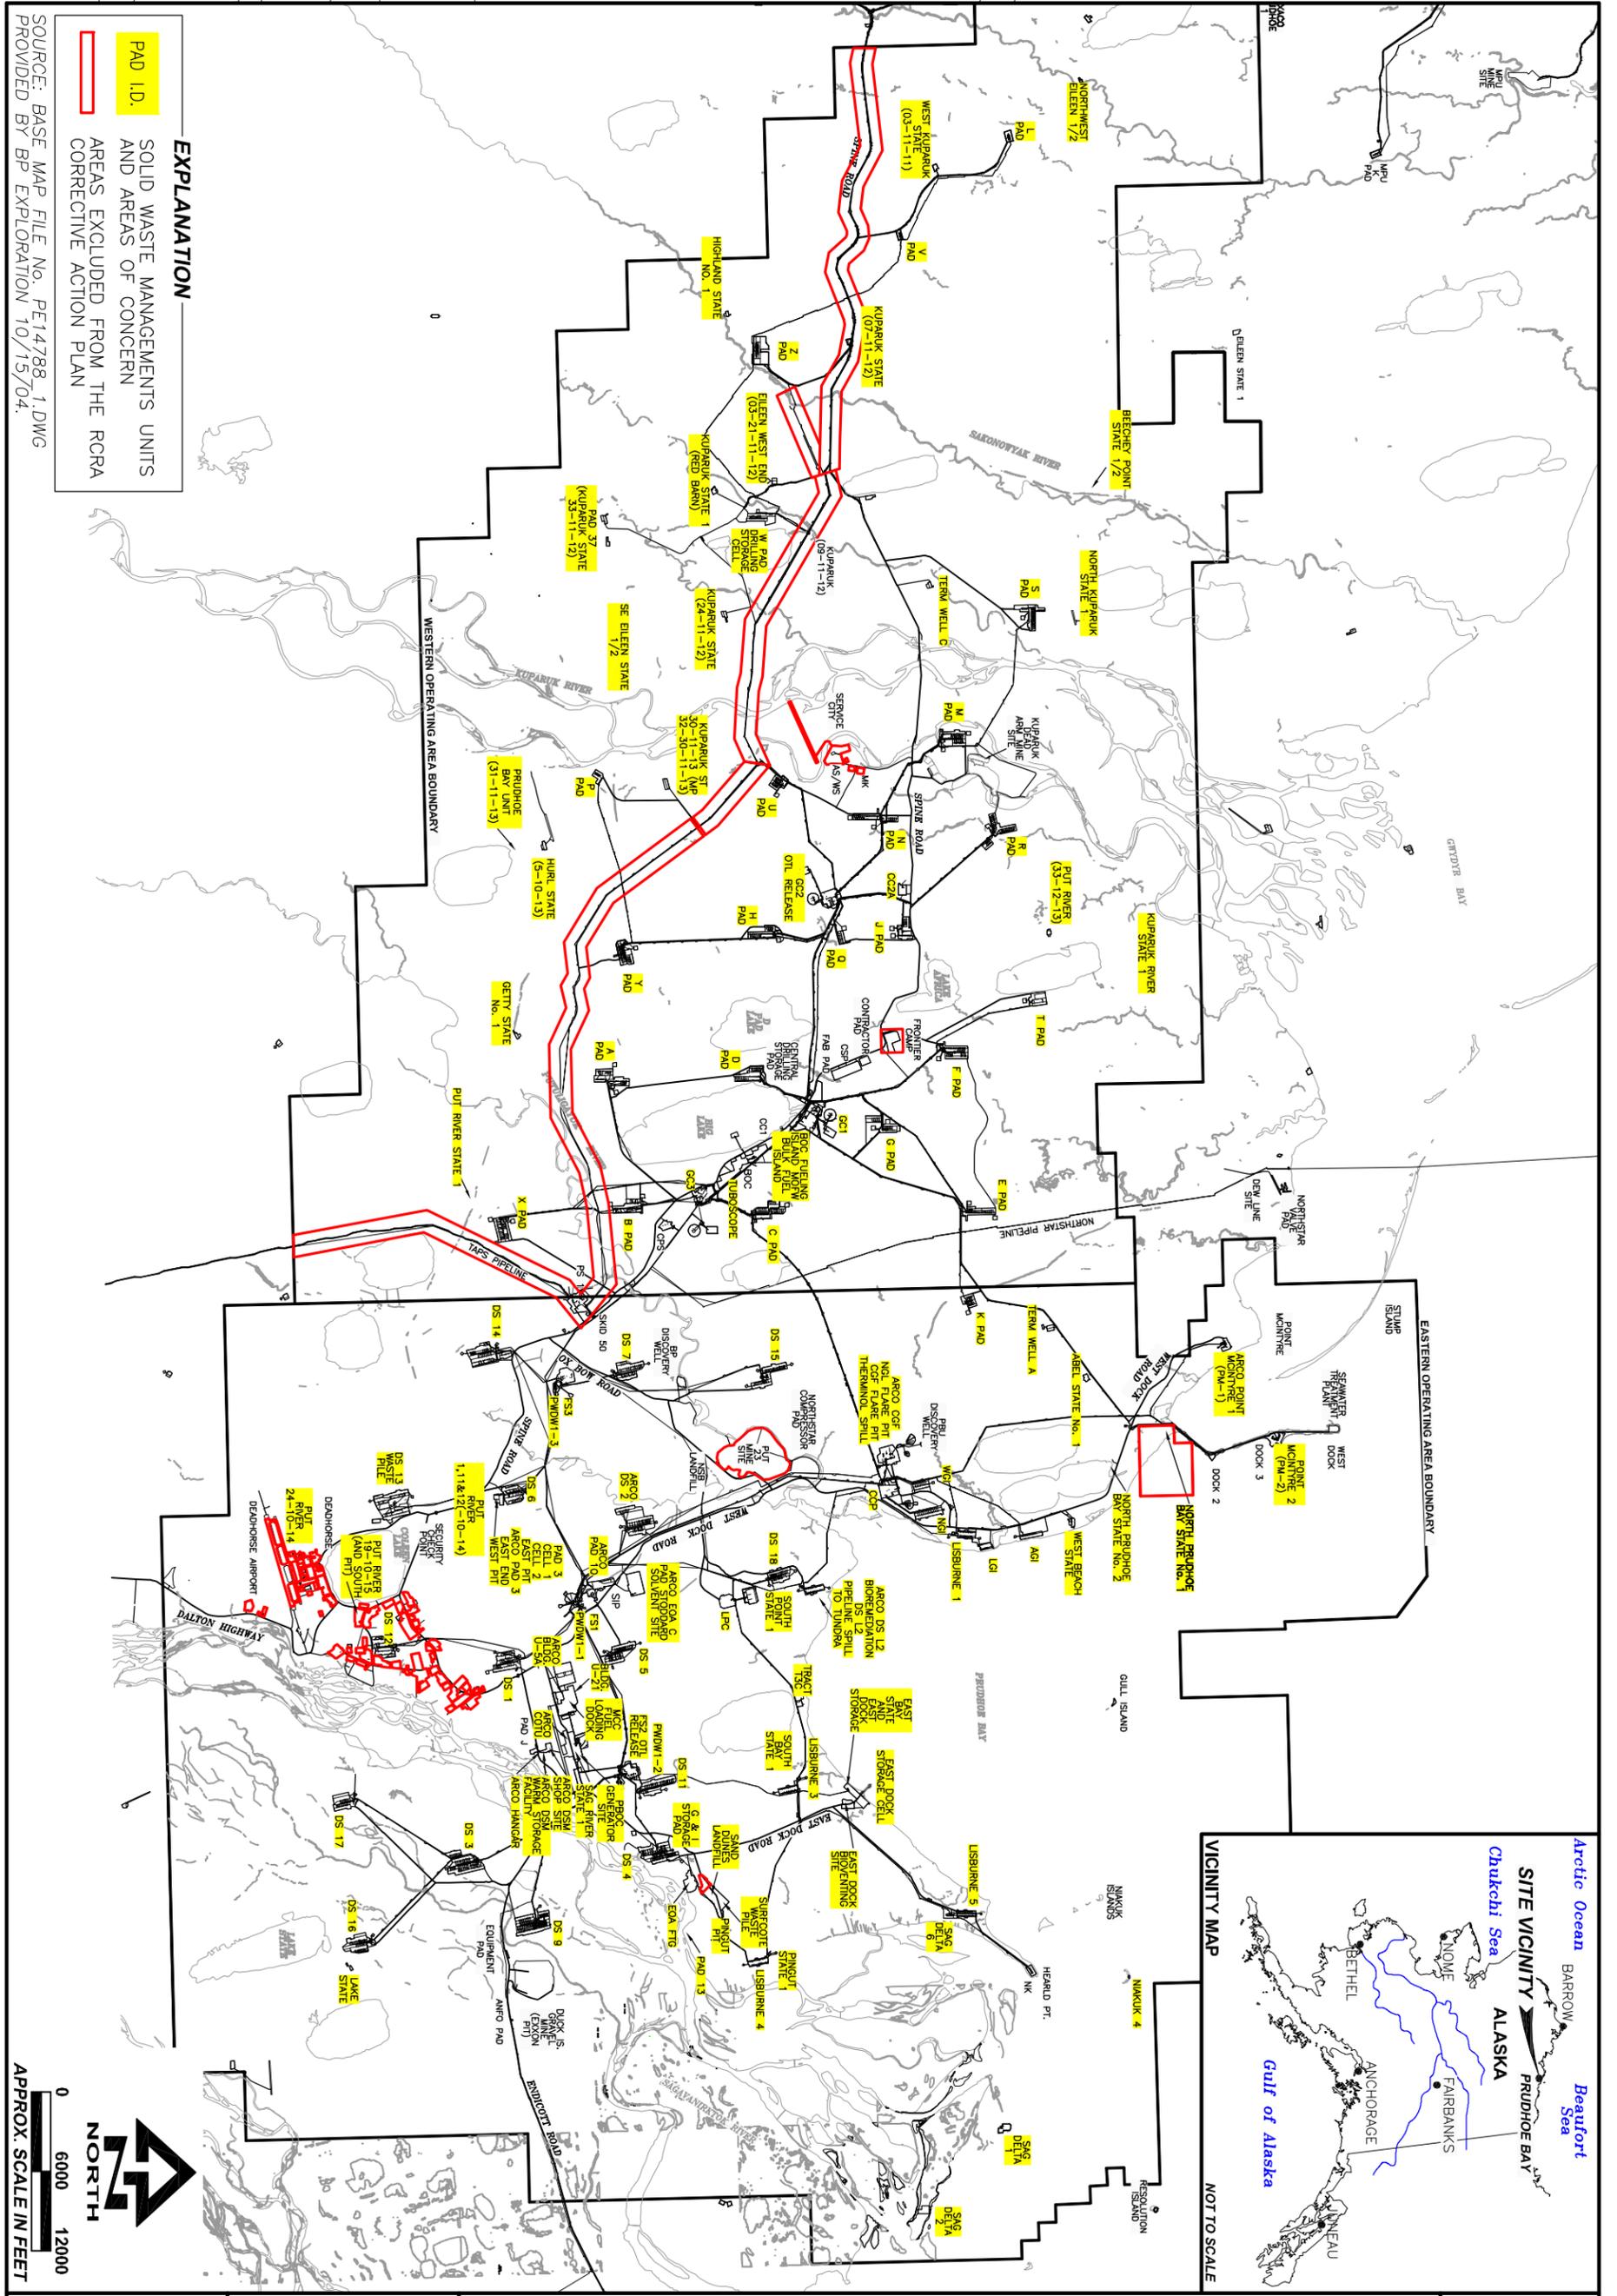
**EXPLANATION**  
 SOLID WASTE MANagements UNITS  
 AND AREAS OF CONCERN  
 AREAS EXCLUDED FROM THE RCRA  
 CORRECTIVE ACTION PLAN

**PRUDHOE BAY FACILITY  
 RCRA FACILITY MAP**

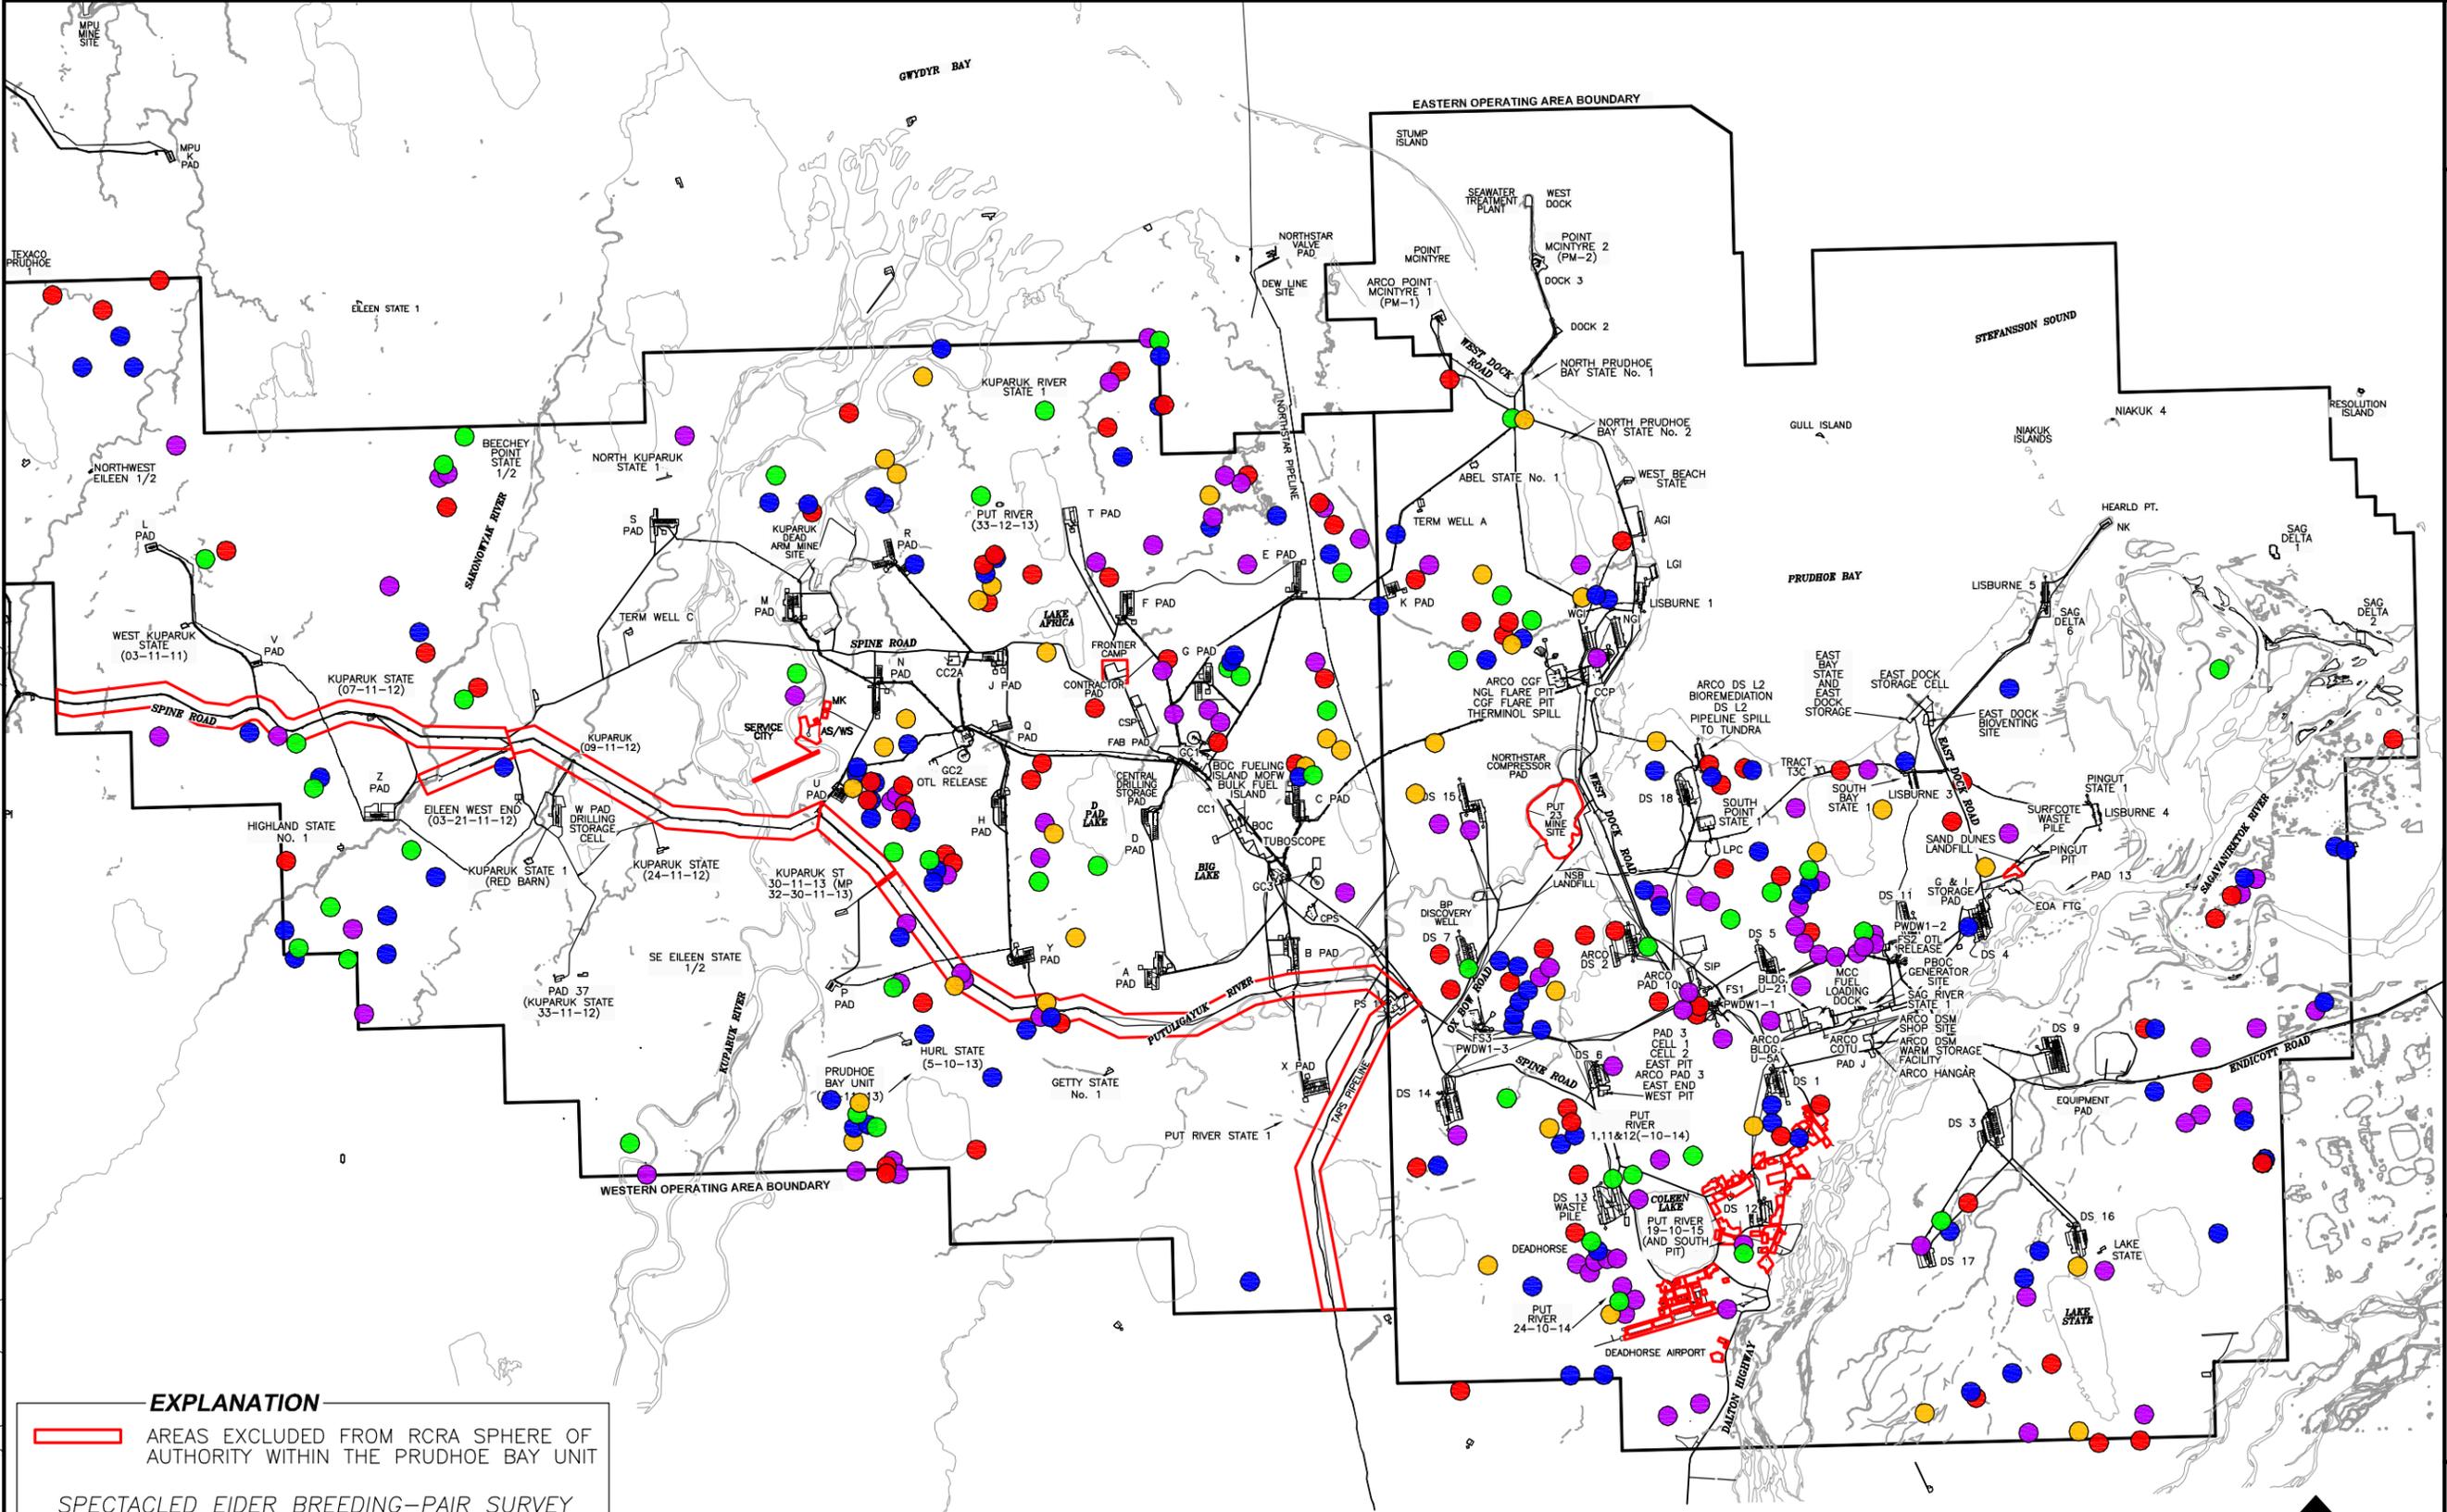
AREAS EXCLUDED FROM RCRA SPHERE OF AUTHORITY WITHIN THE PRUDHOE BAY UNIT
