# Rumney Marsh Restoration Areas

**Total Restoration Area:\* 313.3 acres**

EPA Region 1 GIS Center  
Map #11801, 4/6/2018

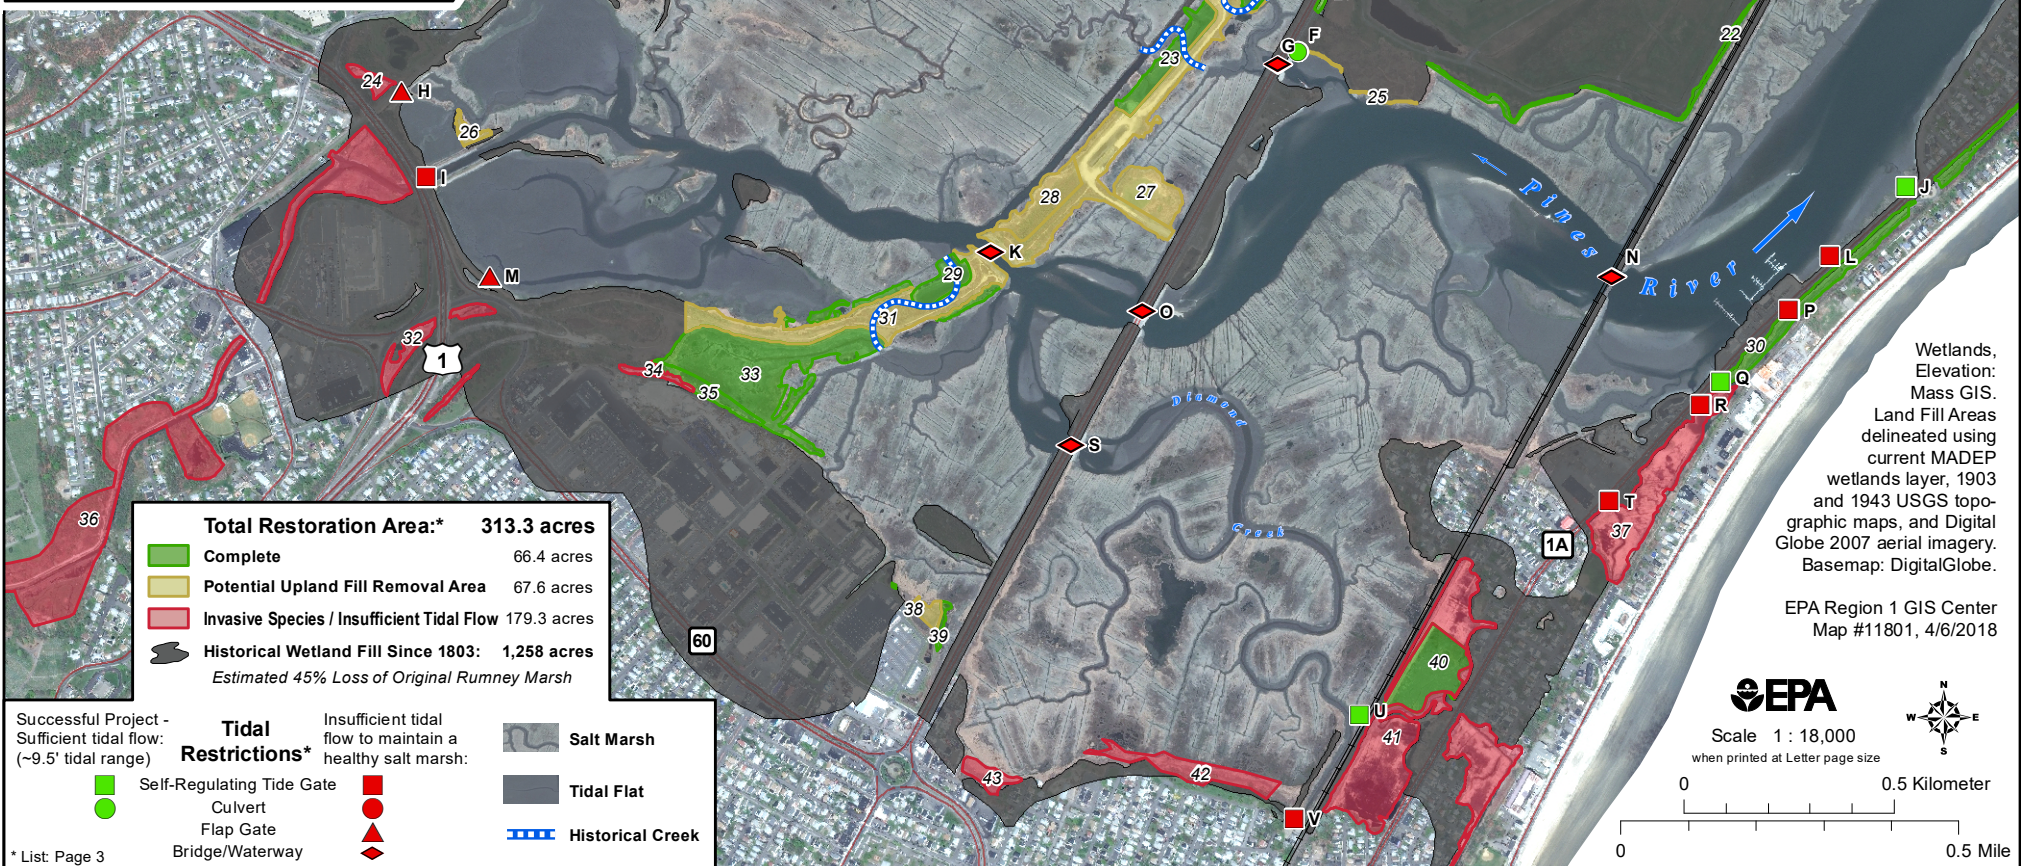
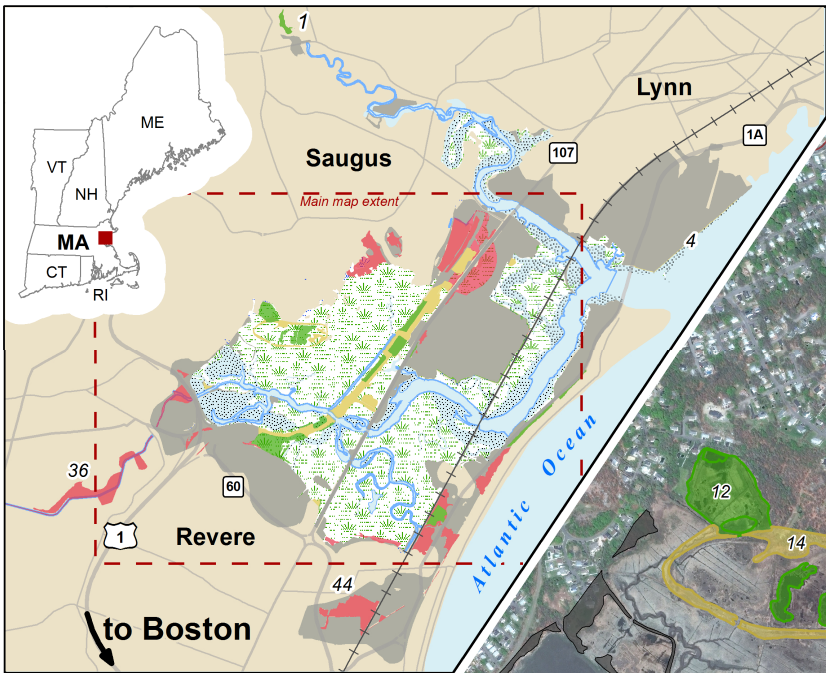
# Rumney Marsh Restoration Areas

**Total Restoration Area:\*** 313.3 acres

Complete	66.4 acres
Potential Upland Fill Removal Area	67.6 acres
Invasive Species / Insufficient Tidal Flow	179.3 acres
Historical Wetland Fill Since 1803:	1,258 acres
<i>Estimated 45% Loss of Original Rumney Marsh</i>

Successful Project - Sufficient tidal flow: (~9.5' tidal range)

**Tidal Restrictions\***

Green square: Self-Regulating Tide Gate	Red square: Insufficient tidal flow to maintain a healthy salt marsh:
Green circle: Culvert	Red circle: Insufficient tidal flow to maintain a healthy salt marsh:
Red circle: Flap Gate	Red triangle: Insufficient tidal flow to maintain a healthy salt marsh:
Red triangle: Bridge/Waterway	Red diamond: Insufficient tidal flow to maintain a healthy salt marsh:
Grey square: Salt Marsh	Dark grey square: Tidal Flat
Blue dashed line: Historical Creek

Wetlands, Elevation: Mass GIS.  
 Land Fill Areas delineated using current MADEP wetlands layer, 1903 and 1943 USGS topographic maps, and Digital Globe 2007 aerial imagery.  
 Basemap: DigitalGlobe.

ID	Name	Type	Functioning	Phragmites	Status	Notes
A	Ballard St Tidegate	Flap Gate	No	Yes	Potential project	Leaking temporary flap gate
B	Seagirt Ave Marsh Tidegate	Culvert	No	Yes	Potential project	Obstructed 18-inch culvert and ditch
C	Crescent Marsh Culvert	Culvert	No	Yes	Potential project	MA DOT proposed culvert replacement
D	Bristol St Culvert #2	Culvert	No	Yes	Potential project	obstructed ditch; 18-inch culvert
E	Bristol St Culvert #1	Culvert	No	Yes	Potential project	Obstructed culvert and ditch
F	Route 107 Bridges Mitigation	Culvert	Yes		Functioning salt marsh	Failed culvert replaced to restore salt marsh
G	Route 107 E Branch Pines River	Bridge	Yes		Complete	Bridge was replaced, with higher and wider structure
H	Linden Brook Tidegate	Flap Gate	No	Yes	Potential project	Old wooden flap gate
I	Townline Brook Tidegates (3)	SRT	No	Yes	Repairs needed	Three SRTs are not being operated per permit conditions; three bottom floats missing

J	Route 1A Tidegate #1	SRT	Yes		Repairs needed	Missing top floats need replacement for flood control
K	I-95 Embankment	Waterway				Armored crossing of Pines River restricts flow and drainage across marsh
L	Route 1A Tidegate #2	SRT	No		Repairs needed	Missing top floats need replacement; obstructed culvert
M	Copeland Circle Tidegate	Flap Gate	No	Yes	Potential project	Cast iron flap gate only supports salt marsh from leakage
N	Pines River Railroad Crossing	Bridge				Limited vertical clearance at high tide - due to low bridge structure
O	Route 107 Pines River	Bridge	Yes		Complete	Bridge was replaced, with higher and wider structure
P	Route 1A Tidegate #3	SRT	No		Repairs needed	Crushed culvert outlet and stolen grated vault cover need replacement
Q	Route 1A Tidegate #4	SRT	Yes		Repairs needed	Stolen grated vault cover needs replacement
R	Route 1A Tidegate #5	SRT	No	Yes	Potential project	Replace 24" culvert with larger size. 48" SRT stolen grated vault cover needs replacement

S	Route 107 Diamond Creek	Bridge	Yes		Complete	Bridge was replaced, with higher and wider structure
T	Route 1A Tidegate #6	SRT	No	Yes	Repairs needed	Completely obstructed 600 foot long culvert. Stolen grated vault cover needs replacement
U	Oak Island Tidegate	SRT	Yes		Under restoration	New combo gate (2013). Portions of salt marsh restored with muted tidal hydrology
V	Central County Ditch Tidegate	SRT	No	Yes	Repairs needed	Not being operated properly to maximize restoration; needs bottom float installation
