GROUNDWATER ELEVATION CONTOUR MAP JUNE 6, 2017			DESIGNED: JMM
FORMER MCCANDLESS FUELS SITE			DETAILED: SGH
2231 Delsea Drive Franklinville, New Jersey		10 LIPPINCOTT LA. MT. HOLLY, NJ 08060 Tel.(856) 273-1009 Fax.(856) 273-1012 1-866-Remedi-8	CHECKED: JMM
SOURCE: anteagroup 20161101_MCCANDLESS.DWG	FILE NAME: 18016_Fig17A	JOB NO.: 18016	DATE: 11/3/2017
			FIGURE: 15A

POST-OZONE INJECTION
 GROUNDWATER SAMPLING RESULTS
 POLYCHLORINATED BIPHENYLS (PCBs)
 JUNE 7-8, 2017
**FORMER MCCANDLESS
 FUELS SITE**
 2231 Delsea Drive
 Franklinville, New Jersey

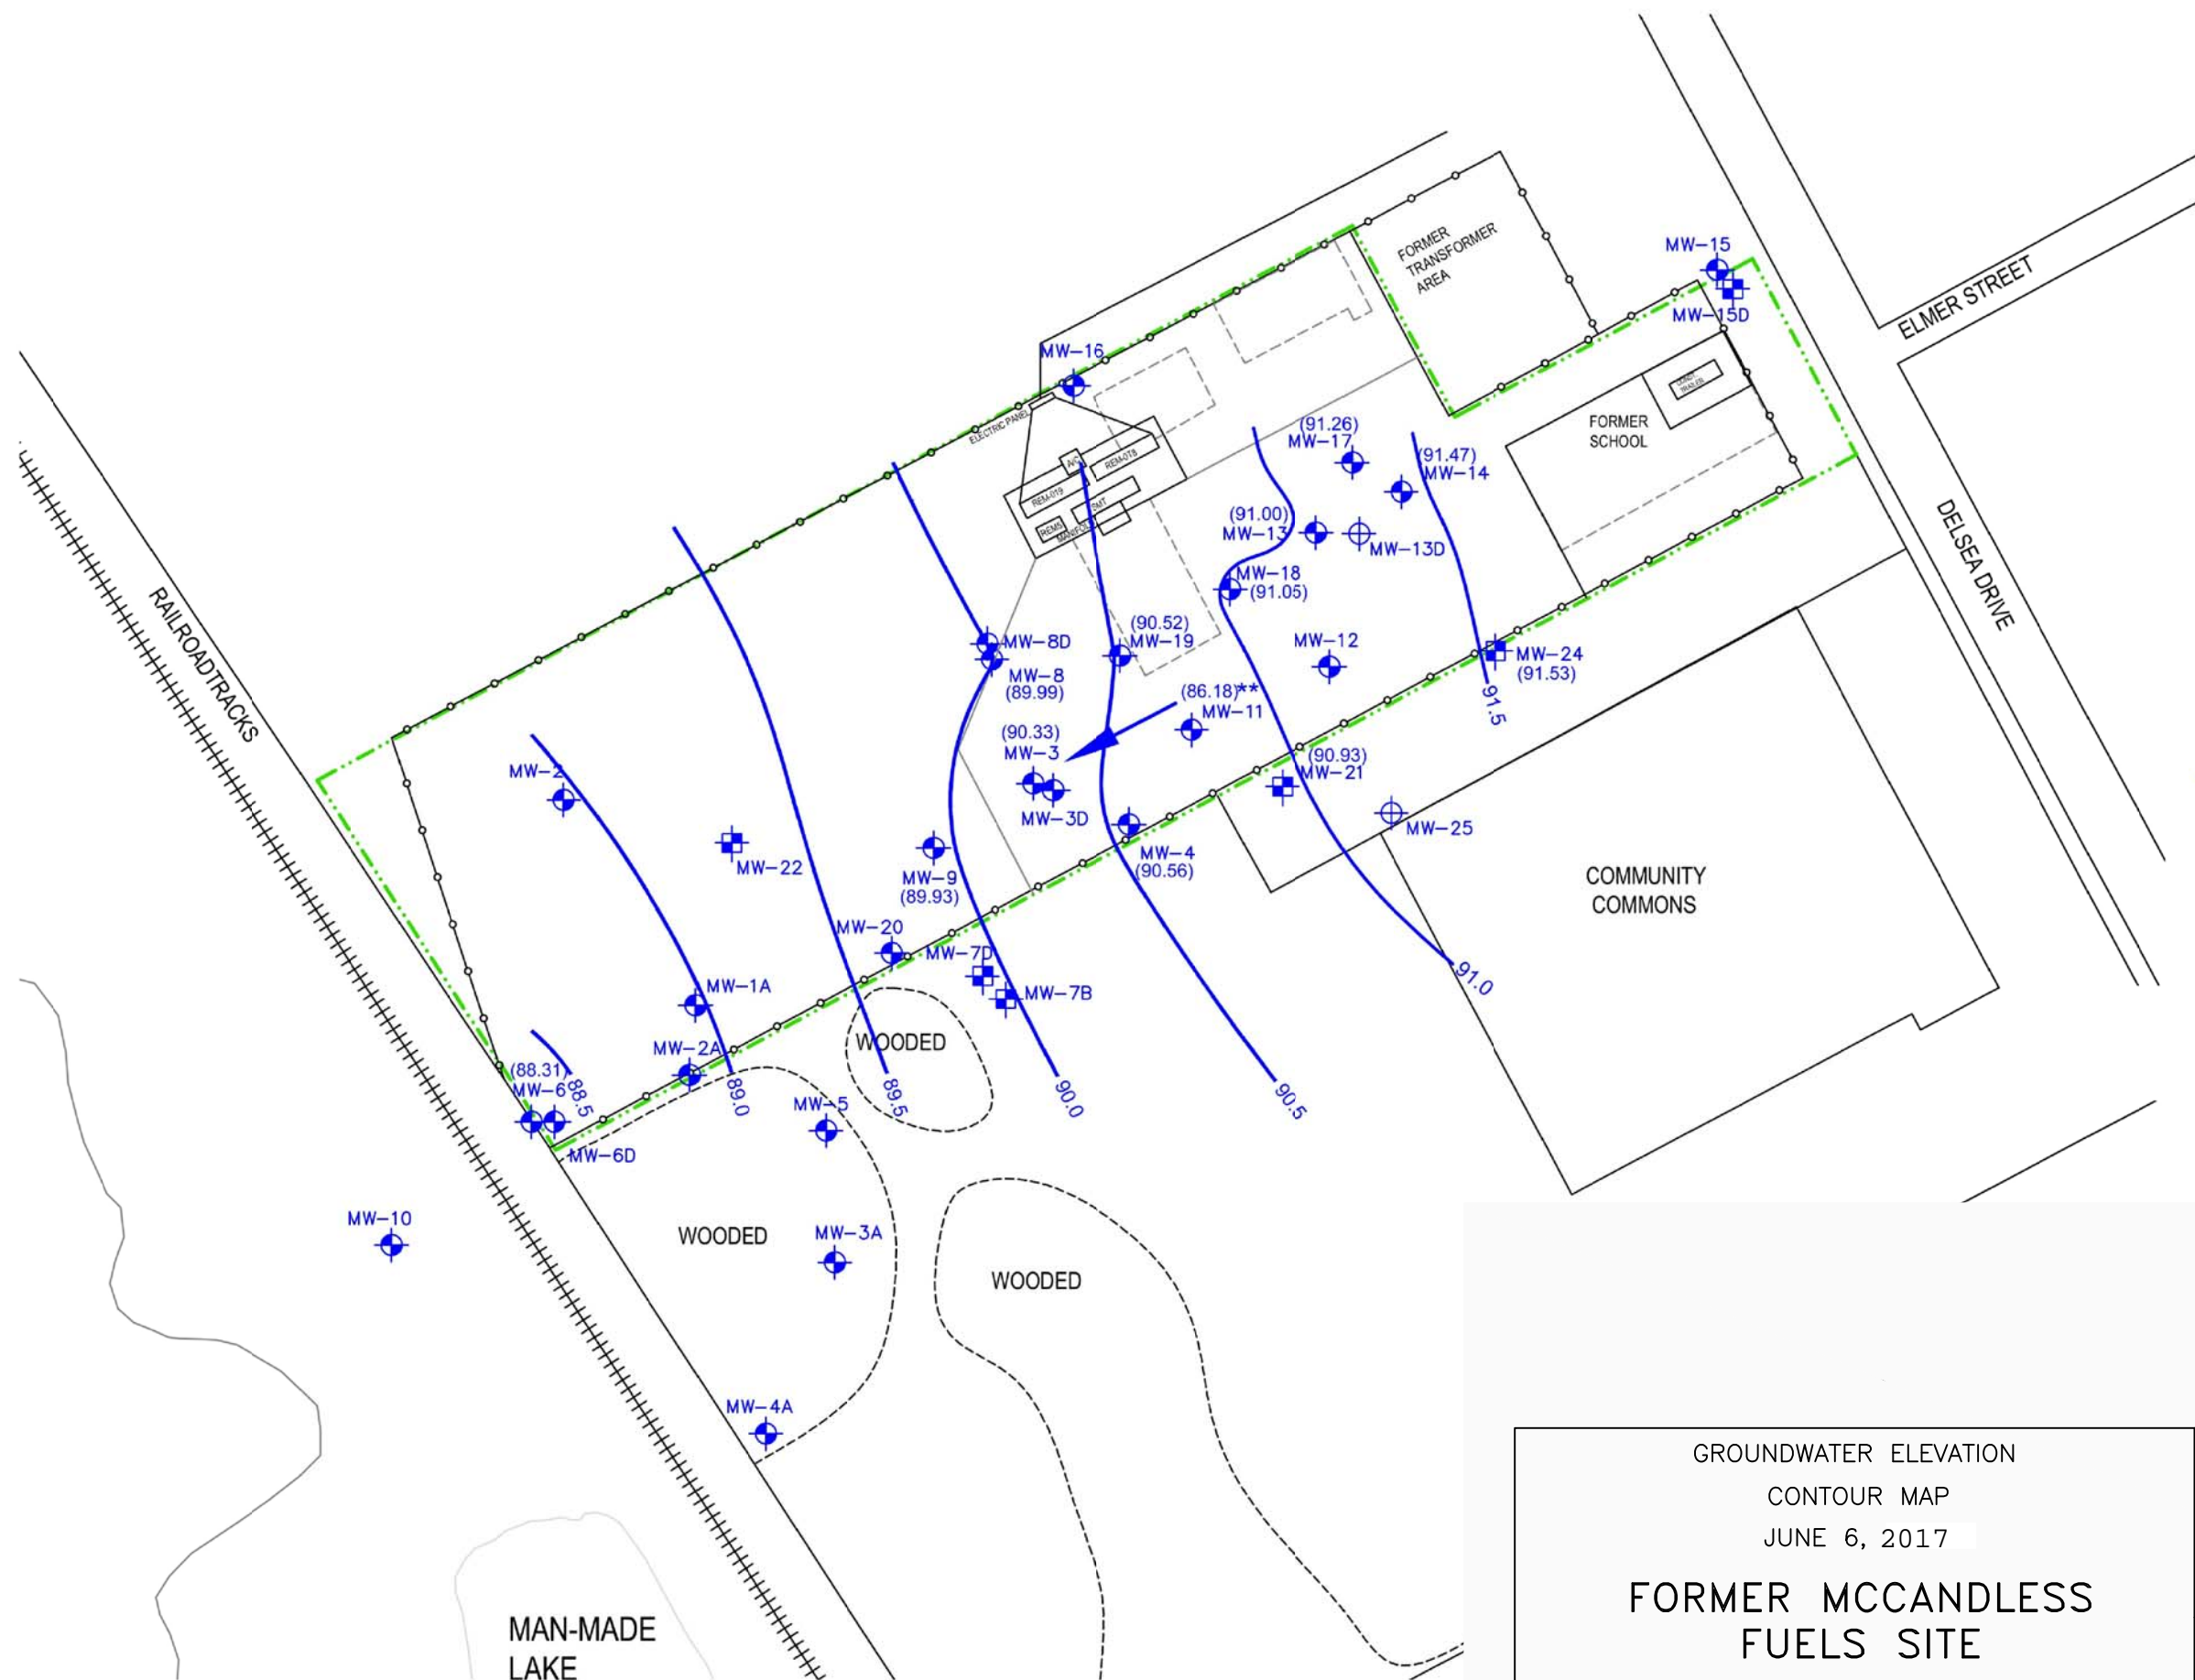
All Elevations Shown in Feet
 Contour Interval = 0.50 foot
 ** Anomalous Elevation Not Used in Contouring

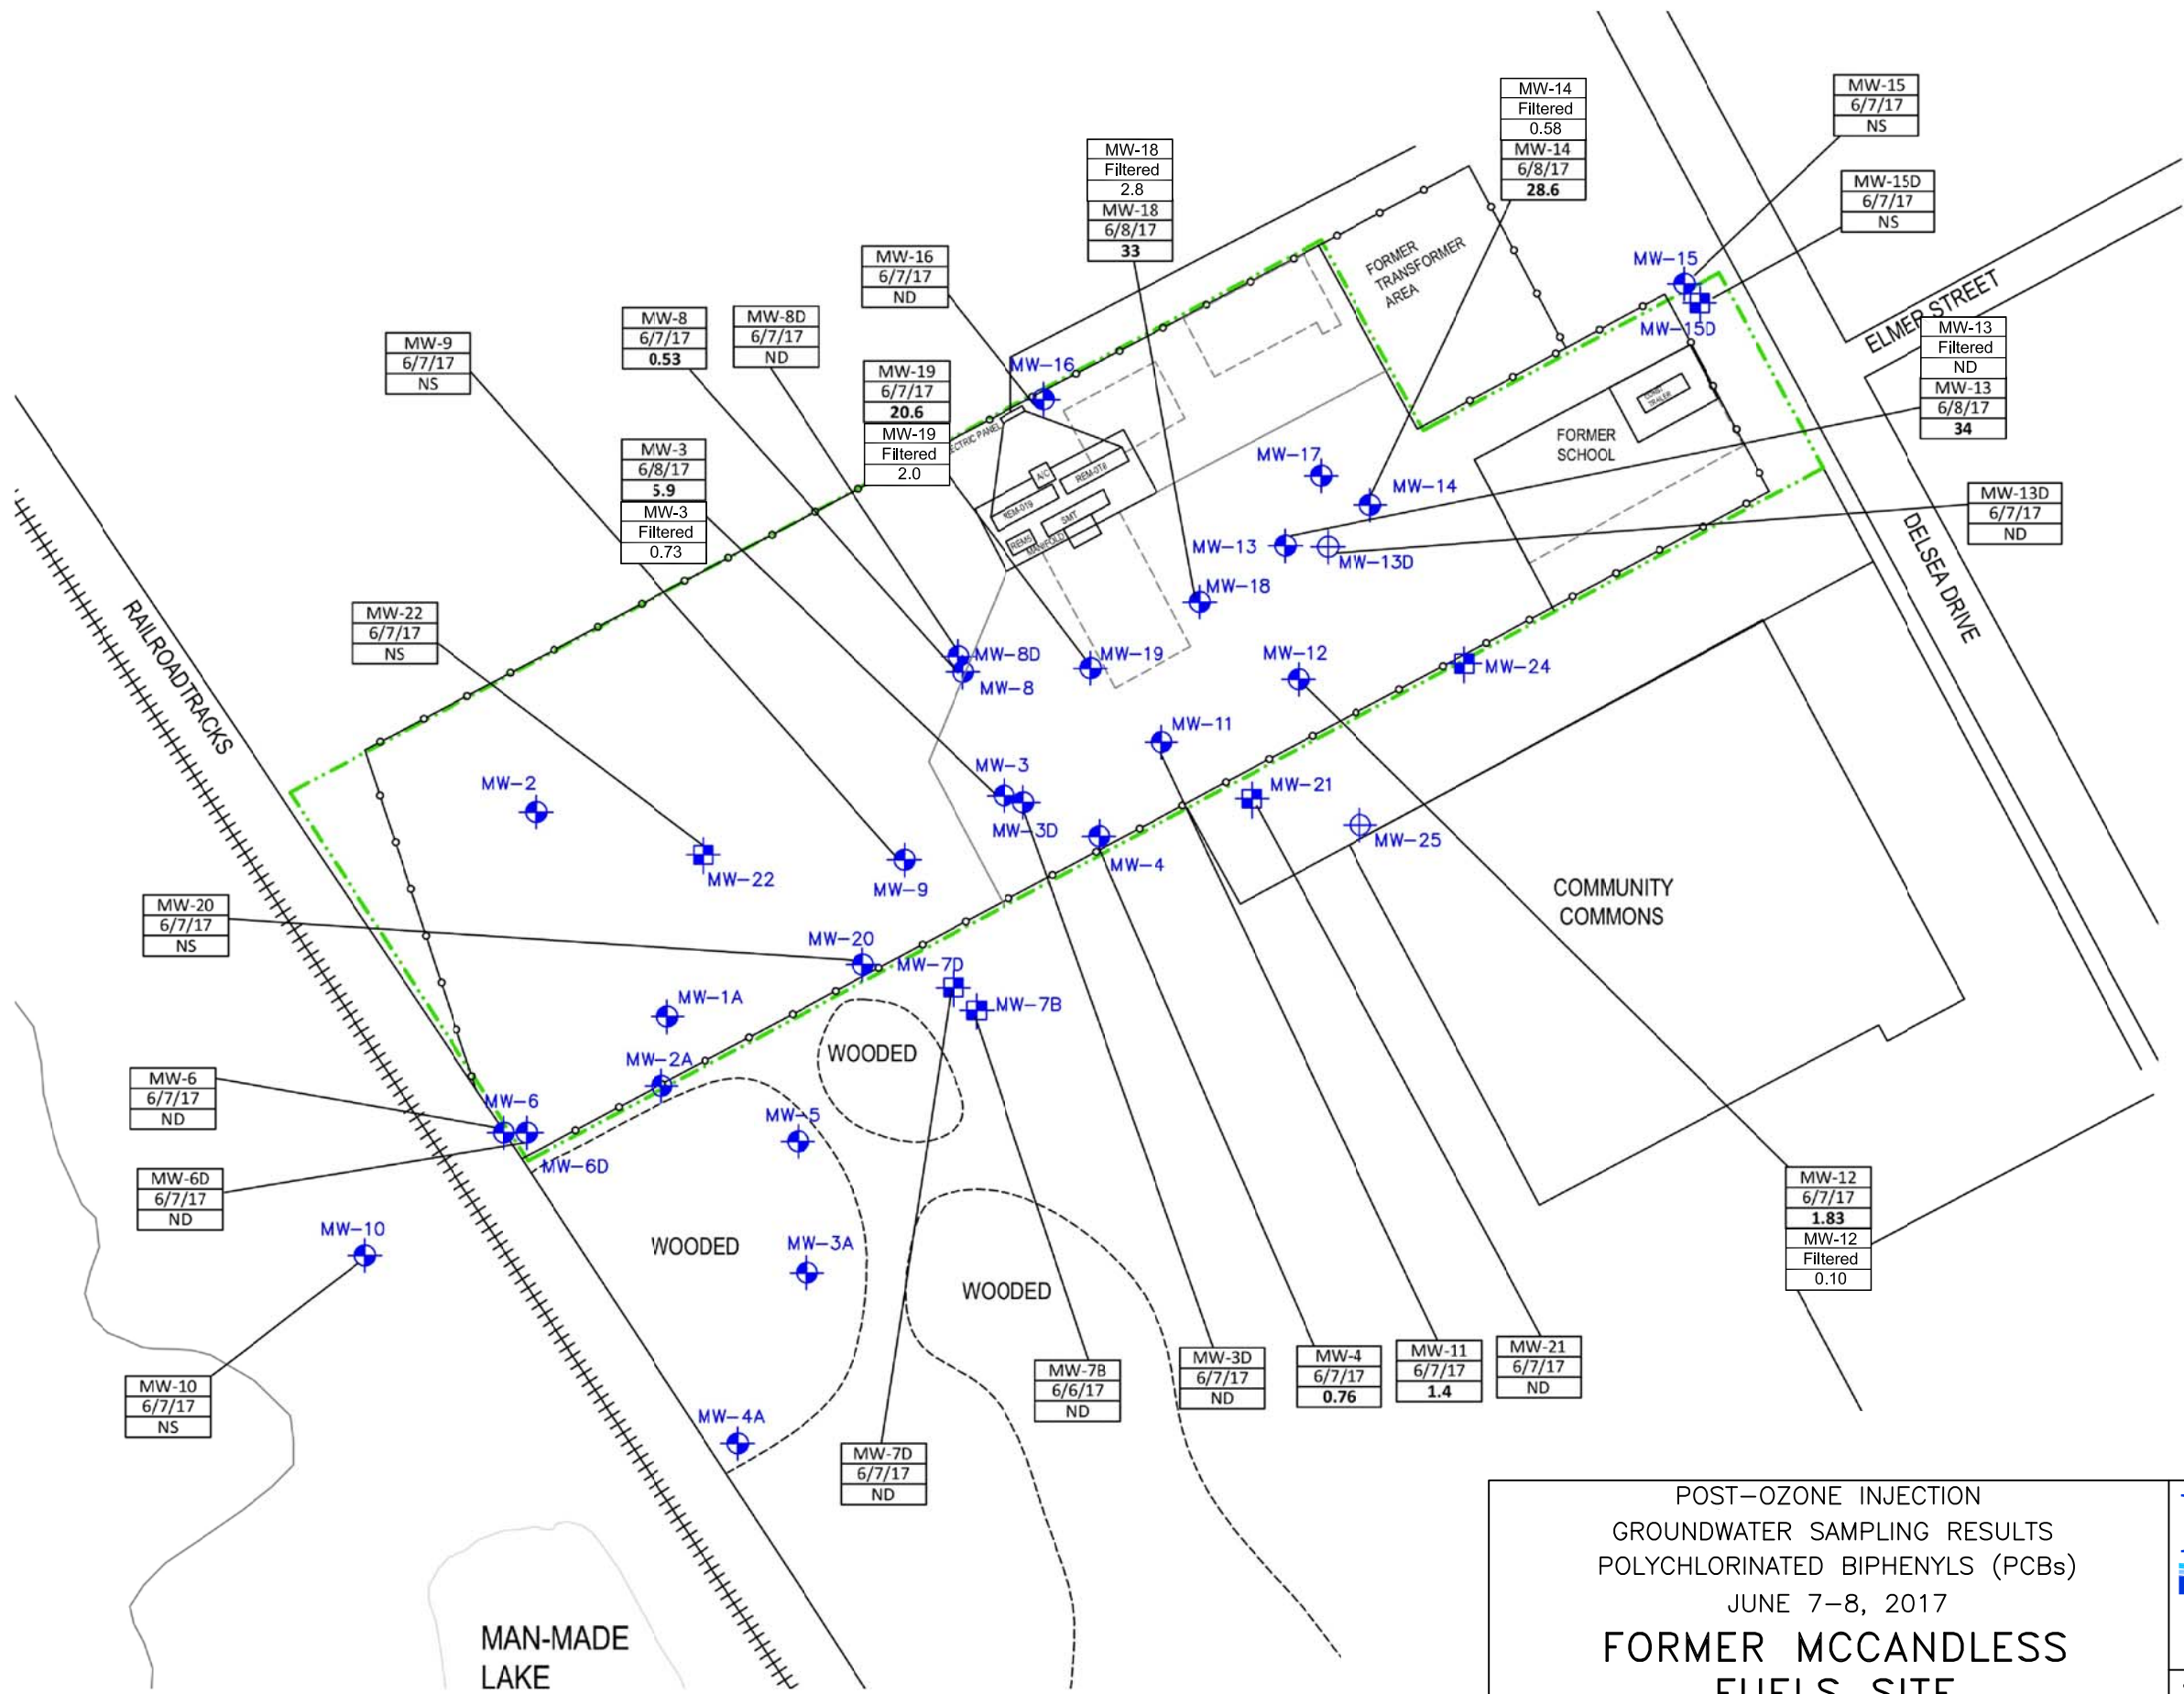
DESIGNED: JMM
DETAILED: SGH
CHECKED: JMM
DATE: 11/3/2017
FIGURE: 15B

Results reported in µg/L (Micrograms per liter).

Bold value exceeds NJDEP Groundwater Quality Standards.
 No exceedances are reported for this sampling event.
