# Characterization of Geologic Structures and Host Rock Properties Relevant to the Hydrogeology of the Standard Mine in Elk Basin, Gunnison County, Colorado

Open-File Report 2010-1008

By Jonathan Saul Caine, Andrew H. Manning, Byron R. Berger, Yannick Kremer, Mario A. Guzman, Dennis D. Eberl, and Kathryn Schuller
Prepared in cooperation with the U.S. Environmental Protection Agency

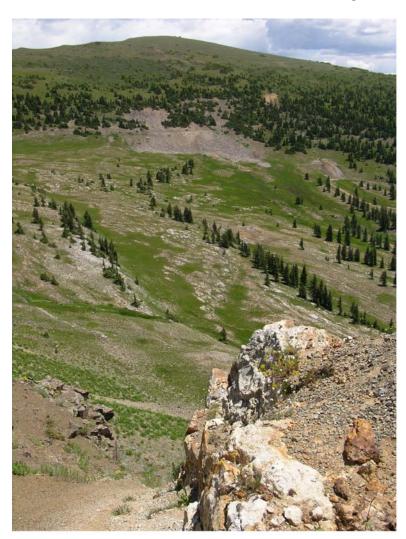
**Figure 5.** Photograph of upper Elk Basin looking east from the cirque ridge. The white rocks at the center base of the photo are part of a fault vein mapped by Gaskill and others (1967). Stratigraphic and geomorphic benches can be seen on the floor of the cirque. The Level 5 portal and an upper adit of the Standard Mine can also be seen in the upper right hand side of the photo.

However, there are numerous "stratigraphic" benches that form a stepped structure to the cirque floor, and this complex surface has been sharply incised by Elk Creek and other lower order stream channels (fig. 5). Some of these benches are cut by meter-wide ribs formed by quartz veins, some wider than 10 m, primarily in the northeastern portion of the upper basin (fig. 10). The Standard and Elk fault veins form first order, subparallel drainage channels. Where the perennial Elk Creek emerges it flows parallel and adjacent to the Elk fault vein on its footwall side. Elk Creek crosses between the Elk and Standard fault veins running south then crosses the Standard (fig. 7). An apparently inactive ephemeral channel has also formed adjacent to part of the surface trace of the Standard fault vein (fig. 7).

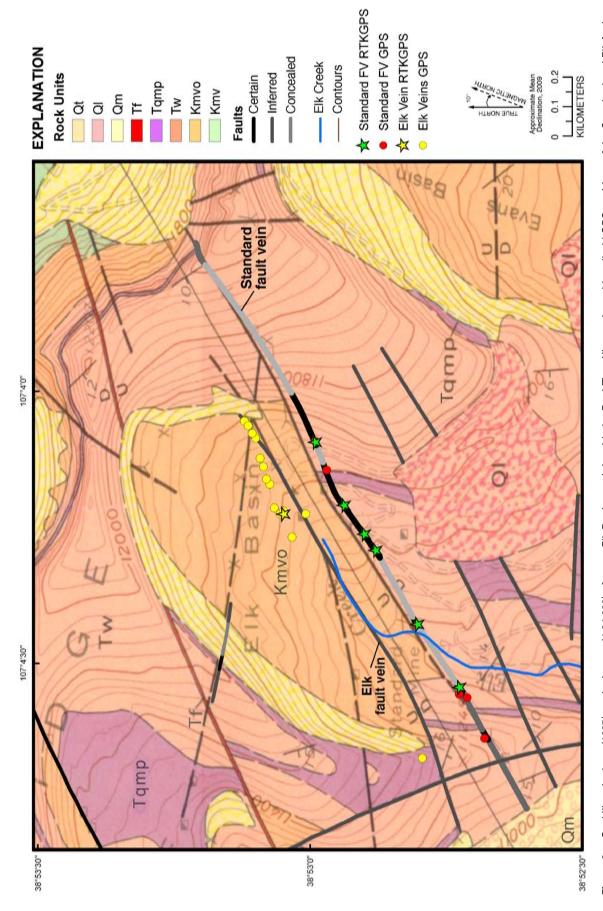
veins. Ot, Quaternary talus deposits; Ol, Quaternary landslide deposits; Om, Quaternary glacial deposits; Tf, Tertiary felsite; Tqmp, Tertiary quartz monzonite porphyry; Tw, Tertiary Gaskill and others (1967) geologic map (1:24,000) of upper Elk Basin overlain with the Real Time Kinematic and handheld GPS positions of the Standard and Elk fault Wasatch Formation; Kmvo, Upper Cretaceous Ohio Creek Member of Mesaverde Formation; Kmv, Upper Cretaceous Mesaverde Formation; FV, fault vein; RTKGPS, real time kinematic global positioning system; GPS handheld global positioning system. Figure 6.

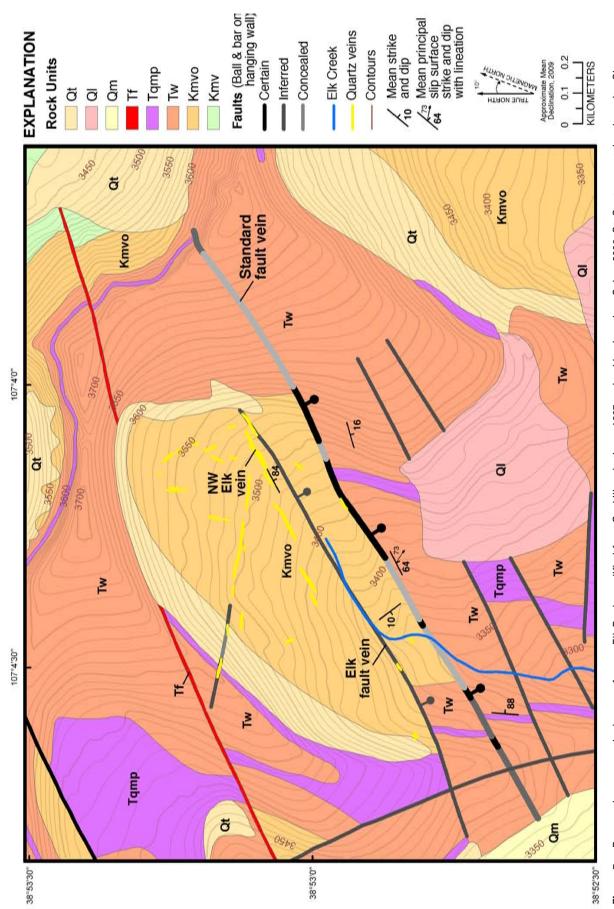
Quaternary landslide deposits; Qm, Quaternary glacial deposits; Tf, Tertiary felsite; Tqmp, Tertiary quartz monzonite porphyry; Tw, Tertiary Wasatch Formation; Kmvo, Upper Cretaceous Mesaverde Formation; Kmv, Upper Cretaceous Mesaverde Formation. Reconnaissance geologic map of upper Elk Basin modified from Gaskill and others, 1967 revised by Jonathan Caine, 2009. Ot, Quaternary talus deposits; Ol, Figure 7.

all observed in Elk Basin. Of 33 fault-related principal slip surfaces measured, a reasonably tight cluster of surfaces has a mean surface orientation of 067/74 (right-hand rule strike/dip) and mean slickenline lineation of  $69^{\circ}$  down from the east-northeast (fig. 9). Although most of these slip surfaces have normal shear sense, some show a minor (rake =  $52^{\circ}$ ) to one showing a moderate (rake =  $28^{\circ}$ ) component of sinistral strike-slip consistent with the mapped separation of the Tqmp dikes (fig. 7) which are near vertical (figs. 9 and 7).

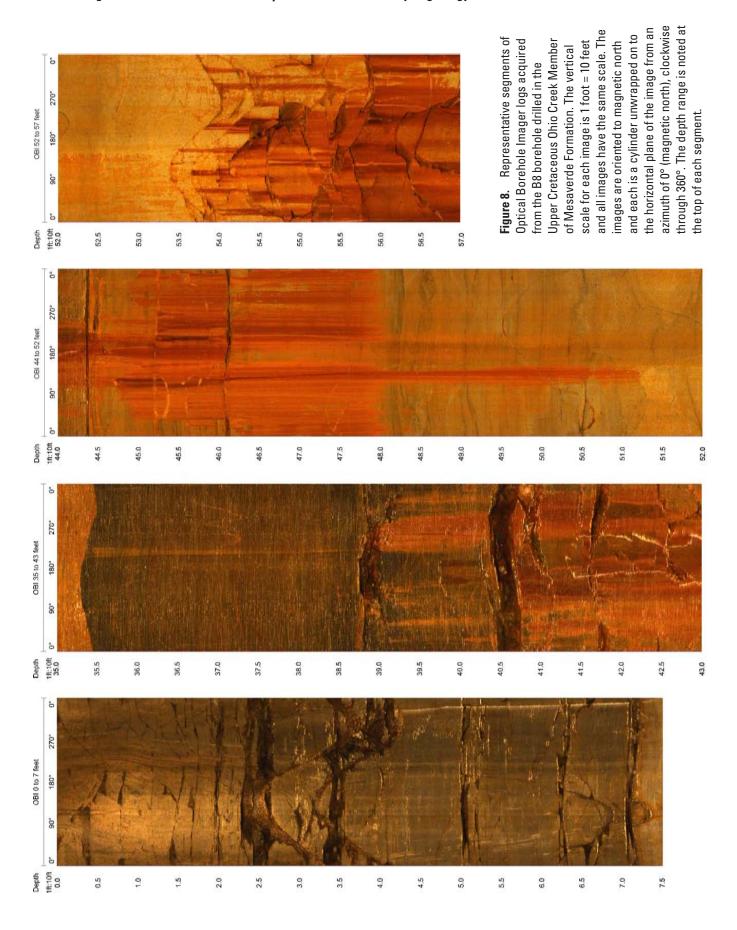
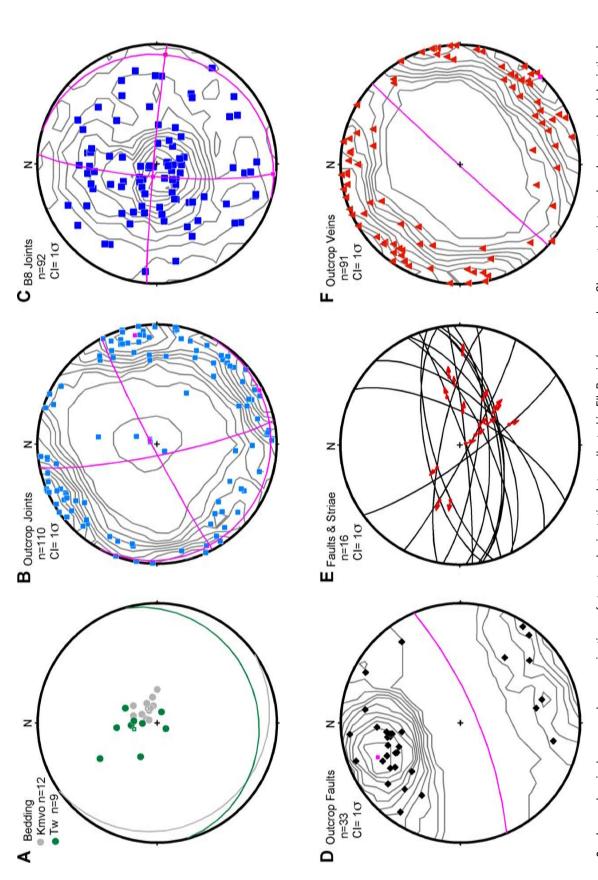
contoured (gray lines) poles (blue squares) to all joints measured from in the B8 borehole image log. (D) Kamb contoured (gray lines) poles (black diamonds) to all faults collected from outcrop. (E) Slip-linear diagram for faults in outcrop that have slickenlines and shear sense indicators. Each black great circle is a single fault with its slip linear shown as a red dot. The red arrows for each dot show the direction of the hanging wall relative to the footwall of each fault. (A) Kamb contoured (gray lines) poles (red triangles) to all quartz circles). The mean great circles for each formation are shown. (B) Kamb contoured (gray lines) poles (blue squares) to all joints collected from outcrop (Kamb, 1959). (C) Kamb or polymetallic veins collected from outcrop. The mean vectors and great circles for assumed cylindrical best fits to each data set are shown in pink (see Allmendinger, 2004). (A) Poles to bedding data collected in outcrop for the Upper Cretaceous Ohio Creek Member of Mesaverde Formation (gray circles) and Tertiary Wasatch Formation (green Figure 9. Lower-hemisphere, equal-area projections of structural orientation data collected in Elk Basin (n = number, Cl = contour interval, and  $\sigma$  = standard deviation).

- 4. Bedding in both Ohio Creek and Wasatch dip gently  $(10^{\circ}-20^{\circ})$  to the south and southwest (fig. 9).
- 5. Stratigraphic formation contacts were not found; however, unit contacts in each formation are generally curviplanar and where channel fill exists there has clearly been erosion. Talus and other surface deposits lie unconformably and nonuniformly on bedrock.

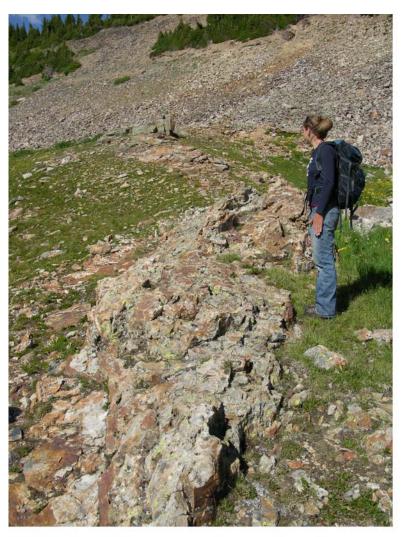
**Figure 10.** Photograph looking northeast at a pinching and swelling massive to stockwork barren quartz vein in the eastern portion of upper Elk Basin.

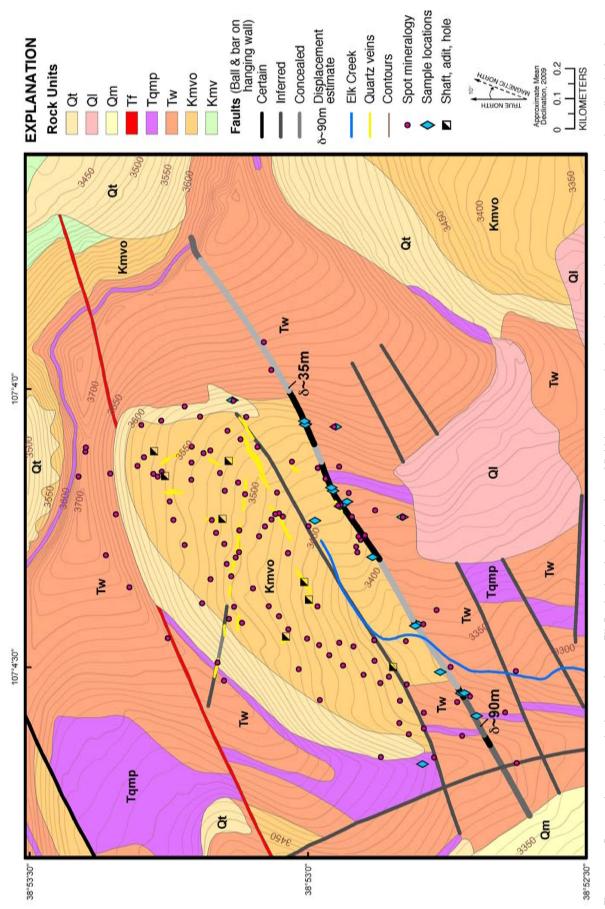
deposits; Tf, Tertiary felsite; Tqmp, Tertiary quartz monzonite porphyry; Tw, Tertiary Wasatch Formation; Kmvo, Upper Cretaceous Ohio Creek Member of Mesaverde Formation; Figure 11. Reconnaissance geologic map of upper Elk Basin showing the locations of field-based spot mineralogy determinations, fault-vein rock samples, adits, shafts, dog holes, and estimates of net displacement (8). Modified from Gaskill and others, 1967. Ot, Quaternary talus deposits; Ol, Quaternary landslide deposits; Om, Quaternary glacial Kmv, Upper Cretaceous Mesaverde Formation

Figure 11 is a geologic map showing the locations of approximately 150 spot mineralogy determinations in the upper Elk Basin. At these localities hand sample mineralogy

southeasternmost exposure where the fault separates a vertical dike (unit Tqmp, fig. 11), the computed net displacement is approximately 90 m, top down to the southeast (fig. 11). This displacement is normal with a minor component of sinistral motion, given that the slickenline rake was 52° down from the northeast and assuming that the bulk motion is representative along this segment of the fault zone. On the basis of the assumed position of Ohio Creek–Wasatch contact just below and at the end of the Level 5 tunnel projected to the surface, the minimum net displacement is approximately 35 m, top down to the southeast. The data are insufficient to evaluate whether these differing displacements indicate a displacement gradient, as is common with normal faults.

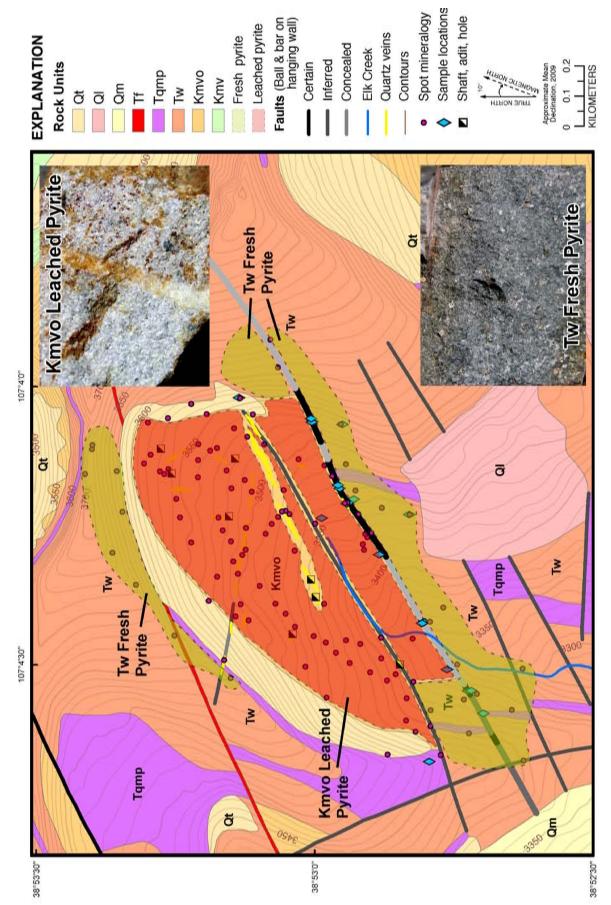
from freshly broken hand samples from the ground surface. Photographs show examples of orange, iron oxide staining in cubic holes where pyrite likely originally resided in Ohio Reconnaissance geologic map of upper Elk Basin showing the spot mineralogy and extent of leached pyrite (orange overlay) versus fresh pyrite (light green overlay) and others, 1967. Ot, Quaternary talus deposits; Ol, Quaternary landslide deposits; Om, Quaternary glacial deposits; Tf, Tertiary felsite; Tqmp, Tertiary quartz monzonite porphyry; Creek Member of Wasatch Formation (top, sample face is about 2 by 3 in) and fresh pyrite in Wasatch Formation (bottom, sample face is about 2 by 3 in). Modified from Gaskill Tw, Tertiary Wasatch Formation; Kmvo, Upper Cretaceous Ohio Creek Member of Mesaverde Formation; Kmv, Upper Cretaceous Mesaverde Formation. Figure 12.

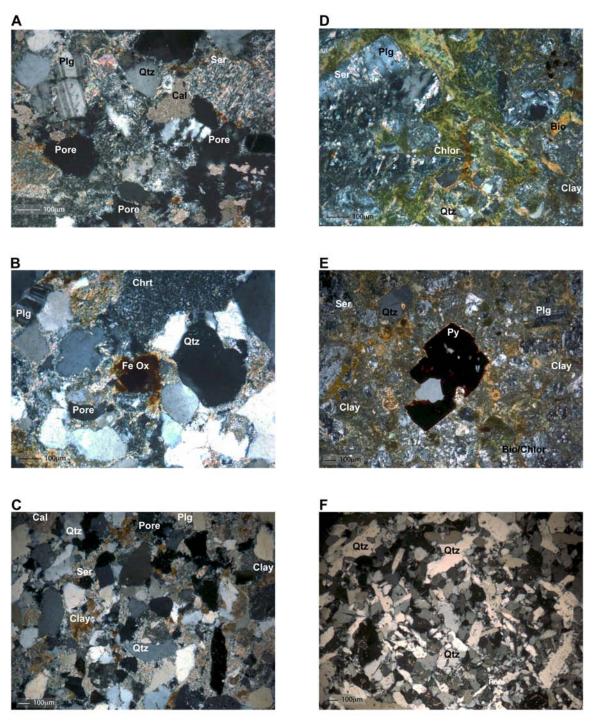
Figure 13. Thin section photomicrographs of representative outcrop samples from Elk Basin. (A) Ohio Creek Member of Wasatch Formation footwall protolith sandstone, about 20 m northwest of the Standard fault vein near the Level 1 portal (sample 70909 7A). (B) Toc footwall protolith sandstone, about 100 m northwest of the Standard fault vein at the Level 3 portal (sample 70909 14A). (C) B8 drill core Ohio Creek footwall protolith sandstone, about 3 m northwest of the Standard fault vein below the Level 2 portal from 23 m below ground surface, 5x magnification (sample B8 75 Feet). (D) and (E) Wasatch hanging wall protolith sandstone, about 80 m southeast of the Standard fault vein between the Level 4 and 5 portals, view (E) is 5x magnification (sample 72209 10A). (F) Wasatch Formation hanging wall damage and mineralized zone, about 1 meter southeast of the Standard fault vein at the Level 1 portal, 5x magnification (sample 72209 10A). Abbreviations include: Qtz = quartz, Plg = plagioclase feldspar, Cal = calcite, Pore = pore space, Chrt = chert, Clay = unidentified clay minerals, Fe Ox = iron oxidation, Py = pyrite, Chlor = chlorite. Scale bars are show at the bottom of each image, all images use crossed polarized light and are 10x magnification unless noted.

Standard size thin sections from surface outcrops of Ohio Creek quartz sandstones show subrounded to rounded grains of quartz, calcic plagioclase, potassium feldspar, muscovite, chert, some lithic fragments, and clots of organic-rich clay (fig. 13). No evidence of silicification was observed. Many feldspars are fresh and some, particularly potassium feldspars, are pseudomorphically replaced by sericite. Pervasive sericite and clays indicate weak argillic hydrothermal alteration (fig. 13). Minor to moderate amounts of calcite are found as a late pore space infill. The pore structure is generally tight with the exception of numerous but isolated holes ranging from about 100s of microns to millimeters in size. Some of these holes have iron oxide staining around them, and the few pseudomorphic grains of what likely was pyrite have been transformed into translucent cubes of iron oxide. One thin section from the B8 drill core at 75 ft below the ground surface shows all of the same characteristics as the surface samples except there are fresh pyrite and partially reacted pyrite grains (fig. 13).

The Wasatch Formation is compositionally and texturally immature (fig. 13). Thin sections of representative sandstones show subhedral to rounded grains of calcic plagioclase, quartz, and biotite; trace amounts of amphibole; and opaque minerals including euhedral pyrite. A variety of lithic fragments, opaque organic materials, and abundant clay minerals are also present. No evidence of silicification was observed and feldspars are fresh to pseudomorphically altered to sericite. Pervasive sericite, moderate amounts of disseminated pyrite and calcite, with minor chlorite is also found and indicates weak propylitic hydrothermal alteration.

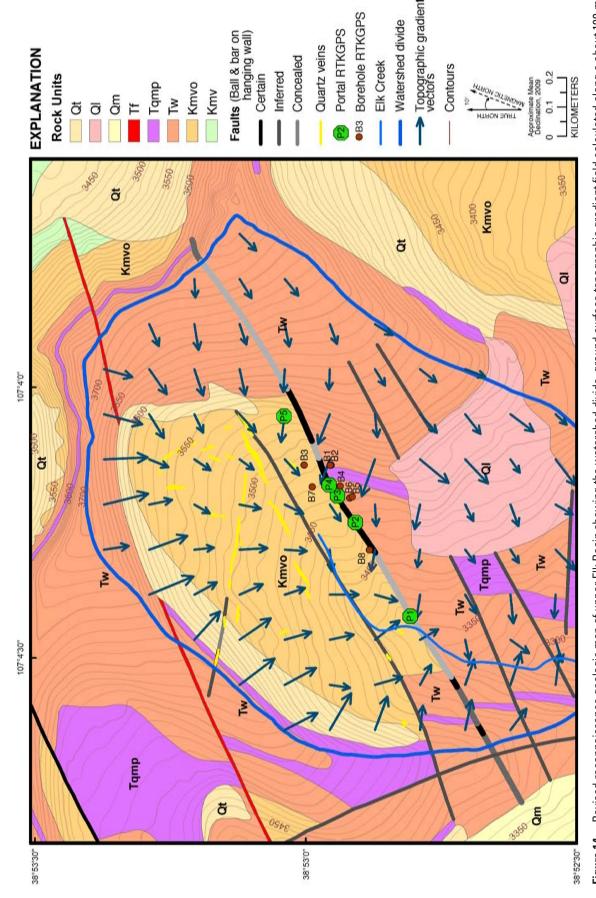
Revised reconnaissance geologic map of upper Elk Basin showing the watershed divide, ground surface topographic gradient field calculated along a about 100-m determined from Real Time Kinematic GPS data. Modified from Gaskill and others, 1967. Ot, Quaternary talus deposits; Ol, Quaternary landslide deposits; Om, Quaternary glacial deposits; Tf, Tertiary felsite; Tqmp, Tertiary quartz monzonite porphyry; Tw, Tertiary Wasatch Formation; Kmvo, Upper Cretaceous Ohio Creek Member of Mesaverde Formation; square grid (blue arrows with length proportional to the magnitude of the gradient), mine portal (PX, purple hexagons), and monitoring borehole (BX, brown dots) locations Kmv, Upper Cretaceous Mesaverde Formation. Figure 14.

Figure 14 shows a vector diagram overlain on the geologic and topographic map of Elk Basin. The vectors (arrows) indicate the relative magnitude (arrow length) and direction of ground surface elevation gradients computed at points on a roughly 100-m square grid from the National Elevation Dataset, 30-m Digital Elevation Model georeferenced to the Elk Basin geologic map. Although the actual direction of surface and shallow groundwater flow is unknown, this

diagram shows the potential direction that this water might flow. Surface water includes water that flows directly on bedrock pavements and in the many low order stream channels and rivulets on top of surficial deposits and soils ("runoff"). By "shallow groundwater" we mean groundwater within the unconsolidated surficial deposits and the uppermost bedrock (to depths of about 3 m) that is either perched or at the very top of the saturated zone. The flow direction of surface and shallow groundwater would almost certainly deviate on a local scale from that shown in figure 14 owing to obstruction by physical features, such as large quartz veins, and by variations in the permeability of surficial deposits and shallow bedrock. However, figure 14 serves as a reasonable approximation of the general direction of surface and shallow groundwater flow on the larger scale of an entire hillslope. Further discussion related to figure 14 refers to the assumed surface and shallow groundwater flow direction depicted on the figure as "shallow flow"The computed gradient field shows that shallow flow moves from the crest of the cirque inward and downhill with semiradial convergence between the ground surface traces of the Elk and Standard fault veins (fig. 14). Most vectors above the Level 1 portal are parallel to the Standard fault-vein trace in the footwall or trend into the fault vein on the hanging wall side. Figure 14 shows that an appreciable number of vectors that intersect with the Standard fault vein originate from the Wasatch hanging wall side as well as the Ohio Creek footwall side. It should be kept in mind that the actual direction of groundwater flow may be considerably different than shown figure 14, particularly the deeper groundwater flow field which may be more influenced by the larger, watershed-scale topography and less by the detailed near-surface topography.

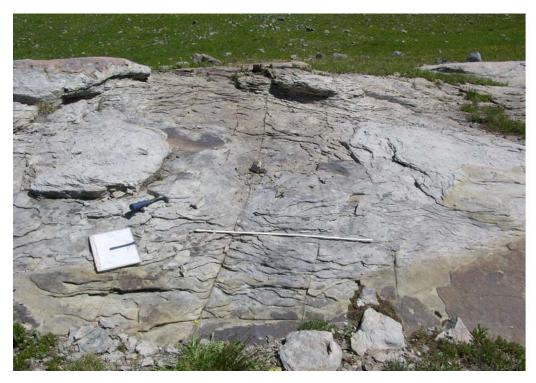
**Figure 15.** Outcrop photograph of Ohio Creek Member of Mesaverde Formation protolith pavement in the upper central part of Elk Basin. The near-vertical joints trend northeast and subhorizontal joints can be seen along cross bedding parallel partings. The carpenters rule is 1 m long.

The third major joint set is a subhorizontal one that also shows great dispersion. Joints in this set are measured both in outcrops and in the borehole televiewer log (figs. 15 and 16). The borehole televiewer log offers a biased view of joint orientations, because it does not capture most near-vertical joints that are subparallel to, but do not intersect, the vertical borehole. On the other hand, joints measured in outcrop can offer a biased view of subhorizontal joints if the height of the outcrop is small. Caine and Tomusiak (2003) provide an exhaustive treatment of joint measurement biases. Subhorizontal joints have dips ranging from a few degrees to 30° or 40° and strikes in virtually every direction with a moderately strong cluster striking south (fig. 9). Many of these joints form parallel to bedforms, particularly crossbeds (fig. 8).

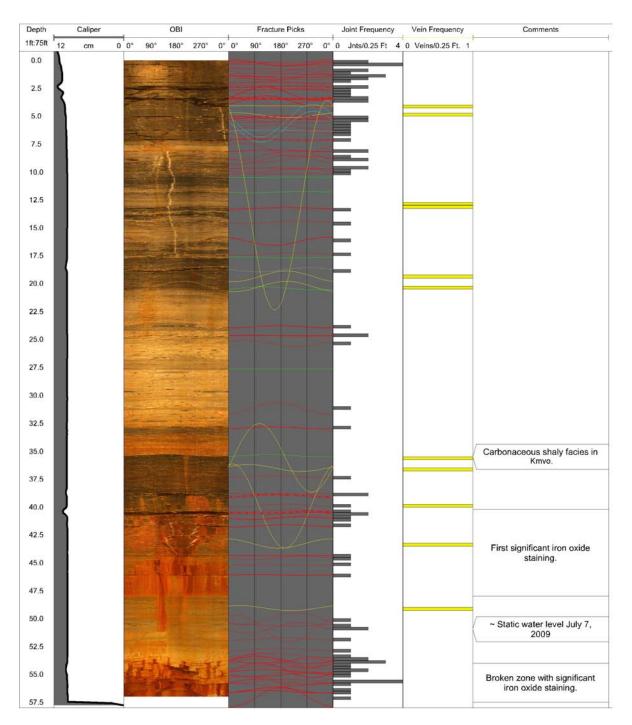
**Figure 16.** Borehole geophysical logs acquired from the B8 borehole. The vertical scale for each image is 1 ft = 75 ft (see fig. 8 with vertical scale of 1 ft = 10 ft). The caliper log shows the average diameter of the open borehole walls and the outer portion is shaded. The Optical Borehole Image log is oriented to magnetic north and is a cylinder unwrapped on to the horizontal plane of the image from an azimuth of  $0^{\circ}$  (magnetic north), clockwise through  $360^{\circ}$ . The Fracture Pick log shows sinusoids from each joint (red), bedding horizon (green), broken zone (blue), or vein (yellow) encountered in the borehole. Joint and vein frequency logs are simple counts of the number of features per 0.25 ft of depth in the borehole. The comment log shows a variety of interpreted features encountered in the borehole.

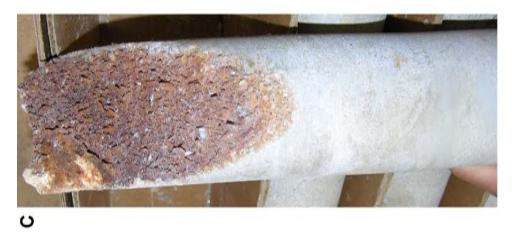
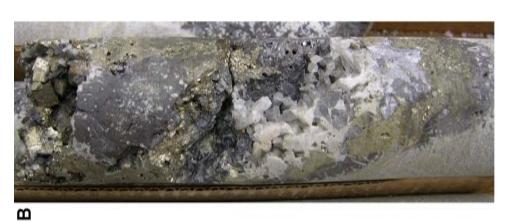
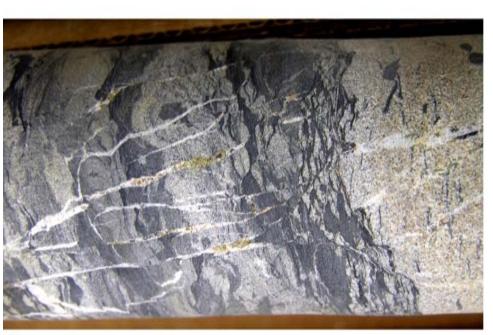
damage zone of the Standard fault vein. Each core is approximately 2 in. in diameter. (A) 76 ft, small quartz + pyrite fault veins; (B) 114 ft, vuggy quartz + pyrite + galena + sphalerite vein; (C) 170 ft, iron oxide stain on euhedral quartz vein. Figure 17. Photographs of drill core from borehole B8, just below Portal 2 of the Standard Mine, in the Ohio Creek Member of Mesaverde Formation footwall

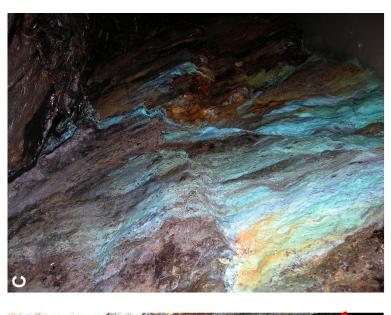
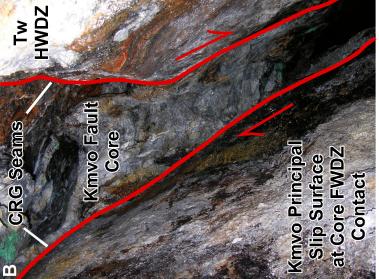
principal slip surface, Ohio Creek fault core, and Wasatch Formation (Tw) hanging wall in Level 3. The fault core is up to 60 cm wide here. (B) Annotated version of figure 18A. Figure 18. Photographs of the Standard fault vein from Levels 3 and 5 in the Standard Mine. (A) View of the Ohio Creek Member of Mesaverde Formation (Toc) footwall (C) Asymmetric groundwater flow and probable copper-rich precipitate on the Ohio Creek footwall principal slip surface of the Standard fault vein in Level 3.

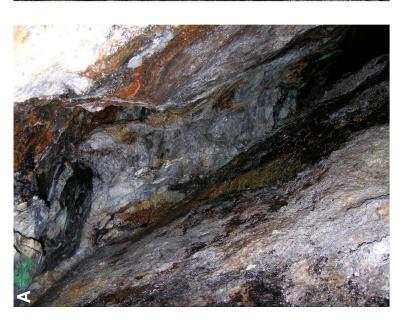
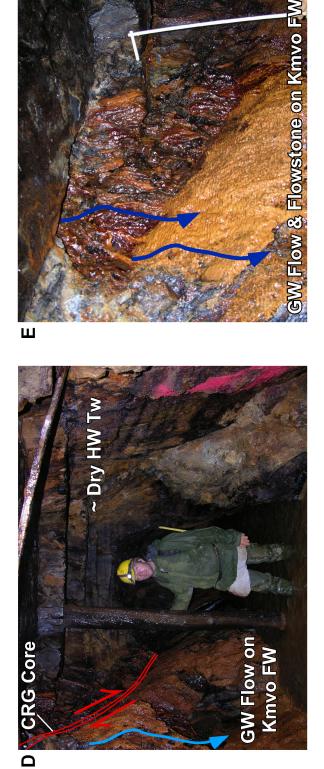
(blue arrows) on the tripe-like (orange-beige to ochre) and drapestone-like (blood-red) flowstone types on the Ohio Creek footwall principal slip surface of the Creek footwall principal slip surface of the Standard fault vein in Level 5. Note the Wasatch hanging wall is nearly dry. (E) Detail view of groundwater flowing Standard fault vein in Level 3. CRG, clay-rich gouge; HW, hanging wall; HWDZ, hanging wall damage zone; FW, footwall; FWDZ, footwall damage zone; GW, Figure 18.—Continued Photographs of the Standard fault vein from Levels 3 and 5 in the Standard Mine. (D) Asymmetric groundwater flow on the Ohio groundwater.

The footwall damage zone-core contact is a nearly continuous sharp, curviplanar, variably striated slip surface in both Levels 3 and 5, except at the end of Level 5 where there are relays (fig. 18). The fault core is distinctive, and at this FWDZ contact it is composed of clay and pyrite-rich fault gouge. This clay-rich seam pinches and swells in thickness but is generally a few centimeters wide. In several places the fault core structure swells to decimeters in width. Near this swelling, the core is composed of a variably thick, highly deformed, argillically altered, and locally brecciated lens of Ohio Creek with minor quartz veins and disseminated pyrite sandwiched between a second seam of pyritiferous clay-rich gouge at the contact with the hanging wall damage zone (HWDZ) and Wasatch Formation. No Wasatch was observed in these lenses and the clay gouge appeared to have primary affinity with Ohio Creek. The fault core total width was measured in numerous locations underground and ranges from 2 to 65 cm with a median of 14 cm (fig. 18). Lenses of entrained Ohio Creek are on the order of several meters long and are parallel to the strike of the master fault. Although a HWDZ occurs in the Wasatch Formation it decreased in intensity within about 1-1.5 m of the fault core-HWDZ contact, which, like the footwall, is a discrete curviplanar slip surface. The HWDZ shows numerous small faults, few veins, disseminated pyrite, and possible localized folding against the core. An argillic alteration halo associated with the Wasatch HWDZ is notably absent.

An important observation in both the Level 3 and Level 5 tunnels of the Standard Mine was that a significant amount of water was entering the mine workings asymmetrically with respect to the strike of the fault zone and was found predominantly on its footwall side (fig. 18). Some flow was entering on the hanging wall side of the fault zone, but there were many more locations of emergence and the overall magnitude of flow was significantly larger on the Ohio Creek footwall. Asymmetric flow was discrete or appeared as sheets a few meters in width. The flow emanated from the footwall damage zone contact with the footwall side of clay-rich core and possibly from fractures in the FWDZ. The footwall slip surface is coated with

a large variety of precipitates, many in shades of ochre, orange, blue-green, and white (Manning and others, 2007). These surface coatings obscured the details of points of emergent flow. Very little flow emanated from within the fault core itself and at many locations with substantial flow along the footwall, the adjacent hanging wall, HWDZ and hanging wall core gouge were dry (fig. 18).

Not only is flow asymmetric at the present locations of flow along the fault zone, but deposits of flowstone are extensive. The composition of the flowstone is undetermined. These deposits are extensive and range from a few centimeters wide to several meters wide and meter-long panels. The textures range from tripe-like sheets to drapestone-like curtains. Many of the drapestone formations have a blood-red color whereas the tripe-like flowstone is commonly orange-beige to ochre. Extensive, asymmetric footwall flowstone at a major fault relay with a dry hanging wall was also observed in Level 5 (fig. 18).

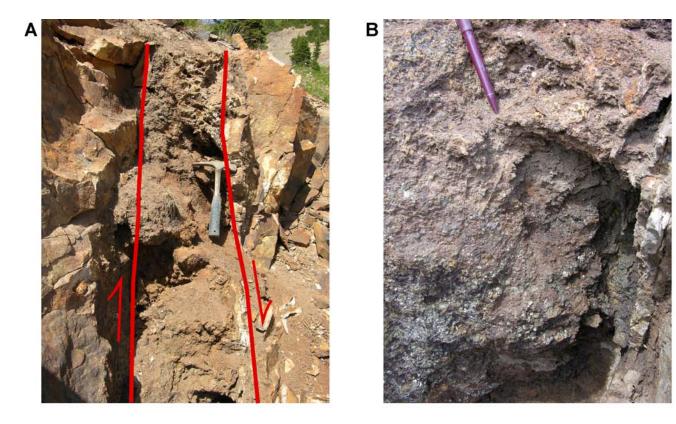
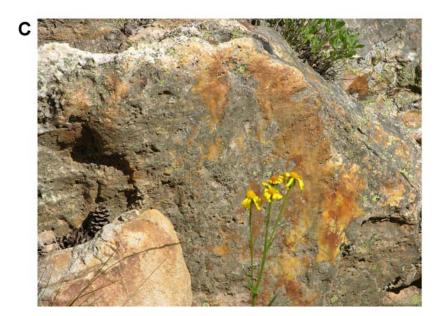
**Figure 19.** Photographs of the Elk fault vein and a bounding polished slip surface on a fault vein composed of quartz. (A) Annotated view of the Elk fault vein looking northeast. (B) Detail of the core of the Elk fault vein showing massive pyrite core, vugs, and hanging wall marginal galena with normal shear sense. (C) Polished and striated principal slip surface of a quartz fault vein. Note the near-vertical striations on the surface to the right of the flowers.

Observations of the nearly vertical Elk fault vein were sparse, but where it is exposed, it appears to be very different in character compared to the subparallel Standard fault vein. Although the surface trace of the Elk is mapped as a continuous feature, in several places the continuity of structure is broken by steps or segmentation (figs. 6 and 7). No suitable piercing points were found along the Elk to estimate net displacement, but in its central region it is intraformational because no other formations are exposed in its hanging wall. It also appears to tip out at its northeastern end. Qualitatively, little fault-related damage was seen on either side of the structure; however, the fault vein itself is jointed. The Elk fault-vein core is exposed at one of the main shafts west of the Level 4 tunnel of the Standard Mine, and at this location the core of the Elk fault vein is 32 cm wide and composed of massive to vuggy, coarse-grained, and largely unweathered pyrite (fig. 19). The hanging wall side of the fault-vein core is composed of a deformed mass of galena; the shear sense is compatible with normal, top down to the southeast motion. This mass of pyrite clearly intersects the ground surface; however, no such intersections of the Standard fault vein were exposed. There are other minor faults and fault veins in upper Elk Basin; however, little evidence was found for the existence of many of the faults inferred from lineament analysis or mapped by Gaskill and others (1967).

Numerous quartz and polymetallic quartz veins are exposed in the upper Elk Basin that are not shown on published maps. Some of these veins are associated with minor normal faults where in every case the vein margins show evidence for motion manifested by polished and lineated striations of the surfaces (fig. 19). Exposed trace lengths range from about 2 m to more than 200 m (fig. 7). These larger veins appear to occur primarily in Ohio Creek but less so in Wasatch within the cirque. Although they are not completely exposed, at several exposures the tips or ends of the veins can be observed, and thus these features are discontinuous. Many of these veins are jointed.

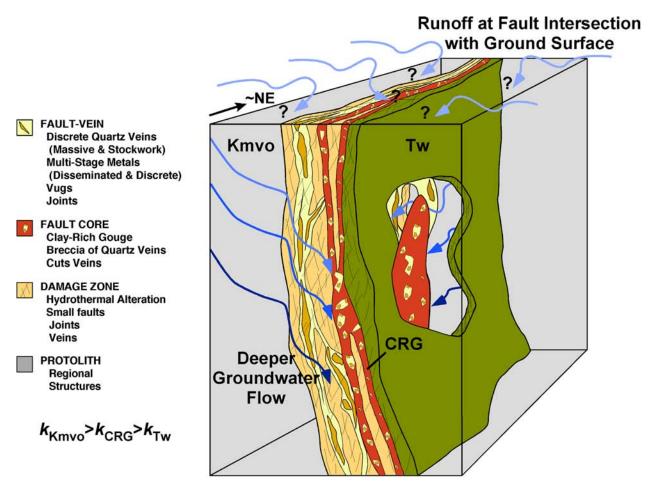
**Figure 20.** Conceptual diagram for the architecture and permeability structure of the Standard fault vein and its possible interactions with surface and groundwaters. Each architectural component of the fault vein is shown and the fractured protolith is removed. The fault juxtaposition of Wasatch Formation on Ohio Creek Member is shown with a cutout through the Wasatch hanging wall. The cutout illustrates the heterogeneity and three dimensionality of the fault vein and its possible behavior as a combined conduit-barrier impeding deeper groundwater flow from the footwall through the fault into the hanging wall but allowing downflow or lateral flow along the fault. The curved blue arrows depict the possible tortuous flow paths and possible decoupling of oxygenated surface waters (light blue) from less oxygenated groundwaters (darker shades of blue). Kmvo = Upper Cretaceous Ohio Creek Member of Mesaverde Formation, Tw = Tertiary Wasatch Formation, CRG = clay-rich gouge, k = bulk permeability, NE = northeast.

The key observations, data, and hypotheses lead to a conceptual model as follows and as depicted in figure 20:

- and groundwater flow in the subsurface. These heterogeneities may also cause tortuous flow paths and possible decoupling of oxygenated surface waters from less oxygenated groundwaters (fig. 20).
