GEOLOGIC FEATURES AND THEIR POTENTIAL EFFECTS ON CONTAMINANT MIGRATION, SANTA SUSANA FIELD LABORATORY

Howard G. Wilshire, Ph.D.

October 5, 2006

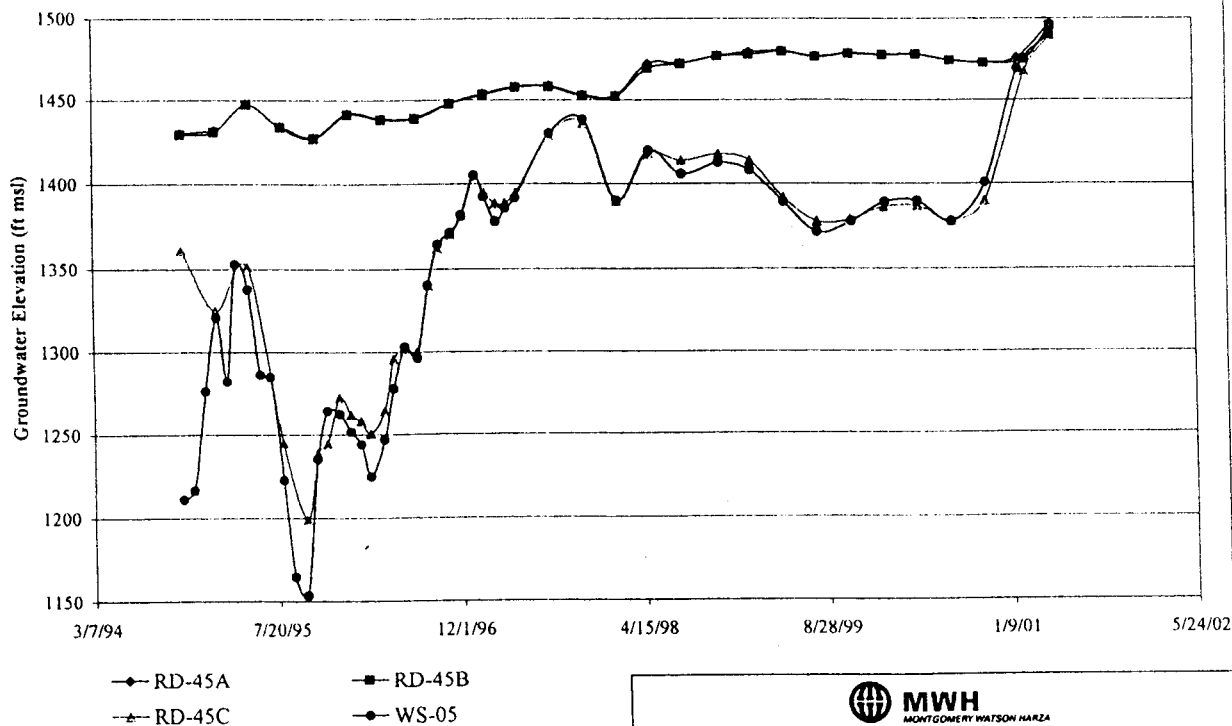
ROCKETDYNE PROPULSION AND POWER
 SANTA SUSANA FIELD LABORATORY
 VENTURA COUNTY, CALIFORNIA
LONG-TERM HYDROGRAPH OF THE RD-45 CLUSTER AND WS-5
 FIGURE 15

Exhibit 2. Hydrographs, 1994-2001, for wells WS-5, RD-45A, RD-45B, and RD-45C. From MWH, Technical Memorandum, Geologic Characterization of the Eastern Portion of the Santa Susana Field Laboratory (February 2002), Figure 15. Note faults differ from current representations.

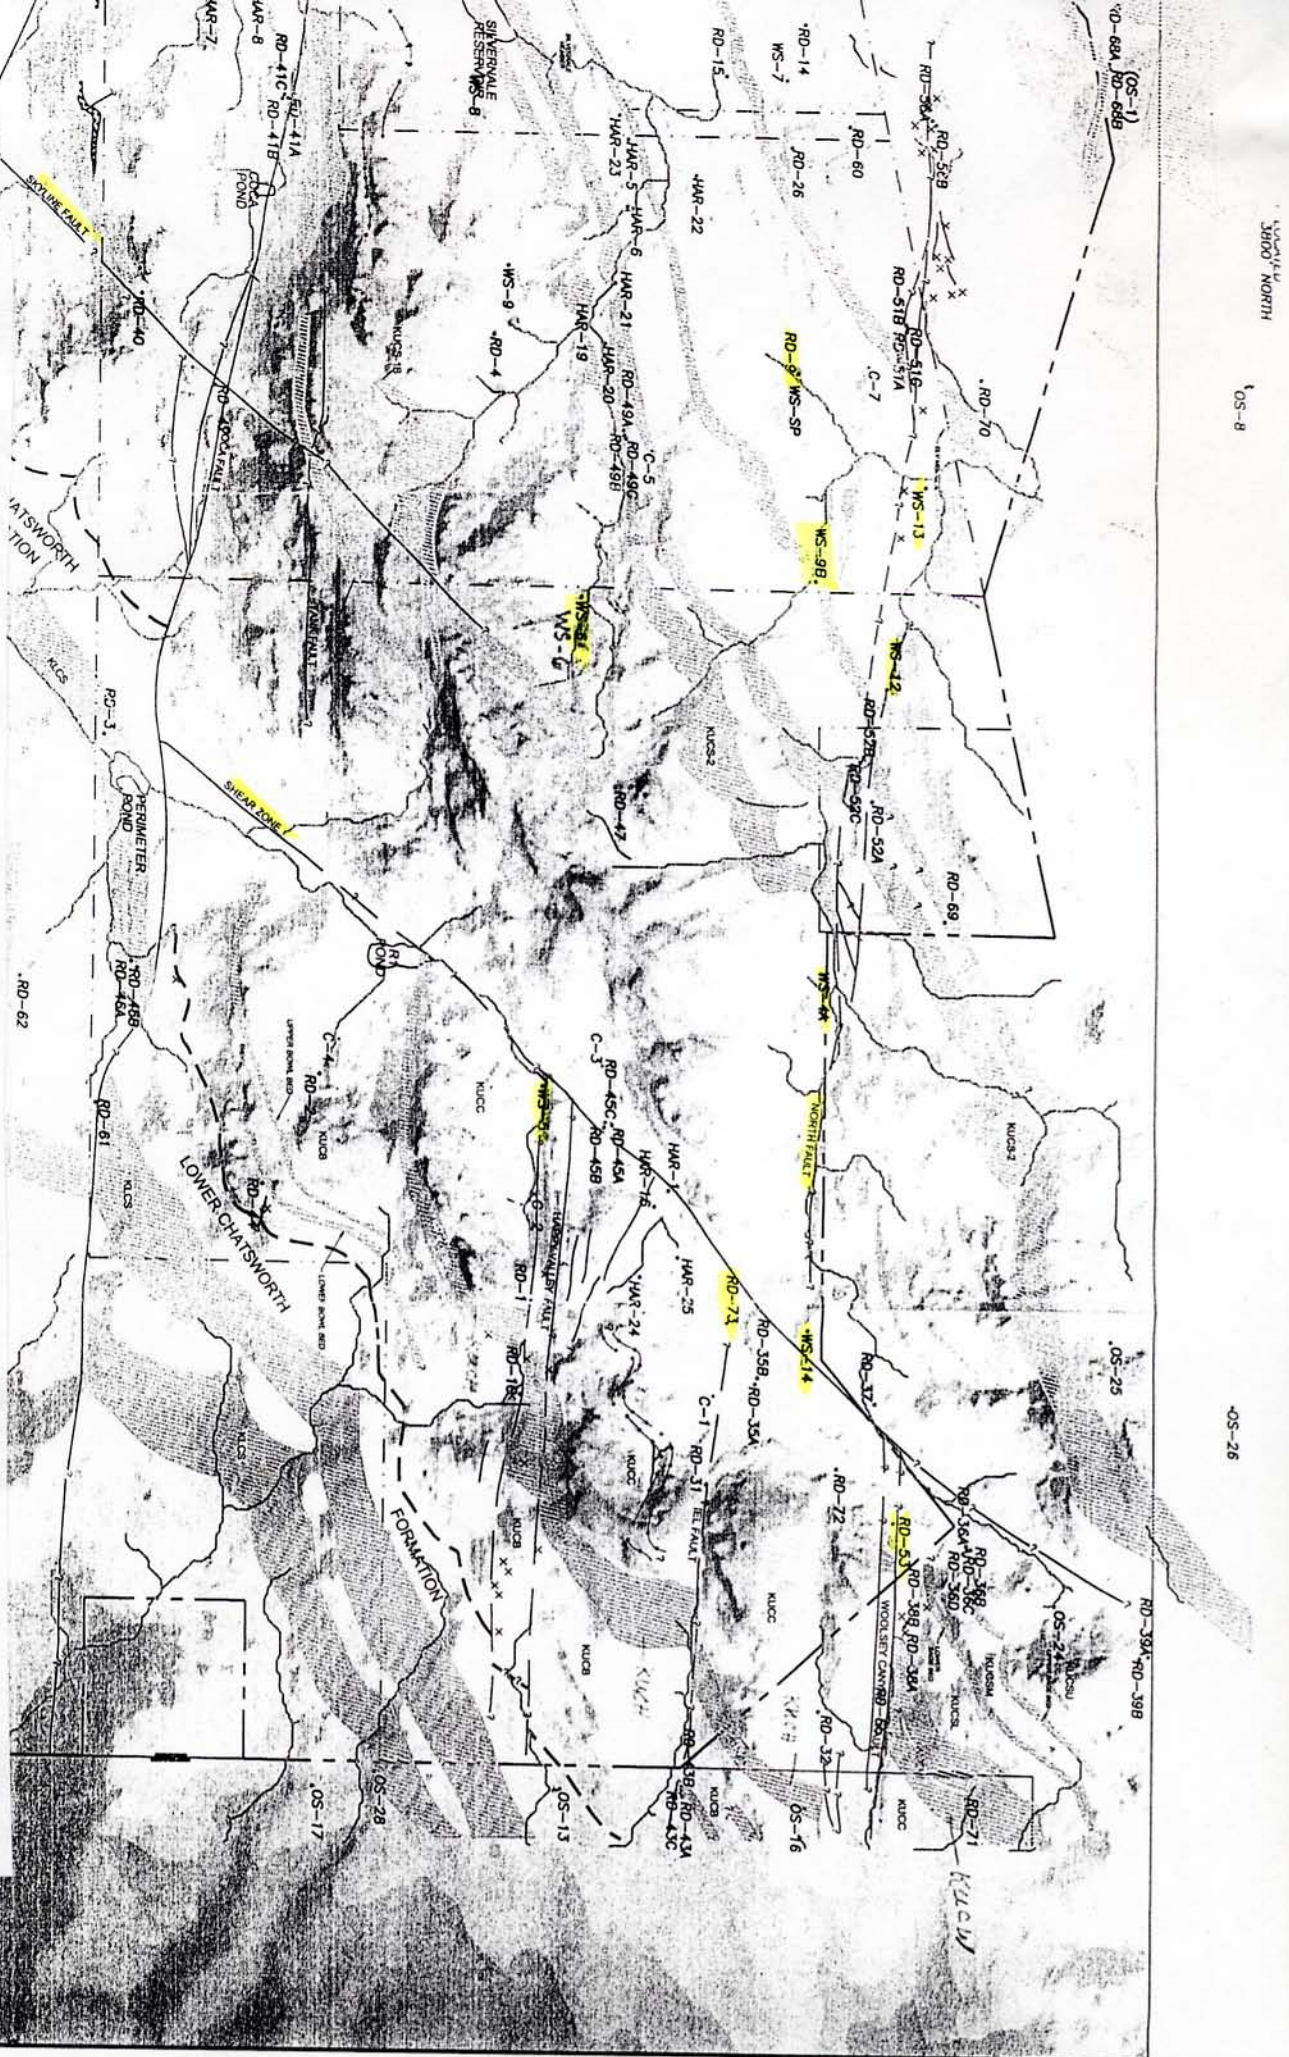
Exhibit 3. Portion of SSFL, showing locations of wells WS-5, RD-73, RD-38A, B, and WS-14, and current locations of faults. From MWH, Near-Surface Groundwater Characterization Report, Santa Susana Field Laboratory (November 2003), Figure 2-9.

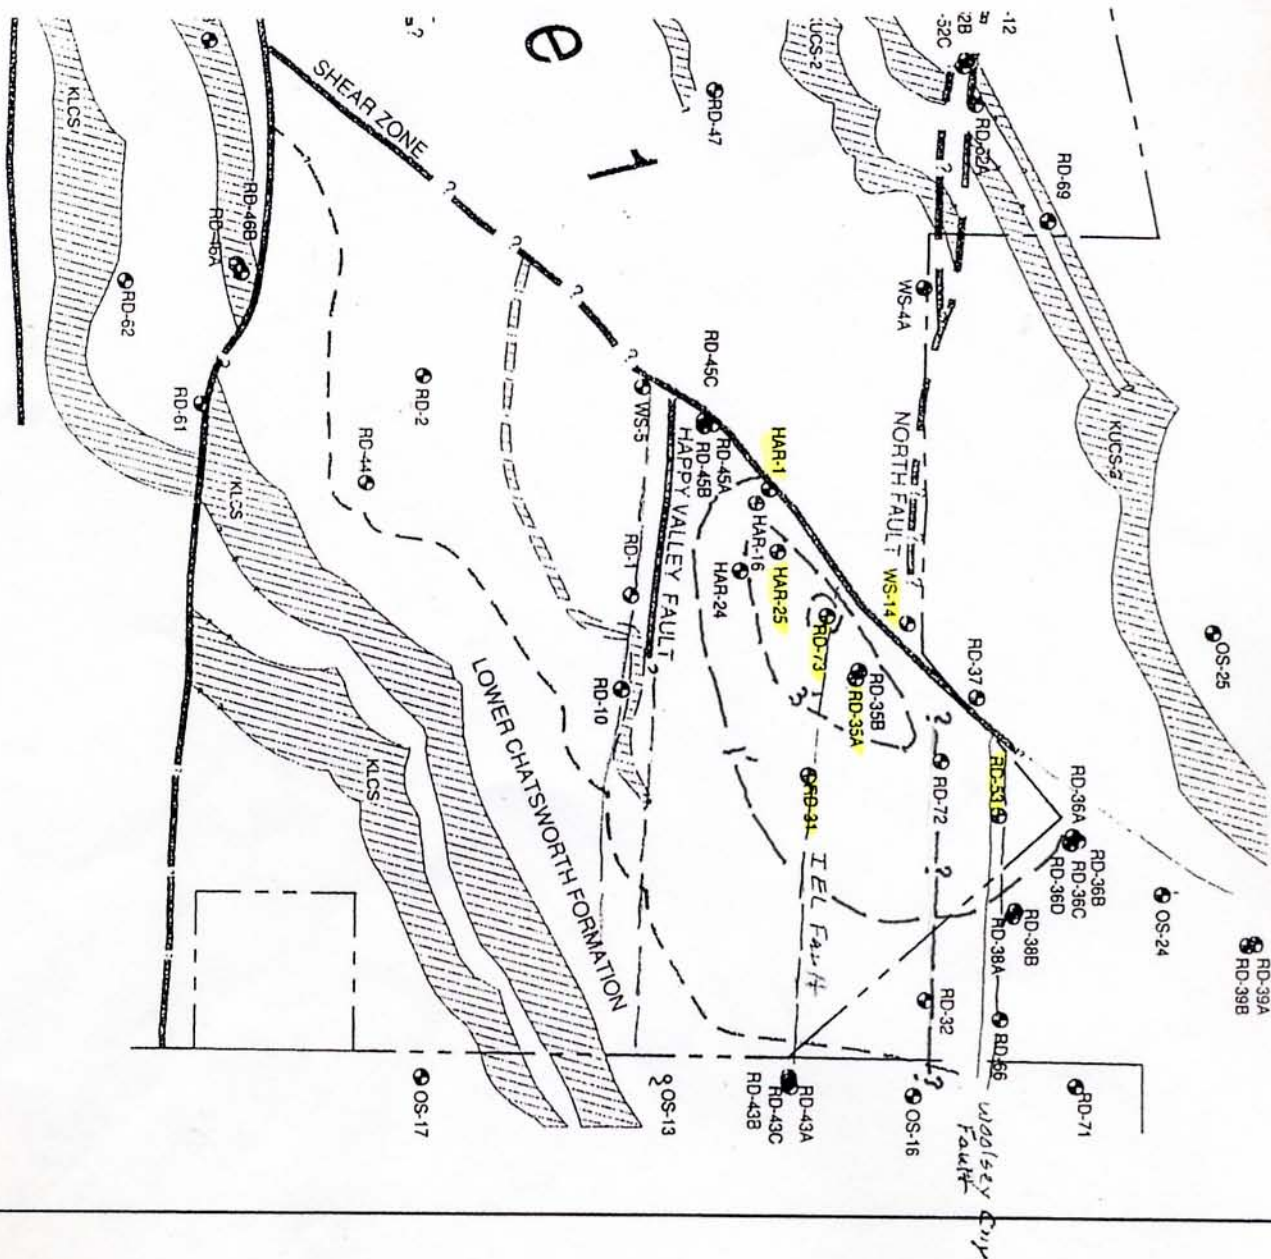
Exhibit 4. Portion of SSFL, showing drawdown contours for 90-day (May to August 1997) pump test of RD-73 (from L. P. Smith (Haley & Aldrich), Appendix B, Conceptual Site Model, Santa Susana Field Laboratory, Hydrogeology Summary Report (April 2000), Figure 2.9), and locations of subsequently mapped Woolsey Canyon and IEL Faults and enlarged Happy Valley Fault Zone (from MWH, Near-Surface Groundwater Characterization Report, Santa Susana Field Laboratory (November 2003), Figure 2-9). A possible E-W fault passes very close to RD-72 and RD-32 (MWH, Technical Memorandum, Geologic Characterization of the Eastern Portion of the Santa Susana Field Laboratory (February 2002), p. 4-4). The video log of RD-32 logs fault indicators (Groundwater Resources Consultants, Well Compendium (September 20, 1995); no logs available for RD-72.

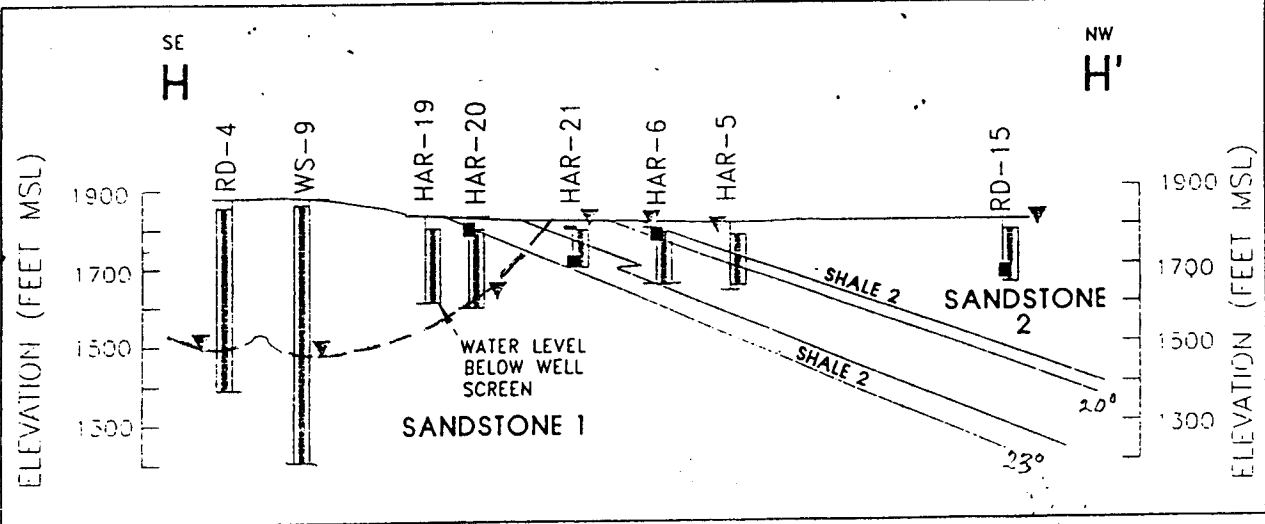
Exhibit 6. Section illustrating 200-300 feet difference in water elevations in wells screened on opposite sides of Shale 2 (from MWH, Technical Memorandum, Geologic Characterization of the Eastern Portion of the Santa Susana Field Laboratory (February 2002), p. 5-1). Note section line is viewed toward the south, contrary to normal practice.

Exhibit 6 illustrates the case that Shale-2 acts as an aquitard between Sandstones-1 and -2 (old designations), as seen in water levels in wells RD-4, WS-9, HAR-19, and HAR-20 screened in Sandstone-1, and HAR-21, HAR-6, HAR-5, and RD-15 screened in Sandstone-2. Wells RD-4 and WS-9 are pumped wells with water levels governed by long-term extraction. Wells screened in Sandstone-2 are about 200 to 300 feet higher than those screened in Sandstone-1. It should be noted that the section in Exhibit 6 is viewed toward the south, contrary to normal practice.⁹⁵ The section does not position HAR-20 and HAR-21 consistently with the rather complex representation of Shale-2 in Fig. 2-9 of the Near-Surface Groundwater study. In addition, the well distribution is a shotgun pattern, but no information is given on how the wells were projected to the section line. It also is not clear why other wells in the area were not used to assess the water level differences—wells not used that might represent Sandstone-1 conditions include RD-49A, RD-49B, RD-49C, and C-5, and those that might represent Sandstone-2 conditions, but which were not used, include HAR-22, HAR-23, and RD-16.

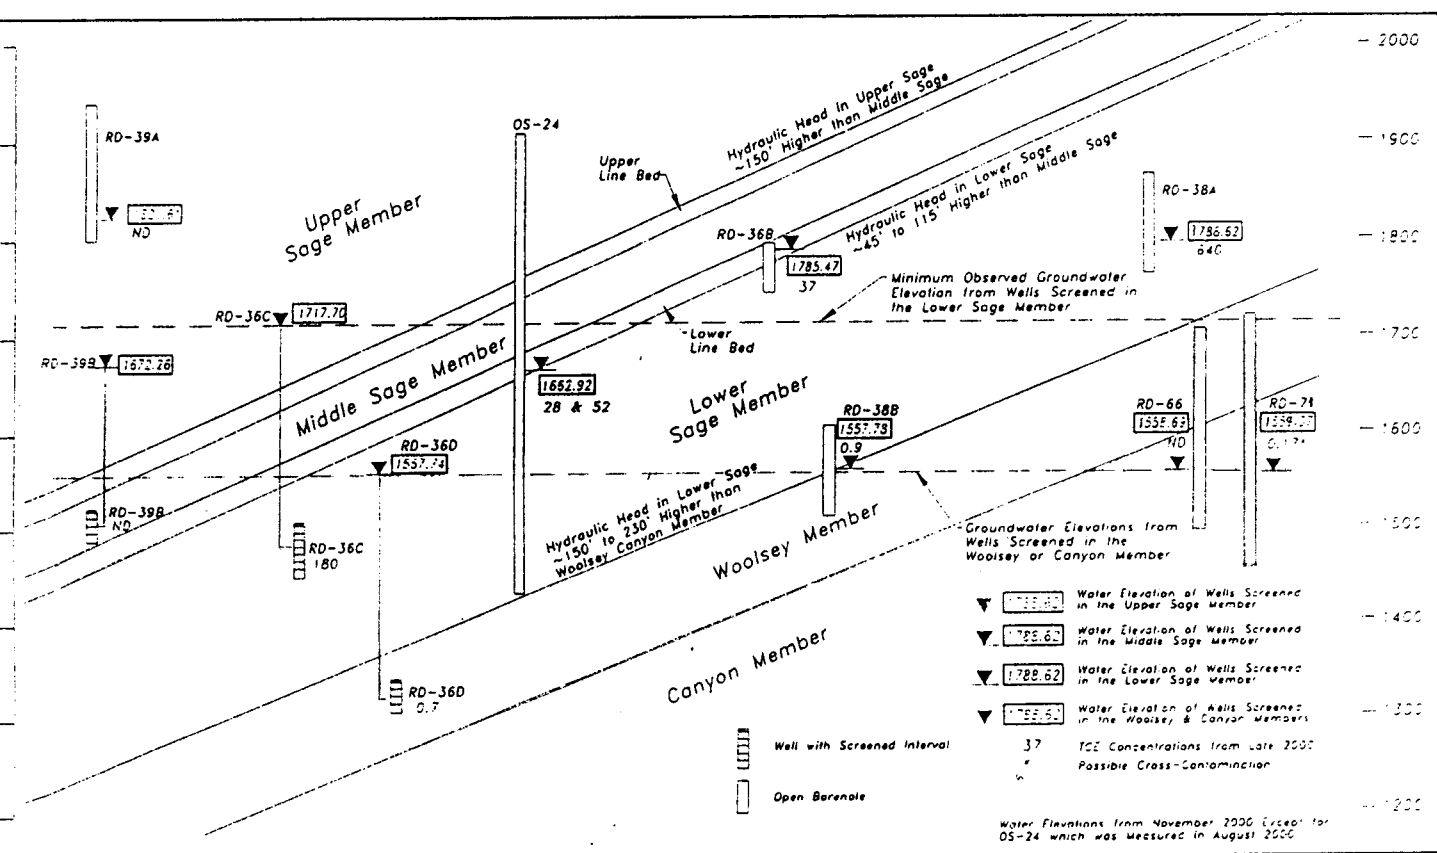
Exhibit 7. Diagrammatic representation of the stratigraphic positions of open intervals for wells RD-39A, RD-39B, RD-36C, RD-36D, OS-24, RD-36B, RD-38B, RD-38A, RD-66, and RD-71 (from MWH, Technical Memorandum, Geologic Characterization of the Eastern Portion of the Santa Susana Field Laboratory (February 2002), p. 5-6).
