## Polychlorinated Biphenyls (PCBs) Research Overview

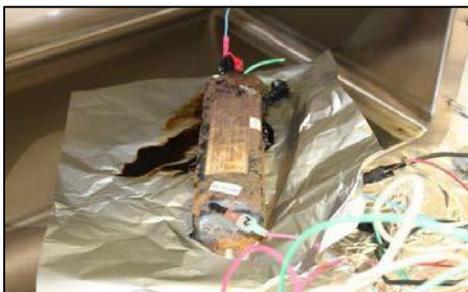
*Above: Picture of ruptured fluorescent light*

[Study 1](#) confirmed that emissions from old caulk causes elevated PCBs in the surrounding air. Old fluorescent light ballasts were also tested for PCB emissions. The emission rates for fluorescent light ballasts containing PCBs were small at room temperature for non-leaking light ballasts but increased significantly at temperatures similar to those reached during operation. Fluorescent lighting fixtures that still contain their original PCB-containing light ballasts have exceeded their designed lifespan, and the chance for rupture and emitting PCBs is significant.
