Hyperspectral Imaging Can Be a Useful Evaluation Tool for Office of Inspector General Reviews Focused on Contaminated Land

Report No. 14-N-0360

September 26, 2014

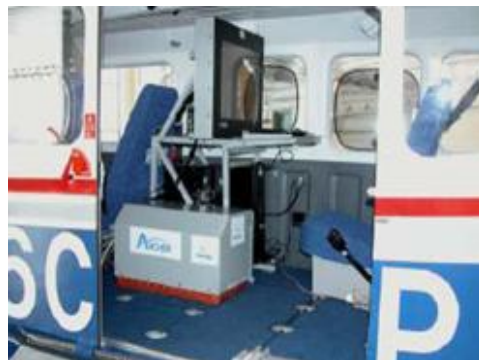
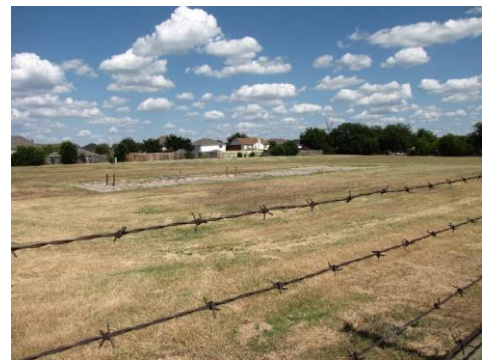
Cover photos: *From left:* Civil Air Patrol's Airborne Real-Time Cueing Hyperspectral Enhanced Reconnaissance (ARCHER) sensor; example of a brownfields site where hyperspectral imagery was collected. (USGS photos)
