# Independent Environmental Sampling Shows Some Properties Designated by EPA as Available for Use Had Some Contamination

Project No. 15-P-0221

July 21, 2015

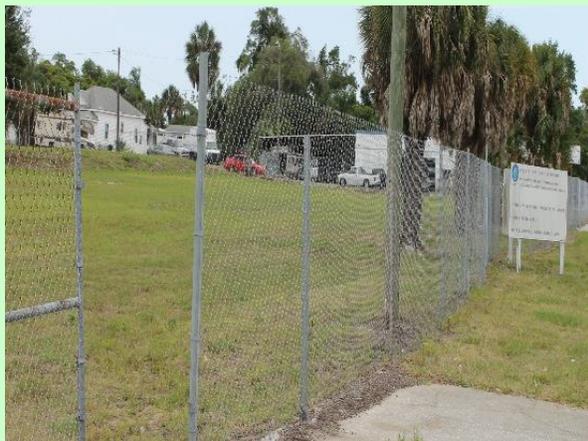
We expected that metal concentrations would be low in the soil samples we collected at the Clearwater Automotive Salvage Yard site because the site records showed it had been cleaned up and was designated in EPA records as RAU. According to EPA's records, the agency provided over \$322,000 to the city of Clearwater for site assessment work, plus more than \$45,000 and loans totaling \$700,000 to clean up the site. Also, the city provided nearly \$500,000 for assessment and cleanup. Therefore, in total, nearly \$1.6 million was provided for assessing and cleaning up the site. On July 1, 2009, following completion of site assessment and cleanup activities, the state issued an order that declared that contaminants of concern in the soil—including arsenic—met state residential standards. The order included no restrictions on residential development of the site and, when work started at the site in 2007, Clearwater anticipated using the site as a mixed-use development that included affordable housing. When we conducted our work in April 2013, we observed that the Clearwater site was adjacent to residential areas and was undeveloped, and site access was poorly controlled.

Clearwater Automotive Site, Clearwater, Florida, in April 2013. Vacant lot is within a residential neighborhood. (EPA OIG photo)

For the Clearwater Automotive Salvage Yard site, where we obtained four samples, all four ICP results showed contamination that did not meet the residential standard for at least one metal—arsenic, copper or lead. The arsenic in two samples was great enough to also not meet the industrial standard. Arsenic is known to cause cancer; copper can be harmful at high levels, and exposure to lead can seriously harm a child's health. Based on our sampling results, EPA Region 4 agreed to conduct additional sampling at this site, but the site owner—the city of Clearwater—denied access to EPA Region 4.
