ST. LAWRENCE RIVER AT MASSENA REMEDIAL ACTION PLAN

—STAGE I—

November, 1990

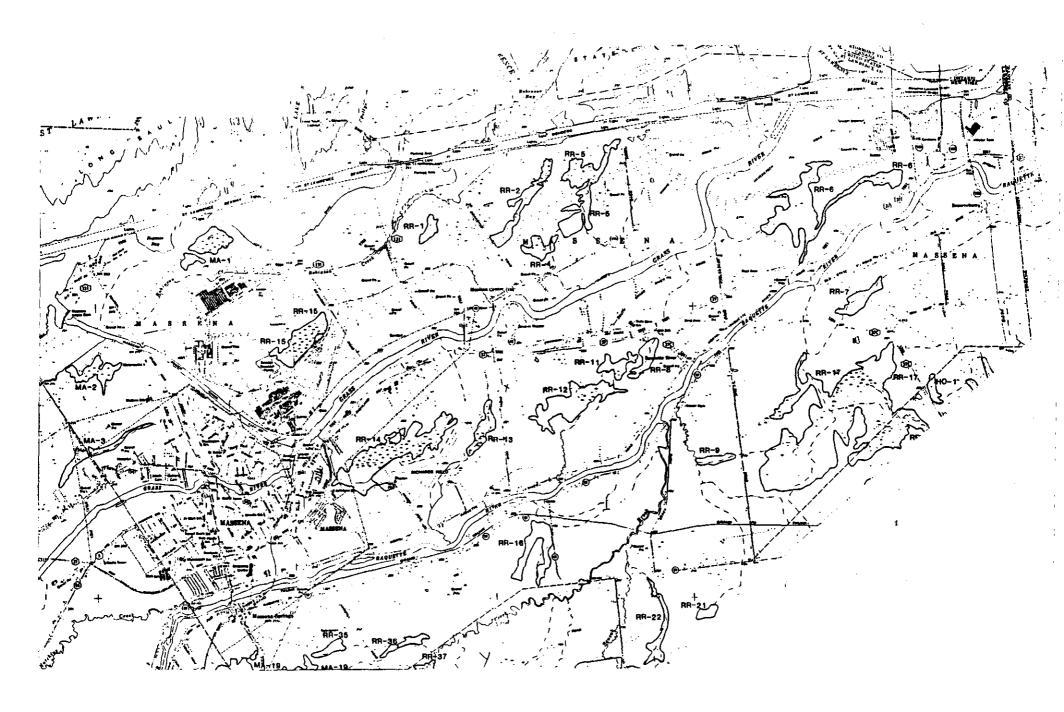
Figure IV-1. Wetlands in the Massena AOC. (Numbering designations refer to NYSDEC wetlands inventory mapping program)

A 170 acre (68 ha) wetland is located in the vicinity of the Reynolds Metals and General Motors property. Sampling and analysis in 1988 in the area of the wetland just south of the Reynolds Solid Waste Landfill (see Appendix B), documented PCB levels ranging from less than 0.1 ppm to 9.4 ppm in sediment (NYSDEC 1989d). The highest levels in sediment were found at the sites closest to the landfill. Two water samples collected from the same area had total PCB levels of 1348.6 ppt and 9111.0 ppt.

A third wetland is located south of the Grasse River, east of the Village of Massena. There are currently no known data concerning the contamination or potential contamination of this wetland.

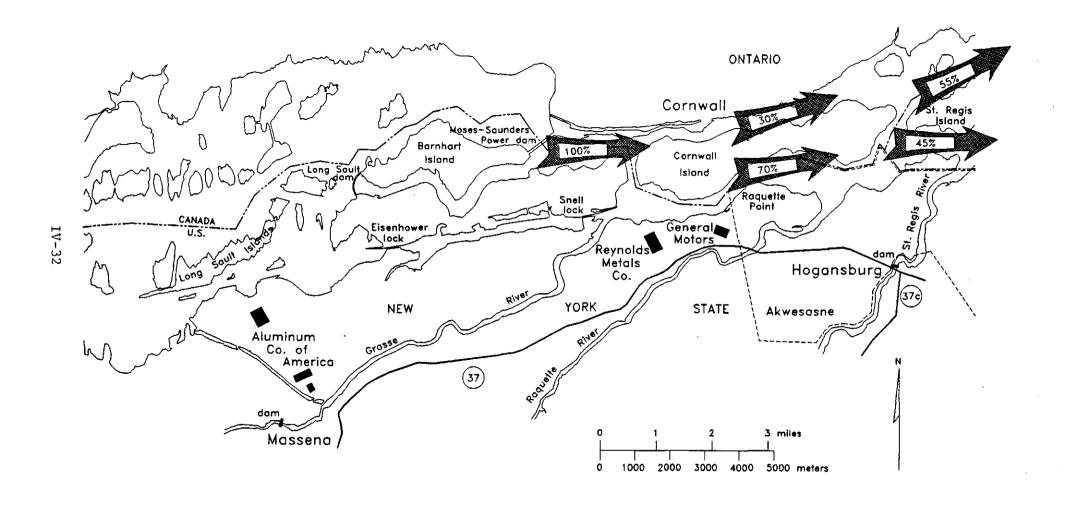
Figure IV-2. Estimated flow (% total) of the St. Lawrence River in the Massena AOC.

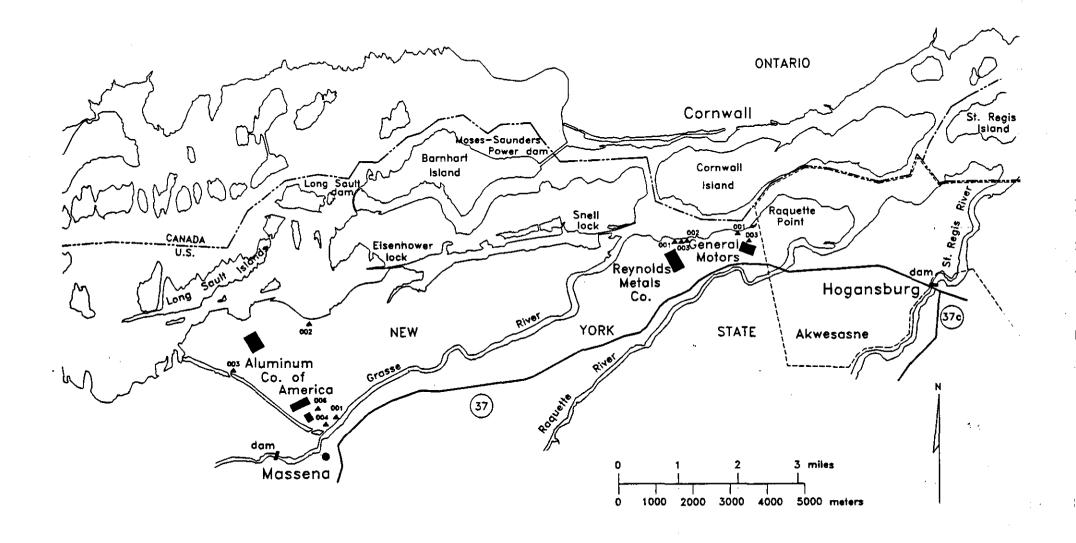
Figure V-2. Industrial (A) and municipal (O) outfalls adjacent to the Massena AOC.

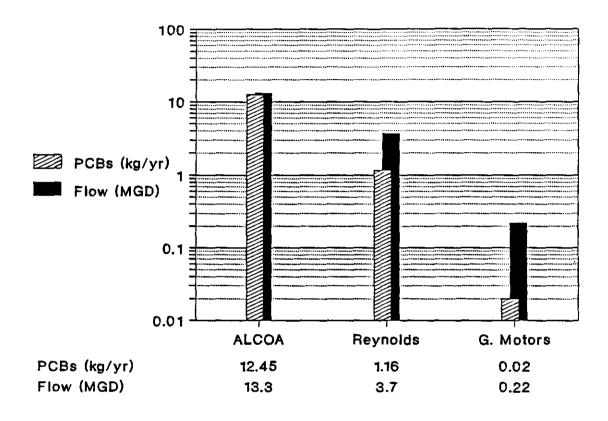
Figure V-4. Estimated annual discharge of PCBs and relative flows for Massena AOC industries (1989 data)

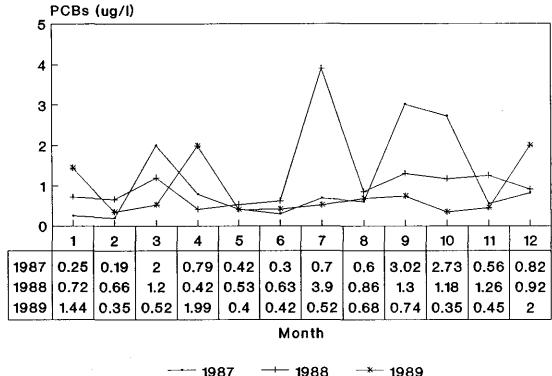
Figure V-5. Monthly maximum discharge of PCBs at ALCOA outfall #001 (detection limit = 0.05 ug/l; permit limit = 2.0 ug/l)

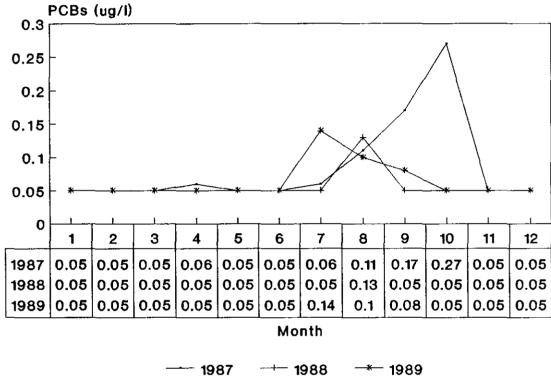
Figure V-6. Monthly maximum discharge of PCBs at General Motors outfall #001 (detection limit = 0.05 ug/l; permit limit = 2.0 ug/l)

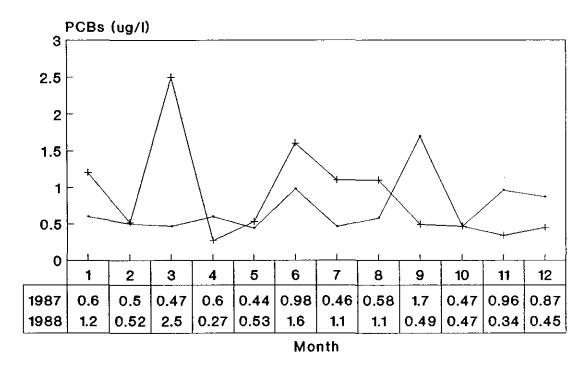
Figure V-7. Monthly maximum discharge of PCBs at General Motors outfall #002 (detection limit = 0.05 ug/l; permit limmit = 2.0 ug/l; outfall abandoned in 12/1988)

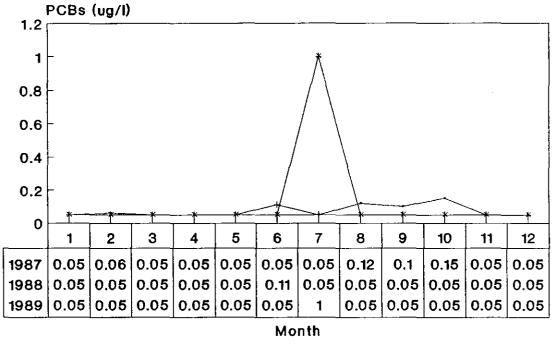
Figure V-8. Monthly maximum discharge of PCBs at General Motors outfall #003 (detection limit = 0.05 ug/l; permit limit = 2.0 ug/l)

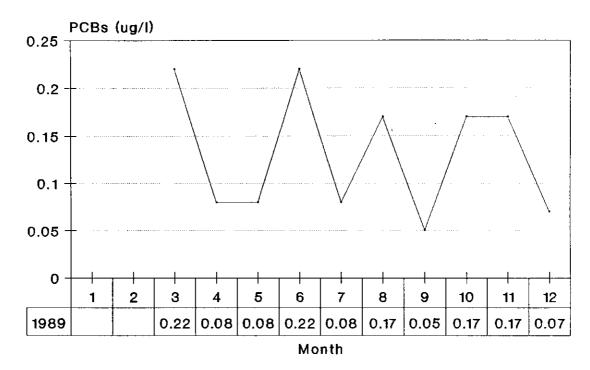
Figure V-9. Monthly maximum discharge of PCBs at Reynolds Metals outfall #003 (detection limit = 0.05 ug/l)

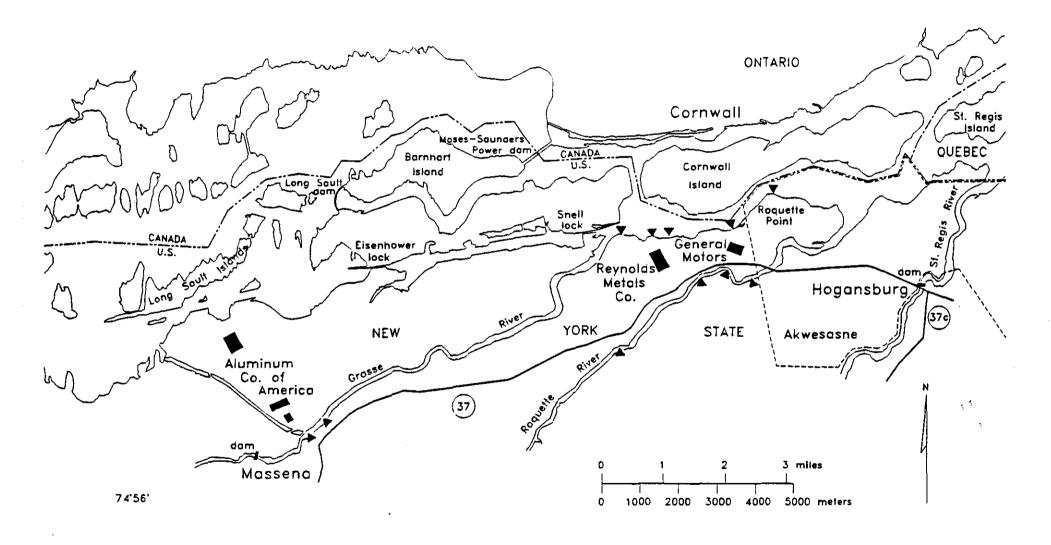
Figure V-10. Approximate locations (▲) in the Massena AOC where sediment samples have been collected for contaminant analyses (Sources: RMT 1986; Woodward-Clyde 1989; Young-Morgan Assoc. 1989)

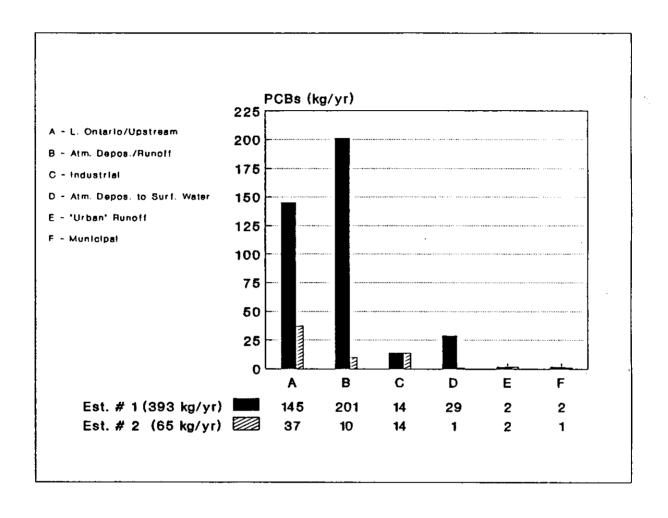
Figure V-11. Estimated annual loading of PCBs to the Massena AOC in 1989 from various sources (#1 @ 40 ng/l PCB in atmospheric deposition; #2 @ 2.4 ng/l)

The largest source of variability is probably in the atmospheric and surface runoff estimates. Dry deposition contributions were estimated from data

developed for Lake Superior, a much less developed basin than Lake Ontario or the St. Lawrence River. Runoff from the watershed was calculated using an average of 31" (0.8m) precipitation on the basin with 7% reaching streams at average PCB concentrations of 40 ug/L (ppb) (Rice 1989). This figure was used in the #1 estimate for the atmospheric components in Figure V-11. Estimate #2 was made using 2.4 ug/L (ppb) in the atmospheric components (IJC 1988). Dry fallout onto surface waters was calculated using 100 ug/m²/yr over 1% of the watershed (Rice 1989). The St. Lawrence River was estimated to average two miles (3.2 km) in width for 110 miles (176 km) in length upstream of Massena. Residential runoff values were calculated using 0.04 ug/L (ppb) PCB at 31" (0.8m) precipitation annually with 50% runoff (Wong 1981). Runoff from industrial areas was estimated by using 0.08 ug/L (ppb) PCB at 31" (0.8m) precipitation annually at 50% runoff (Wong 1981). Discharges of PCBs from municipal point sources in the basin were assumed to be 0.02 ug/L (ppb).

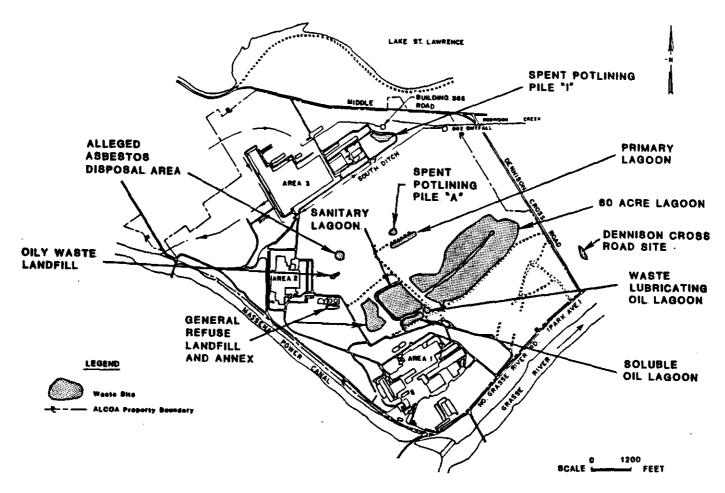
Figure B-1. Locations of inactive hazardous waste sites at the ALCOA facility.

Process wastewater is treated by a lagoon system and eventually discharged to the Grasse River through outfall 001. Wastewater from the primary aluminum process is mainly from the potliner air emission scrubbing system. This wastewater is treated with lime and settled in the primary lagoon. The wastewater is further stabilized in the 60 acre (24 ha) secondary lagoon before discharge through outfall 001.

Other wastewaters from ingot casting, extrusion and fabricating mill enter the lagoon directly without prior pretreatment. Sanitary wastewater is treated in the sanitary lagoon, seasonally chlorinated, and combined with the lagoon discharge for eventual combined discharge through outfall 001 to the Grasse River.

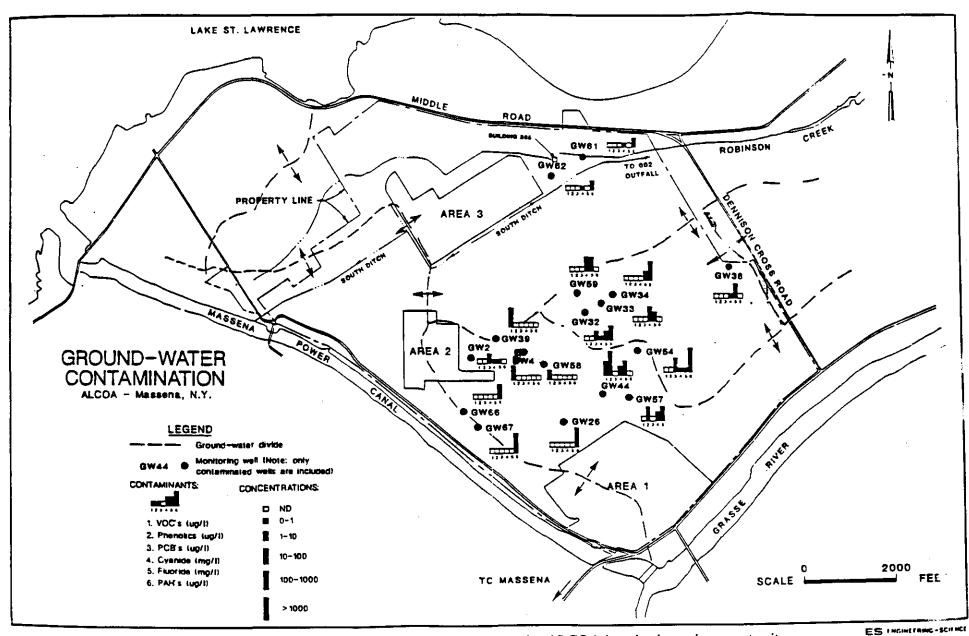
Figure B-2. Groundwater sampling locations and contaminant levels at the ALCOA inactive hazardous waste sites.

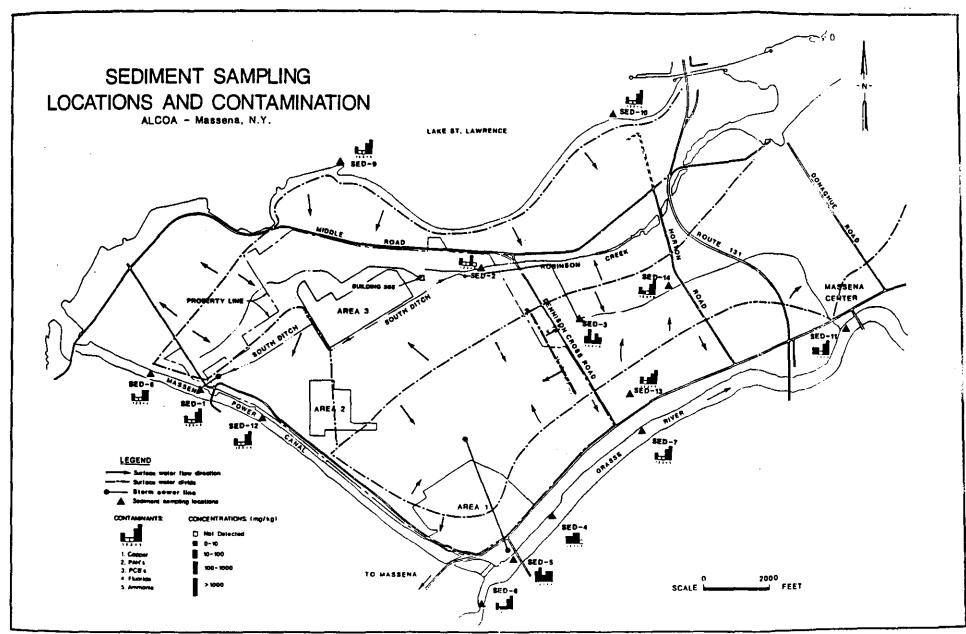
Figure B-3. Sediment sampling locations and contaminant levels near the ALCOA inactive hazardous waste sites.

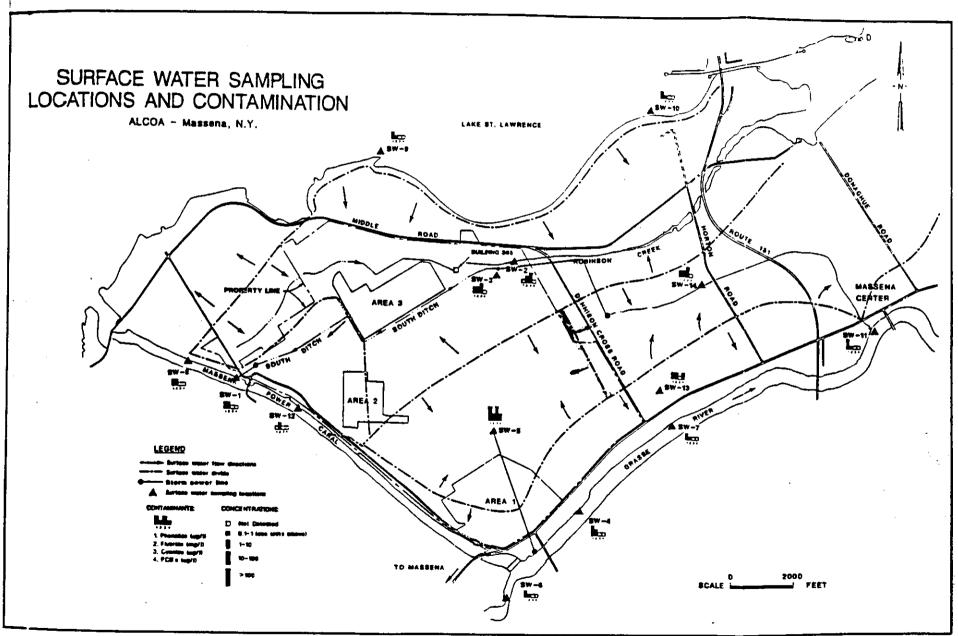
Figure B-4. Surface water sampling locations and contaminant levels near the ALCOA inactive hazardous waste sites.

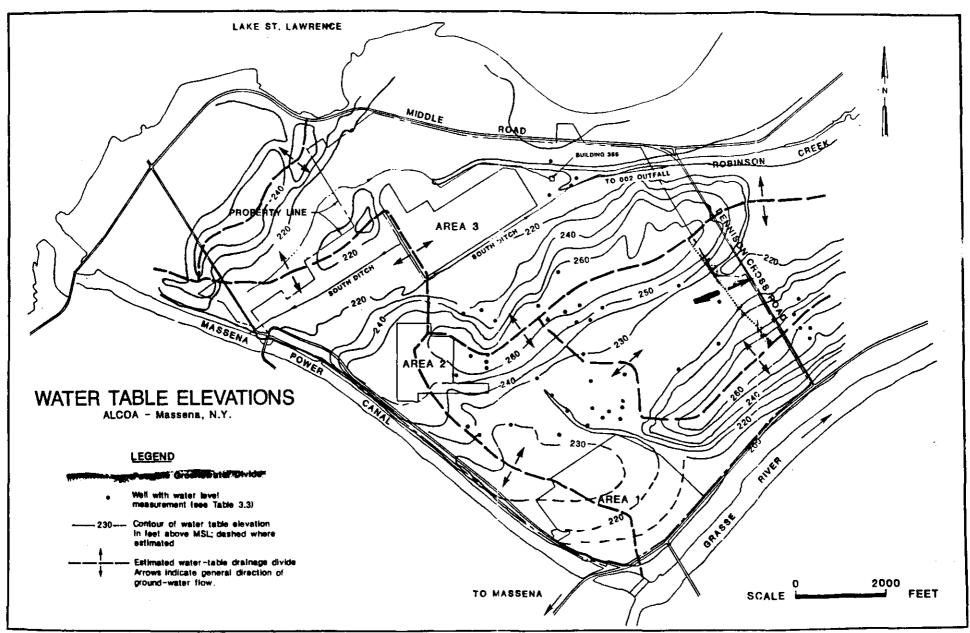
Figure B-5. Estimated groundwater elevations at the ALCOA inactive hazardous waste sites.

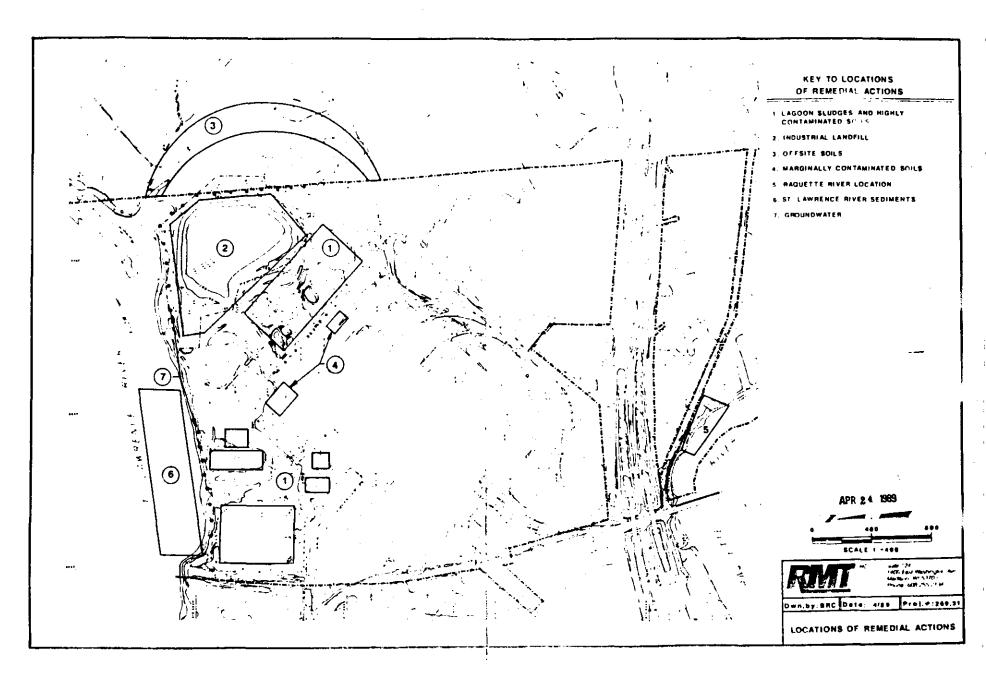
Figure B-6. Location of waste sites at General Motors facility.

Polychlorinated biphenyls (PCBs) were used in die casting machine hydraulic fluid from 1959 until 1973. Past disposal practices associated with PCBs caused this facility to be placed on the EPA's National Priority list (CERCLA). Therefore, this site was the subject of a two-phase remedial investigation and is currently the focus of a feasibility study for site remediation.

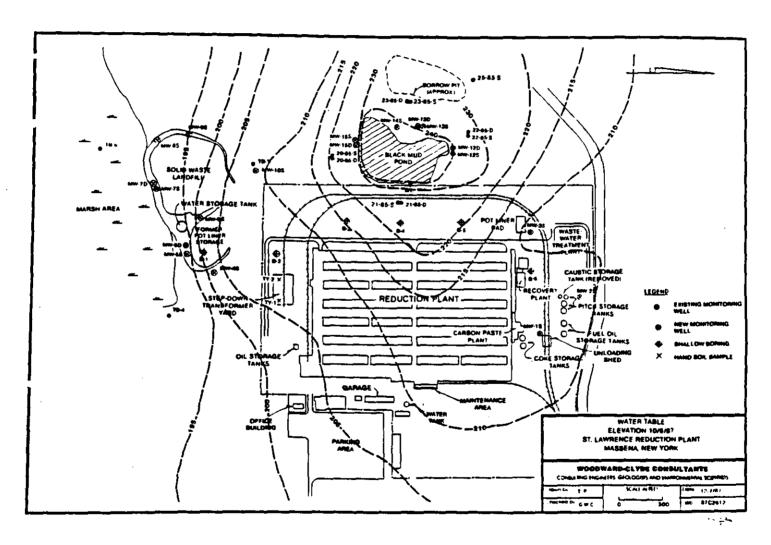
Figure B-8. Location of waste disposal sites, monitoring wells, and water table elevations at the Reynolds Metals facility.

The former pot liner storage area is located in the eastern portion of the landfill. Although the pot liner has been removed, this area continues to be a source of

contamination to the adjacent wetland. Groundwater in this area has shown elevated levels of fluorides, cyanides, sulfates, sodium, aluminum, iron, and pH.

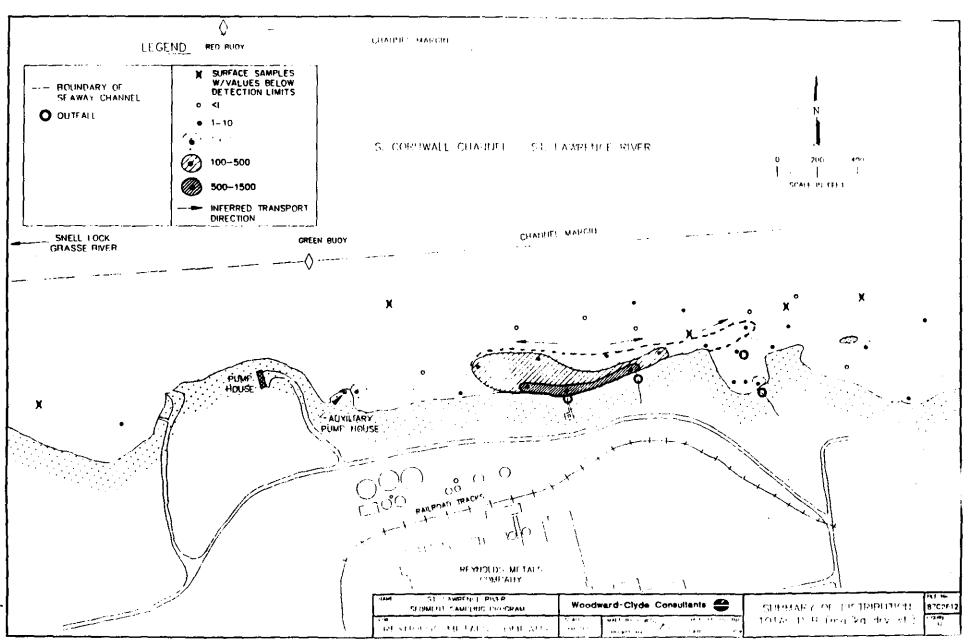
Figure B-9. Bottom sediment sample of PCB levels from the St. Lawrence River near the Reynolds Metals, Inc. facility.

Outfalls to the St. Lawrence River have caused PCB sediment contamination. The sediment sampling program conducted by Reynolds has shown levels of PCBs to be up to 1300 ppm in the near shore sediments, see Figure B-9. The sediment contamination pattern is analogous to water flow patterns in the nearshore area of the outfalls.

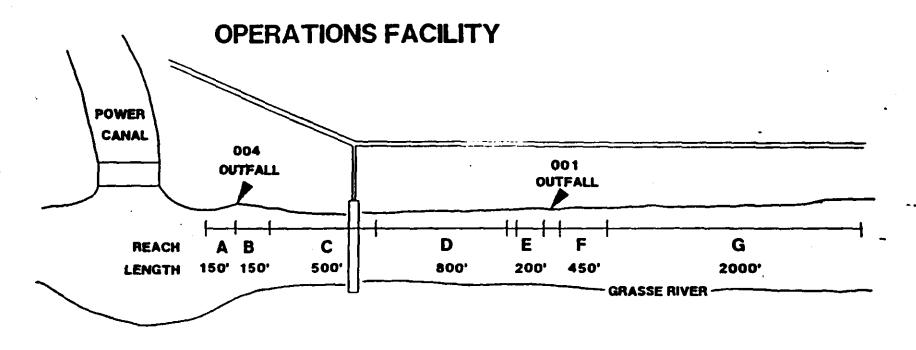
Figure D-3. Locations of 1986 & 1987 Sediment Reaches in the Grasse River, Massena, New York
