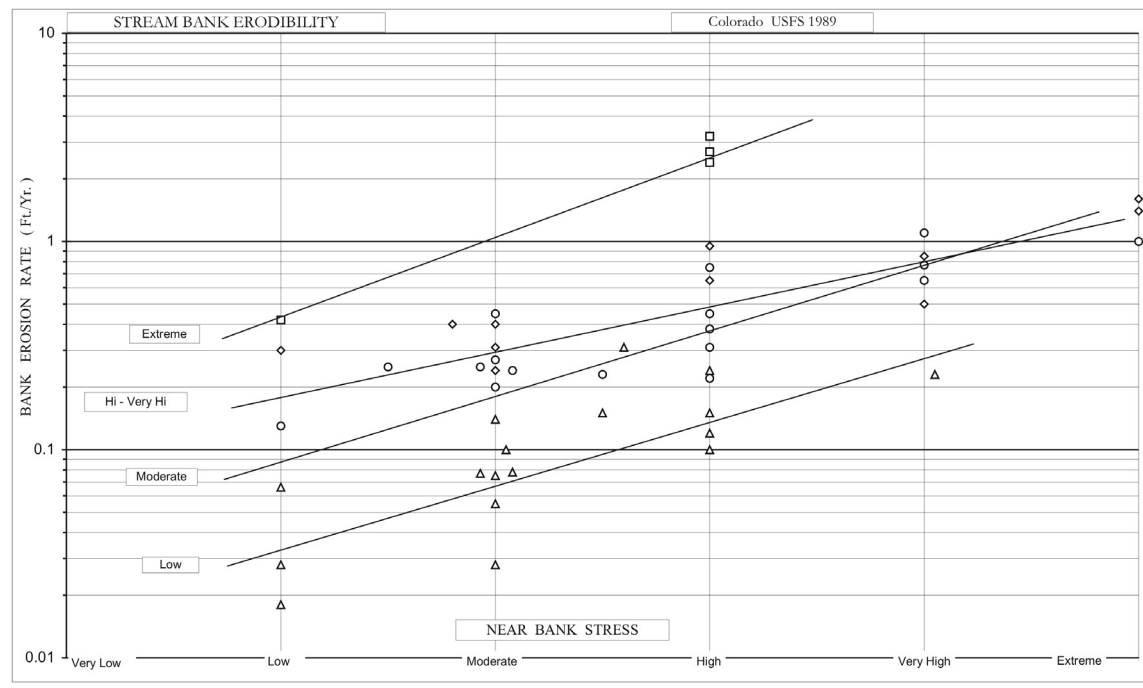
**Figure 115.** Relationship of BEHI and NBS to predict annual streambank erosion rates, Colorado data, 1989 (Rosgen 1996, 2001a).
