NONPOINT SOURCE PROGRAM SUCCESS STORY

Michigan

Excluding Cattle from Stream Area Reduces Phosphorus Input

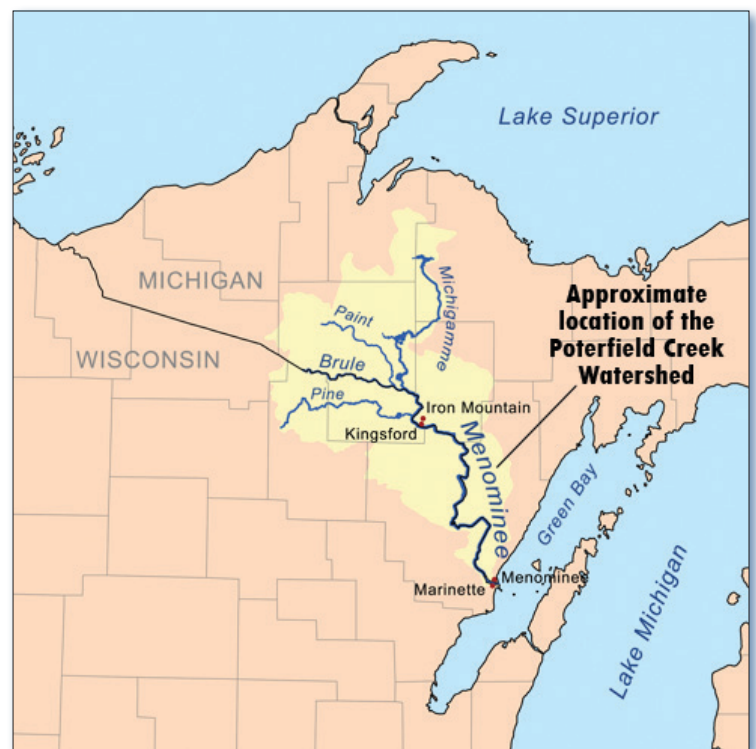
Figure 1. Poterfield Creek flows into the lower Menominee River.

Poterfield Creek drains into the lower Menominee River Watershed near the Village of Carney in Menominee County, Michigan. The Menominee River flows east and follows the boundary between the northeast corner of Wisconsin and the southern tip of the Upper Peninsula of Michigan before emptying into Lake Michigan's Green Bay (Figure 1). The topography in the Menominee River basin was formed and heavily altered by periodic glaciation, the most recent of which was the Wisconsin period (10,000-20,000 years ago). The region is characterized by lakes, glacial plains, end moraines, and poorly integrated east to west drainage. Because of the extensive amount of glacial activity, the Menominee basin consists mostly of sand and gravel called outwash which is underlain by dolomite.

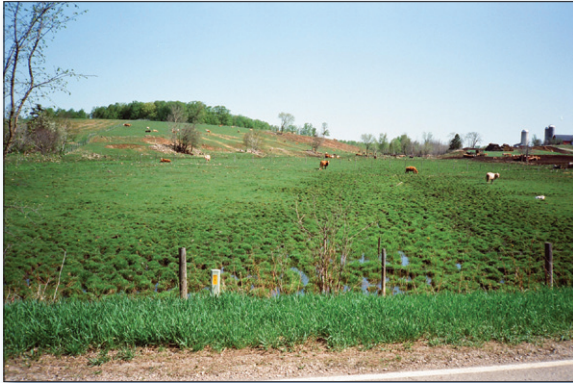
Figure 2. Cows on the Berger Cattle Ranch trample a small stream in the early 1990s. A bare hillside with an uncovered manure storage area (back right of the photo) contributed pollution to the stream.

In the early 1990s, cattle grazed in and around the Poterfield Creek tributary that runs through Berger's Cattle Ranch (Figure 2). The landowner of Berger's Cattle Ranch installed fencing to exclude the cattle from the stream (Figure 3). The Michigan Department of Agriculture provided technical assistance. The partners used CWA section 319 funds to monitor the tributary after the landowner installed the fencing.

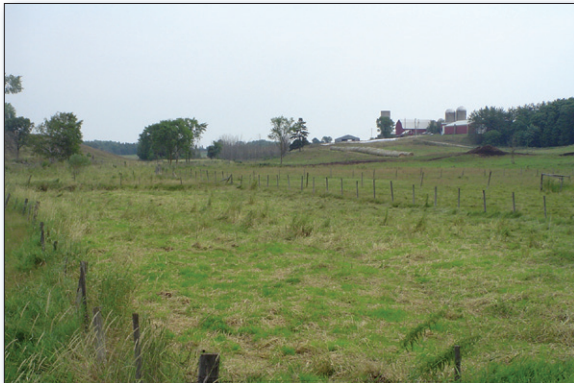
Figure 3. The same site on Berger Cattle Ranch in 2005, after the landowner installed fencing. Note that the waterway is grassed, paddocks are fenced and bare hillslope in the background is revegetated.
