NONPOINT SOURCE PROGRAM SUCCESS STORY

North Carolina

Partners Reduce Polluted Runoff from Agricultural Areas

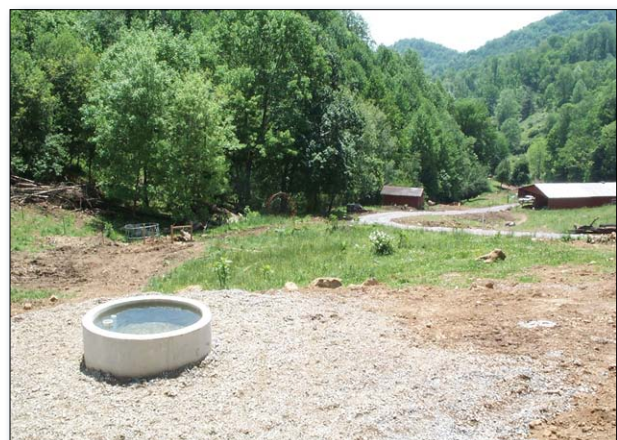
Figure 2. This alternative water source allows livestock to drink without entering Little Ivy Creek.

Partners installed more than 48,000 linear feet of livestock exclusion fencing to keep livestock out of the stream and reduce erosion (Figure 1). Project participants also installed 170 alternative watering facilities (Figure 2). One farmer adopted pasture and hay management plans, protecting an additional 530 acres of natural area. Additional BMPs funded by CWA section 319 grants helped develop a farm access road, 30 acres of riparian buffer and 25 feed/waste management structures (Table 1).
