**CLARIFIER WASTE TREATABILITY STUDY  
PHASE 2 REPORT  
PILOT PLANT DESIGN AND TESTING**

Rhodia, Inc.  
Silver Bow  
119130 German Gulch Road  
Butte, MT 59750

**Feburary 2011**

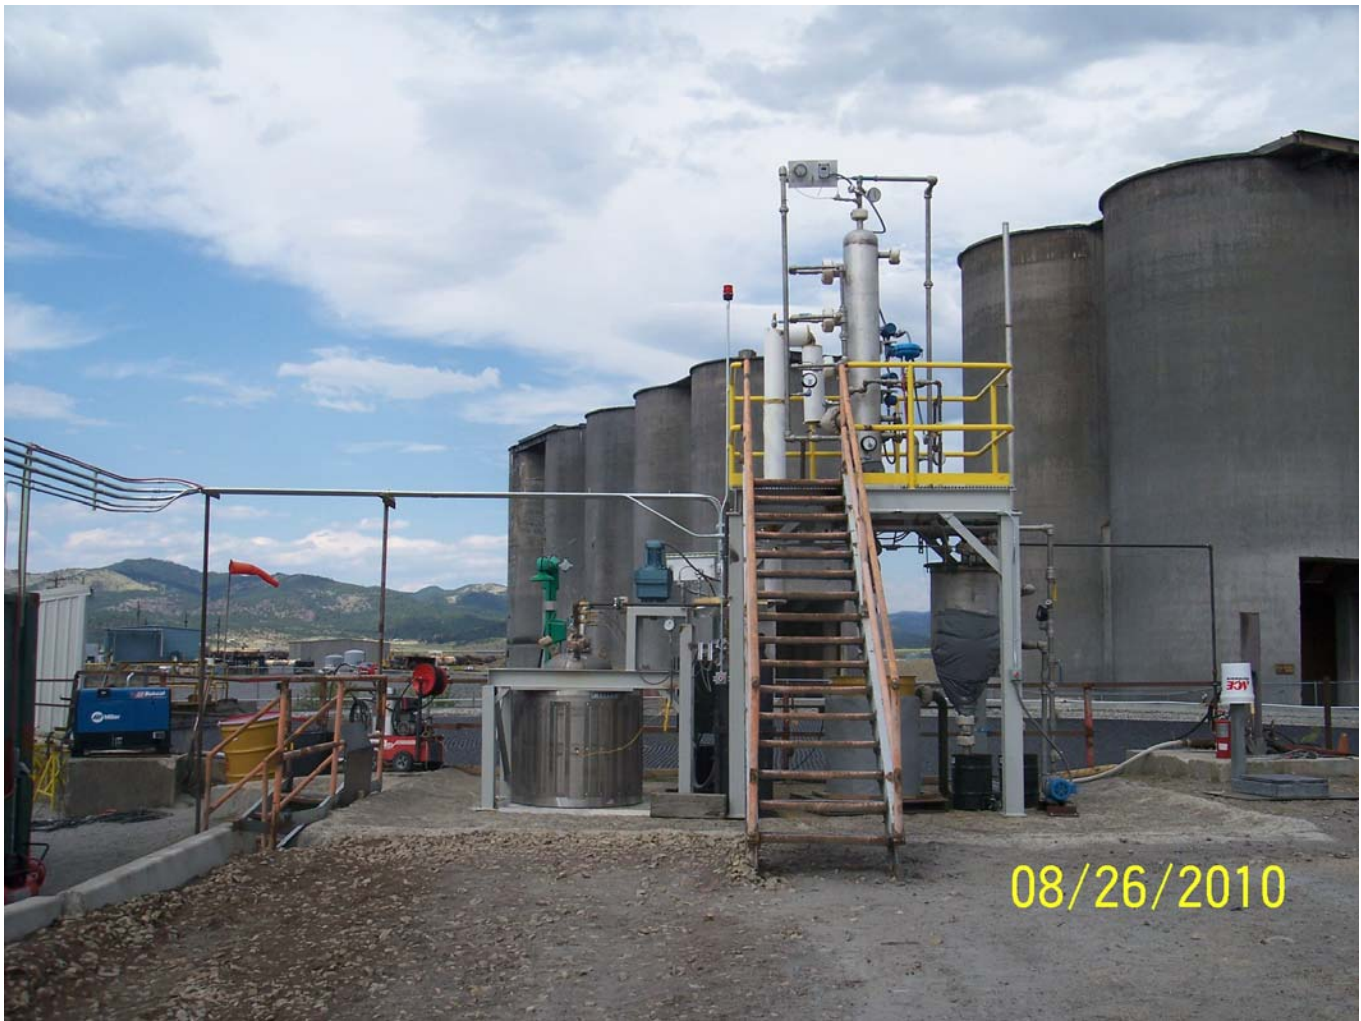
Picture of the overall system

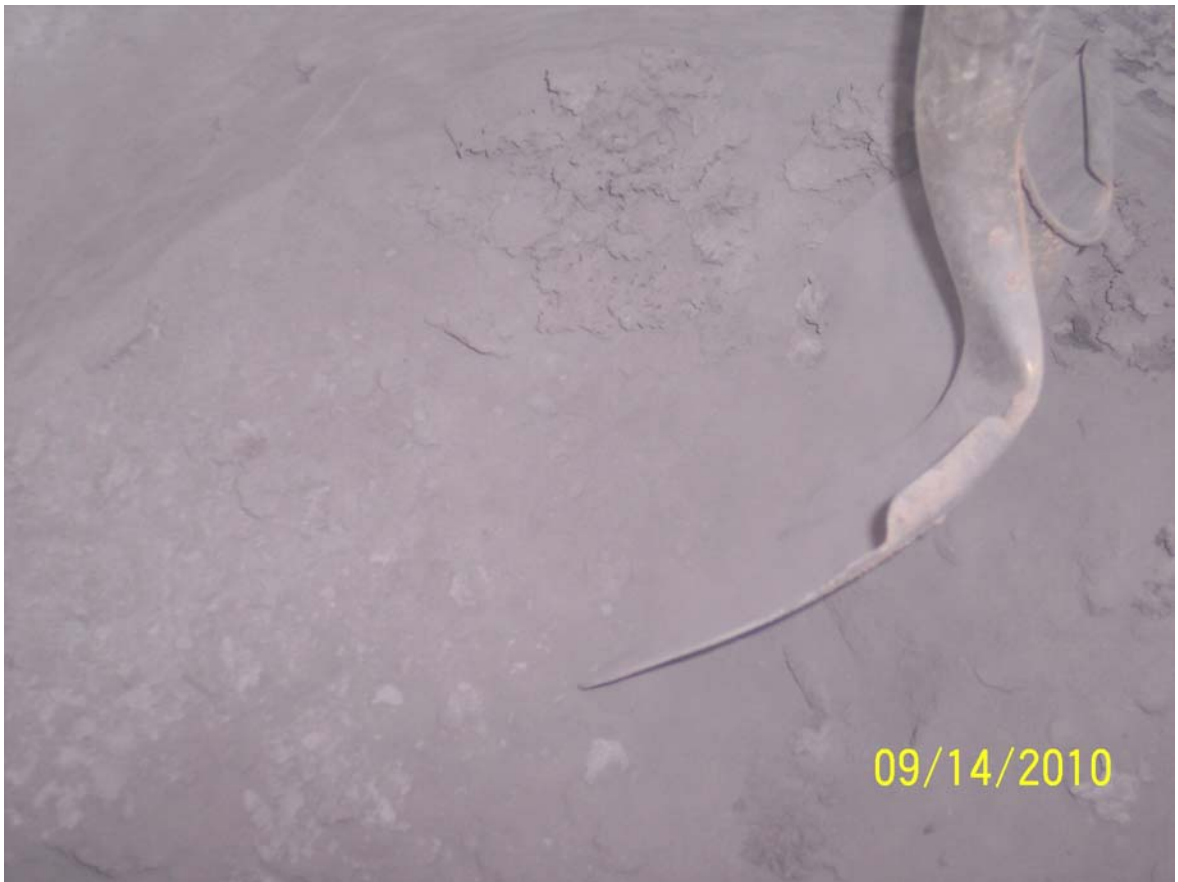
Still residue after Run #2

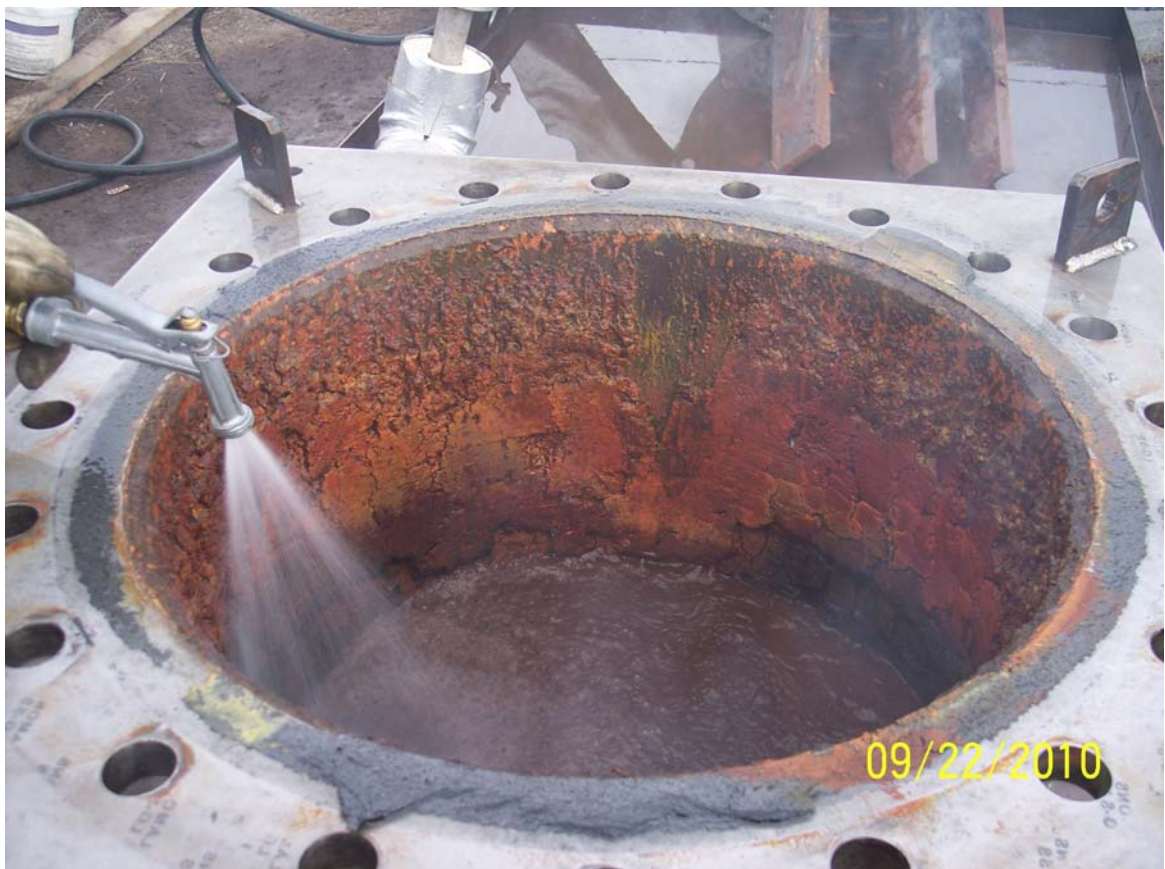
Still residue after Run #3 indicating red phosphorus

The batch time for run #3 was 10 hours, almost the same as run #2. However, run#3 had a larger batch size and did not completely vaporize all of the phosphorus. This was probably mostly due to an incomplete batch cycle. The batch composition was similar to run #2 with ~ 54% (run #3 summary sheet – Figure 12) water vs. ~62% (run #2). A simple heat balance for run #3 (Figure 13) shows that approximately 80% of the BTU's used by the process were used to heat and vaporize the water. The walls of the still were coated in a muddy cake of material.

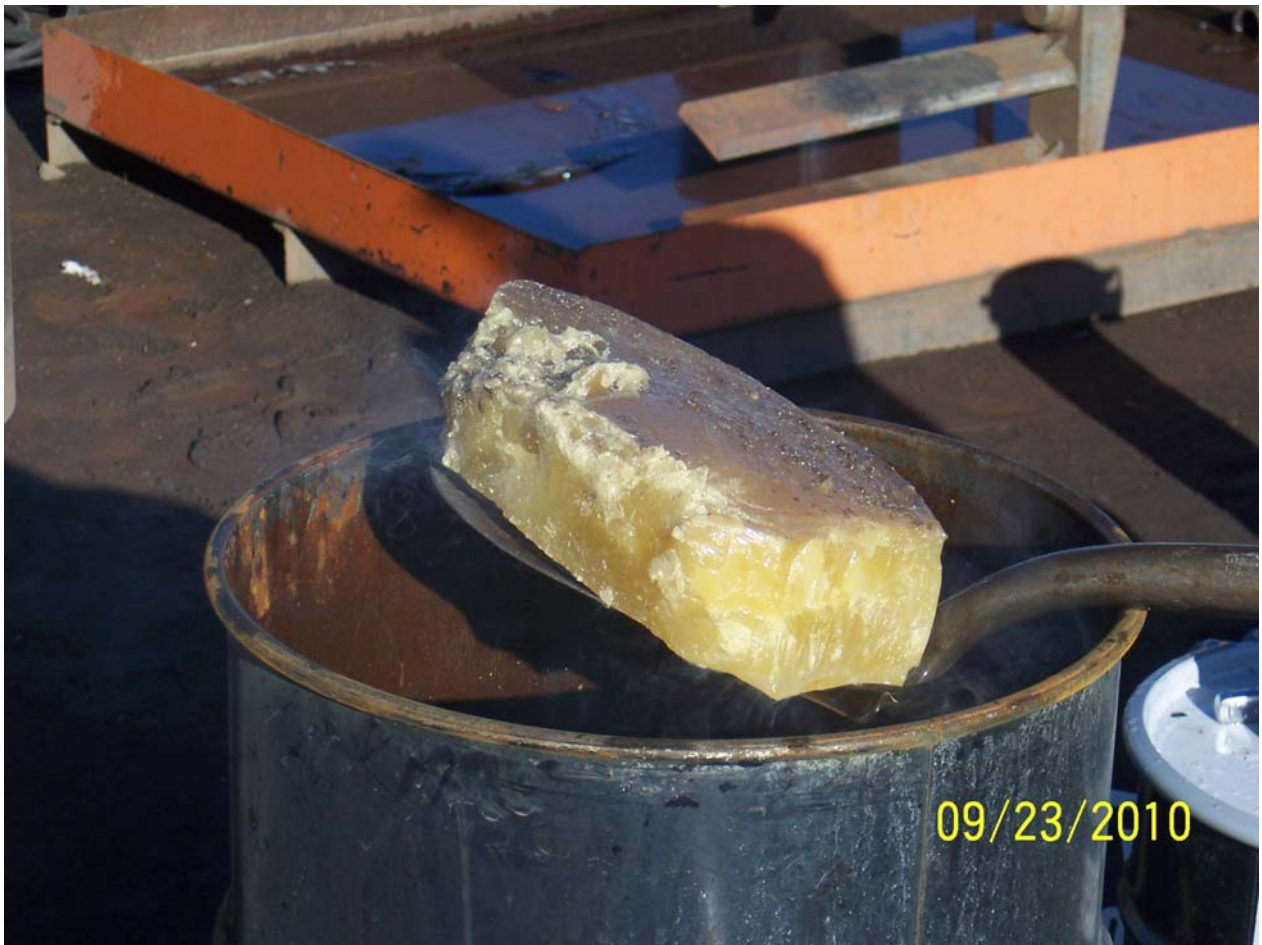
Some of the recovered phosphorus immediately after lifting from the water cap.
