Warning Letter and Certification of Violation Correction

Purpose: RCRA Compliance Evaluation Inspection

Facility: Siemens Water Technologies Corporation

Date of Investigation: June 22, 2009

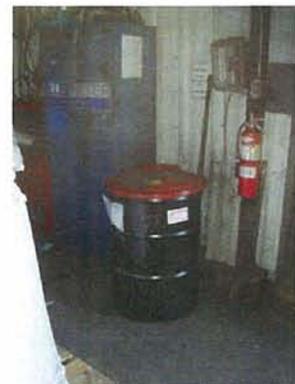
In addition to the containers of spent carbon from off-site facilities pending regeneration, the inspectors observed one 55-gallon satellite accumulation container for warehouse debris, dated 6/12/09, in this area (see photograph to the right). No potential violations were noted.

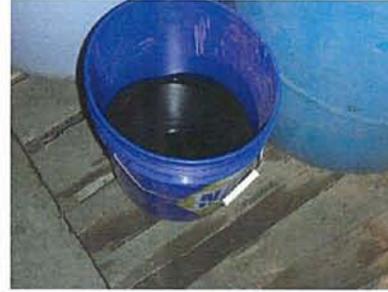
- One 5-gallon container of used oil (approximately 1/5 full) that was not labeled as used oil. This container was added to the properly labeled 55-gallon used oil container during the inspection.

Findings: The inspectors observed one 5-gallon container of used oil that was not marked as required.

Facility Response: This issue was corrected during the inspection.

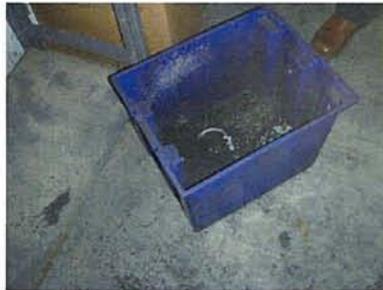
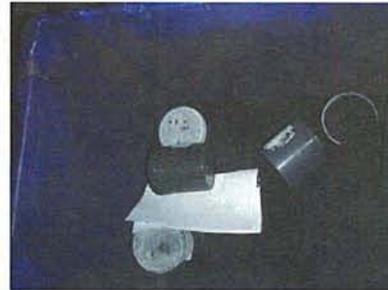
- Two open and unlabeled 5-gallon containers containing carbon from carbon samples (see photographs to the right). The carbon from these

containers was properly managed during the inspection.

Findings: The inspectors observed two containers of spent carbon samples that were open at the time of the inspection.

Findings: The inspectors observed two containers of spent carbon samples that were not labeled at the time of the inspection.

Facility Response: This issue was corrected during the inspection.

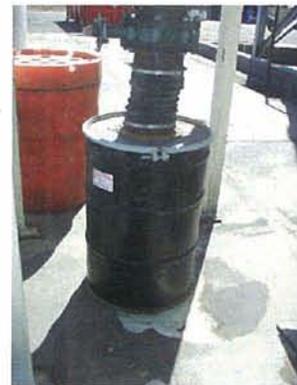
The container attached to the unit was dated March 24, 2009 (see photograph to the right). No potential violations were noted.

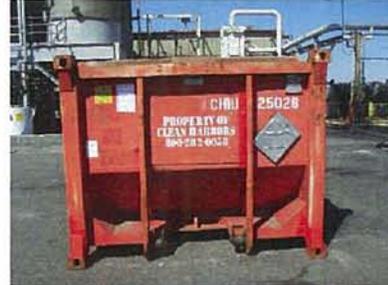
The 20-cubic yard roll-off bin was dated June 12, 2009 (see photograph to the right). No potential violations were noted.

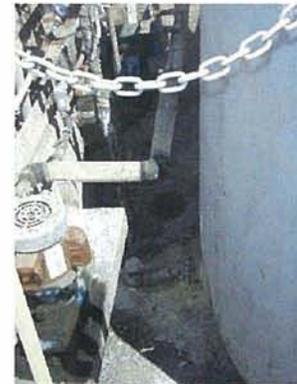
The inspectors observed some caustic residue from the product tank underneath one of the pipes (see photograph to the right). The inspectors informed the facility representative that this caustic should be cleaned up.

Findings: The inspectors observed dried caustic waste underneath a pipe next to the caustic product tank.

Subsequent to the inspection, the facility representatives provided photographs showing that this issue was resolved.

Facility Response: This area was cleaned up subsequent to the inspection.
