# Grasse River Superfund Site

## Public Meeting

November 15, 2012  
7:00 PM

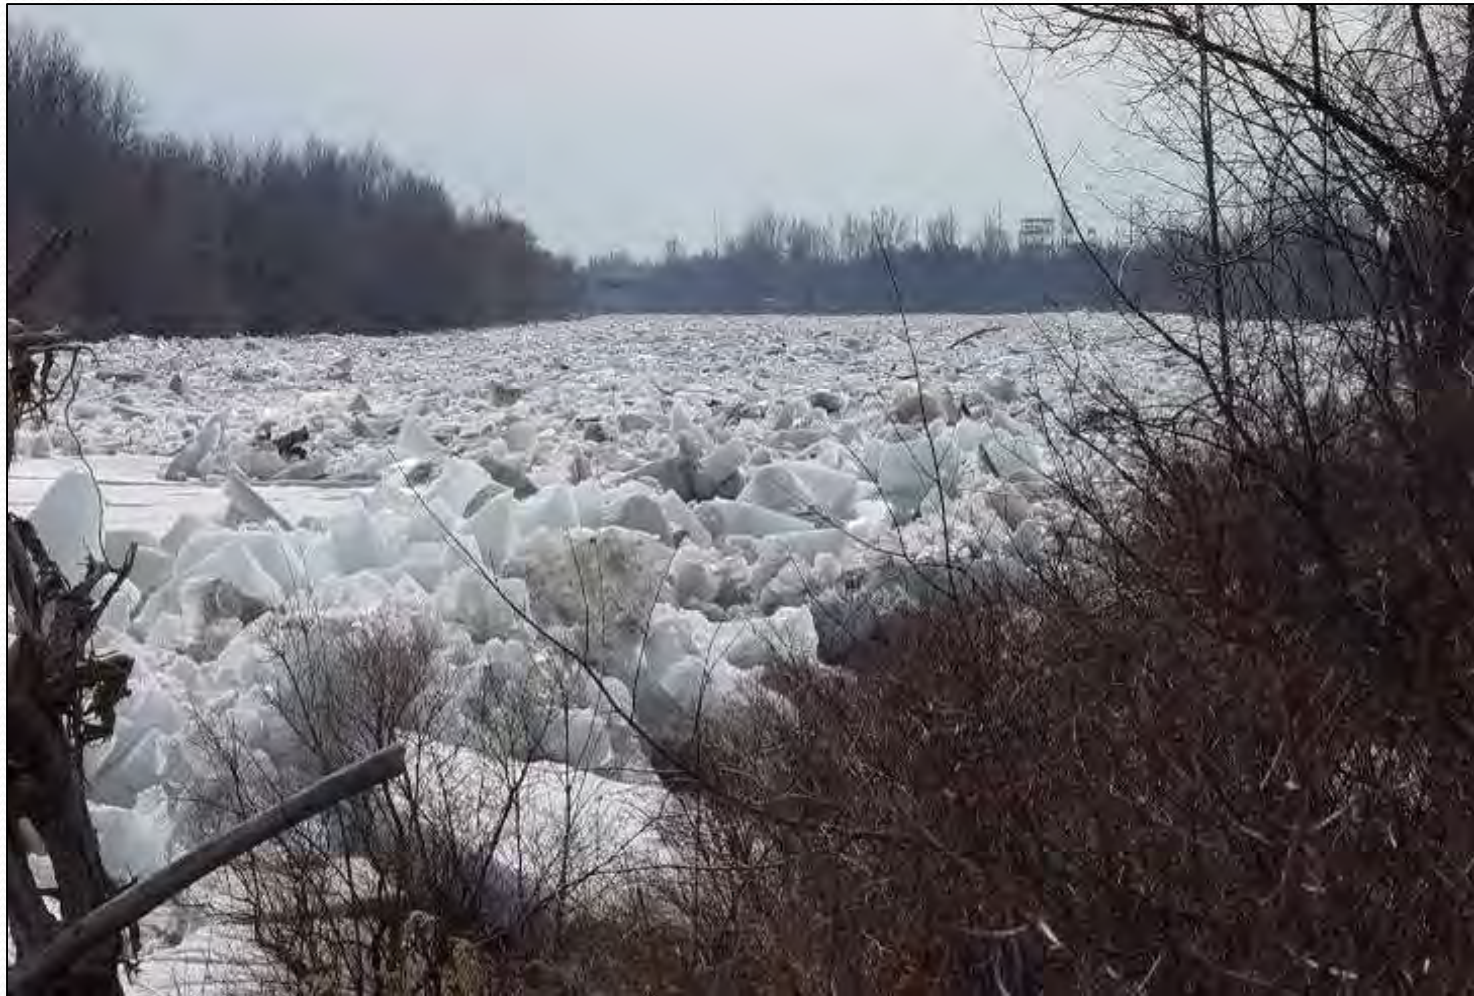
## March 2003 Ice Run Photo: Grasse River

- From 1991 to 2010, numerous studies were conducted to define the extent of contamination and to develop the alternatives for cleanup
- Several pilot studies and demonstration projects of various technologies also conducted in the river
- During post implementation monitoring of the capping pilot study, “ice jam” event severe enough to scour sediment was discovered

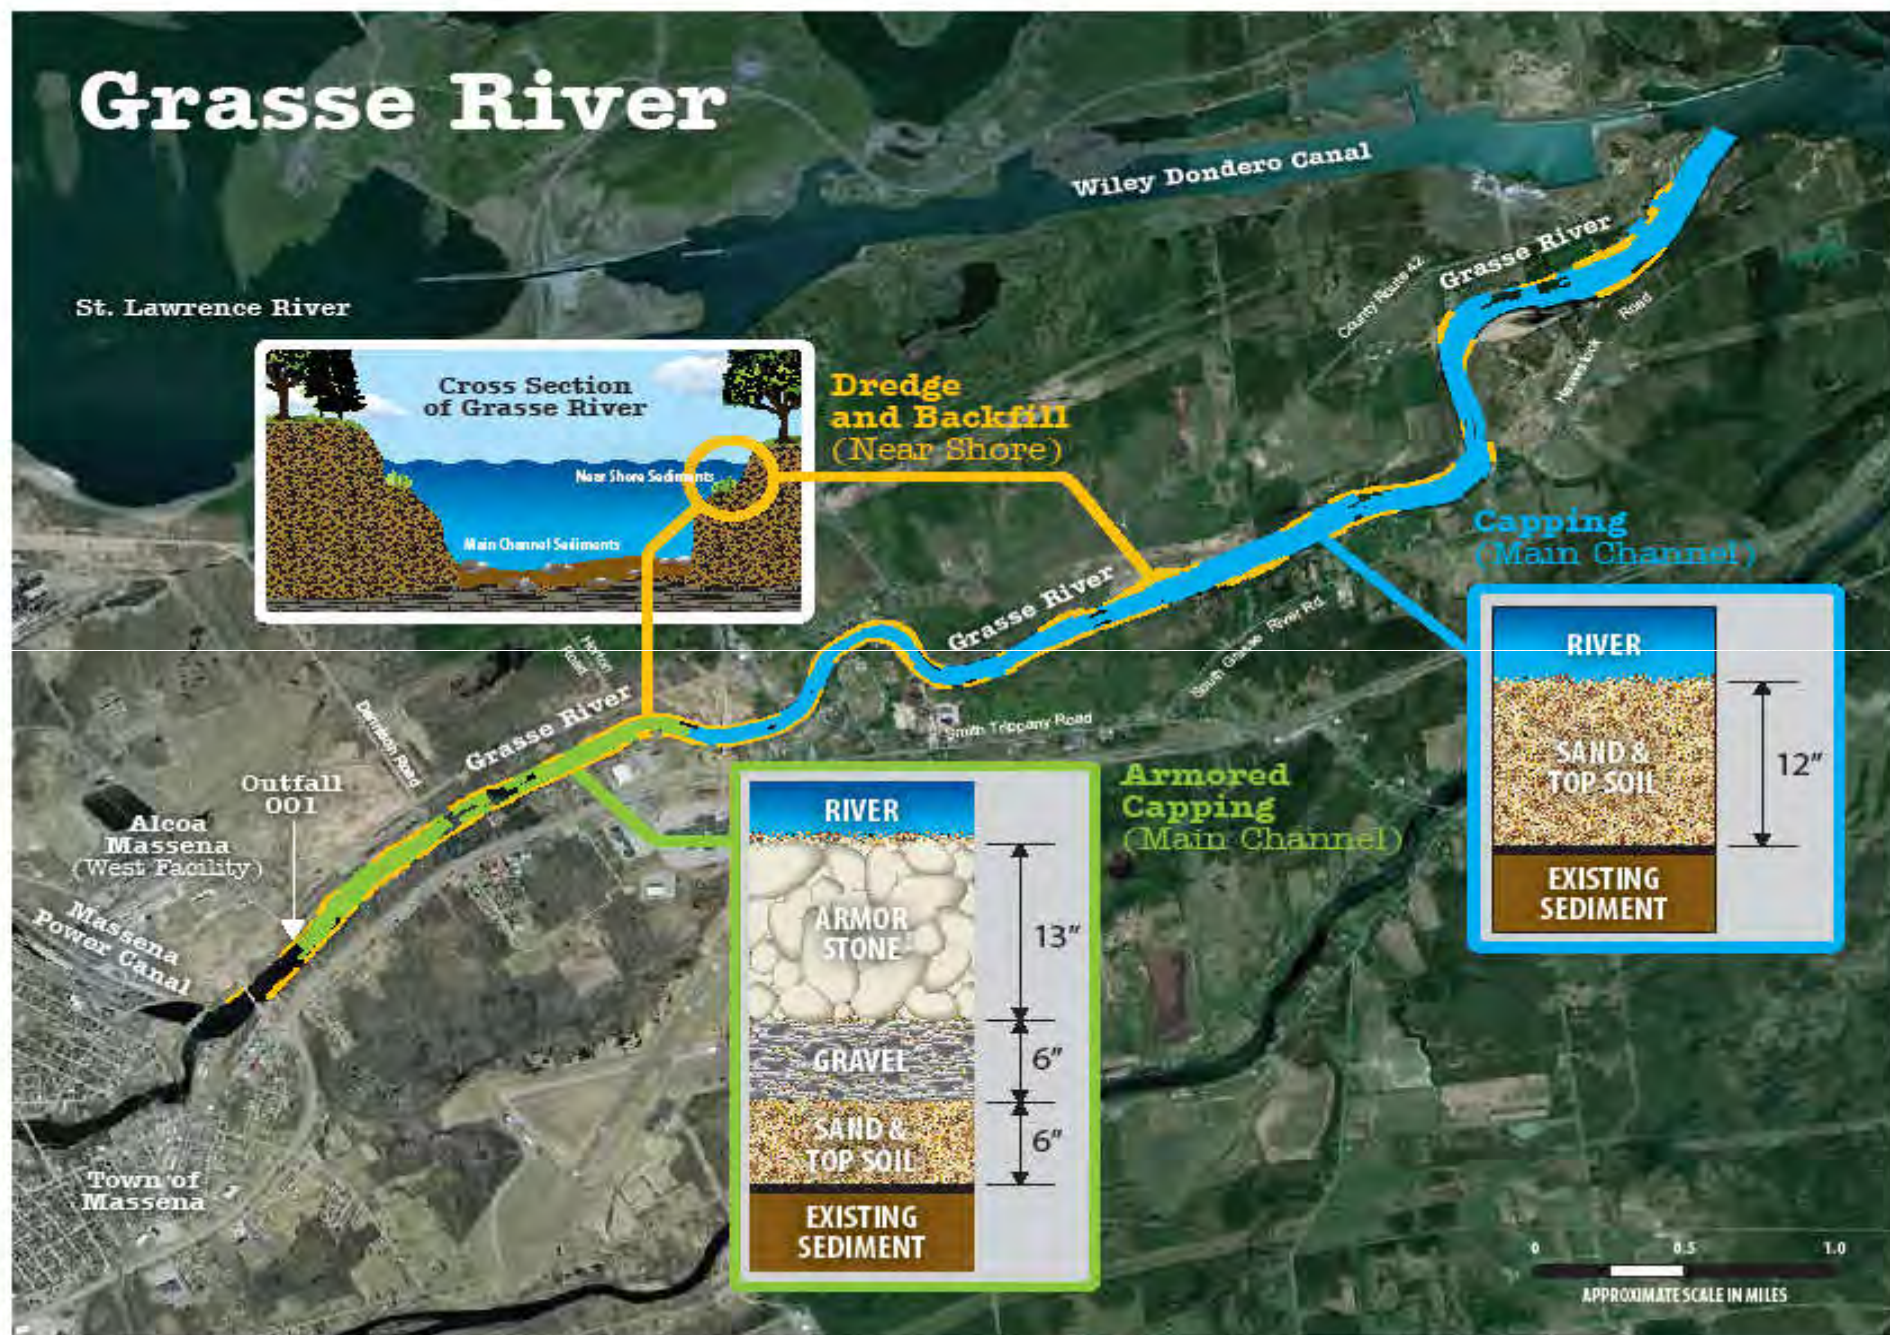
## Alternative 6

- Dredge near shore sediment PCB concentrations  $\geq 1$  parts per million (ppm), followed by backfill to grade (approx. 109,000 cubic yards)
- Place main channel armored cap over T1-T21 main channel sediments where either the segment length weighted average (SLWA) or the maximum surface sediment PCB concentrations  $\geq 1$  ppm (approx. 59 acres)
- Place main channel cap over T21-T72 main channel sediments where the maximum surface sediment PCB concentrations  $\geq 1$  ppm (approx. 225 acres)
- Dewater dredged sediment and dispose in the on-site permitted landfill
- Reconstruct habitat impacted by remedial action
- Long-term monitoring and maintenance

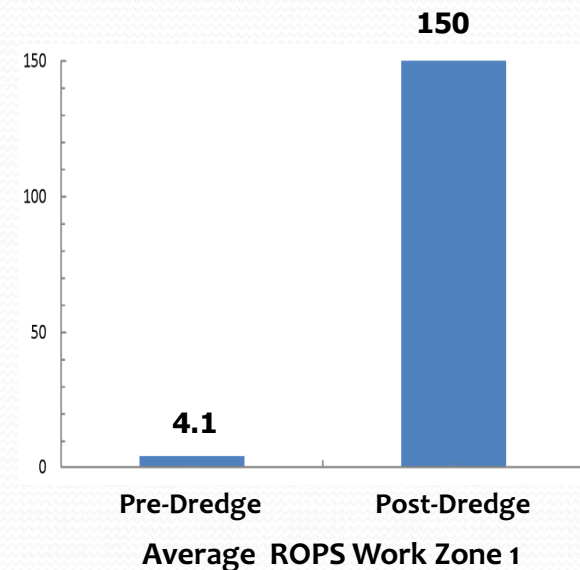
- Site-specific conditions not conducive to dredging main channel. Dredging main channel results in high residual concentration still requiring capping after extensive dredging.
  - Most highly contaminated sediment buried towards the bottom of sediment column
  - Irregular, uneven river bottom
  - Boulders and rock debris

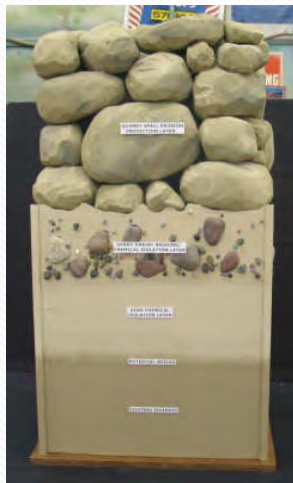
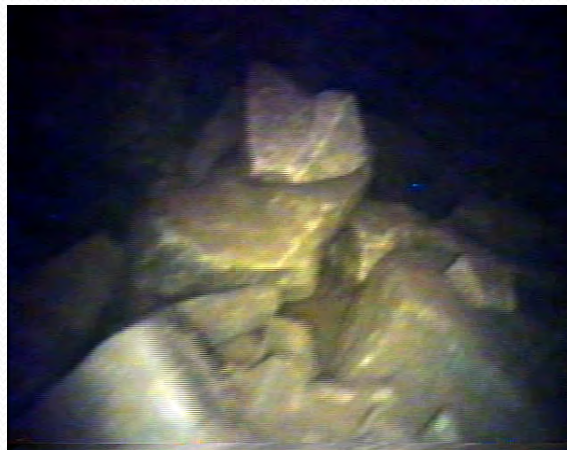
- Armored cap designed and implemented during 2005 ROPS
- Models used to design armored cap address turbulent flow, velocity, and ice thickness. Designed to protect against scouring forces created under the ice jam toe
- In-river armored cap has been used at contaminated sediment sites to address erosional and scouring forces for which sand/topsoil caps are insufficient

Photo of Armored Cap 2005 ROPS

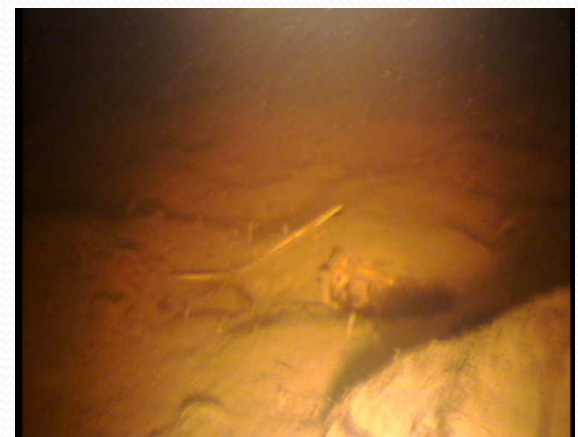
Photo of Armored Capped Area 2009

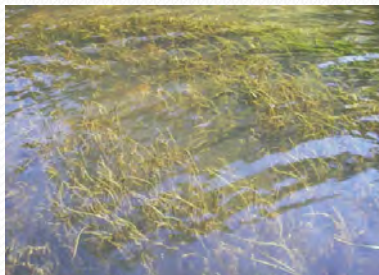
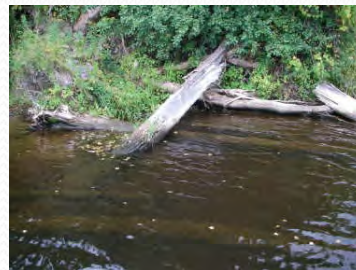
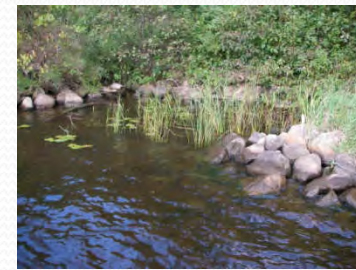
- **Capping the Grasse River near shore is not “as good” as dredging and backfilling to grade**
- **Unlike main channel, near shore can be successfully dredged and not require a cap after dredging**
- **Dredging near shore will take out some of the side-slope, which has been difficult to cap due to its steepness**
- **Near shore is backfilled to grade after dredging to allow for habitat re-establishment and species use**
