RE: **Long Term Stewardship Report**
Former KLI site
EPA ID VAD052356623

Long-Term Stewardship Assessment Report
KLI Site
EPA ID VAD052356623

VDEQ Long Term Stewardship Inspection Aerial Photo
KLI Site – Milford, Virginia

VDEQ Long Term Stewardship Inspection Site Photos

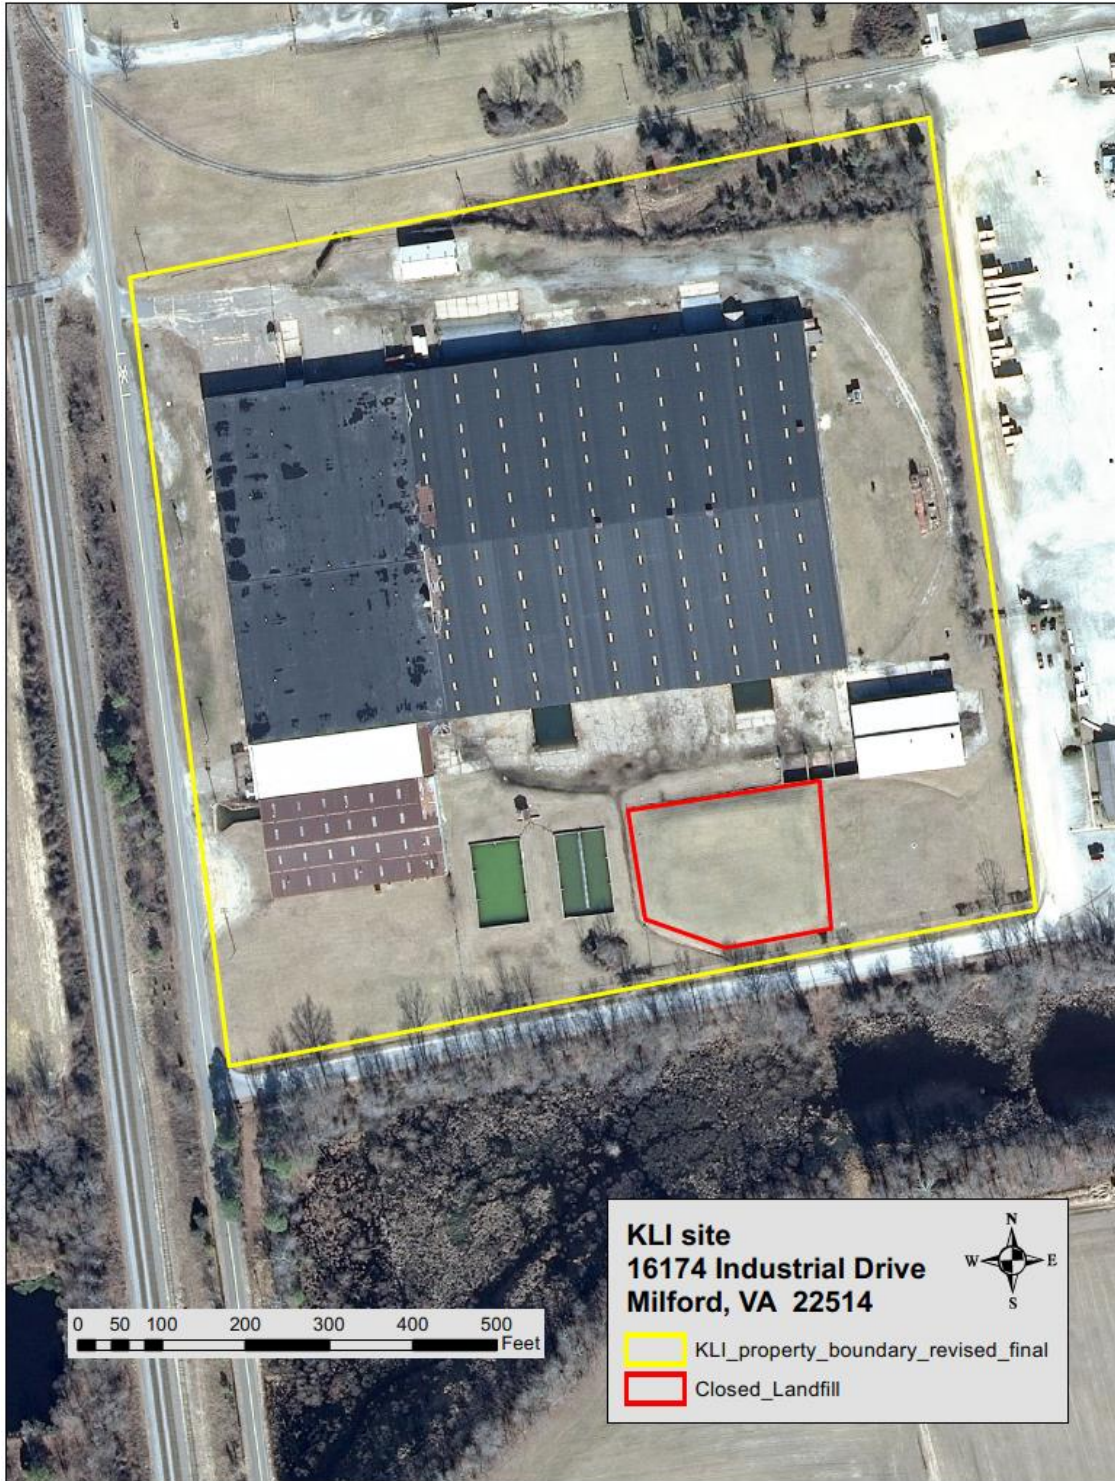
Mapping: The EPA Facility website figure is accurate and includes a geospatial PDF showing the use restriction boundaries. The map was field-verified and no issues were noted.

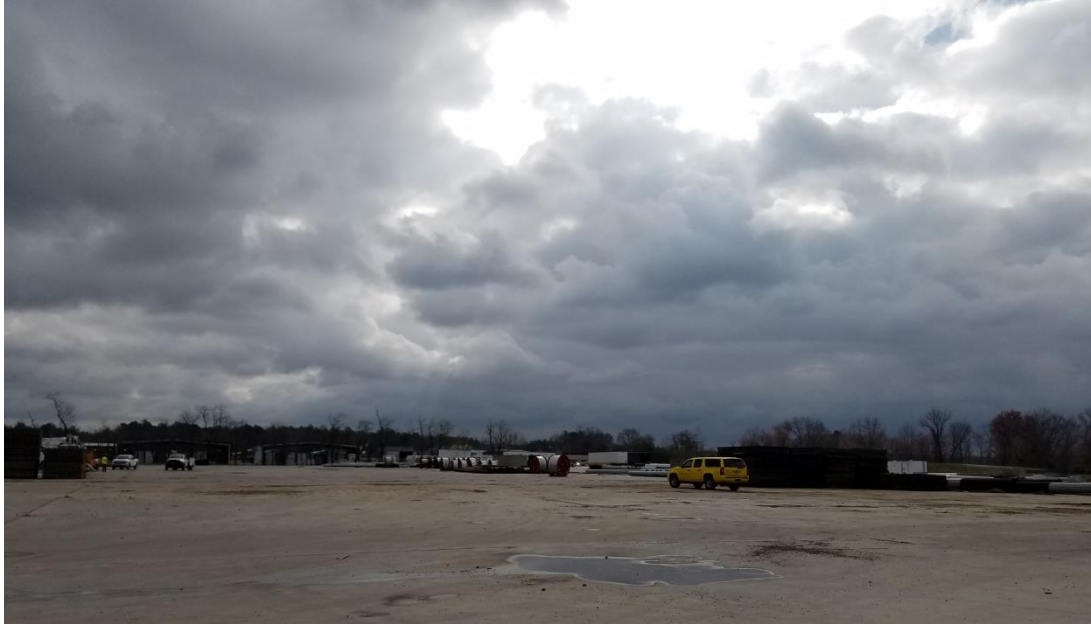
Facing East – Current Site Use - Equipment Staging on concrete building pad

- Groundwater not in use, 1 well currently being monitored for PCE annually.
- Additional monitoring wells remain onsite.
- Site currently being leased as a staging area / concrete pad where former building was.
- No issues identified during site walkover
- Geospatial PDF accurate.

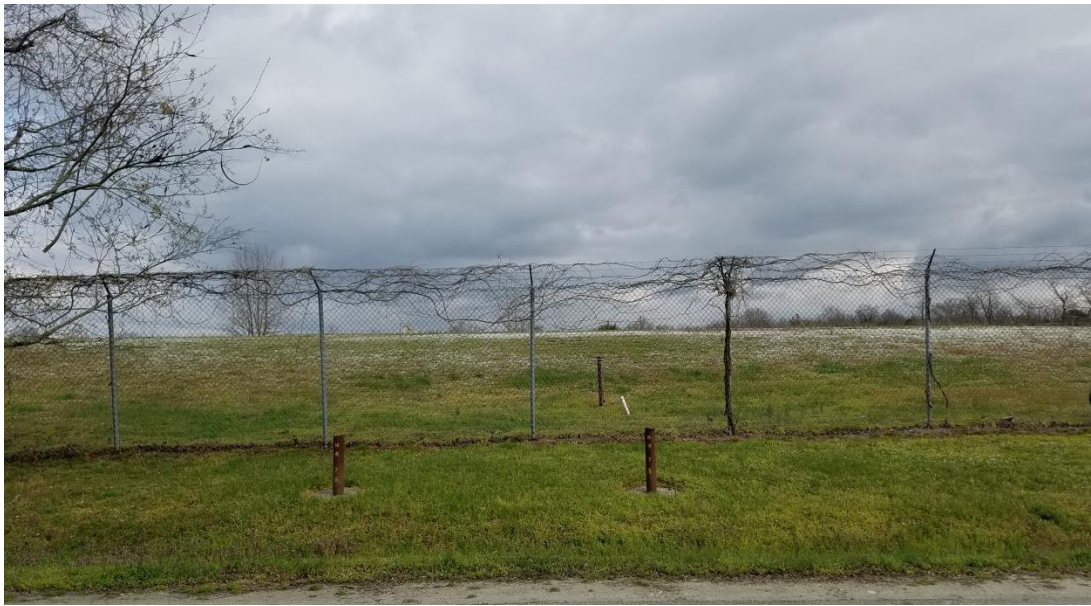
Access Controls: The surface impoundment is capped and surrounded by a locked gate and fence.

Conclusion: The engineering and institutional controls selected are implemented and remain intact and undamaged. No EC/IC deficiencies have been identified.

Closed Impoundment (SWMU #10) – Facing North from South Property Boundary
