MIP Investigation Report
and
Workplan for High Resolution Site
Characterization

RCRA-05-2010-0012
Former Tecumseh Products Company Site
Tecumseh, Michigan

Revision 2 April 2015

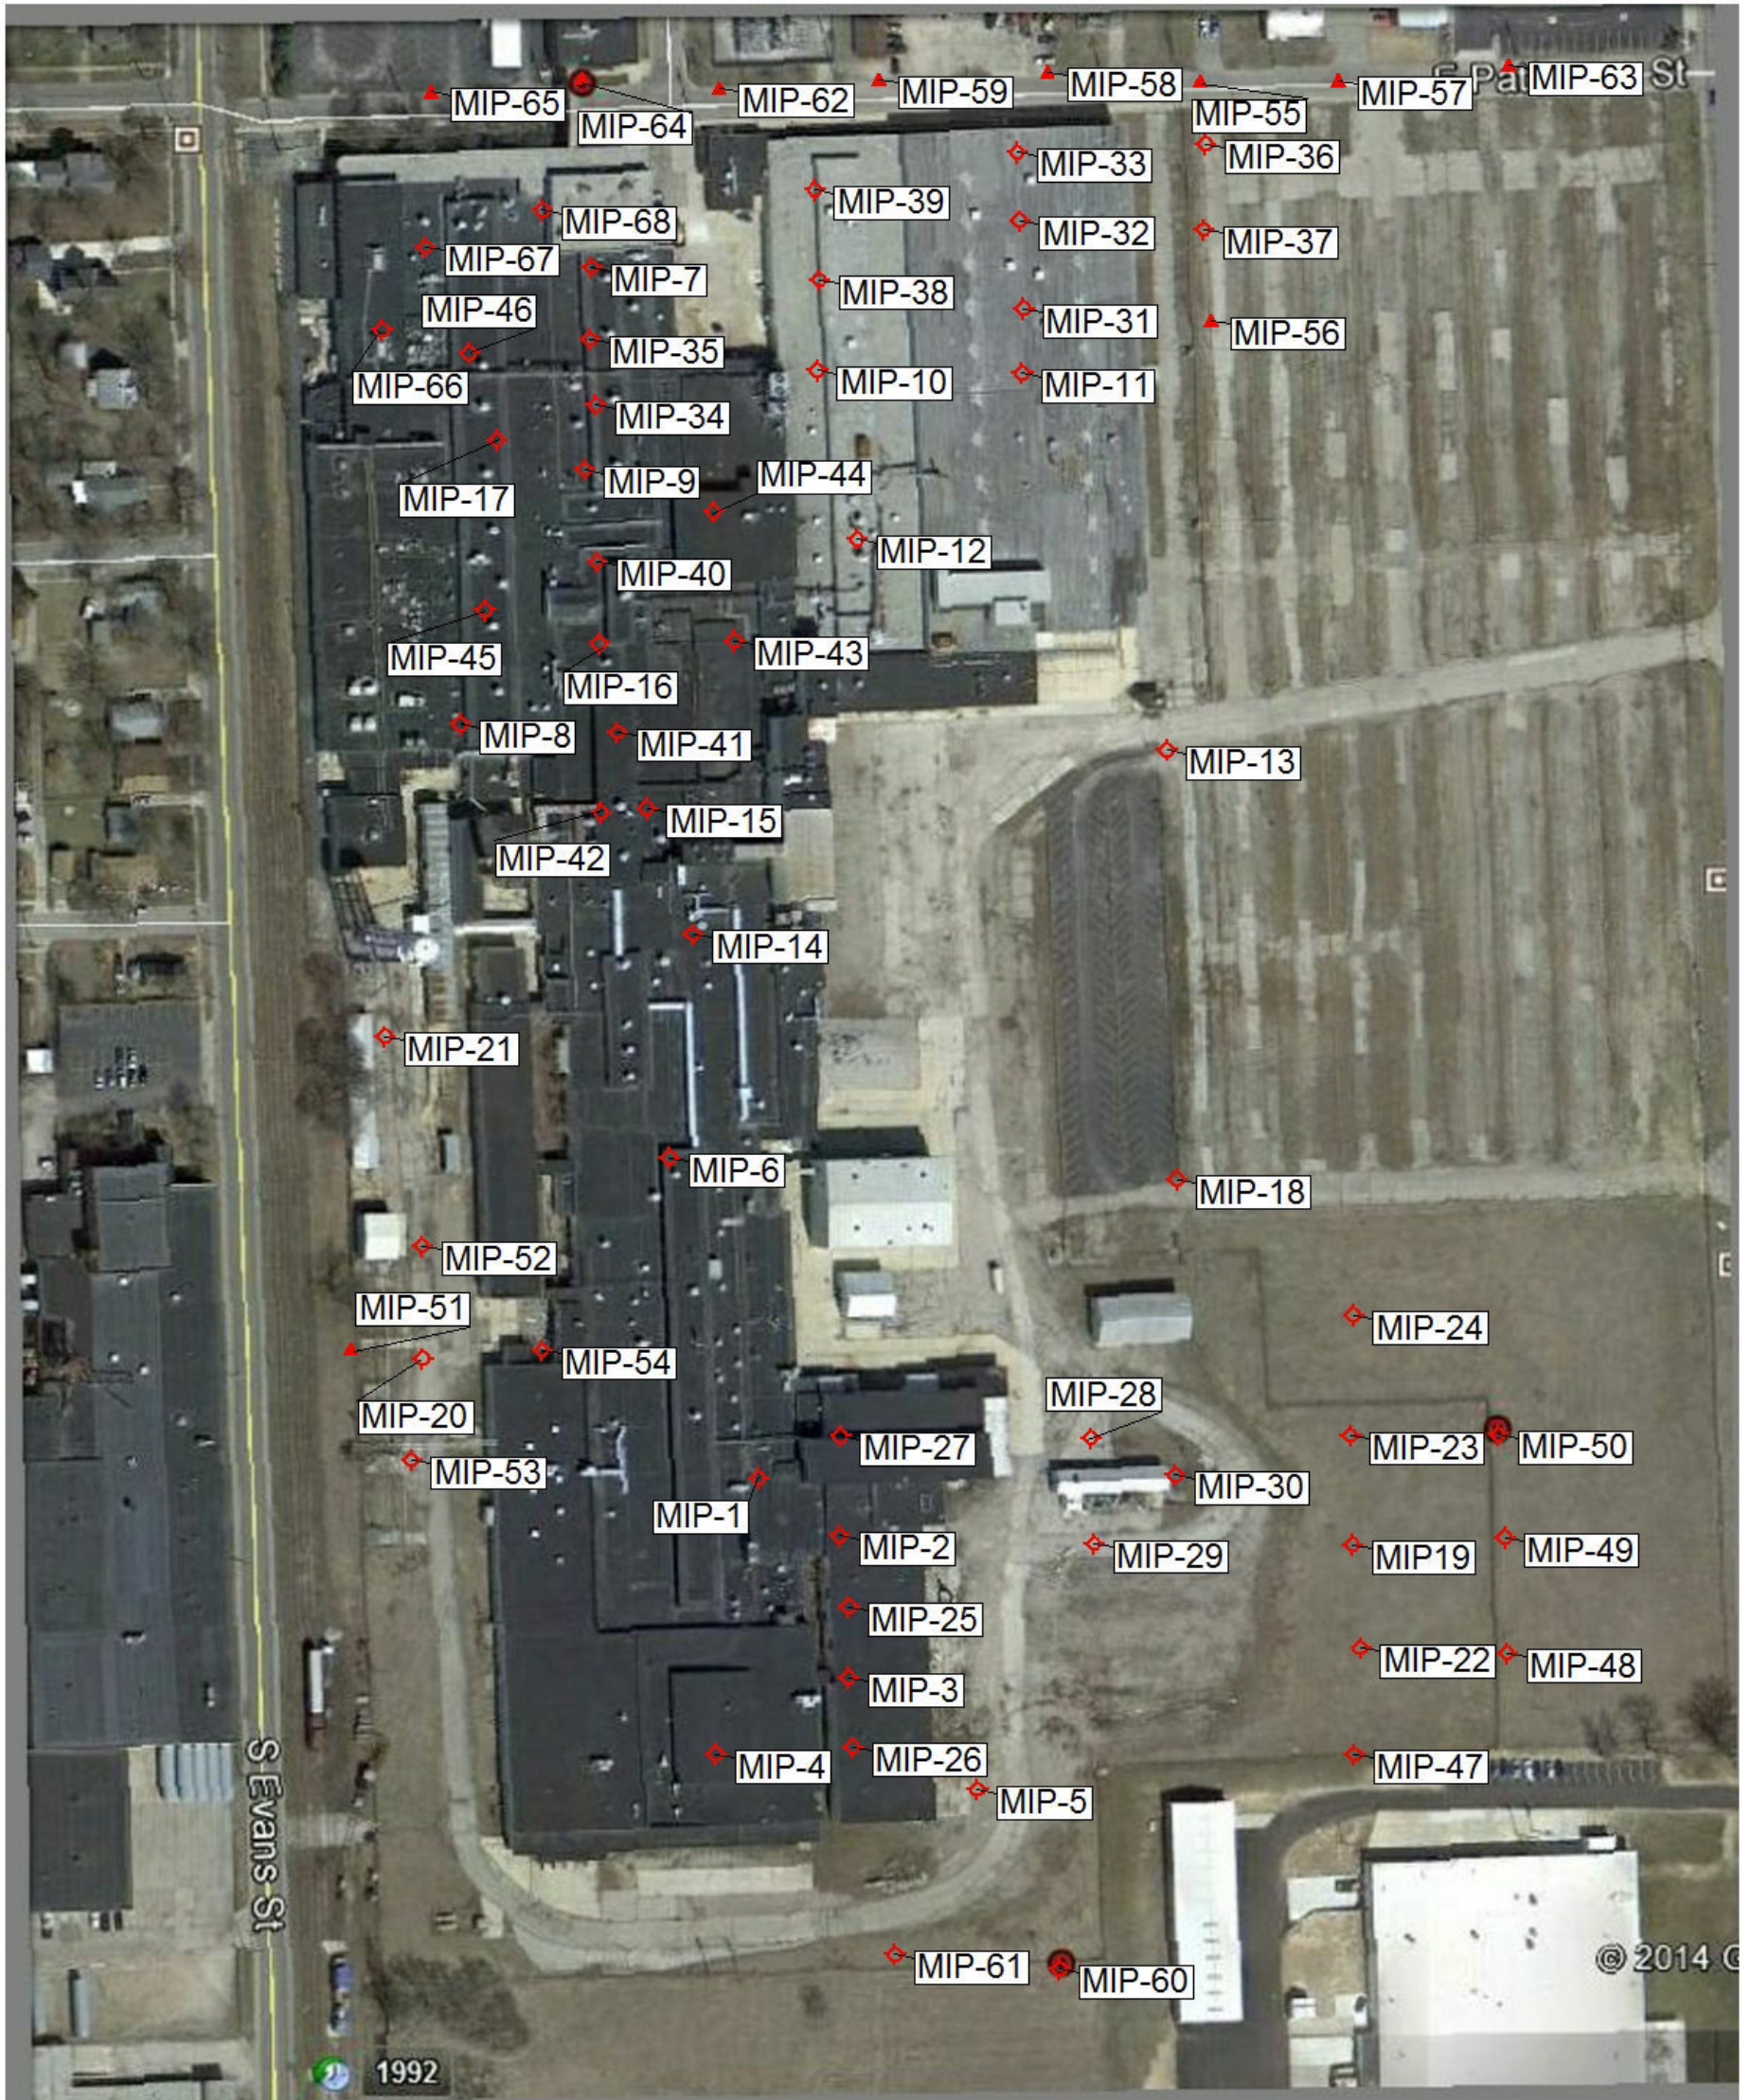
MIP-10 MIP Boring Location.
For Total Depth, Refer to
Attachment B

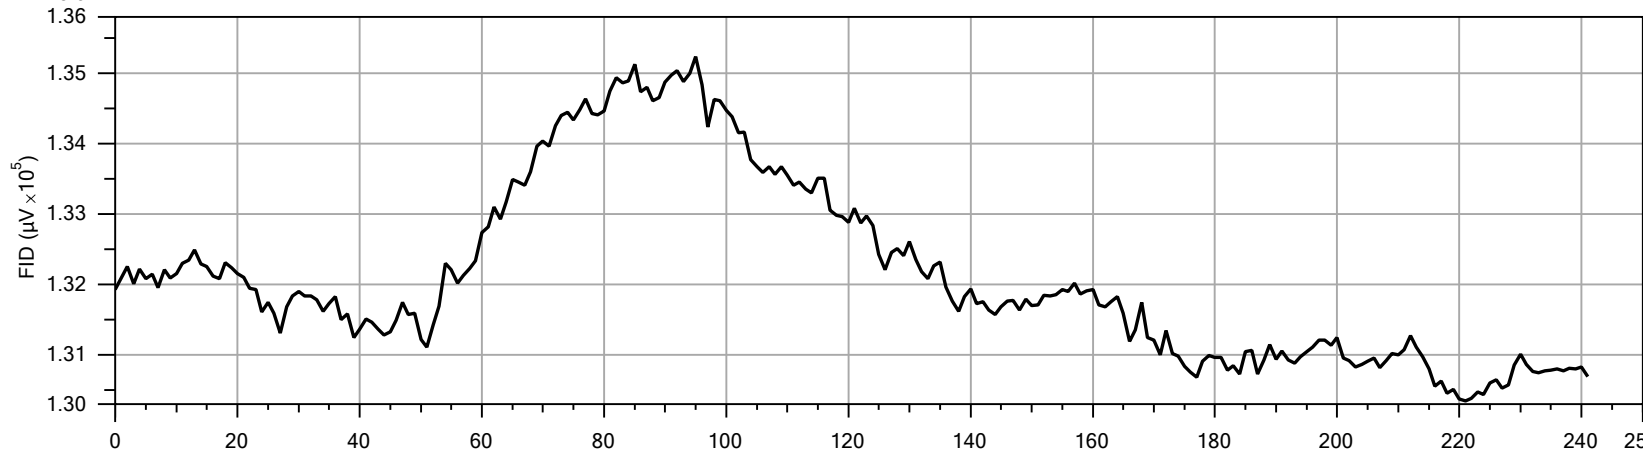
PRE-LOG RESPONSE

Detector:	PID
Peak Response:	63540 μV
Baseline:	0 μV
Compound:	TCE
Concentration:	1.0 ppm

Detector:	FID
Peak Response:	135235 μV
Baseline:	0 μV
Compound:	TCE
Concentration:	1.0 ppm

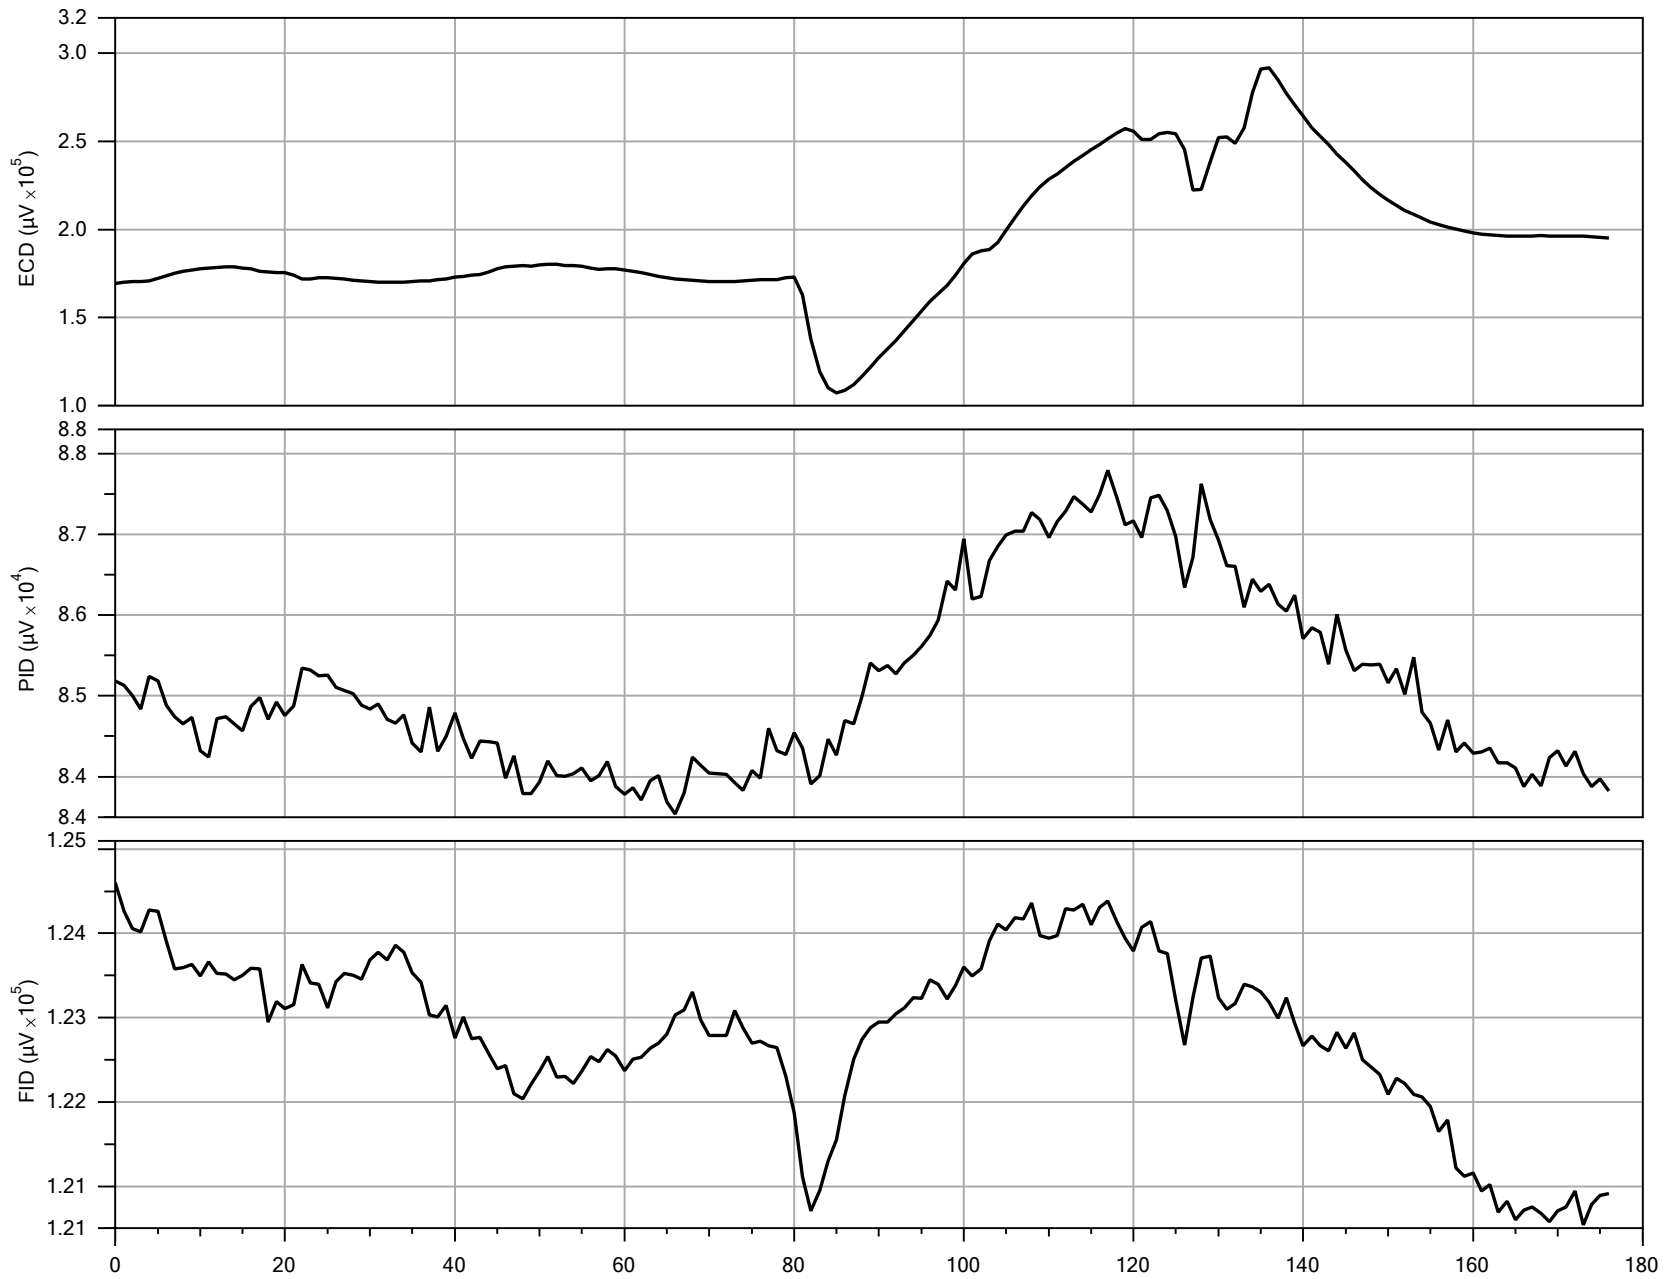
Company:	SER90	Operator:	S. Sirhan	File:	MIP-37.PRE.TIM
Project ID:	TPC-2014-RI	Client:	TRC Solutions	Date:	7/10/2014

Detector:	ECD
Peak Response:	291620 μV
Baseline:	0 μV
Compound:	TCE
Concentration:	1.0 ppm

Detector:	PID
Peak Response:	87794 μV
Baseline:	0 μV
Compound:	TCE
Concentration:	1.0 ppm

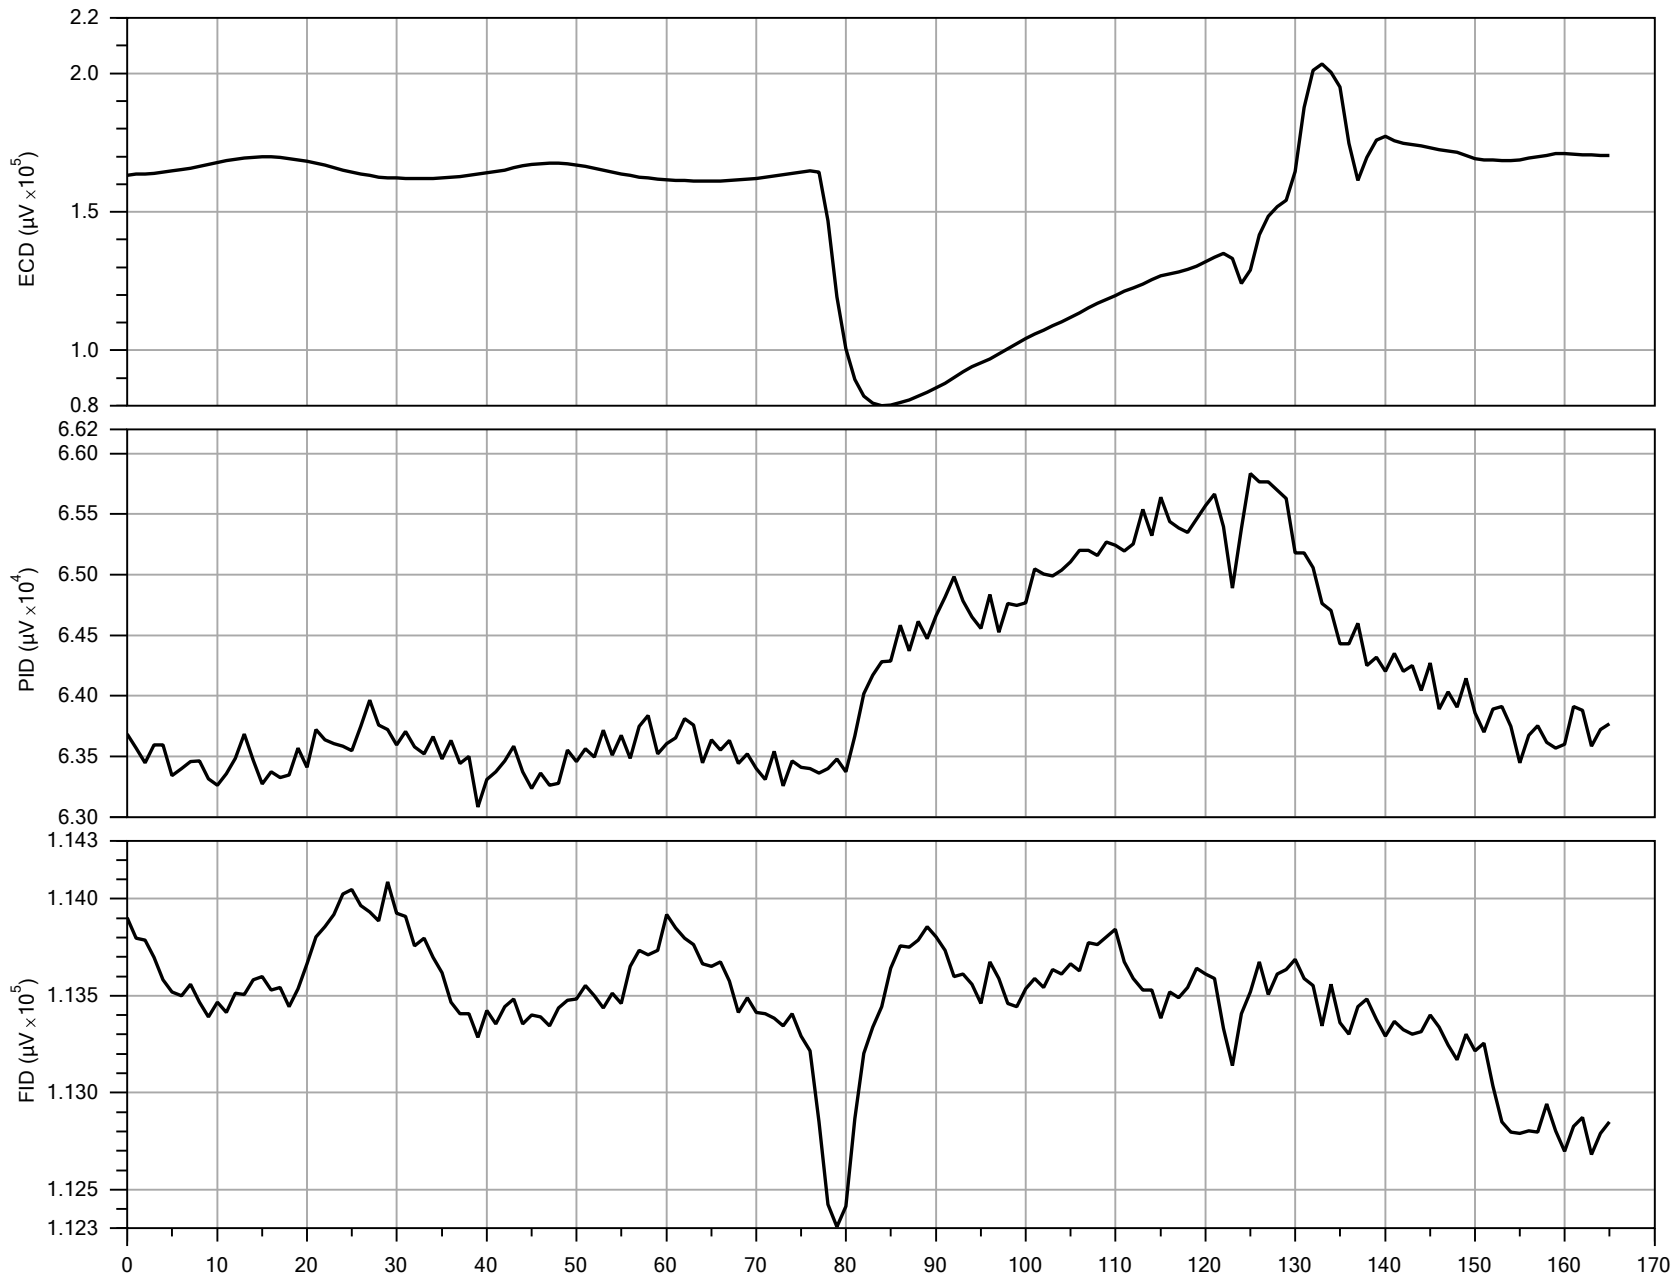
Company:	SER90	Operator:	Sammy	File:	MIP-53.PRE.TIM
Project ID:	TPC-2014-RI	Client:	TRC Solutions	Date:	7/17/2014

Detector:	ECD
Peak Response:	203307 μV
Baseline:	0 μV
Compound:	TCE
Concentration:	1.0 ppm

Detector:	PID
Peak Response:	65836 μV
Baseline:	0 μV
Compound:	TCE
Concentration:	1.0 ppm
