APPENDIX A

Subject: Enforcement Action Memorandum – Determination of Threat to Public Health and the Environment at the Wolverine Worldwide Tannery and House Street Disposal Site, Rockford and Plainfield Township, Kent County, Michigan (Site ID # C593)

SITE LOCATION AND LAYOUT MAPS

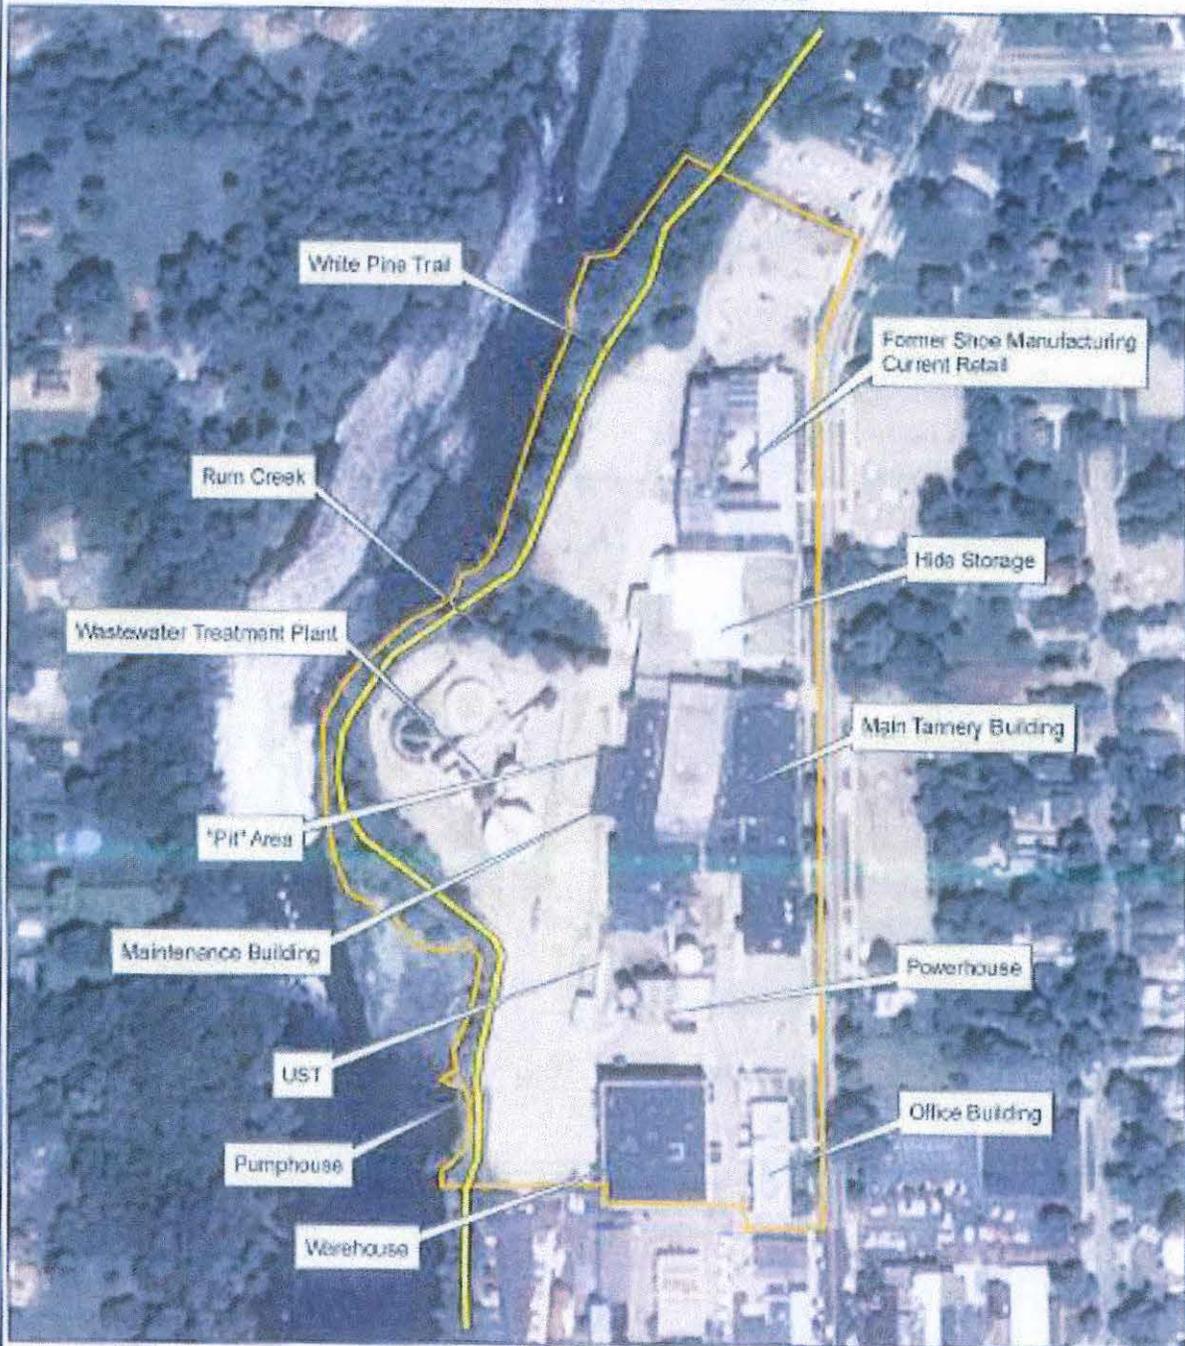
Historical/Current Site Features

- White Pine Trail
- Site Boundary

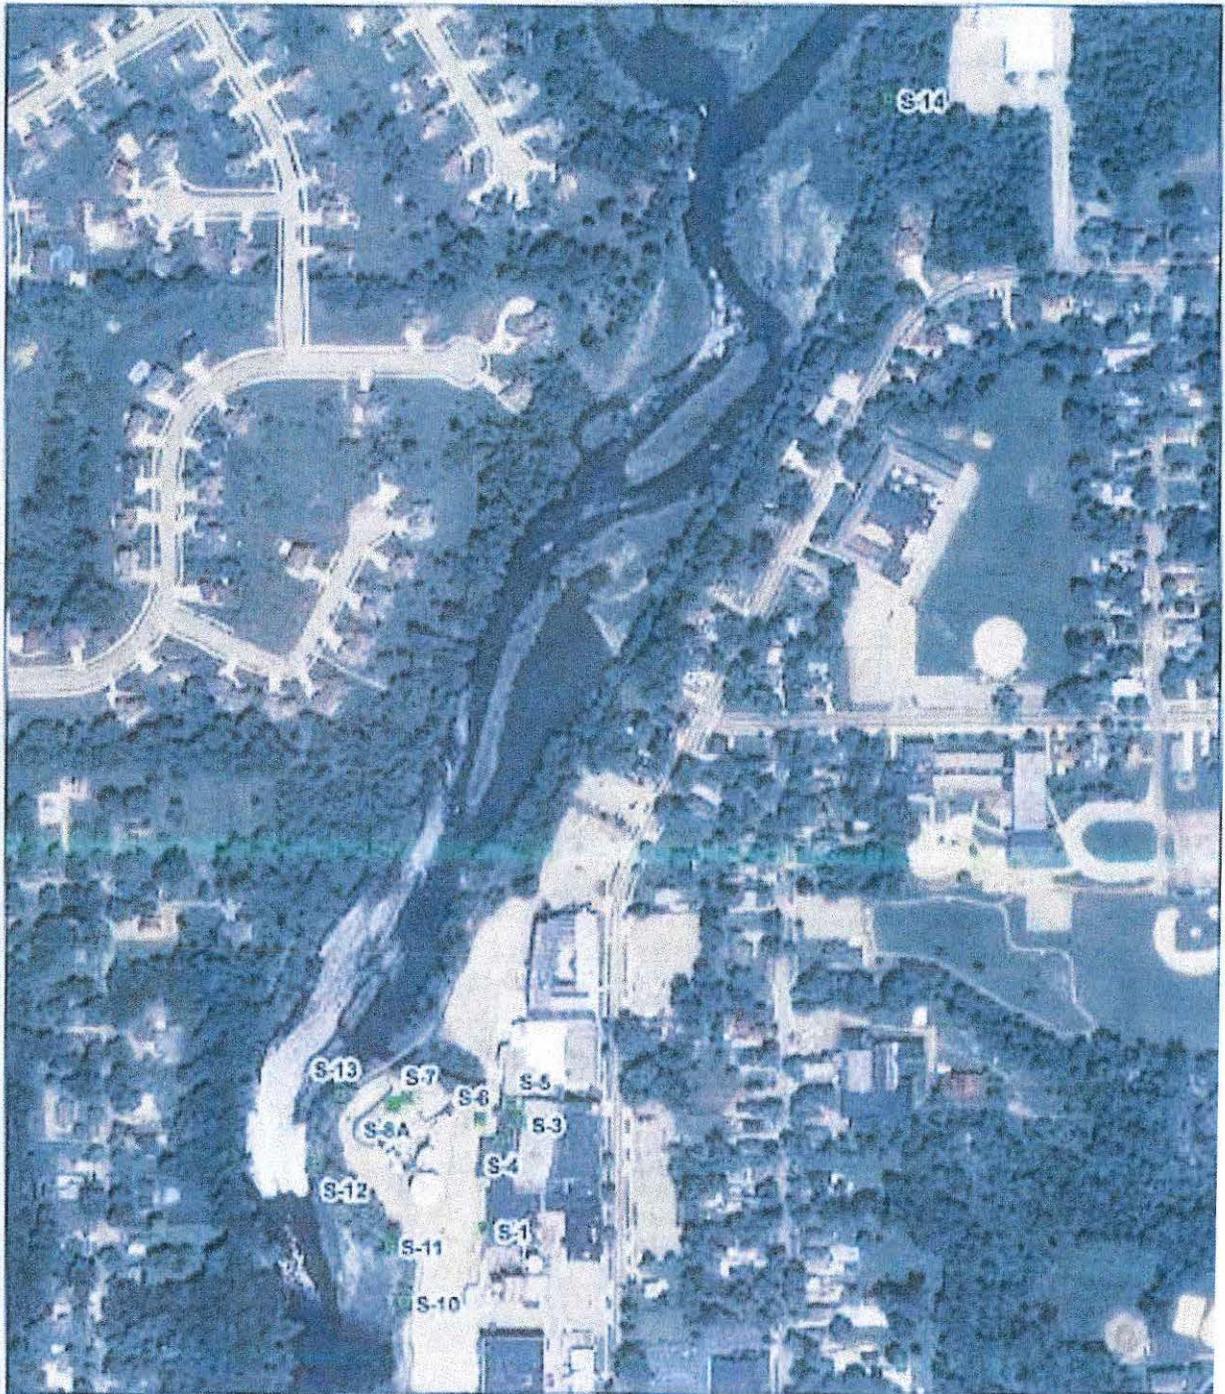
Legend
■ S-1 Soil Sample Locations

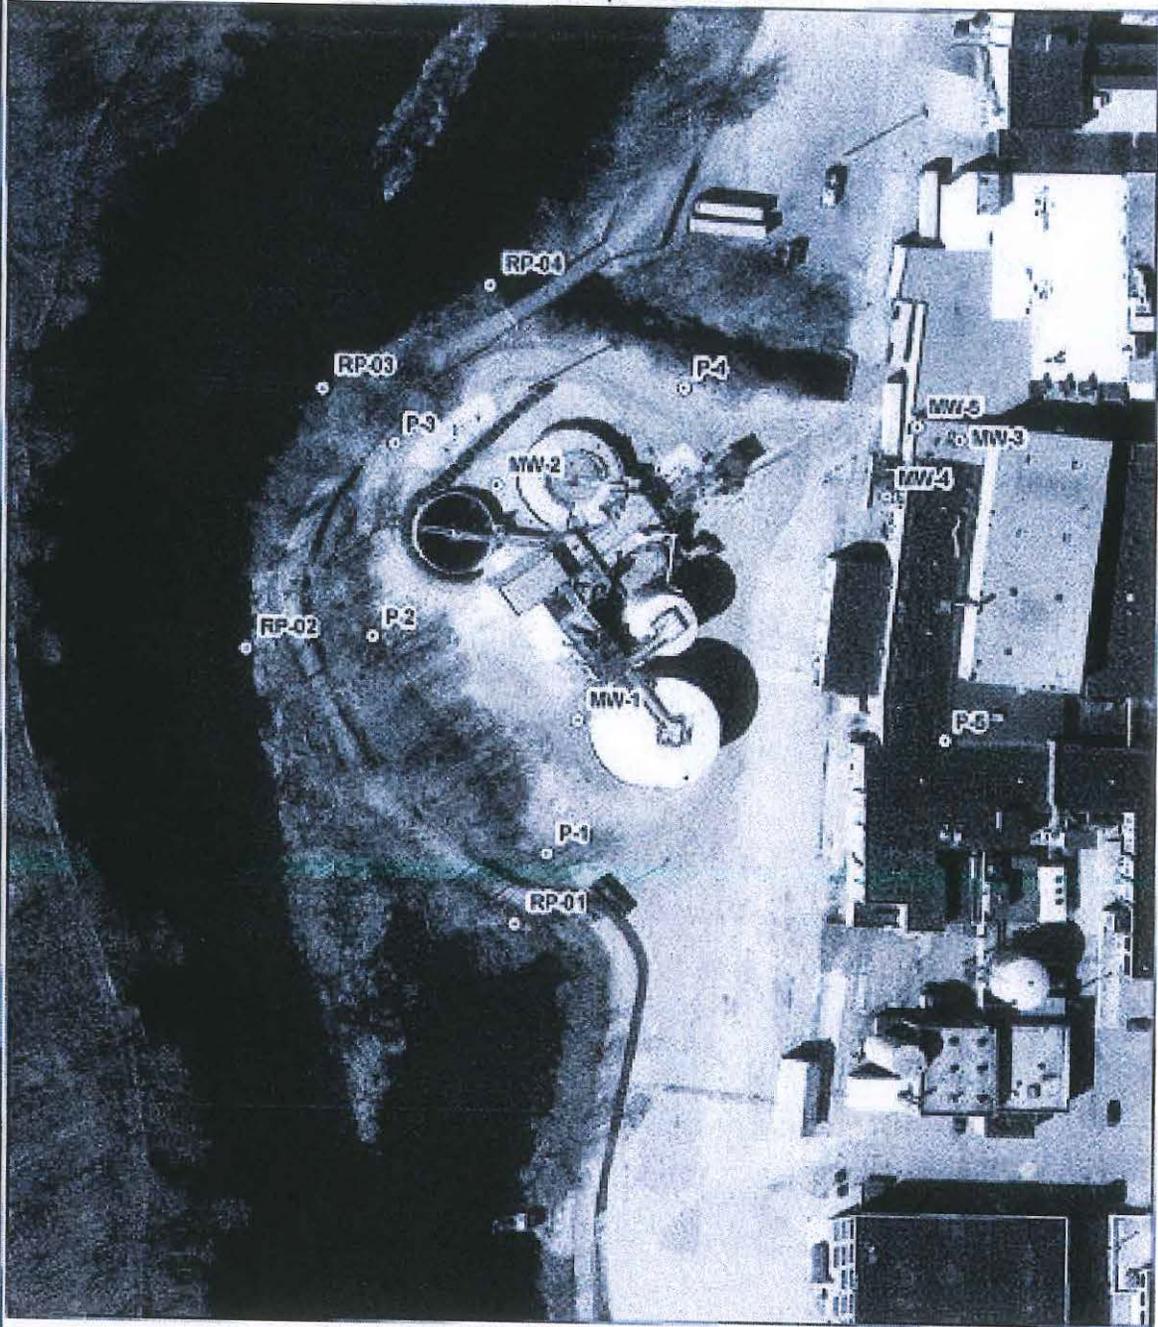
Groundwater Sample Locations

- ① MW-1 Monitoring Well Locations
- ② P-1 & RP-01 Piezometer/River Piezometer Locations

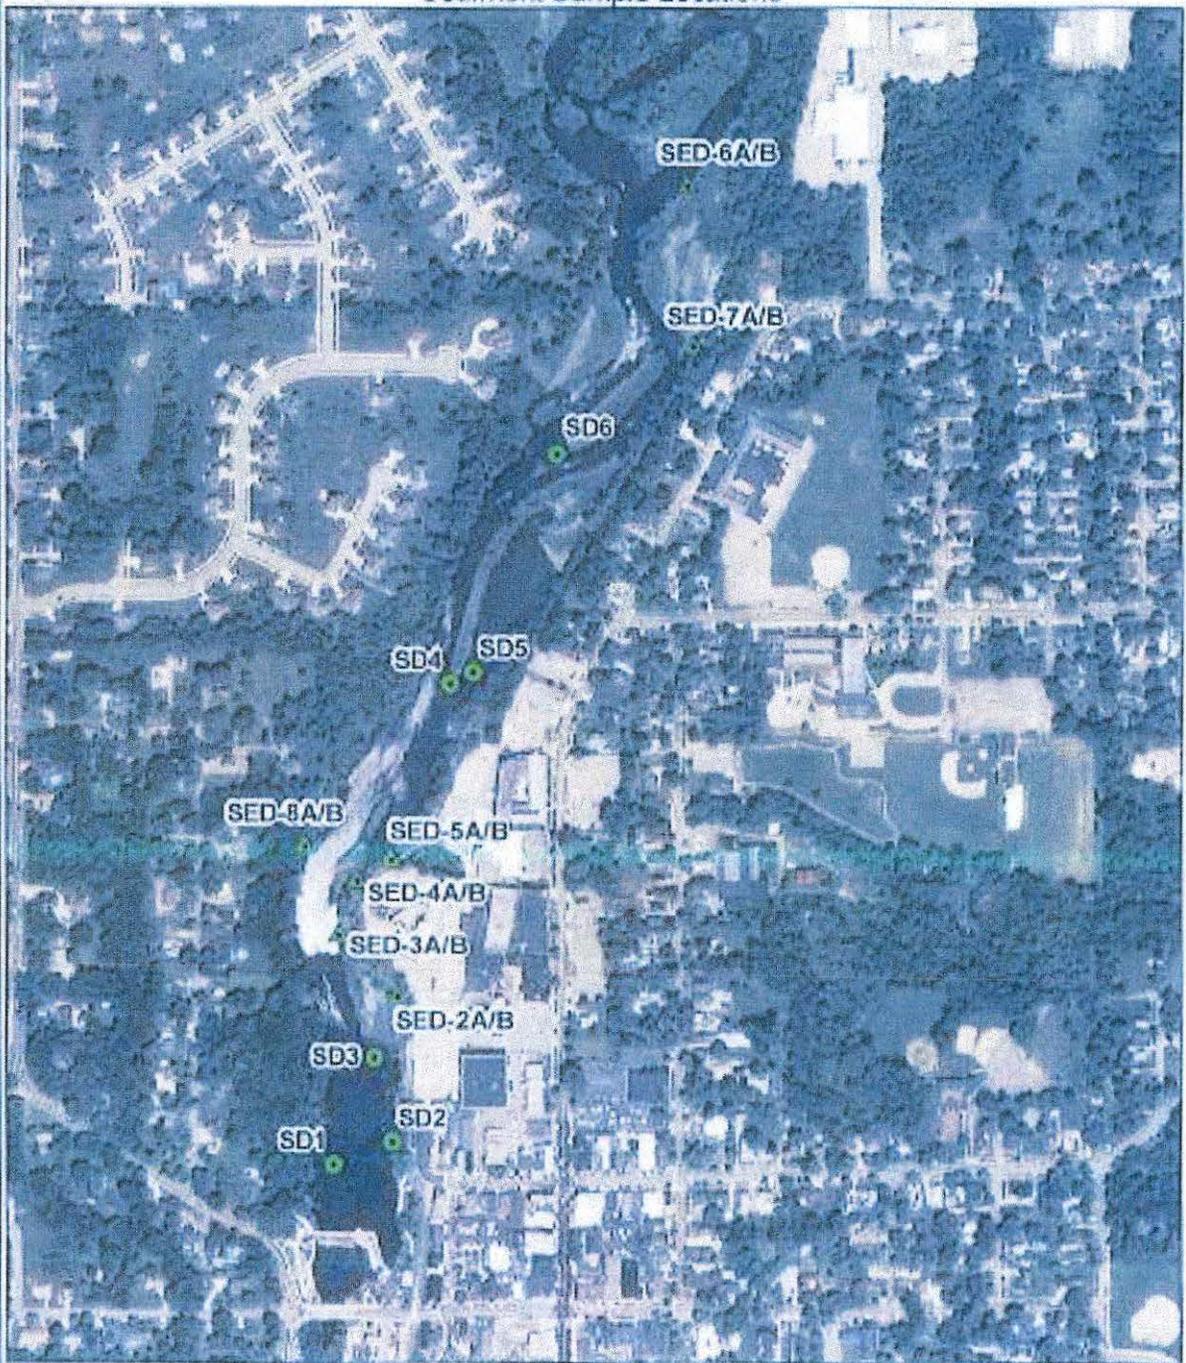
Sediment Sample Locations

- Sediment Sample March 2012
- ▲ Sediment Sample December 2011
