# Low-Concentration Hydrogen Peroxide (LCHP) Vapor for Bioremediation

## Assessment and Evaluation Report

Contract EP-C-15-008

Jacobs Technology, Inc.  
Research Triangle Park, NC 27709

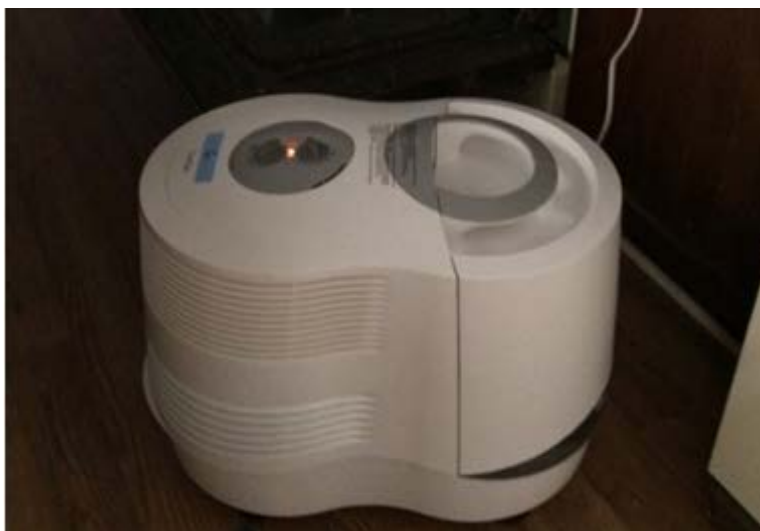
**Figure 3-2. Humidifier Placement in Kitchen**

Fifteen sampling locations were selected to place test coupons to evaluate the efficacy of the decontamination process over the entire CTH. Variables included locations of humidifiers, amount of HP solution used to charge the humidifiers, and whether or not spaces were sealed (such as the crawl space and attic). Initial conditions called for placing one humidifier in each of the following areas: kitchen, den, and the three bedrooms; two humidifiers in the living room; and three humidifiers each in both the attic and crawl space, for a total of 13 humidifiers. Humidifiers, as shown in Figure 3-2, generally were placed in or near the center of the room. Each humidifier was charged with 2 gallons of 3 or 4% liquid HP solution. All windows and exterior doors were closed, and the attic and crawl space were loosely sealed. The door for each room was left open during the decontamination event. An oscillating fan (model 2521, Lasko Products, Inc., West Chester, PA) was placed in each room that did not have a ceiling fan to aid in mixing.

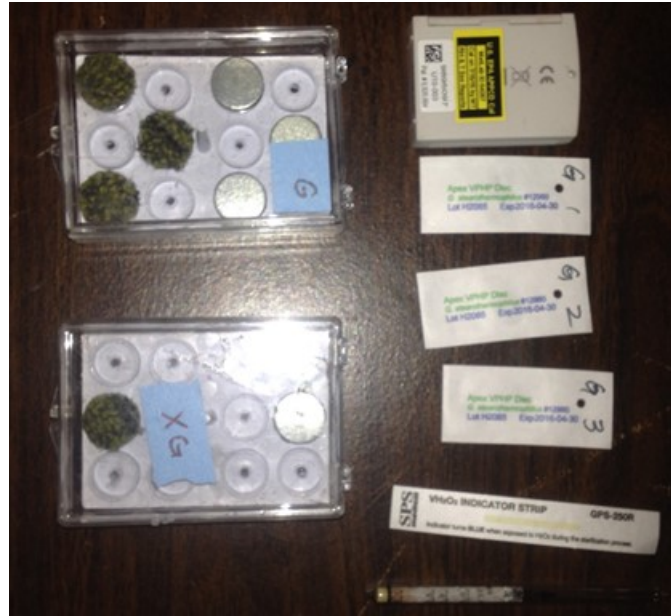
**Figure 3-3. Typical Sampling Set with Coupons in Plastic Holders, Temperature and RH Monitor, Three BI discs in Tyvek Envelopes, HP Test Strip, and Dräger Tube**

- (5) an SPS Medical GPS-250R VH202 Chemical Indicator Strip (SPS Medical Supply Corp., Rush, NY) to monitor exposure to HP.
- (6) a Dräger HP tube (Dräger™ Short-Term Detector Tubes – Hydrogen Peroxide, Cat. No 8101041, Dräger, Inc., Houston, TX) with one end open to monitor (similar to chemical indicator test strips) HPV diffusion into the tube.

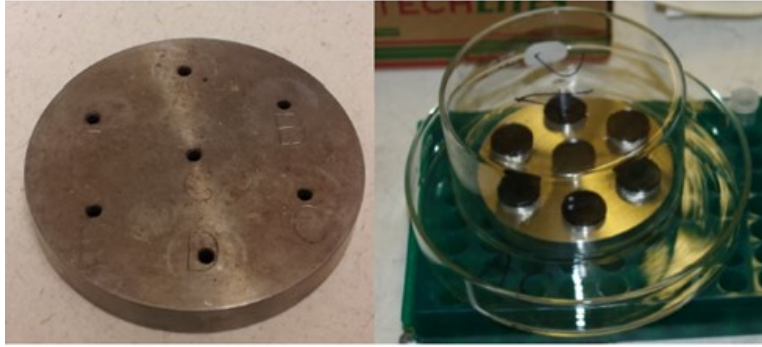
Figure 3-4. Stainless-Steel Stage for Coupon Sterilization

1. The coupons were randomly selected and loaded into stainless-steel stages (see [Figure 3-4](#)).
2. The stage loaded with the coupons was placed in a glass petri dish and loosely covered with a crystallization petri-dish (see [Figure 3-4](#)).
3. Each petri dish was placed into an appropriate sterilization bag (PN:333 EOGas®, Haw River, NC).
4. The sterilization bags were loaded into a cabinet for sterilization using EtO.
5. The sterilization bags were removed from the EtO cabinet with the crystallization dishes covering the petri dishes to maintain coupon sterility.

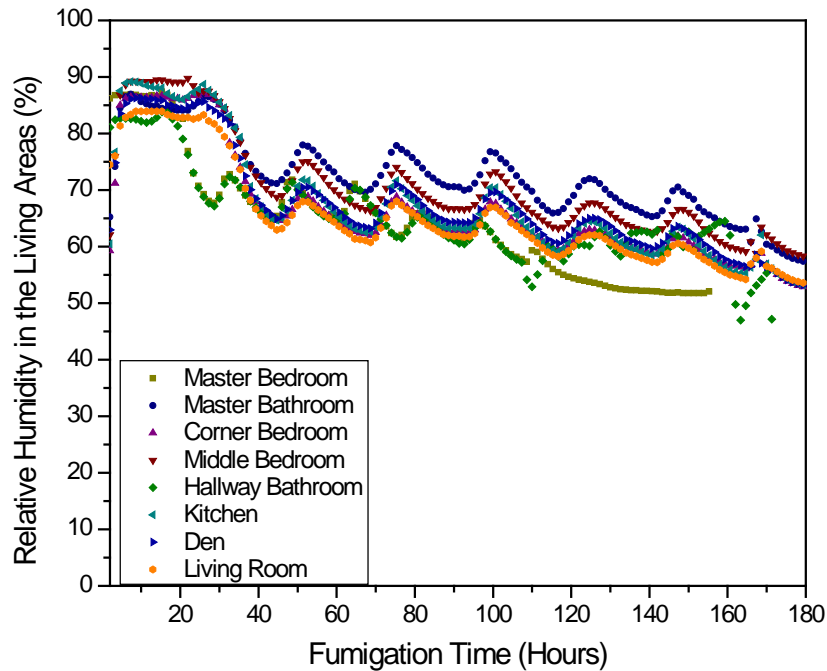
**Figure 5-3. Baseline Test Temporal RH in Living Areas**

Figure 5-3 shows the effect of the humidifiers on RH throughout the CTH living areas for eight locations (master bedroom, master bathroom, corner bedroom, middle bedroom, hallway bathroom, kitchen, den, and living room).

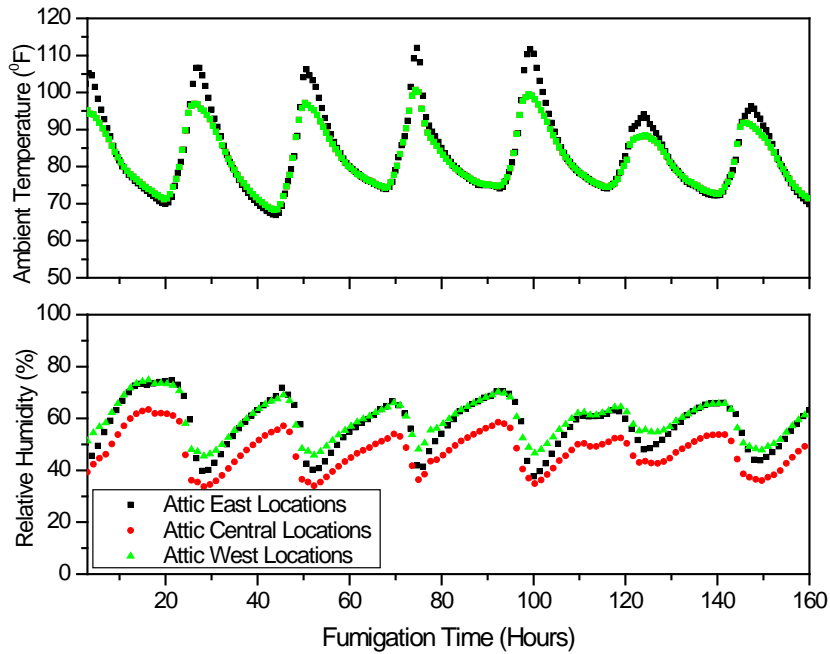
Figure 5-5. Baseline Test Temporal Environmental Conditions in Attic

The effect of the three humidifiers on the RH/temperature in the attic was monitored for more than 7 days at three locations (east side, central location, and west side). [Figure 5-5](#) shows the RH results for the attic. These RH results show a cyclical process between days and nights, regardless of sampling location. The oscillations observed for the temperature/RH inside the attic may be due to the cycling of the outdoor temperature/RH between day and night. The cyclical process includes RH ranges well below 50% that could affect decontamination efficacy and fumigation effectiveness for HP.

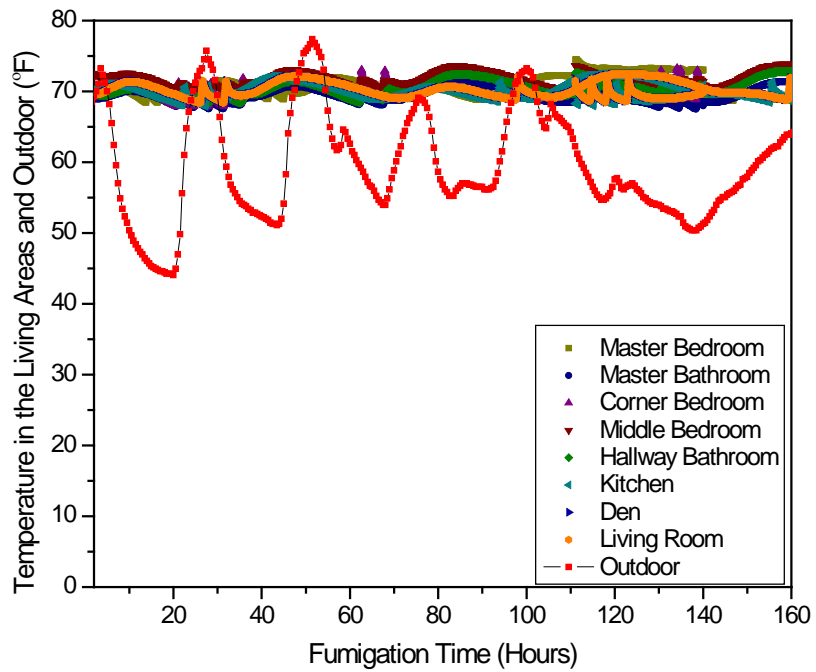
Figure 5-8. Test 1 Temporal Temperature in Living Areas vs. Outdoors

The temperature inside the living areas was monitored during the fumigation sequence at eight locations (master bedroom, master bathroom, corner bedroom, middle bedroom, hallway bathroom, kitchen, den, and living room), as shown in [Figure 5-8](#). The outside temperature measurements were monitored via a weather station, and illustrated also in [Figure 5-8](#). The central AC unit was set to “heat” with a setpoint of 70 °F, and the fan was set to run continuously. As expected, the temperatures in the living areas were uniform and were affected neither by the humidification process, nor by fluctuations in the outdoor temperature.

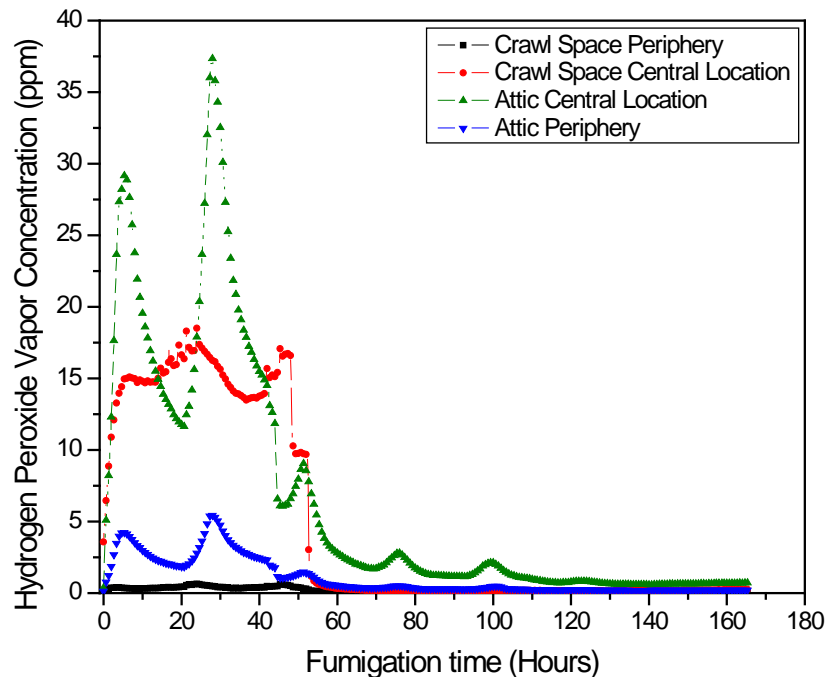
Figure 5-9. Test 1 Temporal HPV Concentration in Crawl Space and Attic

The temporal HPV concentrations of the crawl space and attic area were monitored at their central and periphery locations (Figure 5-9). The highest HPV concentrations were detected in the central locations of the crawl space and attic, and these concentrations were comparable to those observed in indoor rooms. The peripheral locations had much lower HPV concentrations which may have been caused by leaks of fresh air through the vents.

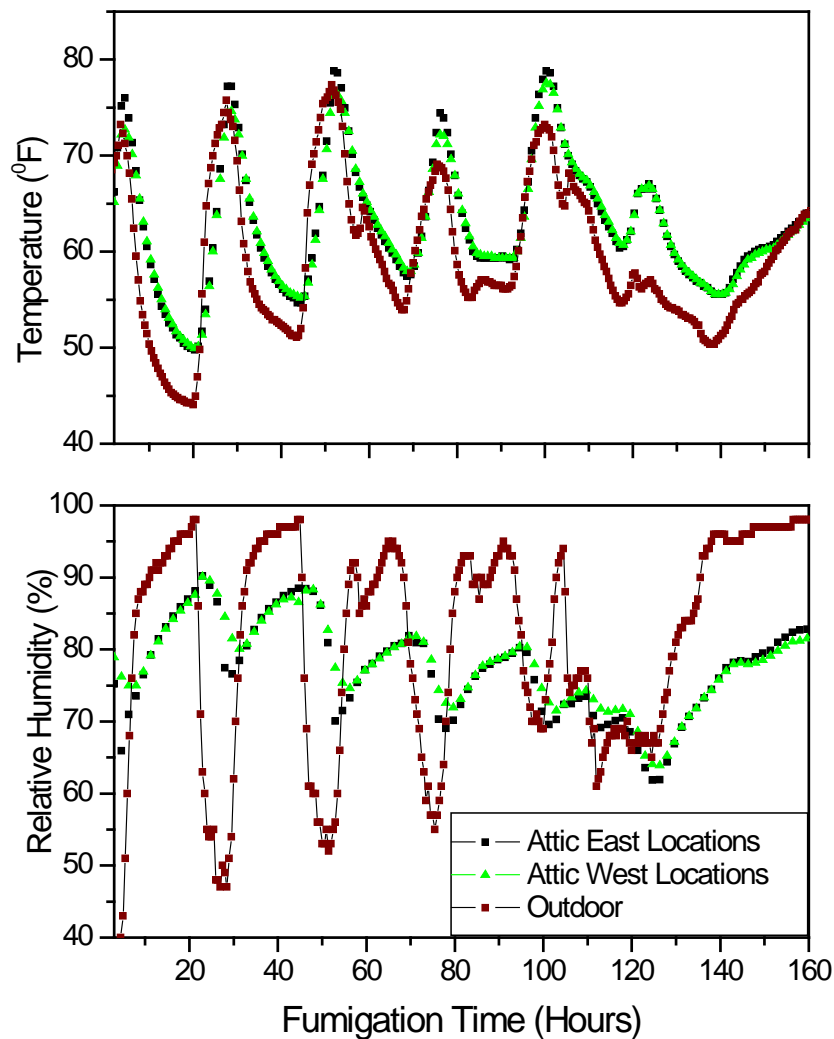
Figure 5-11. Test 1 Temporal RH in Attic vs. Outdoors

The effect of the humidifiers on the RH was monitored during the fumigation sequence at two locations in the attic: east and west locations (see [Figure 5-11](#)). The temperature and RH inside the attic mimic the cyclical pattern of the outdoor environmental conditions. This would suggest that the driving forces for the attic conditions are the outdoor environmental conditions.

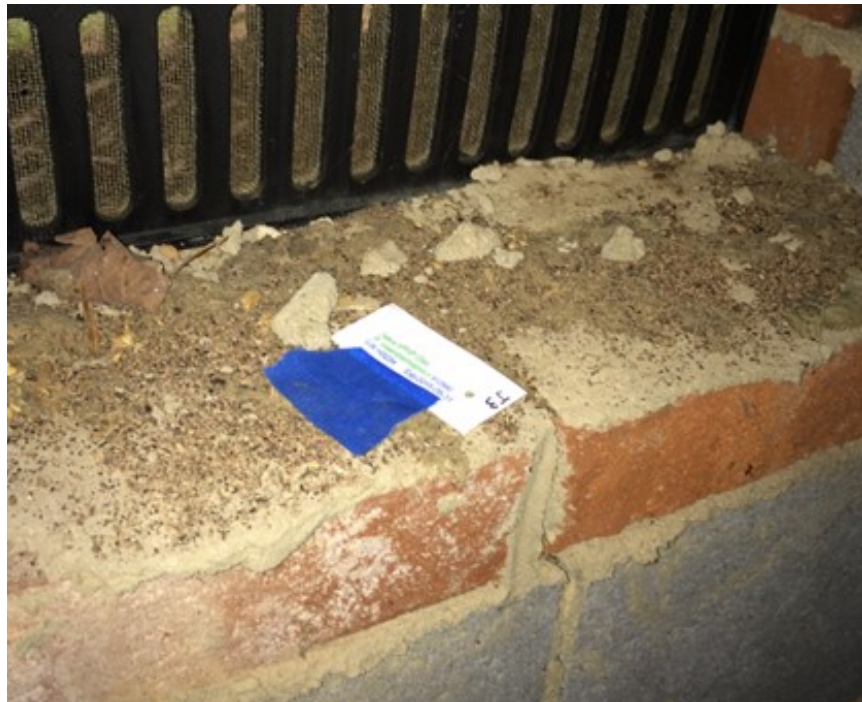
Figure 5-12. BI Disc Package Placement at Periphery of Crawl Space

All the Gs BI discs in the crawl space showed growth despite the observed full decontamination of the co-located test coupons. Three of those BI discs were co-located with the coupons, while other BI discs were placed in the periphery of the crawl space as shown in Figure 5-12. The periphery of the crawl space had very low HPV concentrations (less than 1 ppm), and therefore less HPV exposure.

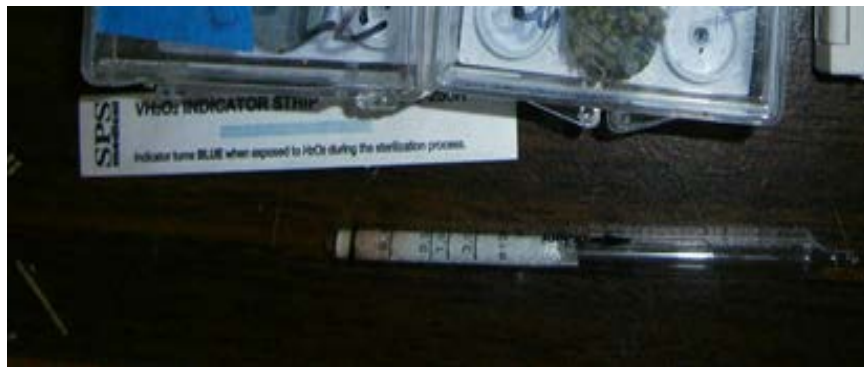
**Figure 5-13. Post-Decontamination Dräger Tube in Living Area**

A Dräger HP tube with one end open was used to determine that HPV diffused into the tube in the living areas. Figure 5-13 shows a typical Dräger tube. Dräger tube results generally were less than 3 ppm, regardless of location. Since the Dräger tubes were used as passive samplers, and no flow was pulled through them, per manufacturer’s instructions, these results should be considered qualitative at best. However, the Dräger tube results can be used as indicators of HPV presence in various test areas.

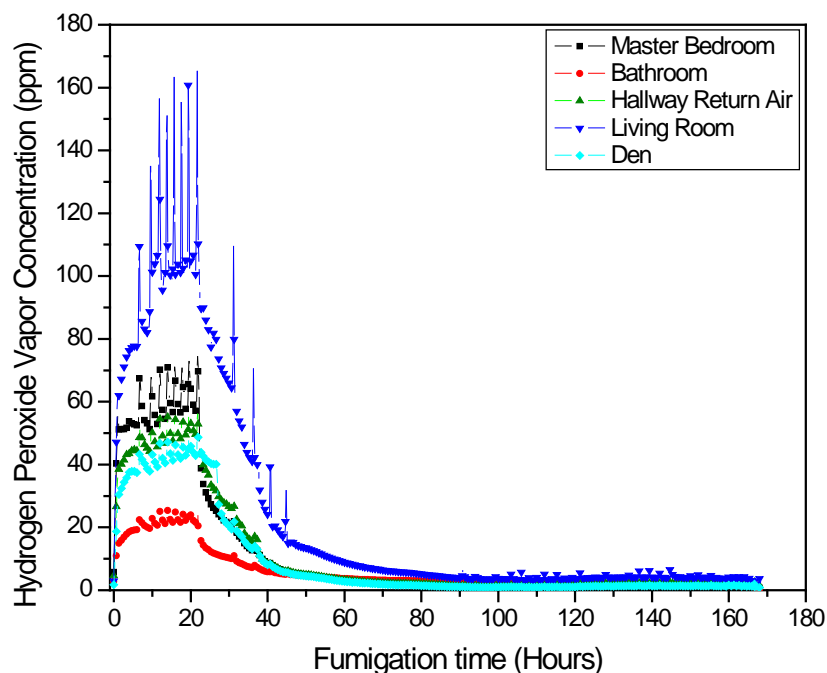
Figure 5-15. Test 2 Temporal HPV Concentration in Living Areas

The HPV concentration was monitored using HP sensors at the five following locations: master bedroom, bathroom, hallway air return, living room, and den (see Figure 5-15). The increase in concentration from 3 to 3.8% of the HP aqueous solution resulted in an overall increase in HPV concentration throughout the CTH. The results indicate that moving one humidifier to the hallway resulted in an overall increase in HPV concentration and CT ppm-hours in the hallway, bathroom, and air return areas.

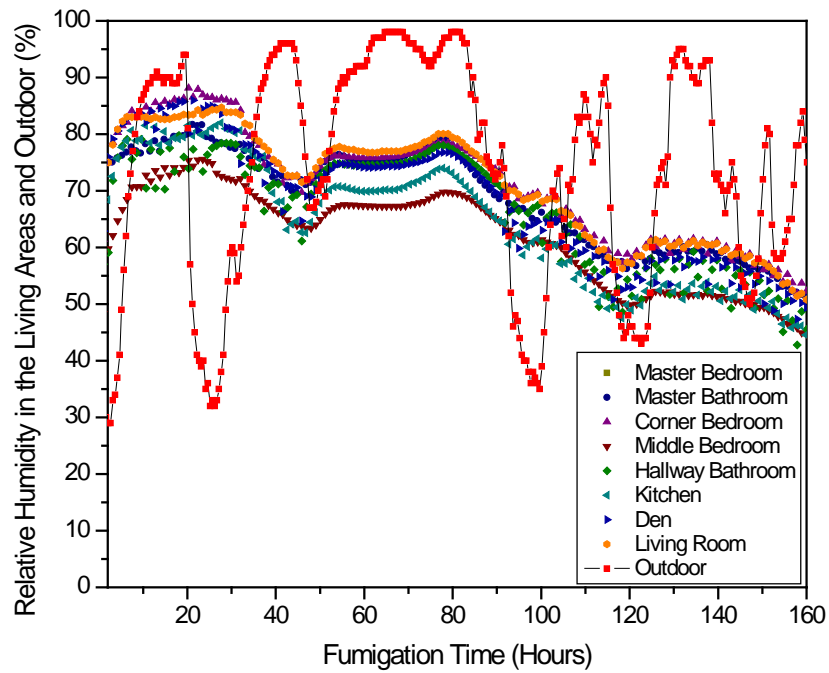
Figure 5-16. Test 2 Temporal RH in Living Areas

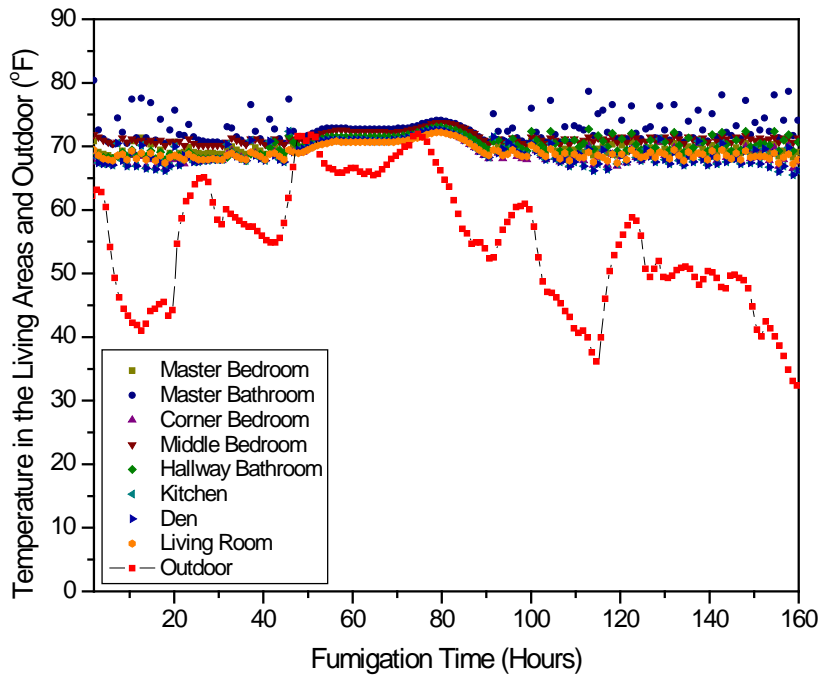
Figure 5-17. Test 2 Temporal Temperature in Living Areas

The temperature inside the living areas was monitored throughout the fumigation sequence at eight locations as shown in [Figure 5-17](#). As observed during Test 1, the temperature inside the living areas was uniform and was affected neither by the humidification process nor by the outside environmental conditions.

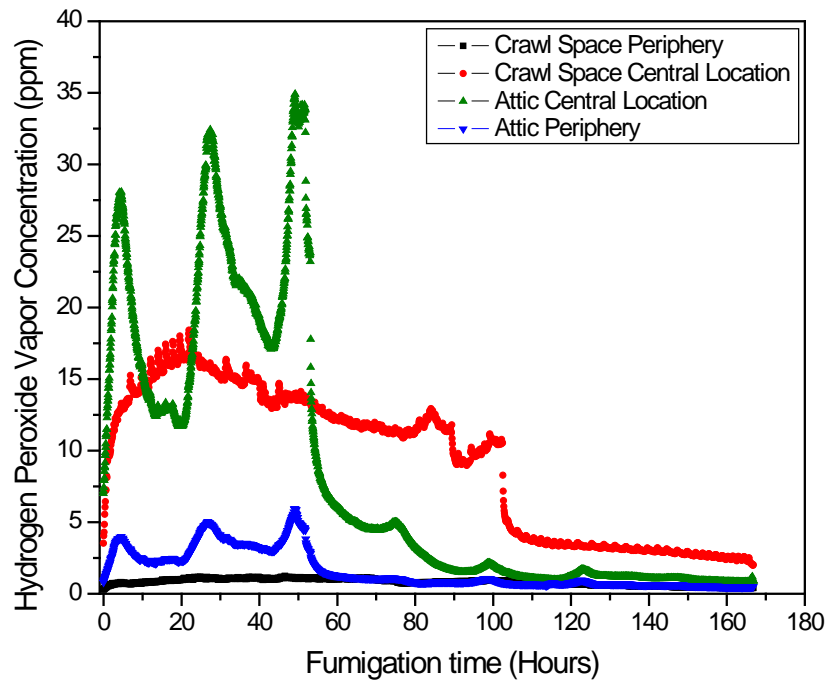
Figure 5-18. Test 2 Temporal HPV Concentration in Crawl Space and Attic

The temporal HPV concentrations in the crawl space and attic areas were monitored at their central and periphery locations (see [Figure 5-18](#)). The test conditions in the crawl space and attic were the same as Test 1, except that the liquid HP concentration was increased from 3 to 3.8% and more liquid was added to the crawl space humidifiers. The HPV results were of the same order of magnitude as the Test 1 results.

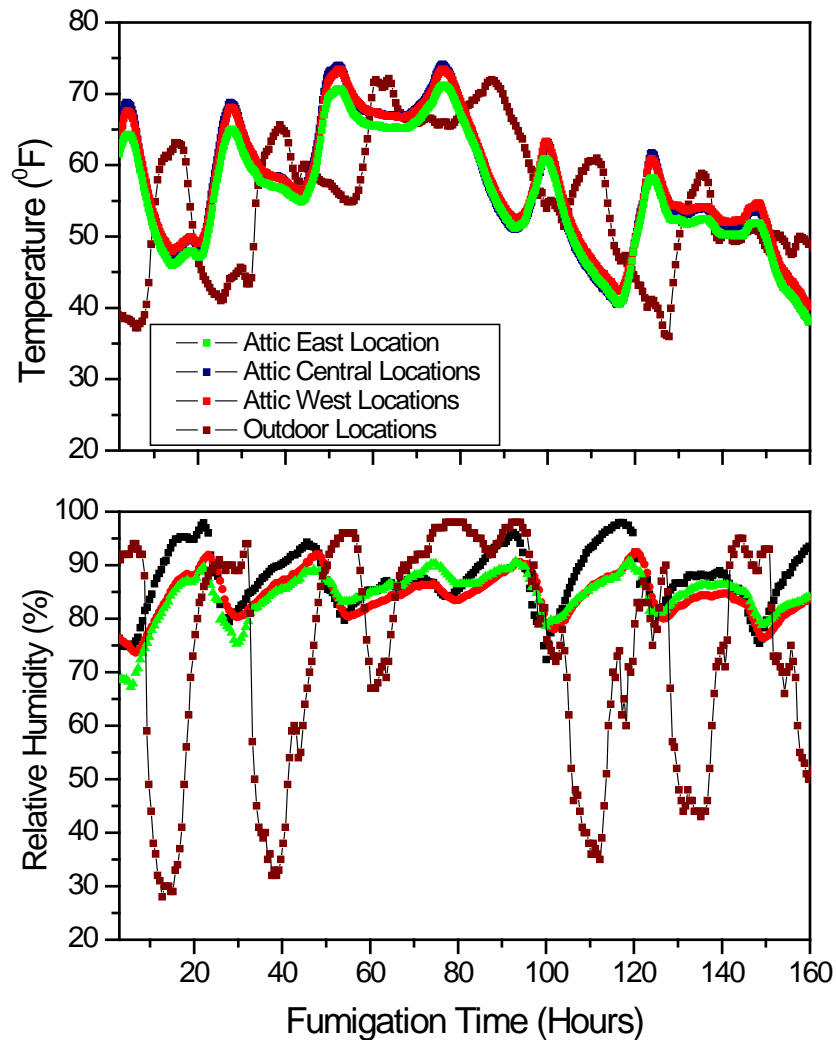
Figure 5-20. Test 2 Temporal RH in Attic

The effect of the humidifiers on RH was monitored during the fumigation sequence at three locations in the attic: east, central, and west locations (see [Figure 5-20](#)). The driving force for the cyclical pattern observed in the attic seems to be the outdoor environmental conditions; however, the large swings in the outdoor RH (between less than 30% to almost saturation) was dampened in the attic, where the RH was above 70% throughout the testing sequence.

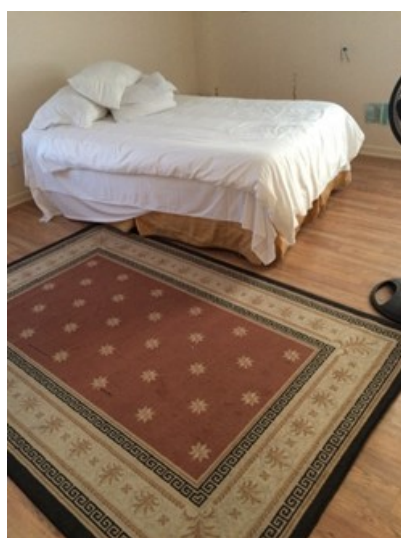
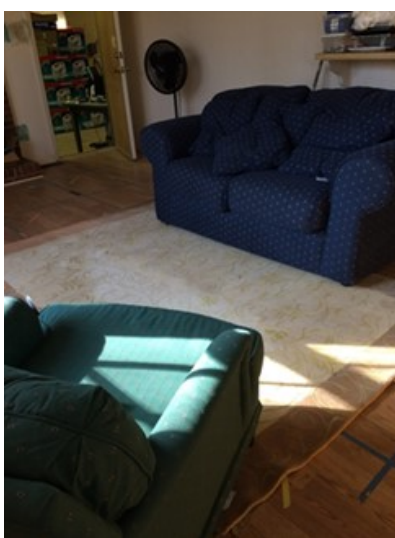
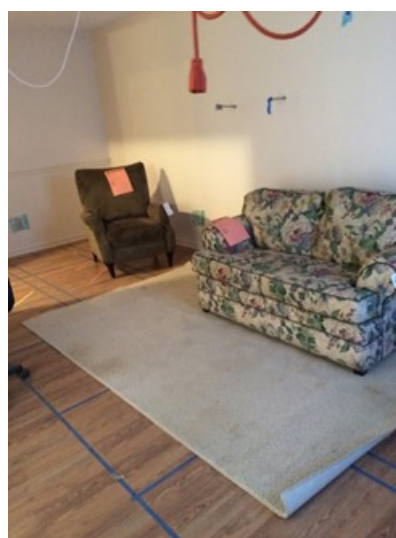
For Test 3, the humidifiers, fan, test coupons, and BI disc placements were kept the same as Test 2. All humidifiers were loaded with 3.0% HP aqueous solution. The humidifiers in the crawl space and attic were each loaded with 3.4 gallons of HP aqueous solution, and the humidifiers in the living areas were charged with only 2 gallons of this solution. Further, for this test, furniture was added to the CTH, including three beds with bedding and pillows, clothing, five rugs, two couches, two chairs, and three boxes of paper and books. Figure 5-21 shows the placement of some of these items in the CTH.

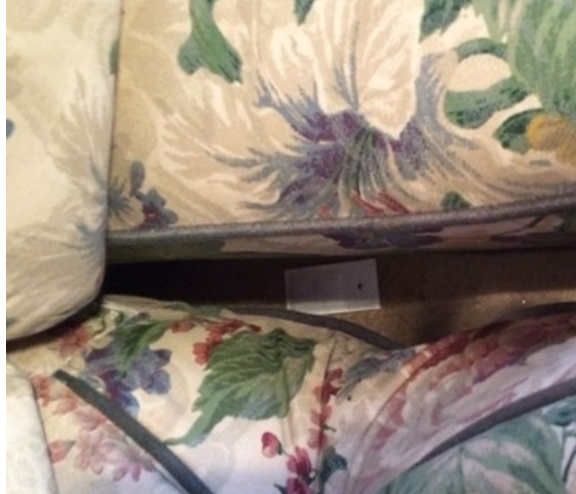
**Figure 5-22. Test 3 Placement of BI discs Between Couch Cushions**

- Between couch cushions ([Figure 5-22](#))
- Under carpet (jute-backed) ([Figure 5-23](#))
- Inside a closed bathroom drawer ([Figure 5-24](#))
- Under one and also under five pieces of paper ([Figure 5-25](#))

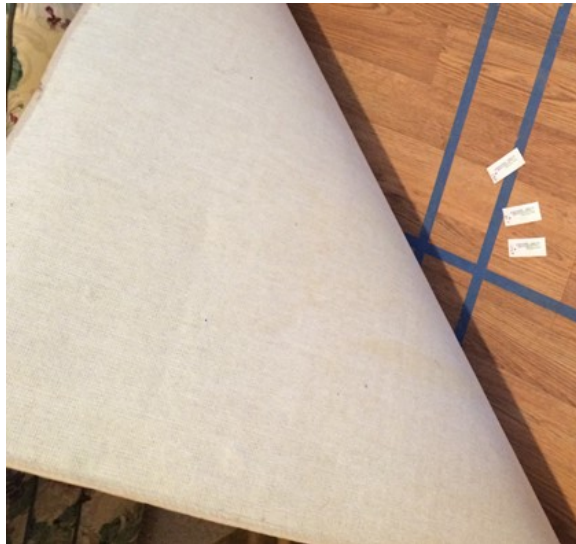
**Figure 5-23. Test 3 Placement of BI discs Under Carpet**

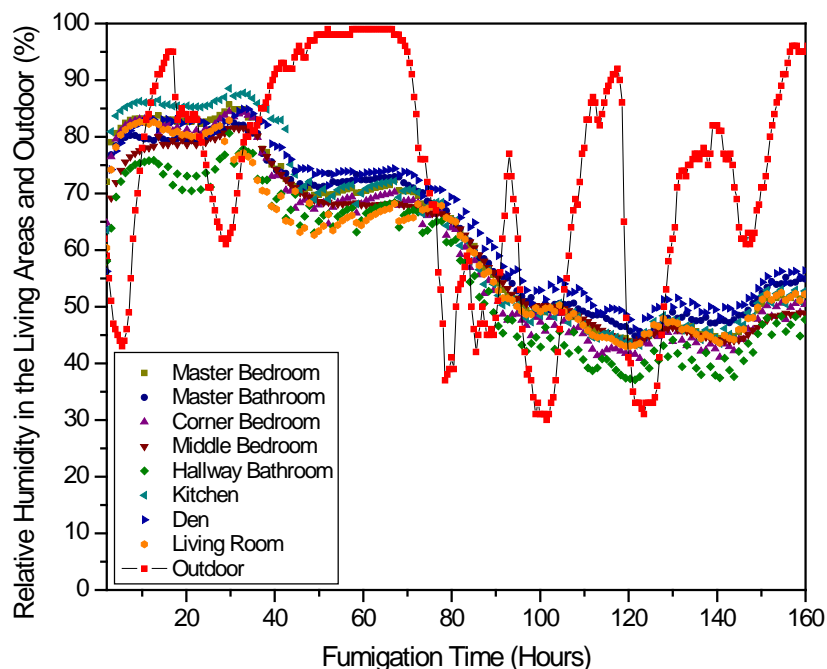
Figure 5-27. Test 3 Temporal RH in Living Areas

fumigation in the living areas. As shown in Figure 5-27, the RH dropped below 70% after about 70 hours, when the fumigant was depleted below 10 ppm in the living areas.

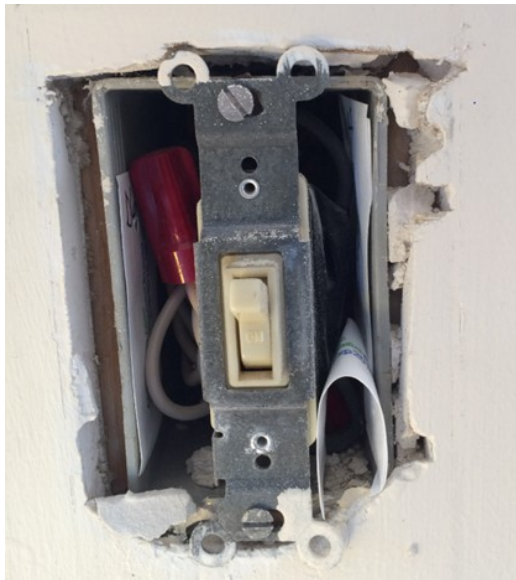
Figure 5-32. Test 4 BI discs Behind Light Switch Plate

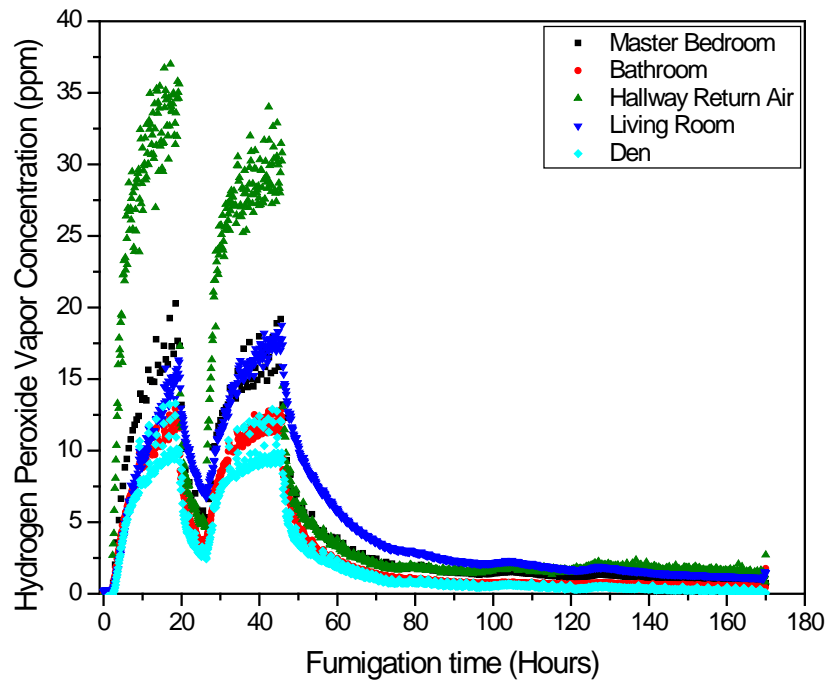
Figure 5-33. Test 4 Temporal HPV Concentration in Living Areas

The HPV concentration was monitored using HP sensors at the same five locations used during Test 2: master bedroom, bathroom, hallway air return, living room, and den (see [Figure 5-33](#)). Reducing the number of humidifiers in the living area from seven to two and placing them in the hallway under the air return vent decreased the maximum concentration of HPV in the living room by more than 84% when compared to Test 3, but decreased the HPV concentration in the other rooms much less. The HPV concentration in the whole house decreased rapidly to about 5 ppm after 24 hours of fumigation before increasing again with the start of the second humidifier.

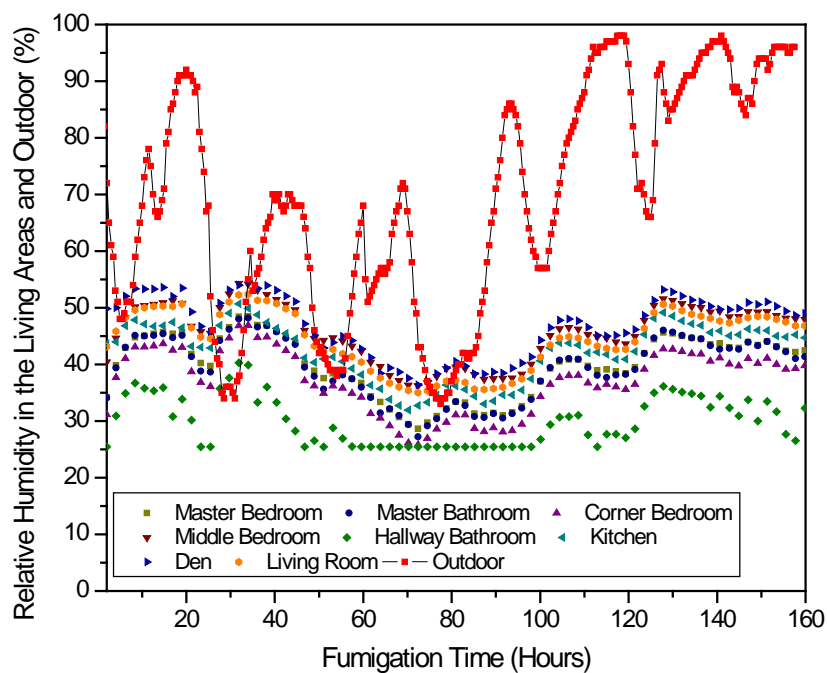
Figure 5-34. Test 4 Temporal RH in Living Areas

The results shown in [Figure 5-34](#) illustrate fumigation RH conditions, using only two humidifiers run sequentially 24 hours apart, throughout the decontamination testing. The RH for most of the living areas, except for the den, remained below 50% for most of the fumigation period. The temperature, as expected, remained steady near 70 °F as maintained by the CTH HVAC system (data not shown). As observed for the prior tests, outdoor conditions appear to have little bearing on the RH conditions observed for the living areas inside the CTH. As shown in [Figure 5-34](#), outdoor RH widely fluctuated, but the indoor RH had a more even trend and remained mostly under 50% throughout the test period.

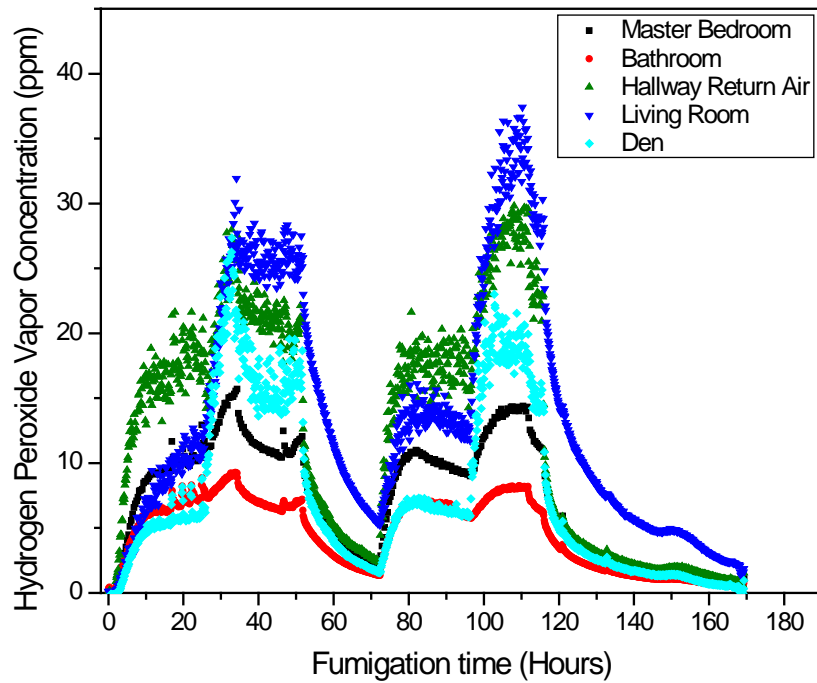
Figure 5-37. Test 5 Temporal HPV Concentration in Living Areas
