HUDSON RIVER PCBs  
SUPERFUND SITE  
DRAFT FACILITY SITING REPORT

**Hudson River PCBs Superfund  
Site  
Draft Facility Siting Report  
Public Review Copy**

**April 2004**

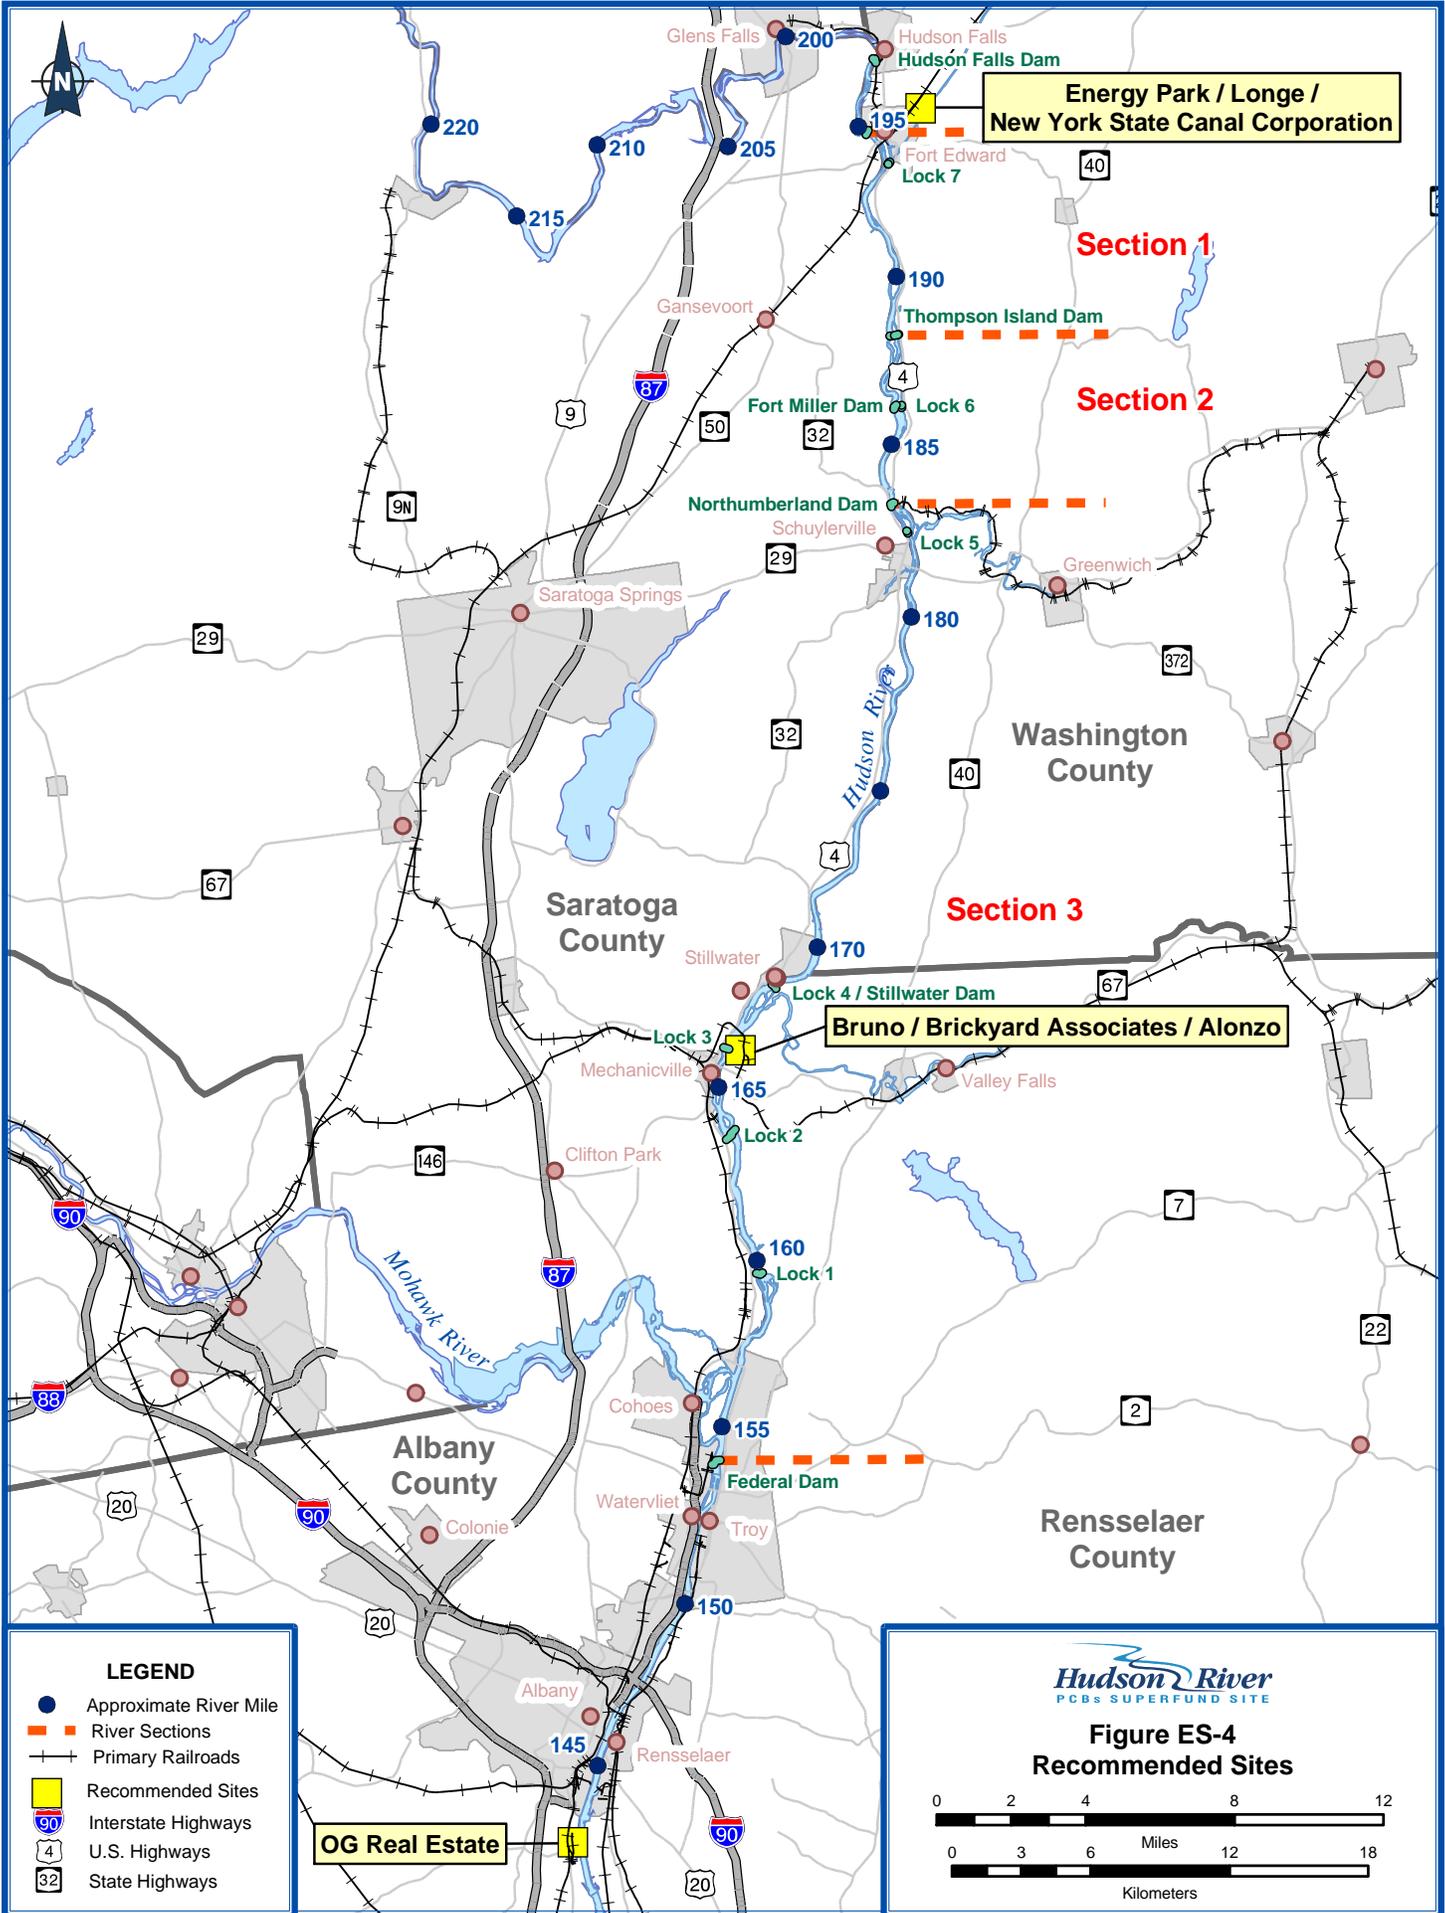
**Figure ES-4  
 Recommended Sites**

EPA's three Recommended Sites (see Figure ES-4) are:

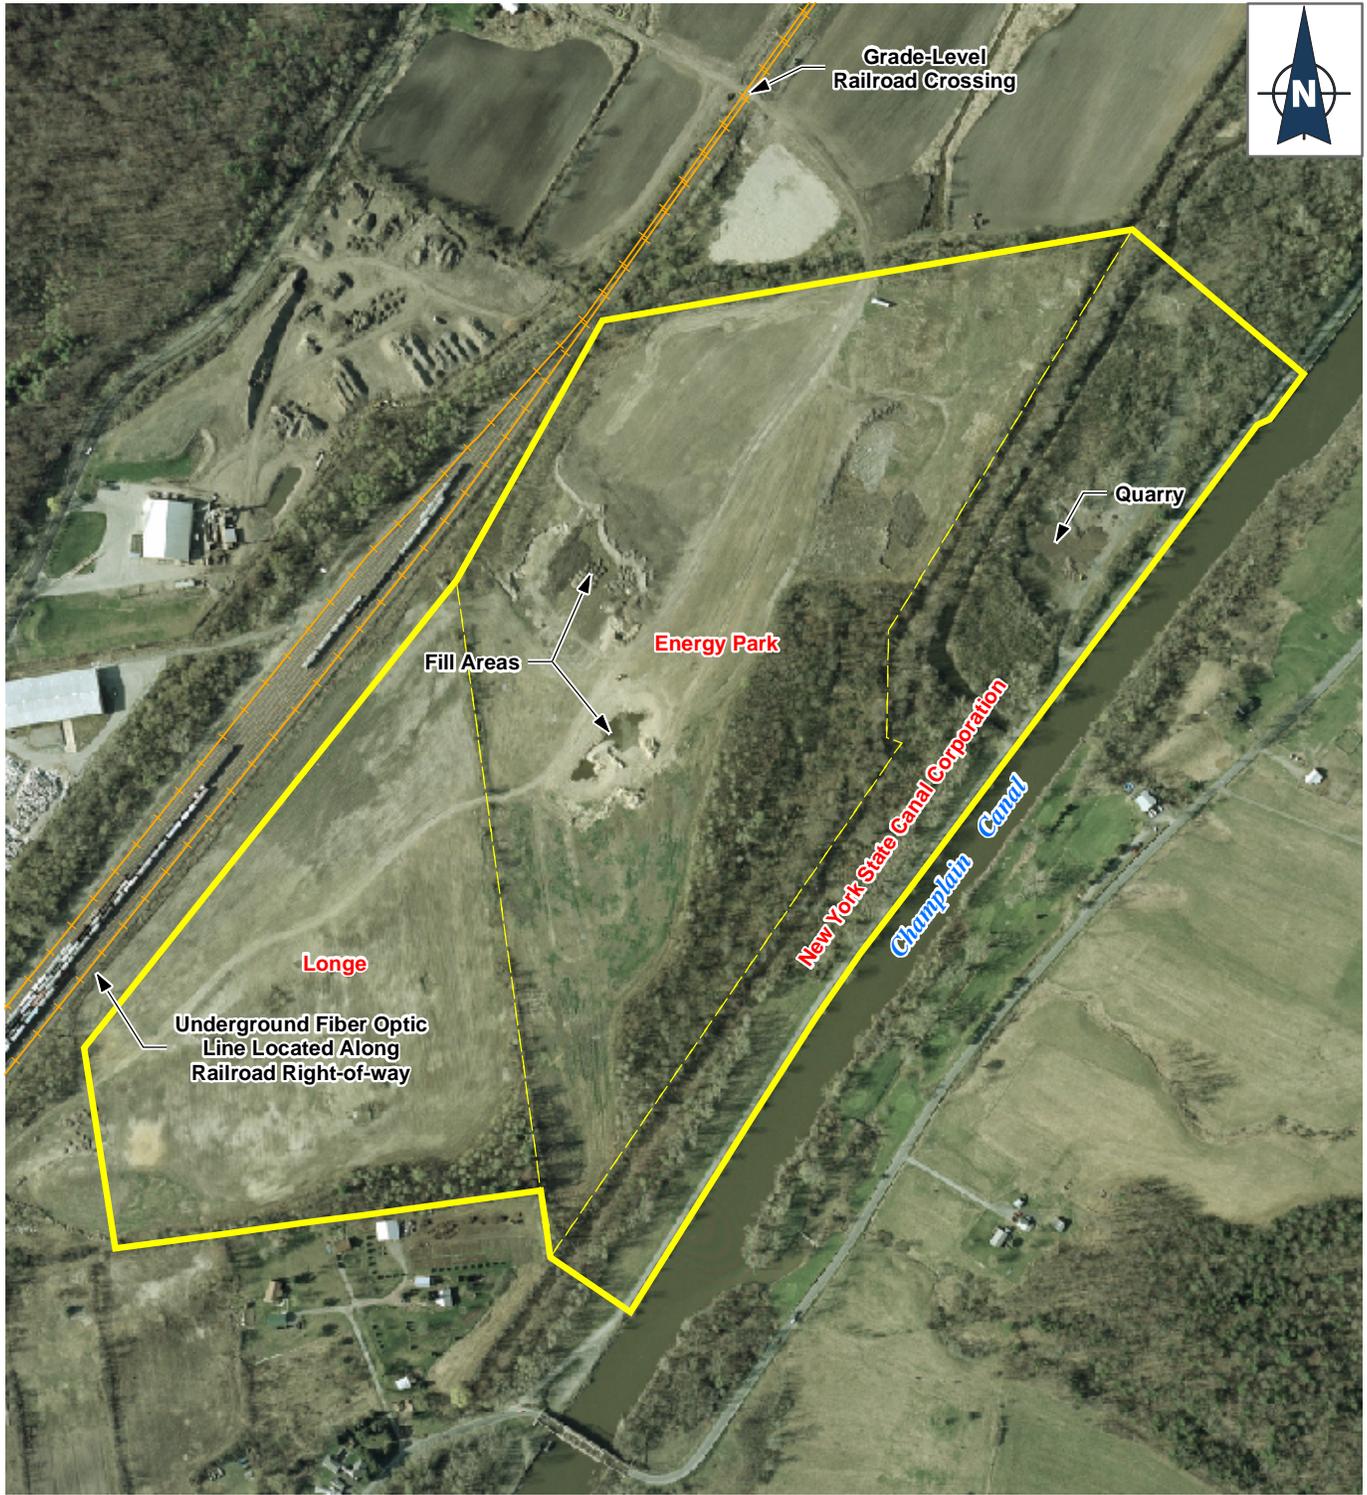
The environmental investigations at this site included collecting nine surface soil samples, three surface water/sediment samples, seven subsurface soil samples, and five groundwater samples from newly installed temporary monitoring wells; geotechnical soil testing at five locations; and the installation of one stream gauge for hydrologic monitoring purposes (see Figure 3.2.1-2).

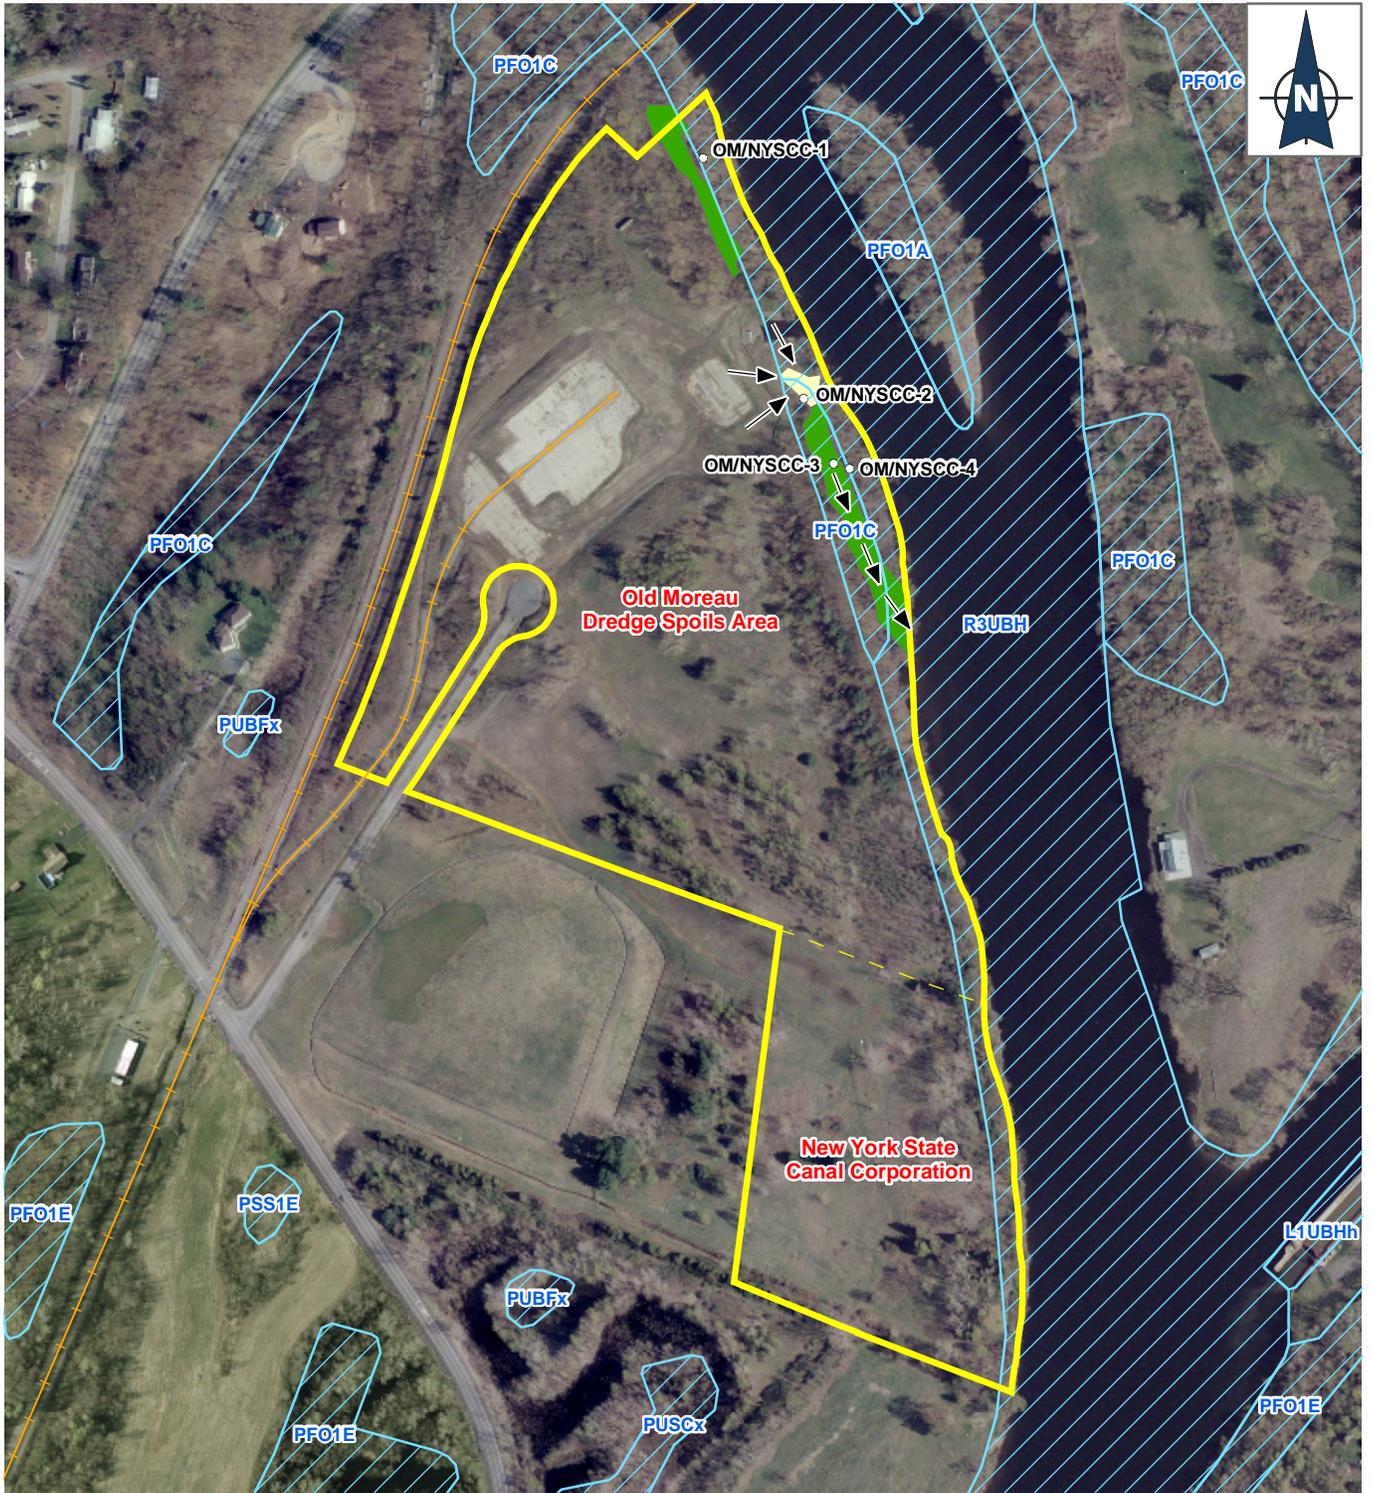
Figure 3.2.2-5 shows that portions of the Old Moreau Dredge Spoils Area/NYSCC site are located within the 100-year and 500-year floodplains. The site is located on the west side of the Hudson River, opposite Rogers Island, in the Town

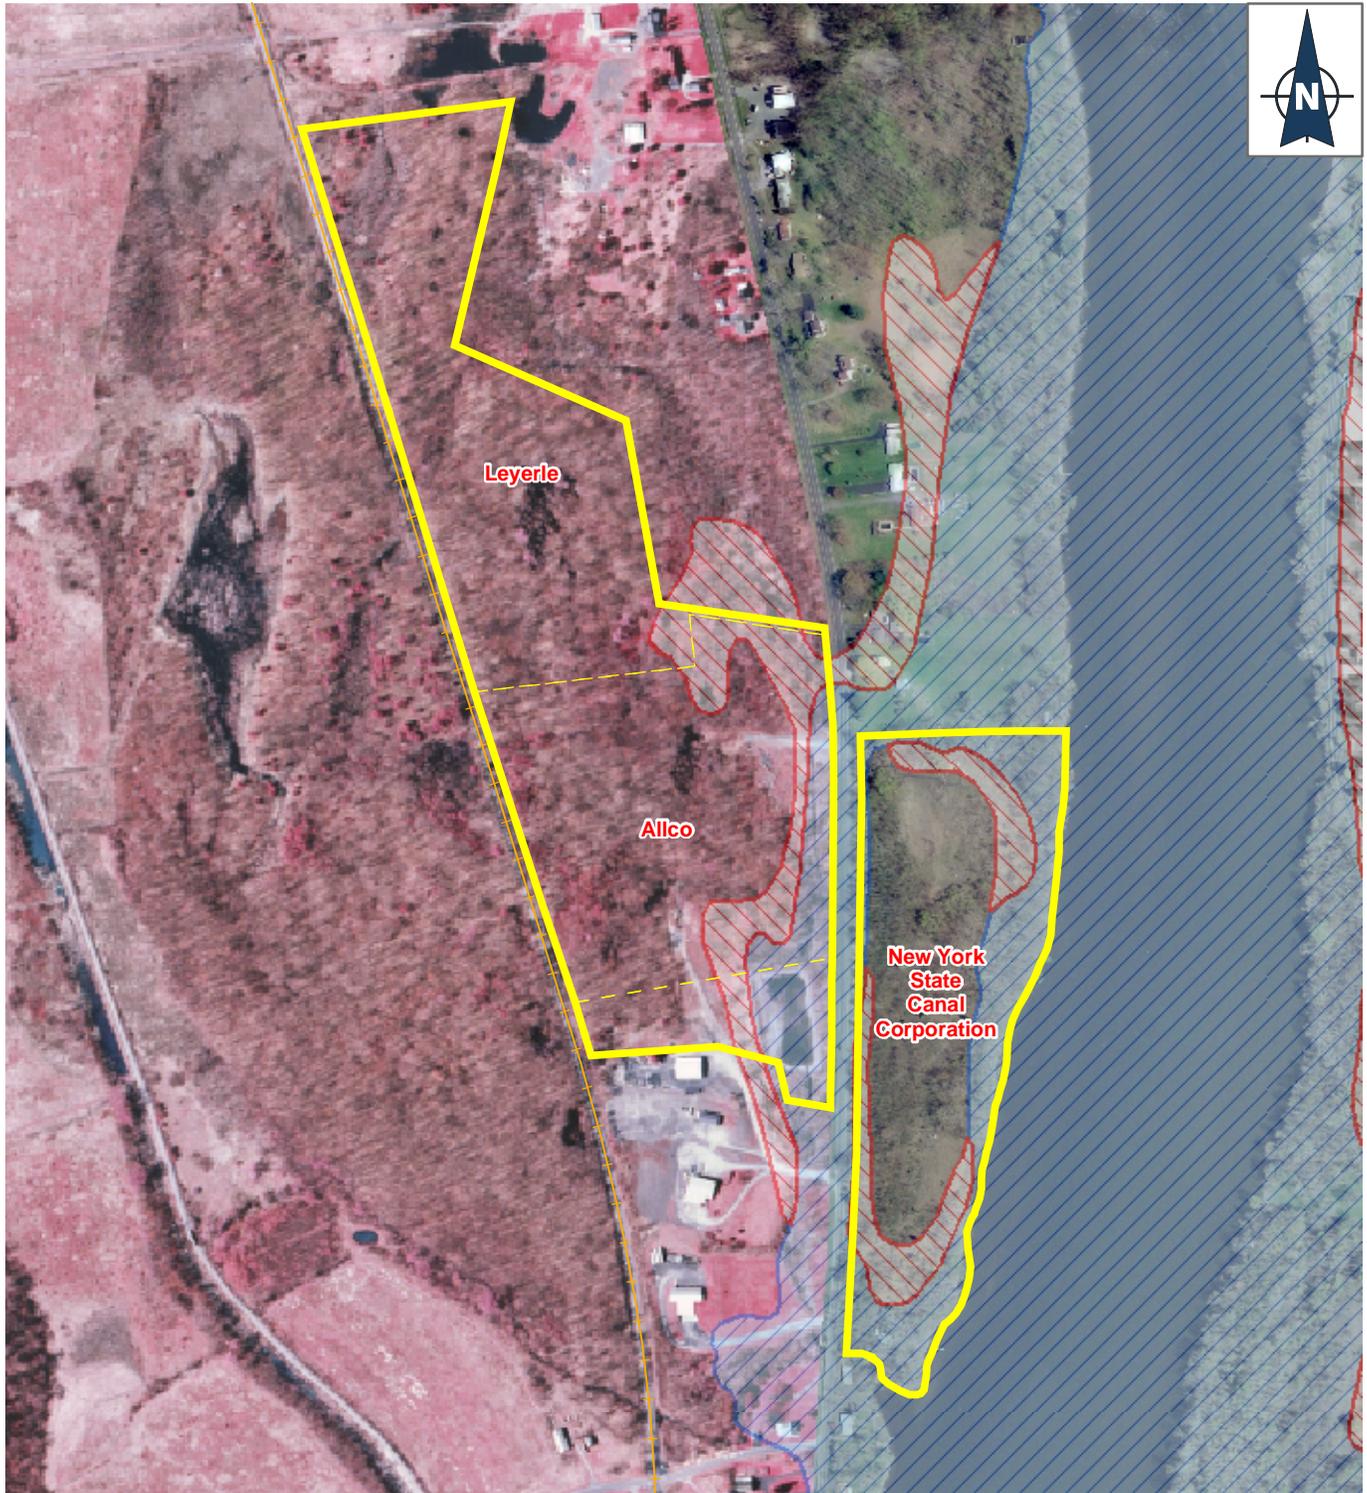
Figure 3.2.5-5 shows that portions of the site are located within the 100-year and 500-year floodplains. The site is located on the west side of the Hudson River in the Town of Halfmoon. The areas included within the 100-year floodplain are adjacent to the Hudson River within the NYSCC parcel and to the west of Route 4 within the Allco parcel. Approximately 16.2% (12.0 acres) is mapped as occurring within the 100-year floodplain and approximately 20.5 acres (approximately 28% of the total site area) are located in the 500-year floodplain.

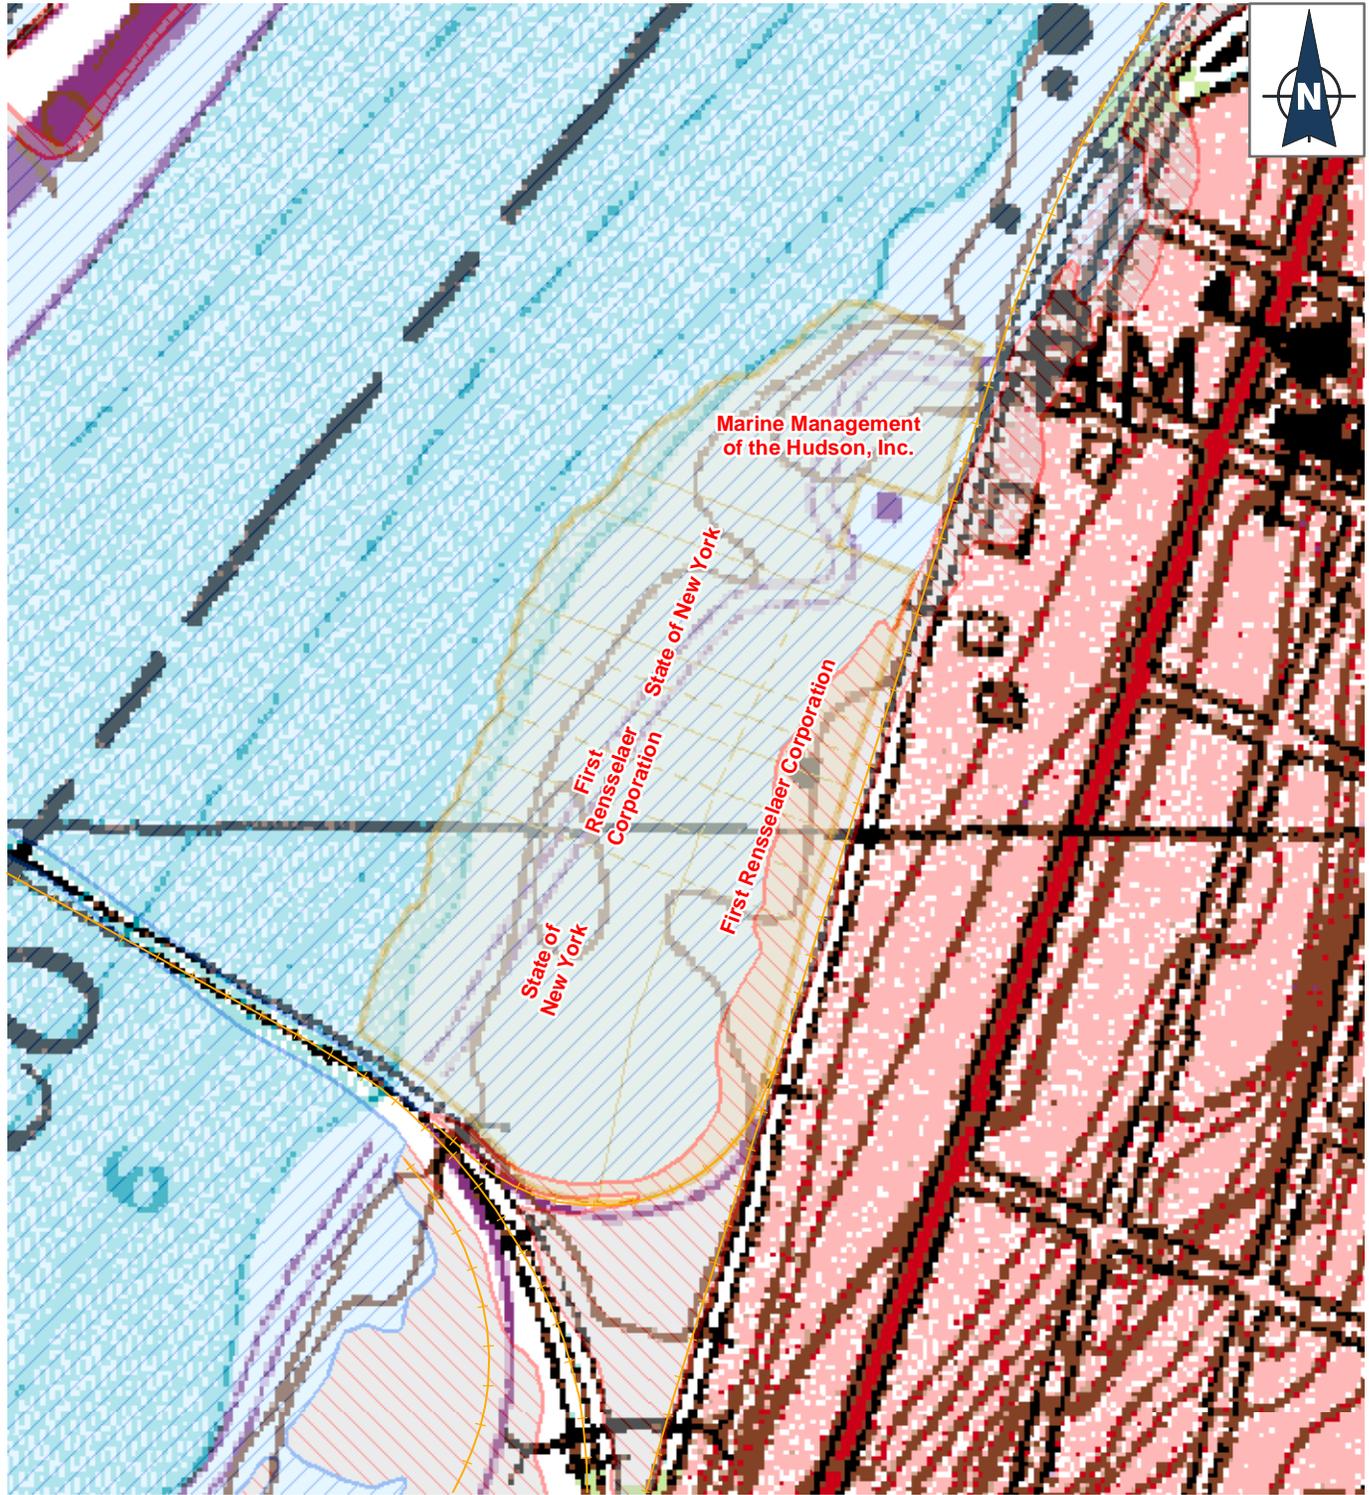
Figure 3.2.6-5 shows that portions of the site are located within the 100-year and 500-year floodplains. The site is located on the east side of the Hudson River in the City of Rensselaer. The site is located almost entirely within the 100-year floodplain, with the exception of a narrow strip of land along the eastern boundary. This latter area is mapped as occurring within the 500-year floodplain. The entire width (~575 feet) of the northern portion of the site is within the 100-year floodplain. Approximately 89.8% (14.9 acres) of the total area is within the 100-year floodplain and approximately 16.6 acres (100% of the total site area) is within the 500-year floodplain.

An initial floodplain assessment was conducted on the State of New York/First Rensselaer/Marine Management site in order to determine the presence, extent, and orientation of FEMA-mapped floodplains within site boundaries. Flood magnitudes and historic river stages from gauging stations as close as available to the site were examined to obtain an initial sense of the characteristics of on-site flooding.
