Tuba City, Arizona September 14-16,-2010

Water Quality in Unregulated Water Sources

Perry H. Charley, Dine College – Shiprock (505) 368-3514

# Public Health Concerns Related to Water Hauling on Navajo Nation

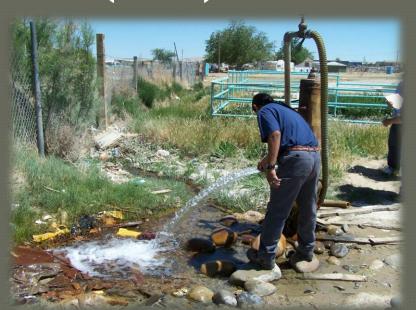
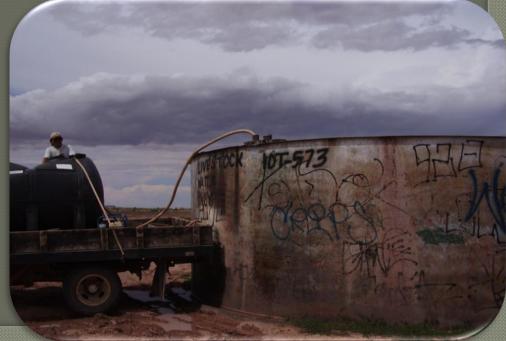
## How Common is Water Hauling?

- 65 (22%) haul some or all of drinking water
- § 175 (59%) do not haul water

• 56 (19%) could not be confirmed

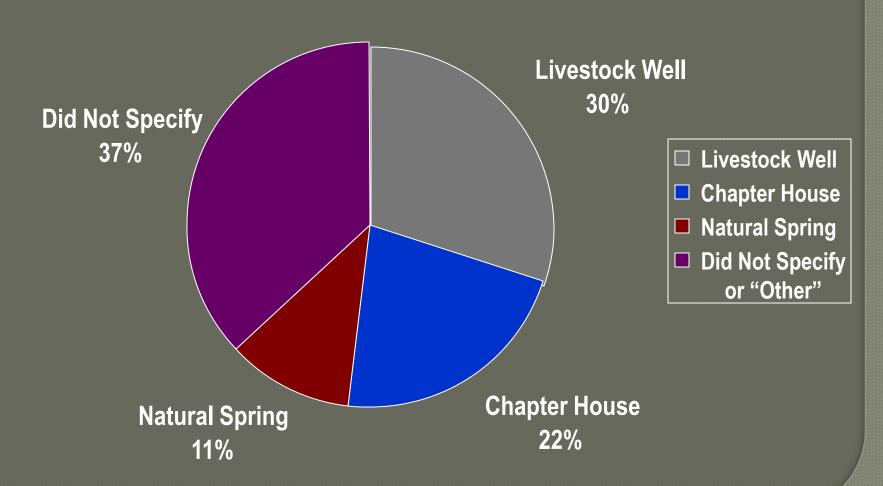
# From Where Do People Haul Drinking Water?

94 responses, multiple sources could be used by same individual

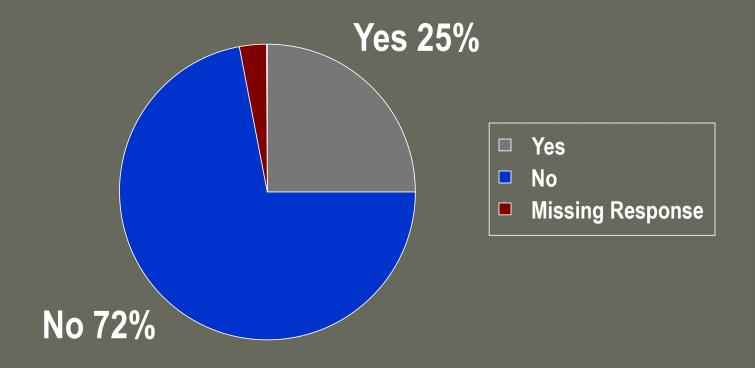
# Do People Who Haul Water Treat Their Drinking Water?

Results for 65 responses from people who hauled drinking water

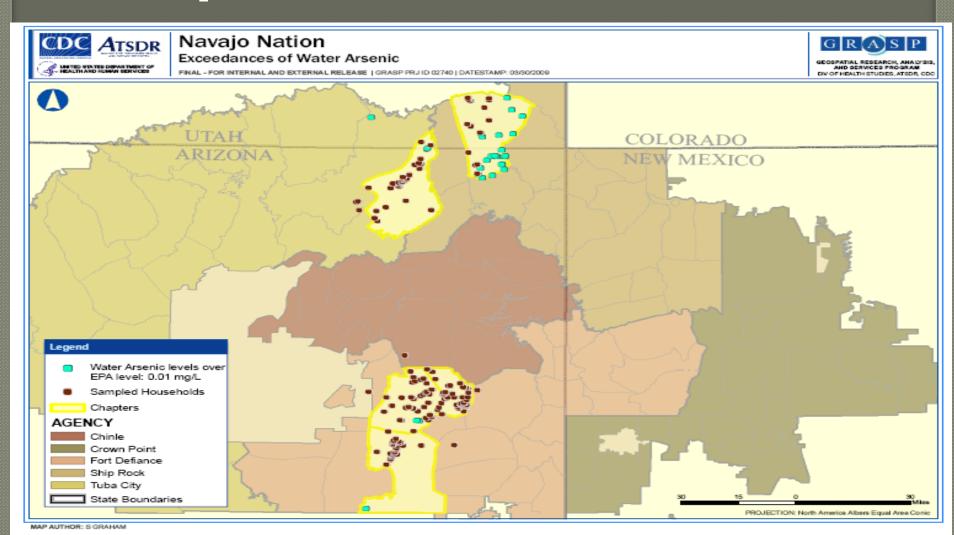
# Geographic Distribution of Water Arsenic Levels

82% samples > Arsenic EPA limit were from Red Mesa
