Re: August 24, 2010 Clean Water Act Inspection

**Industrial User Inspection Report**

**Industrial User:** Air Louvers/Samson Products, Inc.  
**Industrial User Address:** 6285 Randolph St., Commerce, CA 90040

**Inspection Date:** August 24, 2010

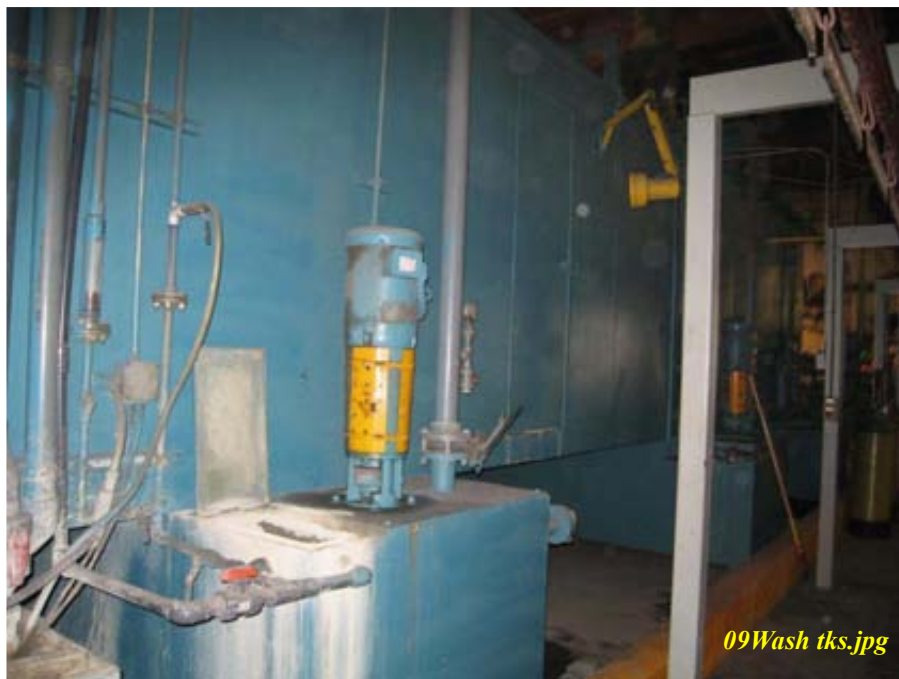
**Photo 1**

Parts hanging on rods are conveyed to a four-tank wash/phosphating system (*see Photo 1 in Attachment 1*) before being painted. At Tank #1, phosphating occurs during which an iron phosphate coating is applied to the part. This phosphating solution not only degreases the part but also prepares the part so that the paint will more readily stick to the part. At Tanks #2 and #3, the part is rinsed with tap water. At the final tank, the part is rinsed with deionized (DI) water.

Countercurrent rinses are employed in all rinse tanks. The used DI water from the final tank is circulated to Tank #3, the used rinse water from Tank #3 is circulated to Tank #2, and the used rinse water from Tank #2 is circulated to Tank #1 to mix with a phosphoric acid-based solution for the phosphating step.

Four-Tank Wash/Phosphating System  
*Taken by Anna Yen on August 24, 2010*

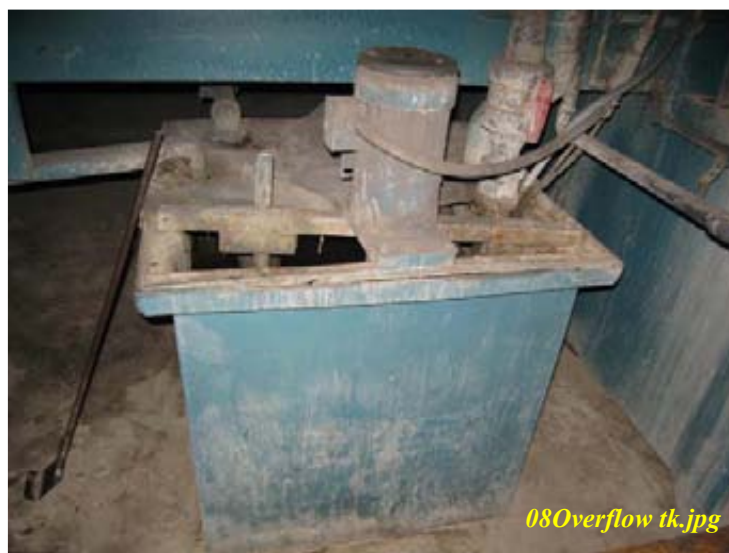
**Photo 2**

An overflow tank is located next to the four-tank wash/phosphating system. *See Photo 2 in Attachment 1*. Air Louvers stated that it is hardly ever used. For example, when the facility cleans the tanks, it just adds water to the system, the excess water overflows into the overflow tank. At the time of the inspection, it was three-fourths full. Air Louvers stated that this liquid is pumped to the onsite wastewater treatment system. Air Louvers could not remember when it was last pumped. Air Louvers stated that it does not use much water. When pressed for an estimate, Air Louvers gave a rough estimate of much less than 100 gallons per week of water that has to be put into the system. This estimate is much less than the amount currently stated in Air Louvers' pretreatment permit. In a follow-up phone call, Air Louvers confirmed that it has made operational changes to decrease the amount of wastewater it sends to the local sewer system.

Overflow Tank  
*Taken by Anna Yen on August 24, 2010*

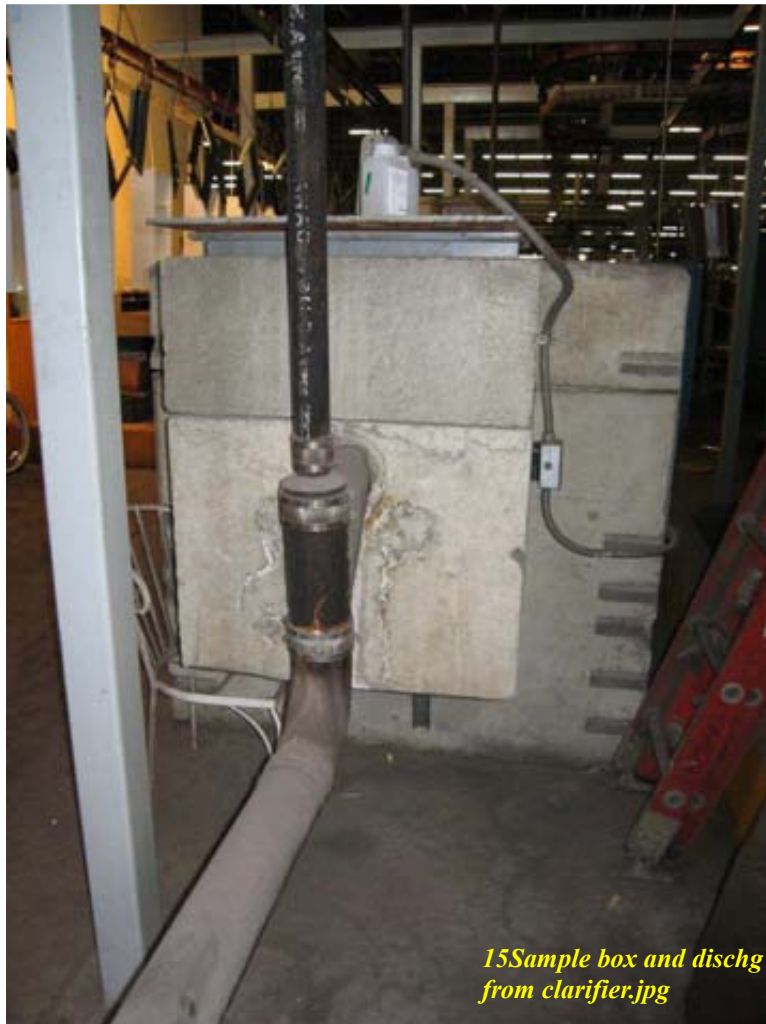
**Photo 3**

The facility's wastewater treatment system consists of a pH adjustment tank and a three-stage clarifier, with a sample box directly downstream of the clarifier. *See Photo 3 in Attachment 1.* The pH adjustment, through the addition of acid or caustic, occurs automatically. The pH is recorded continuously and is also logged manually. Discharge from the clarifier flows to the local sewer system. *See Photos 4 & 5 in Attachment 1.*

Sample Box at Discharge End of Clarifier  
*Taken by Anna Yen on August 24, 2010*

Based on the facility's written responses and follow-up sampling and analysis, it appears that the facility's compliance problems are resolved when the clarifier is cleaned out. In a follow-up conversation with Air Louvers on October 27, 2010, EPA learned that Air Louvers has been working with LACSD to find a solution to the compliance issues. Air Louvers has implemented a more frequent schedule for cleaning its clarifier and has been taking monthly samples for analysis to report to LACSD. Air Louvers now cleans its clarifier every three months instead of every six months. Air Louvers stated that it has not violated its copper and zinc limits since April 2010 and is confident that this more frequent cleaning schedule will prevent future violations of the copper and zinc limits.

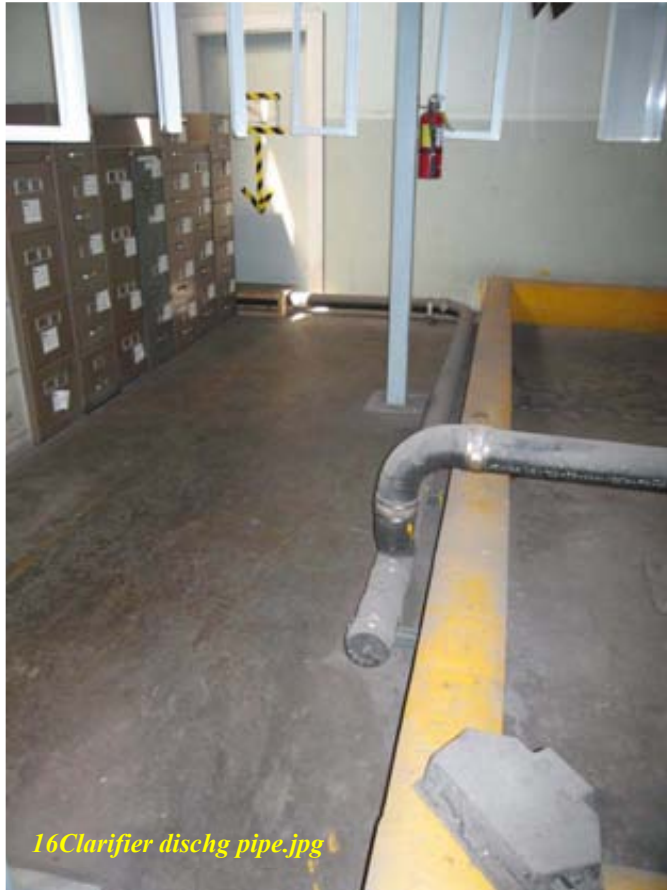
**Photo 4**

Discharge pipe from clarifier to outside  
building

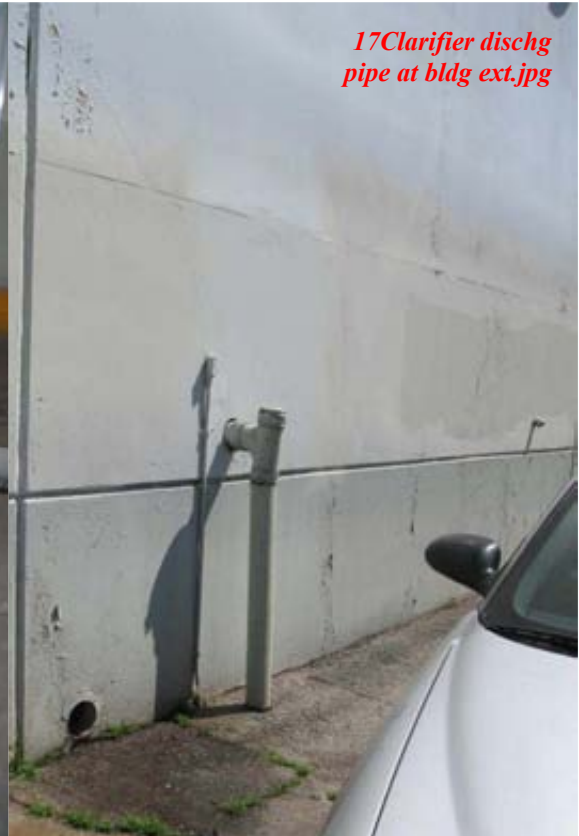
**Photo 5**

Clarifier discharge pipe outside of building  
- leading down to local sewer system
