UNITED STATES ENVIRONMENTAL PROTECTION AGENCY
REGION IX

GUAM POWER AUTHORITY
Tanguisson Power Plant

NPDES Permit No. GU0000027

FINDINGS OF VIOLATION

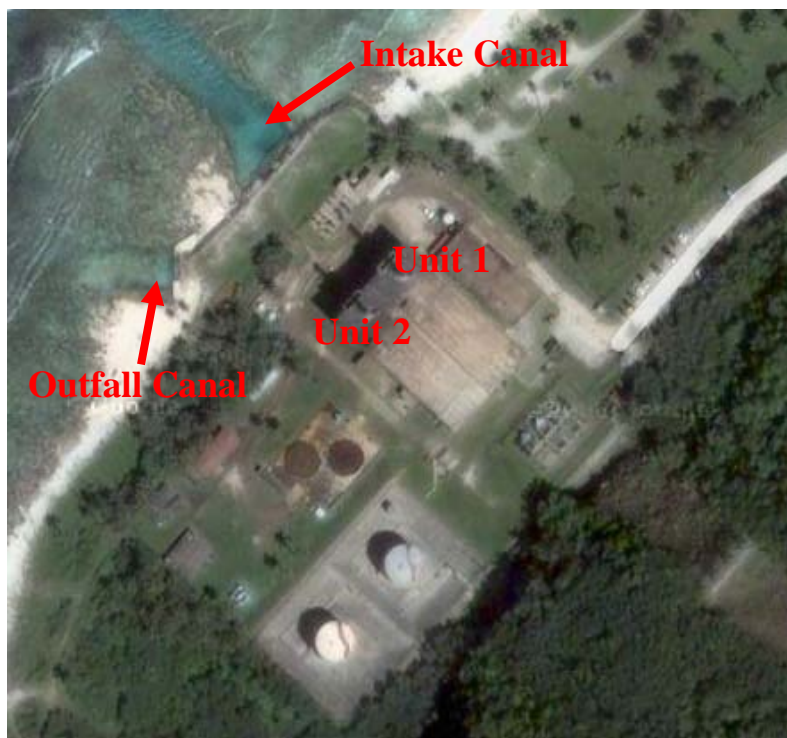
Photo 2: Overview of the Tanguisson Power Plant from Google Maps, with intake canal, outfall canal, and Units 1 and 2 identified.

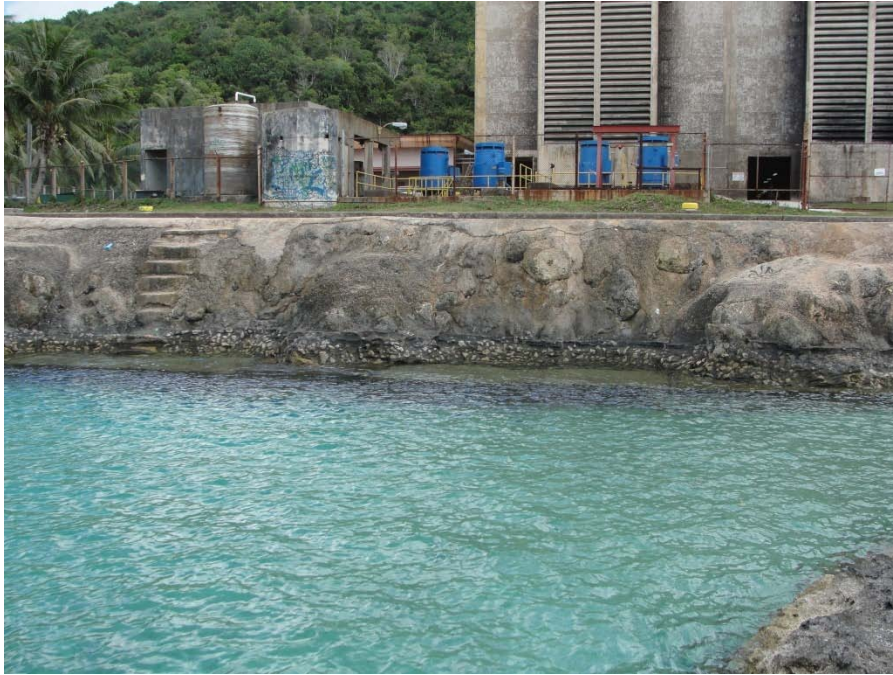
Photo 3: Intake structure, located below water level. Note blue intake pumps in the background.

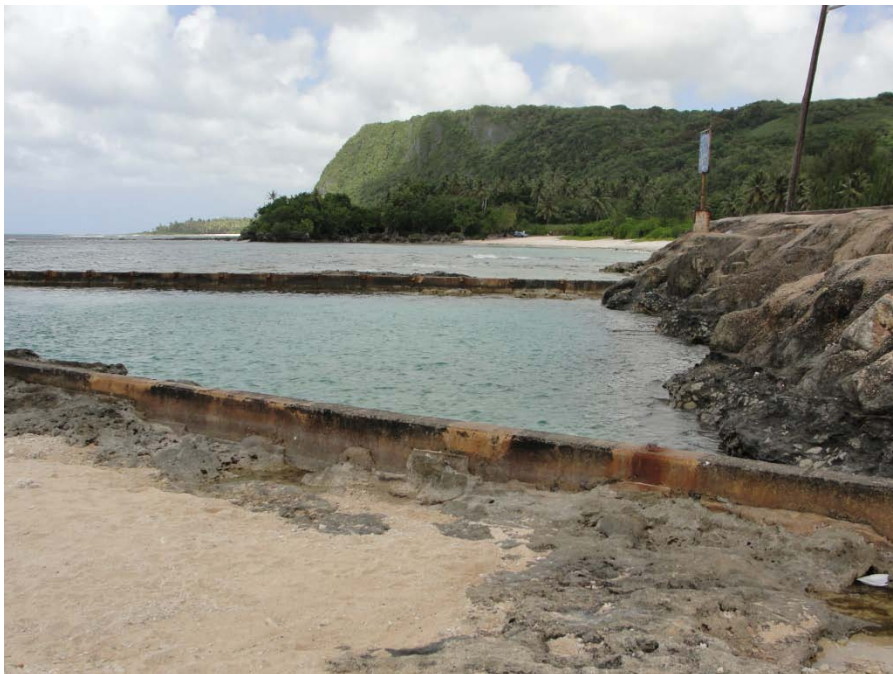
Photo 4: Intake canal, leading to intake structure, which is located below water level.

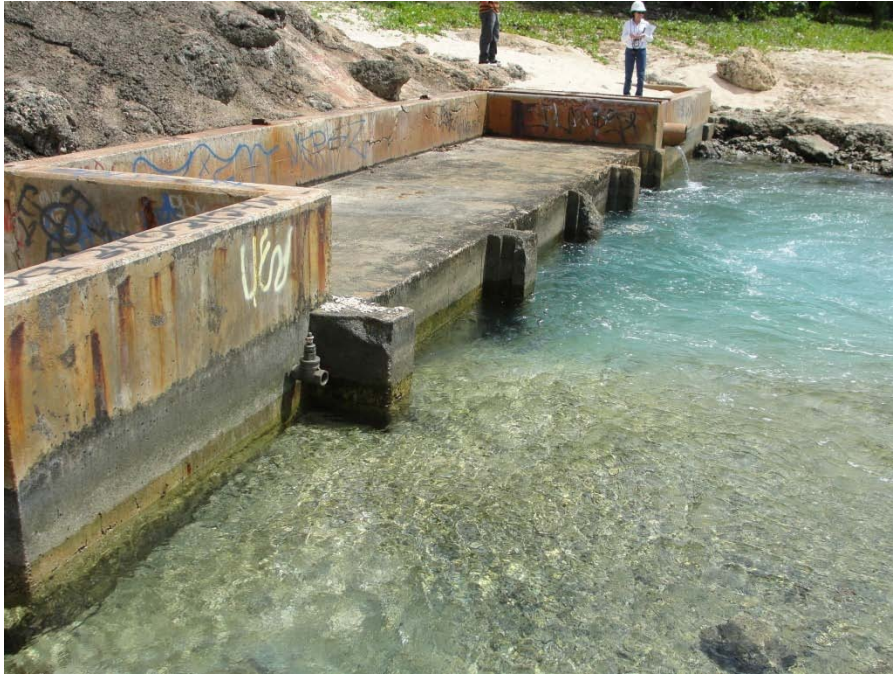
Photo 5: Outfall Serial No. 001.

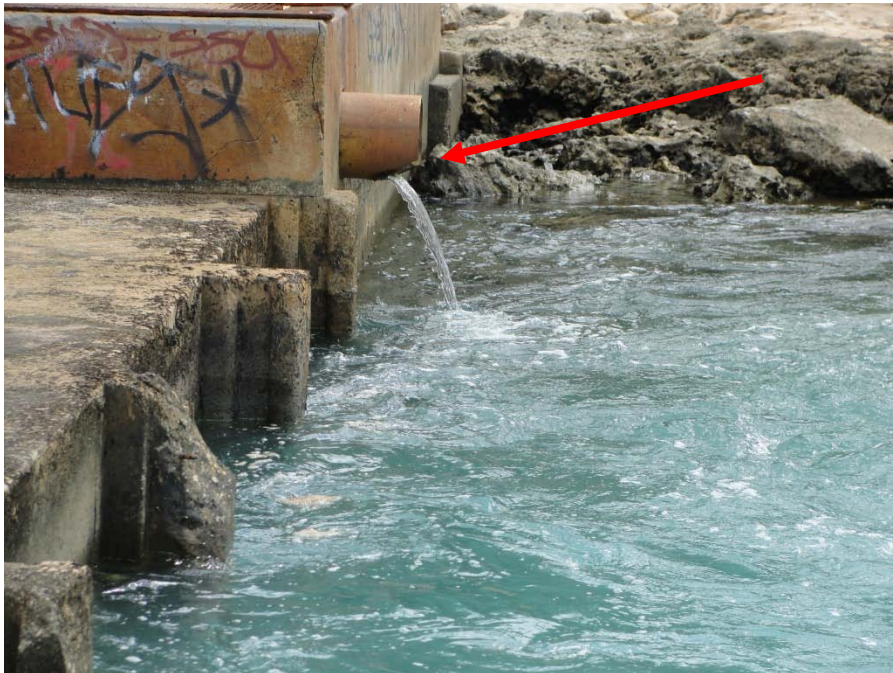
Photo 6: Outfall Serial No. 001A, located adjacent to Outfall Serial No. 001.

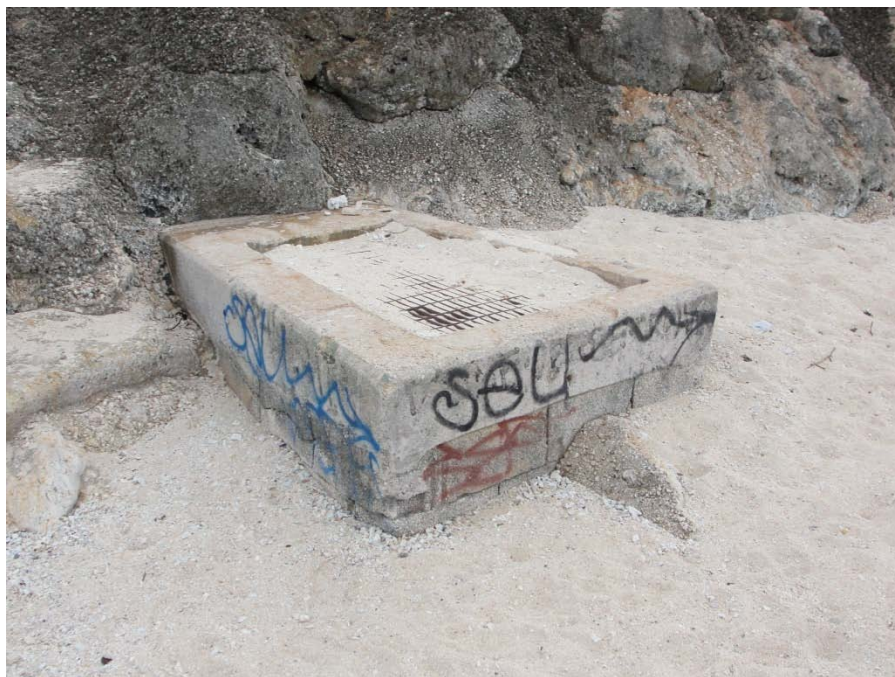
The traveling water screens are equipped with a high pressure seawater wash system; however, this wash system is not used by the Discharger. Due to sand infiltration into Outfall Serial No. 001B that effectively clogs the discharge location for the traveling water screen wash water unless frequently cleaned, the Discharger elects to manually hand clean the screens (simply removing debris on the screen by hand). [proposed revision to previous sentence, if accurate: Due to sand infiltration, traveling water screen wash water cannot be discharged from Outfall Serial No. 001B and the screens are manually cleaned.] The Discharger is permitted to discharge up to 0.004 mgd of traveling screen wash water through Outfall Serial No. 001B.

Photo 8: Outfall Serial No. 001B. Note that the outfall is clogged with sand and is not being utilized.

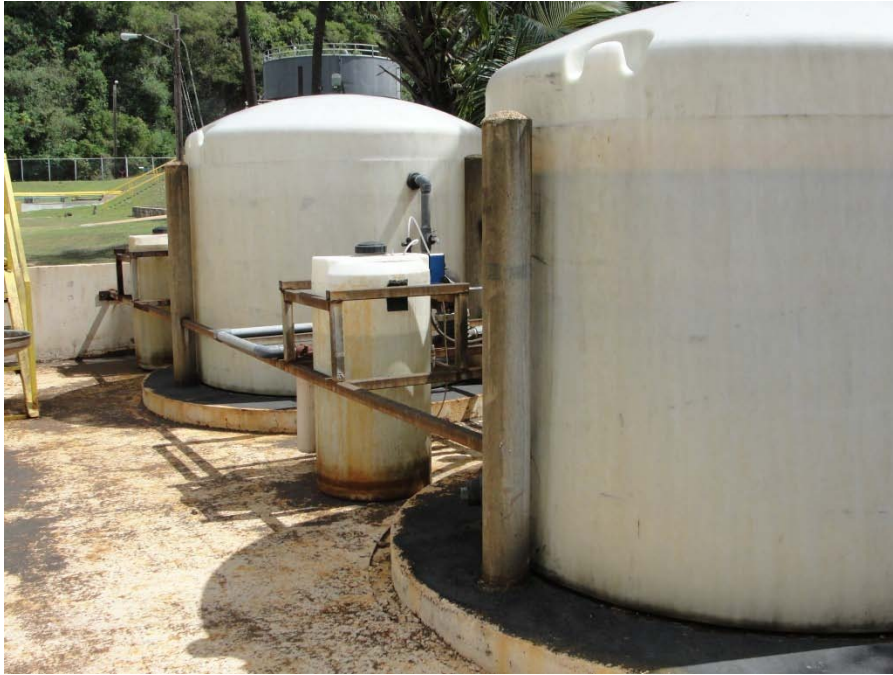
Photo 9: Low volume waste treatment system.

- a) An O&M plan. The plan shall include repair of the oil/water separator and low-volume wastewater treatment system so that each operates as intended. The schedule for completion of all work shall not exceed 6 months;

- a) Achieve and maintain compliance with all flow monitoring and reporting requirements of its Permit.
 - b) Complete all repairs necessary to bring the oil-water separator and low-volume wastewater treatment system into proper function.

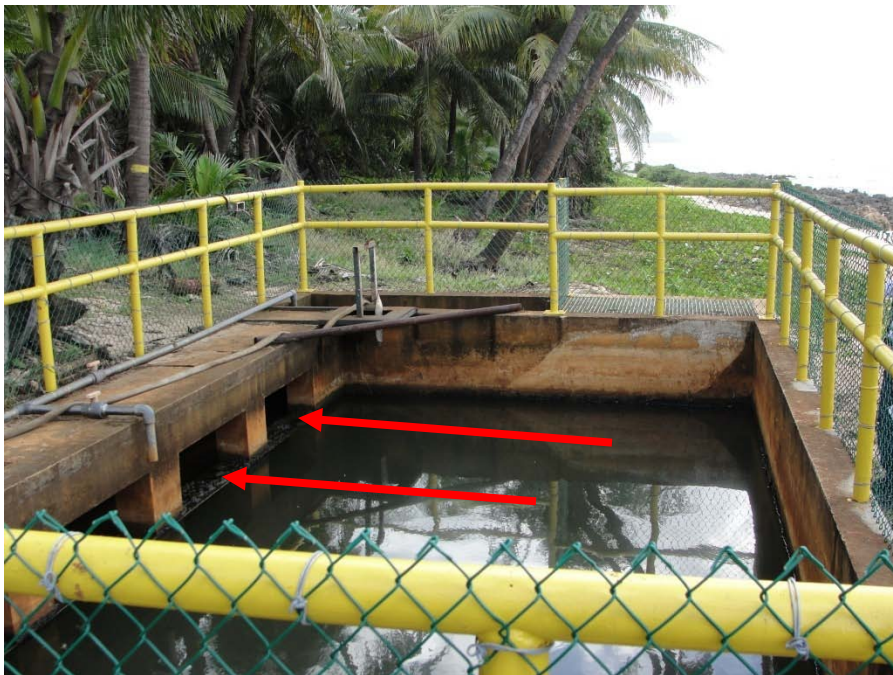
Photo 10: Low volume waste final pH adjustment basin. Effluent flows through the openings on the left, down a channel, and is then discharged out through Outfall Serial No. 001A.

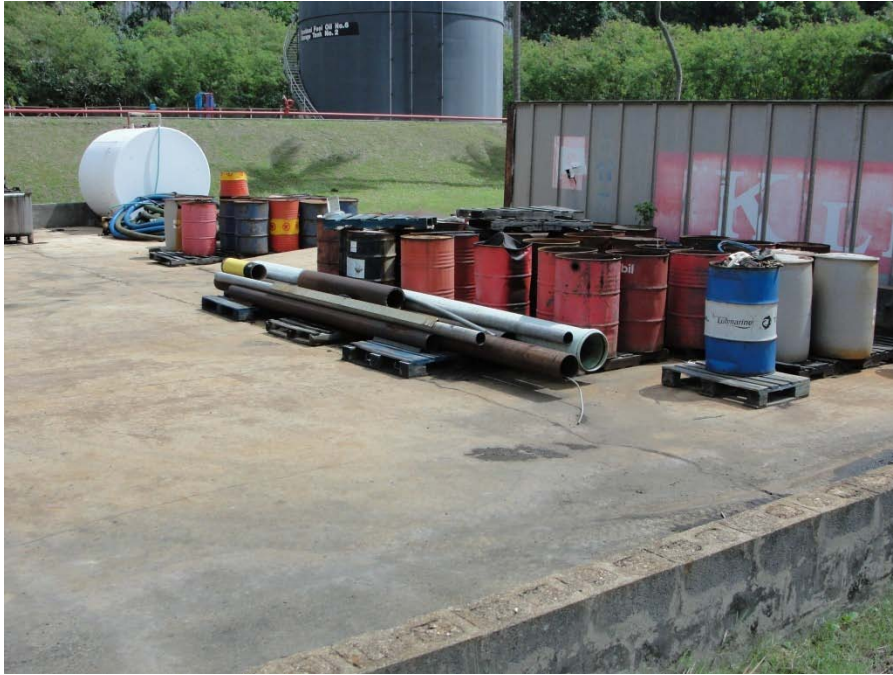
Photo 11: Material storage within secondary containment.

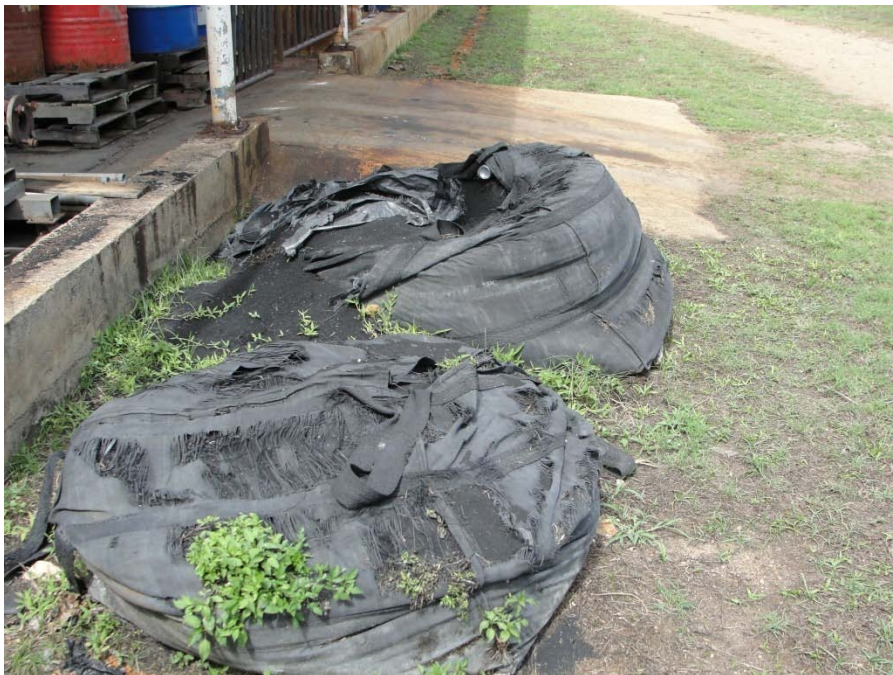
Secondary containment appeared to be utilized where appropriate, and general housekeeping appeared to be adequate with a couple exceptions. Two broken bags of sandblasting grit were observed on-site, with the grit spilling onto the ground. In addition, used tires were observed stored on-site adjacent to a storage shed. Because the Discharger does not discharge storm water to a receiving water, neither of these findings are included as 'Major Findings'.

Photo 12: Spilled sandblasting grit was observed on the ground during the inspection.

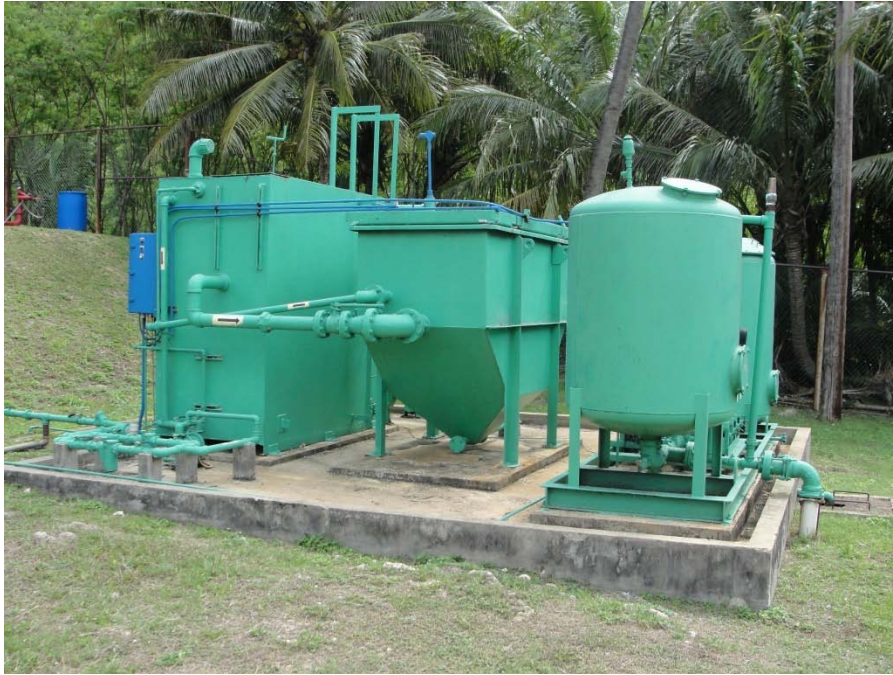
A ground water remediation project was observed on-site; however, the project was outside the scope of the inspection and was therefore not reviewed.

Photo 13: On-site ground water remediation project. Unrelated to NPDES Permit No. GU0000027.

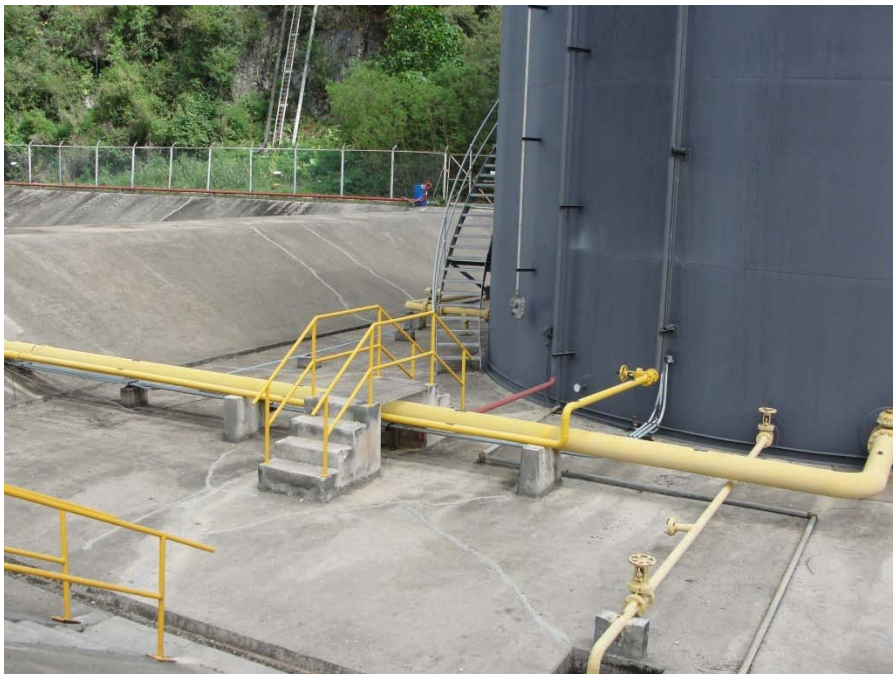
Photo 14: Secondary containment for above ground storage tanks.
