C. Infrastructure Analysis

Churchrock Chapter Land Use Plan

Final - 11/02

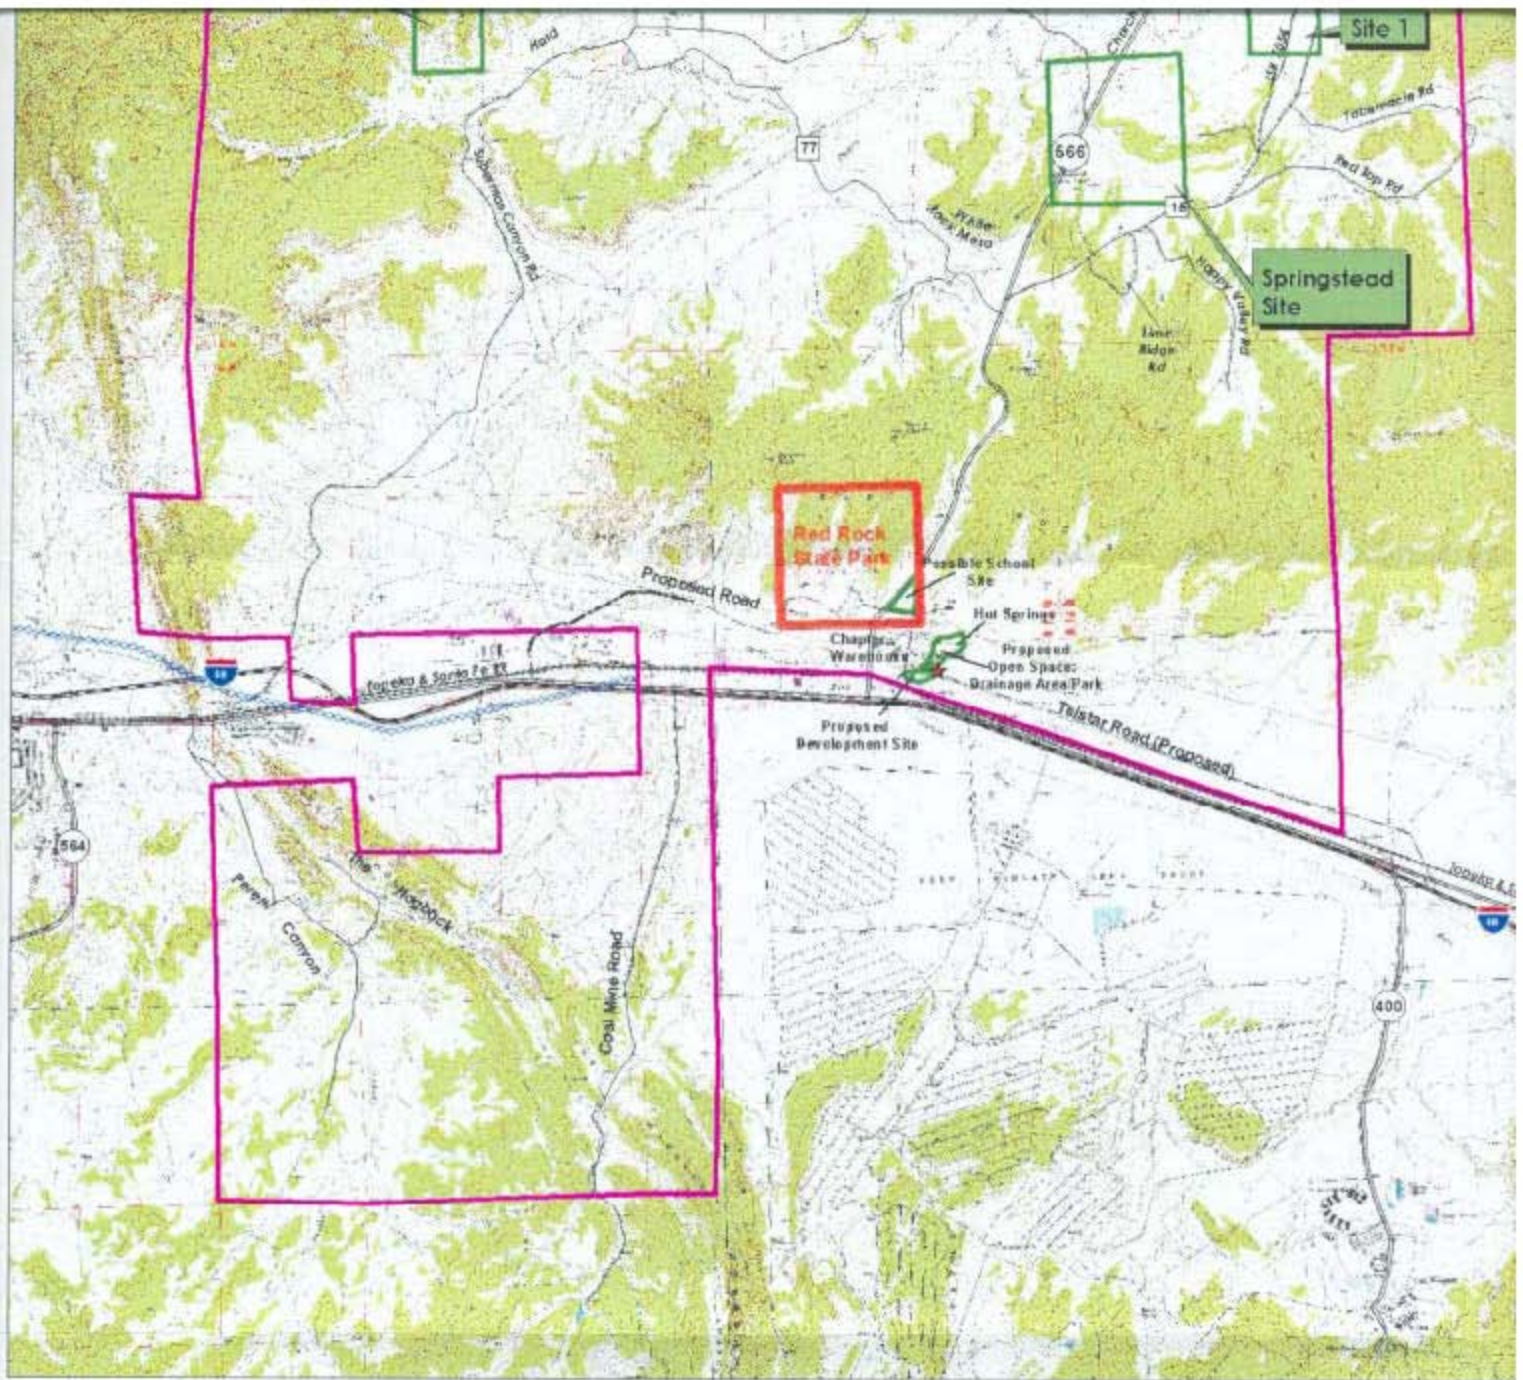
Churchrock Chapter Proposed Land Use

- Chapter Boundary
- ★ Chapter House
- Proposed Development

Utilities

- ~ Navajo/Gallup Water Supply Pipeline (Proposed)

This section describes the existing and needed infrastructure in the Churchrock Community. Infrastructure is shown in Exhibit 24.
