Re: May 21, 2008 Clean Water Act Inspection

**U.S. Environmental Protection Agency
Region 9
Clean Water Act Compliance Office**

Industrial User Inspection Report

Industrial User:	Metalast International, Inc. – Metalast Tech Center
Industrial User Address:	2241 Park Place, Suite C, Minden, NV 89423
Inspection Date:	May 21, 2008
EPA Region 9 Inspector:	Anna Yen, Environmental Engineer Water Division, CWA Compliance Office
Douglas County Inspector:	Steve Rippe, Utility System Technician I Douglas County Community Development
Facility Contact During Inspection:	Danielle Rosenquist, Director of Product Development
Report Date:	August 12, 2008

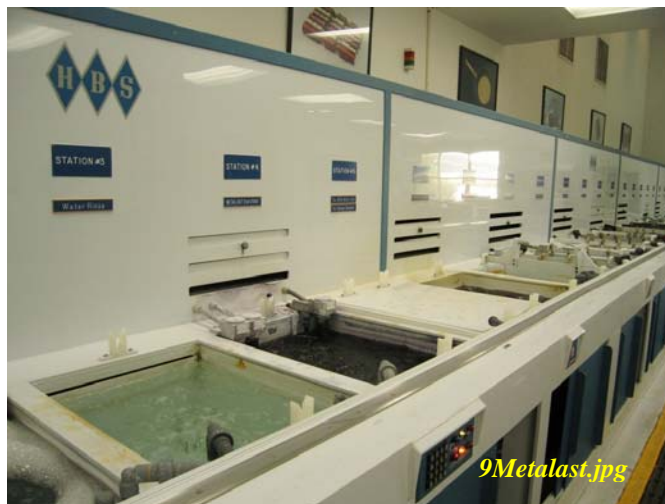
Photo 1

The process tanks are all set up in one row with an overhead hoist that holds the object to be anodized or coated and transfers it from tank to tank. Housed in "cabinets" below the process line, a container sits below each process tank and serves as secondary containment. Grating serves as a walkway in front of these tanks with secondary containment underneath, which is separate from the process tanks' secondary containment. Discharge piping runs from each tank into a common header which drains to the contained area under the walkway. A floor drain in the contained area under the walkway connects to the local sewer system. *See Photos 1 & 2 in Attachment 2.*

Anodizing/conversion coating line
Taken by Anna Yen on May 21, 2008

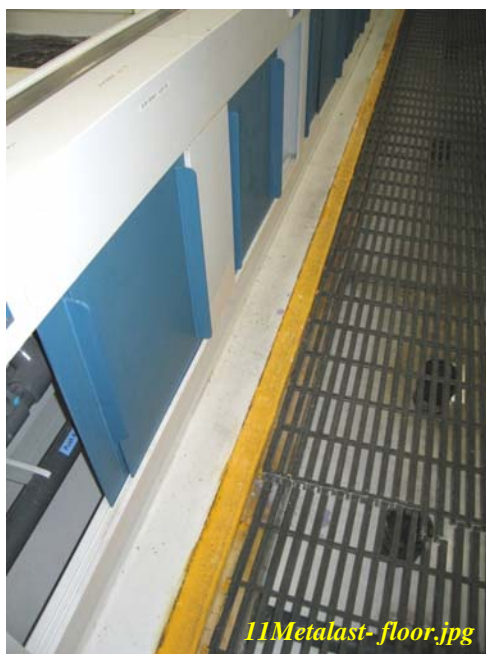
Photo 2

Discharge piping in “cabinets” under anodizing/coating tanks, secondary containment
under walkway grating
Taken by Anna Yen on May 21, 2008

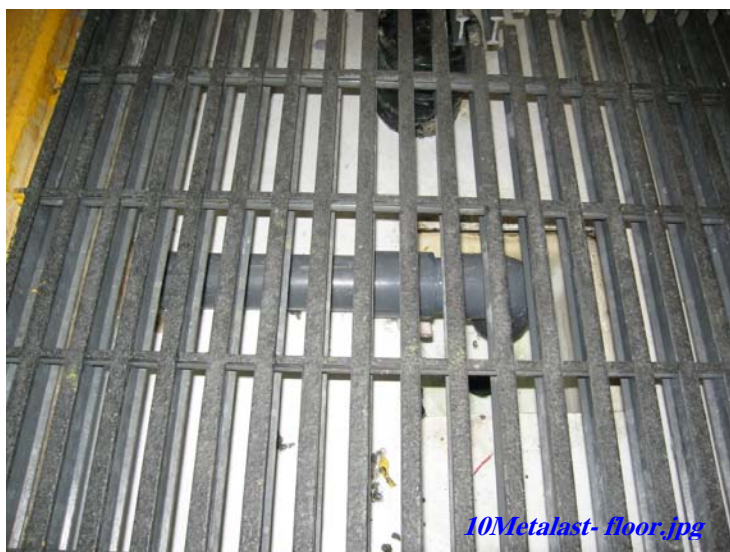
While the facility is running a batch through the process line, fresh water flows continuously into each rinse tank, while the used water in the rinse tank flows out at the same rate. The outgoing water flows via hard piping into the contained area under the floor grating. The wastewater then flows out to the local sewer system through a floor drain in the contained area. *See Photo 3 in Attachment 2.*

More significantly, flow-through rinses that (1) discharge directly to the sewer system, untreated, and (2) discharge continuously instead of on an as-needed basis, indicate non-compliance with the federal pretreatment standard that prohibits the use of dilution as a substitute for treatment. *See Section 2.1 for a more detailed discussion.*

For the first factor, the answer is yes because Metalast's wastewater discharges from the process line to the sewer system are untreated. For the second factor, excessive amounts of water are being used within the process line because the flow-through rinse tanks allow water to discharge continuously to the sewer system regardless of whether parts are being rinsed at that moment. Therefore, Metalast may be in non-compliance with 40 CFR 403.6(d).

Discharge piping from the process line to the secondary containment under the walkway;
floor drain directly under the discharge piping outlet

The facility should make changes to its flow-through rinse tanks so that the rinses are operated only on an as-needed basis. The resulting discharge to the sewer system should then be analyzed to determine if treatment is necessary.

Two common examples of controlling the flow of incoming fresh water based on production are conductivity-controlled makeup water inlet valves and on-demand kickplate switches, though there are other methods.

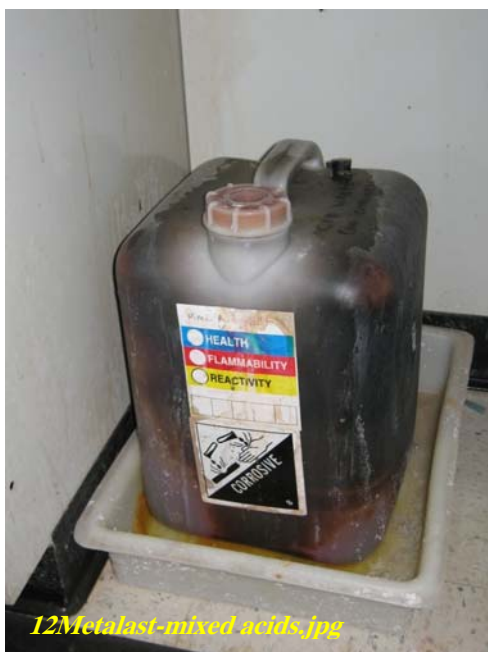
Photo 4

Each satellite waste tote sits in a secondary containment basin. The contents of each type of satellite waste tote are regularly transferred to a corresponding 55-gallon drum. These drums are then hauled offsite as hazardous waste. *See Photos 4 & 5 in Attachment 2.*

Satellite waste tote for mixed acids

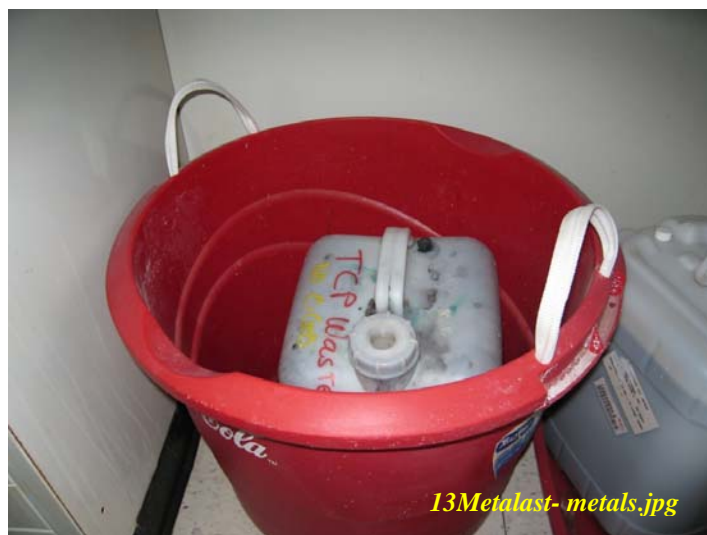
Photo 5

Satellite waste tote for metals
Taken by Anna Yen on May 21, 2008

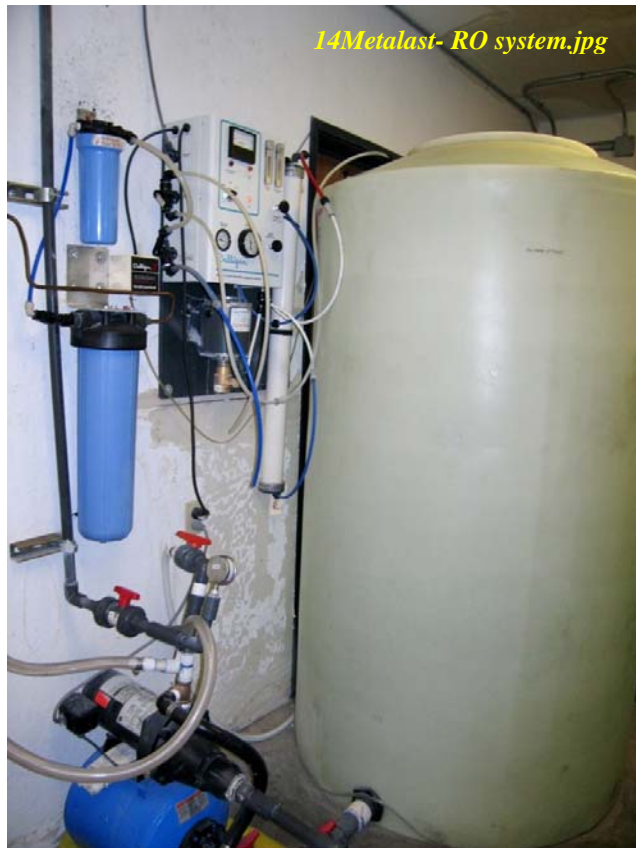
The facility has a reverse osmosis (RO)/deionized water system on site to provide the DI water used in the anodizing/conversion coating process line. City water is piped to the RO system first, the treated water is stored in a holding tank, then pumped through a DI cartridge when water is needed. *See Photos 6 & 7 in Attachment 2.* A sediment filter and a carbon filter are located upstream of the RO membrane. These filters are replaced at regular intervals and the old ones disposed of in the trash. The RO membrane has not been replaced yet and has been in operation for at least four years. The reject water from the RO membrane is discharged directly to the sewer system. DI cartridges are picked up by the manufacturer regularly and replaced with fresh cartridges.

Photo 6
RO/DI system, with storage tank
Taken by Anna Yen on May 21, 2008

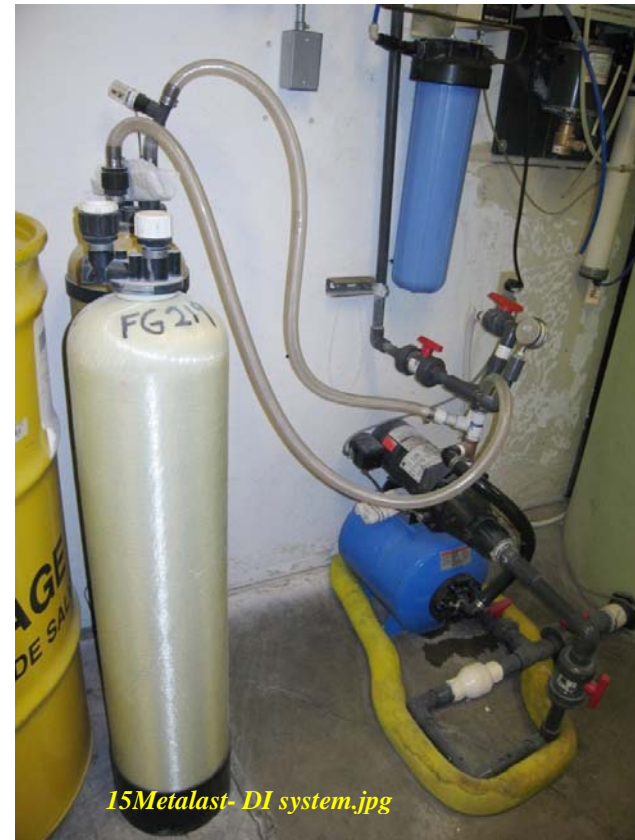
Photo 7
RO/DI system
Taken by Anna Yen on May 21, 2008
