Weekly Update

Milltown Reservoir Sediments Superfund Site

Issue #32
Oct. 3, 2007

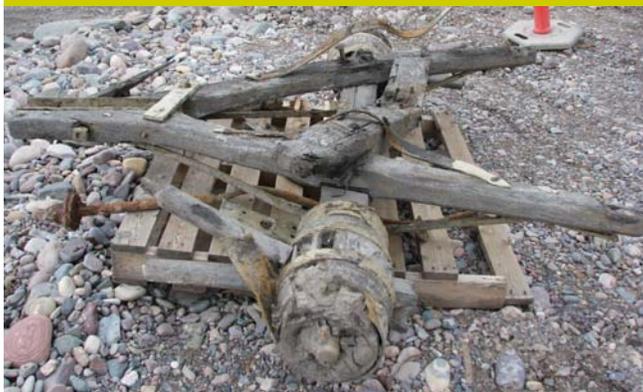
Remains of a freight wagon were found on-site during excavation of the Clark Fork River bypass channel. Pictured here is the yoke and axle of the freight wagon.

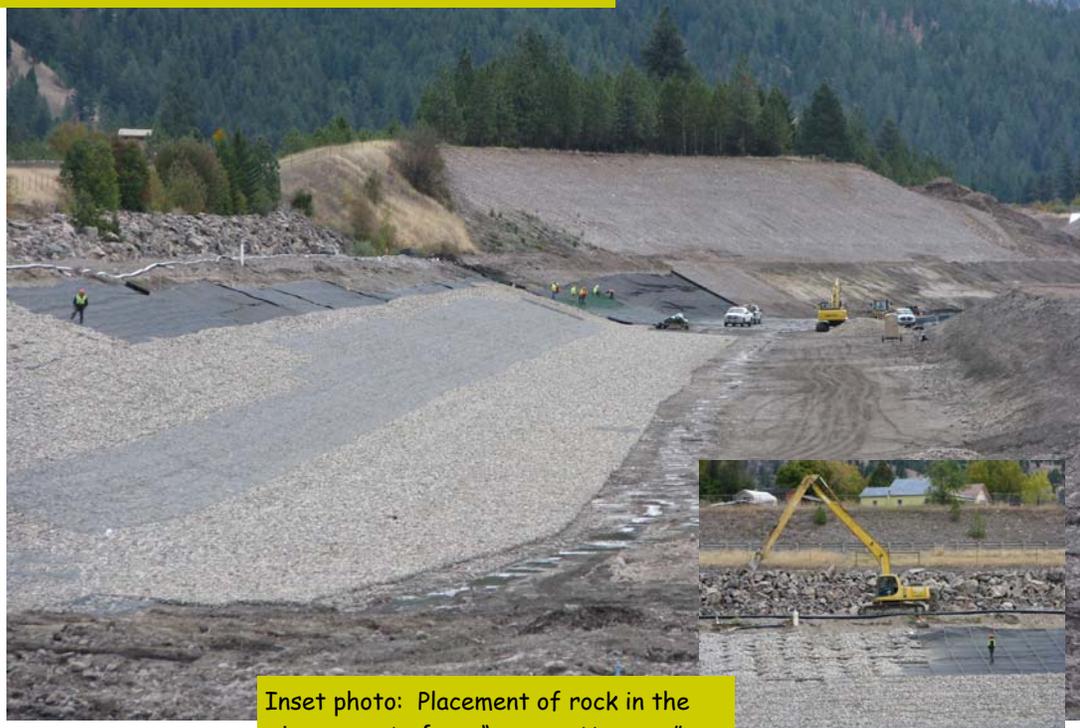
Below is the **Clark Fork River bypass channel**, looking upstream. To protect the channel from erosion, the bypass channel is lined with geo-fabric, turf reinforcing mat, and covered with rock-filled reno mattresses. The channel is designed to withstand a 100-year flood.

Inset photo: Placement of rock in the wire cages to form "reno mattresses"

- Workers are busy lining the bypass channel with "**reno mattresses**," and are about 25% complete. **Trucks continue to haul rock** to fill the "reno mattresses" for the bypass channel. The number of trucks is between 10-18 truckloads per day (I-90 and Rustic Road).
