## Cleanup Update

# Milltown Reservoir Sediments Superfund Site

Issue #76

March 4, 2009

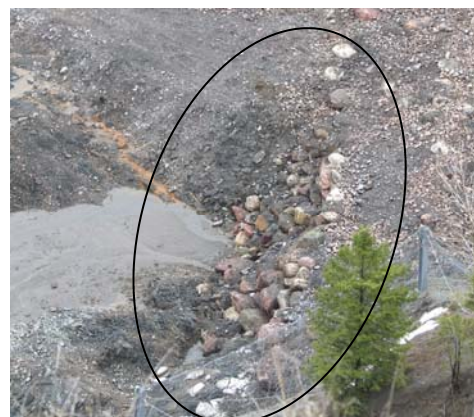
**Grade control structure as seen from the bluff.** When the de-watering pumps below the former spillway are turned off, this area will flood and the structure will no longer be visible. The "hole" is expected to fill in with cobbles and gravel during this spring's high flow.

- **Grade control work is complete.** The grade control will help reduce the head-cutting (erosion back upstream in the river channel) in the restored channel that might otherwise occur when the spillway coffer dam is breached (expected the week of March 23).

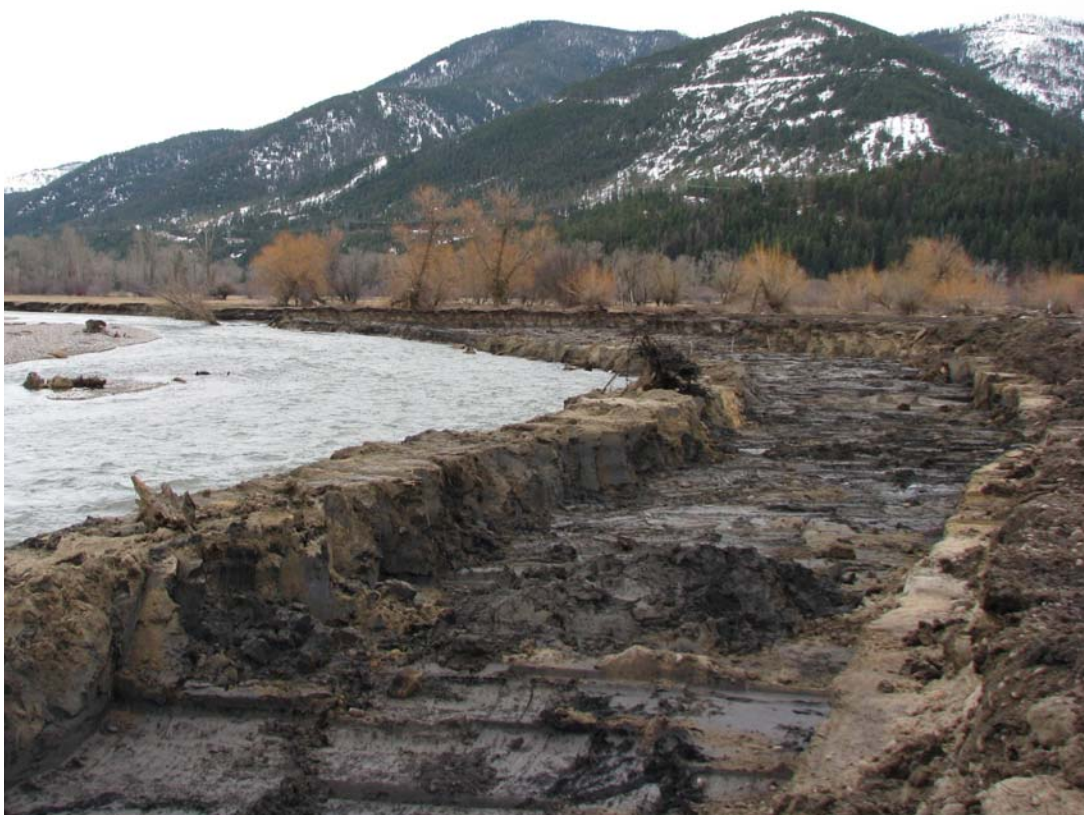
The photo above (3/3/09) shows the initial removal of contaminated sediments upstream of the remedial project area (Area 4) to prevent them from scouring during spring high flows. Preventative measures such as these reduce downstream river and fisheries impacts. If all goes as planned, up to 100,000 tons of material could be removed by April 2009.

- **Excavation of upstream sediments is about 10% done;** expected to be complete before April. EPA and the MT Natural Resources Damage Program are working with Envirocon to remove approximately 60,000-100,000 tons of material in the restoration area (Area 4) upstream of the remedial project area. If not removed, this material might otherwise scour downstream, if above normal flows occur this spring.
