## Weekly Update

# Milltown Reservoir Sediments Superfund Site

Issue #55

April 16 2008

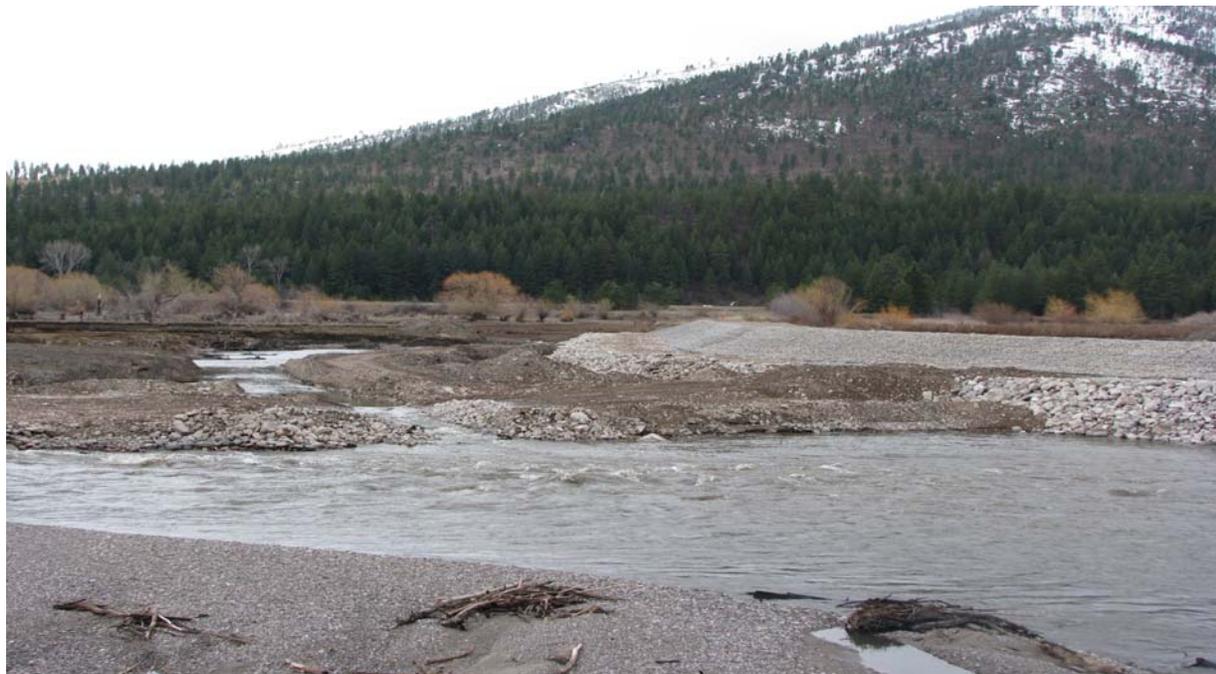
Shown on center Right is the finished upstream dike blocking of the CFR at head end of bypass channel. Deer Creek is entering by-pass channel at center left.

- **Completed the diversion dike upstream of the bypass channel on April 12th.** This substantial dike is needed to keep the Clark Fork River flowing into the bypass channel (and out of the old channel). The Deer Creek flow is also directed into the bypass channel. The diversion dike, constructed of compacted fill and rock, is designed to withstand a 100-year flood.

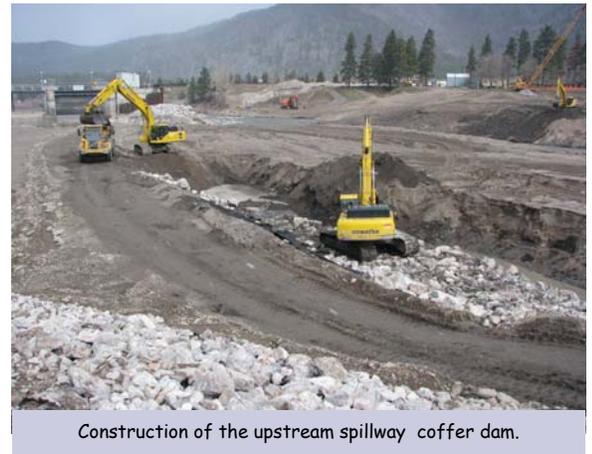
Construction of the upstream spillway coffer dam.

- **Construction of the coffer dam upstream of the Milltown Dam spillway continues.** This coffer dam will protect the sediments upstream of the spillway from erosion during high flows and provide a dry work environment for the upcoming spillway and radial gate removal. In preparation, some rip rap from the Blackfoot River flood berm has been removed. Construction of this coffer dam should be completed by April 25th. .

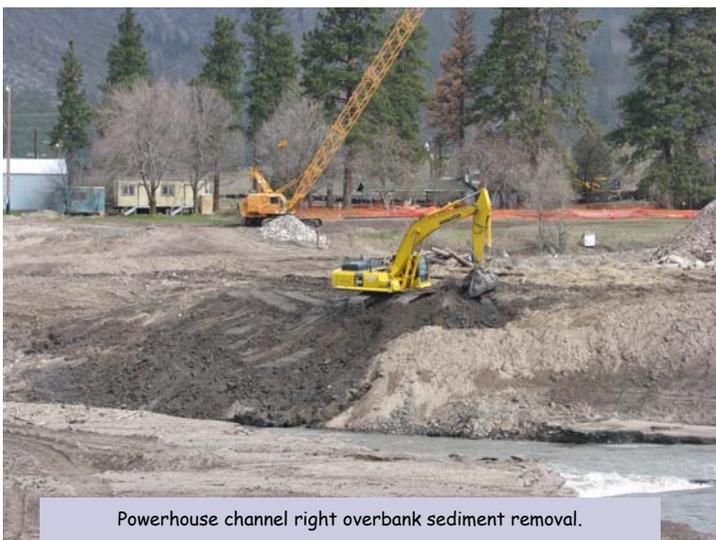
Powerhouse channel right overbank sediment removal.
