## Weekly Update

# Milltown Reservoir Sediments Superfund Site

Issue #35  
Oct. 24, 2007

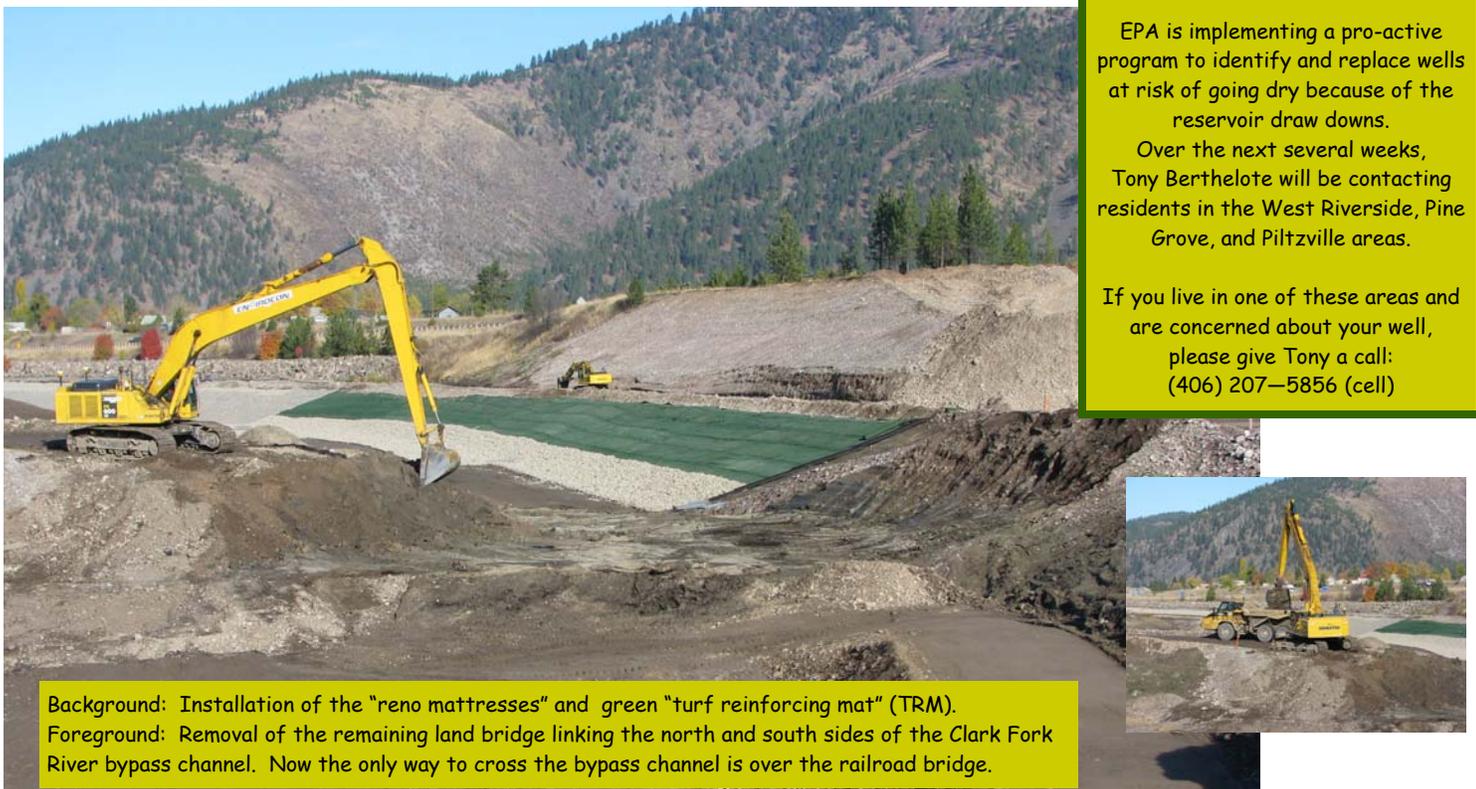
Background: Installation of the "reno mattresses" and green "turf reinforcing mat" (TRM).  
Foreground: Removal of the remaining land bridge linking the north and south sides of the Clark Fork River bypass channel. Now the only way to cross the bypass channel is over the railroad bridge.

- **Excavation of the bypass channel is essentially complete; workers are now removing the last remaining land bridge.** The rail bridge is now the only access across the bypass channel.

- **Workers are busy lining the bypass channel with "reno mattresses,"** and are about 38% complete.; installation should be complete in early December. **Trucks continue to haul rock** to fill the "reno mattresses" for the bypass channel. The number of trucks is between 10-18 truckloads per day. Trucks are traveling on Highway 200 through Milltown and then on Hwy 210 E to the Rustic Road entrance. Rock hauling should continue through November 2007.
