## Weekly Update

# Milltown Reservoir Sediments Superfund Site

Issue #36

Oct. 31, 2007

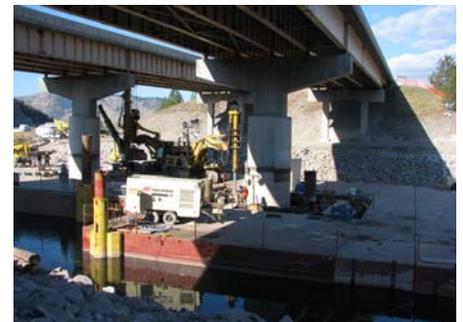
Drilling shafts under the I-90 bridges on the Blackfoot River to ensure bridge stability after the Milltown Dam is removed.

- **USACE and its contractors** continue to work 24/7 to strengthen and stabilize the **I-90 bridge center piers**. Work has been going slowly as crews have encountered remnants of an earlier coffer dam (including 16" I-beams) while installing the bridge supports. Eight of the 16 drilled shafts will be in by the end of this week. I-90 Bridge mitigation should be complete in January 2008.

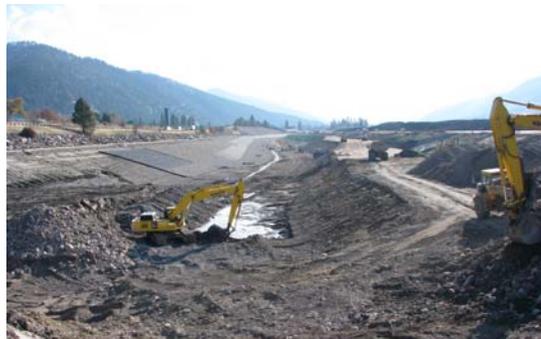
Excavation continues on the west end of the bypass channel, near where the outlet will be to the Blackfoot River.

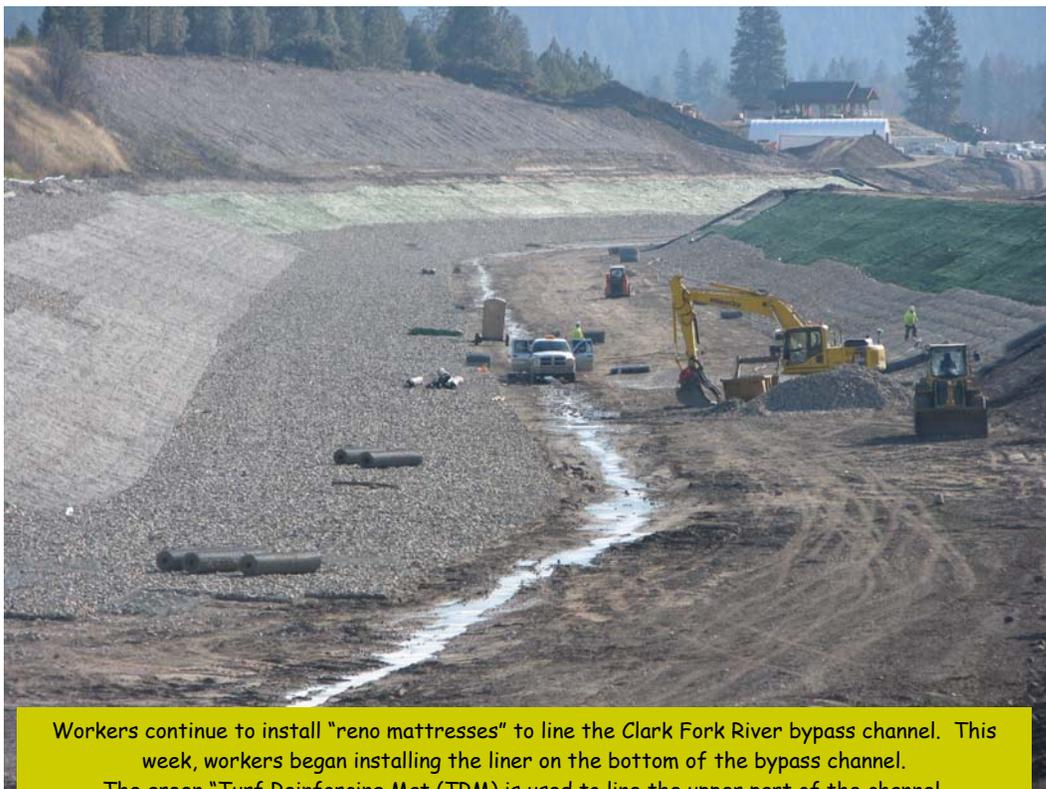
Workers continue to install "reno mattresses" to line the Clark Fork River bypass channel. This week, workers began installing the liner on the bottom of the bypass channel. The green "Turf Reinforcing Mat (TRM)" is used to line the upper part of the channel. The bypass channel should be complete in mid-December 2007.

- Workers continue to line the bypass channel with "**reno mattresses**" and have begun lining the base of the channel. Installation should be complete in early December. **Trucks continue to haul rock** to fill the "reno mattresses" for the bypass channel. The number of trucks is between 14-15 truckloads per day. Trucks are traveling on Highway 200 through Milltown and then on Hwy 210 E to the Rustic Road entrance. Rock hauling should continue through November 2007.

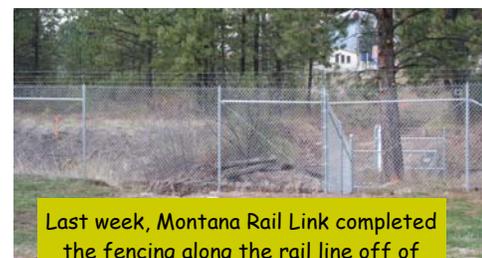
Last week, Montana Rail Link completed the fencing along the rail line off of Hellgate Drive in Piltzville.
