Rio Blanco Restoration: Adopted Rocks and Homemade Jelly Help Fund Demonstration Project

Rio Blanco Restoration

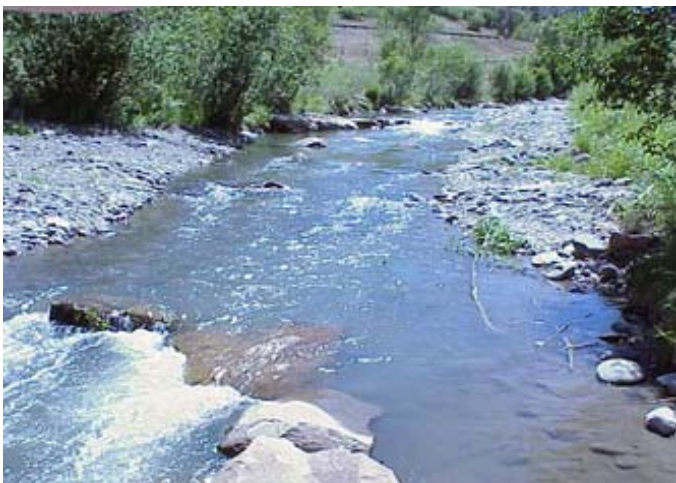
The J-hook in the foreground is typical of the structures installed in the river. It directs stream flow toward the thalweg and away from the banks.

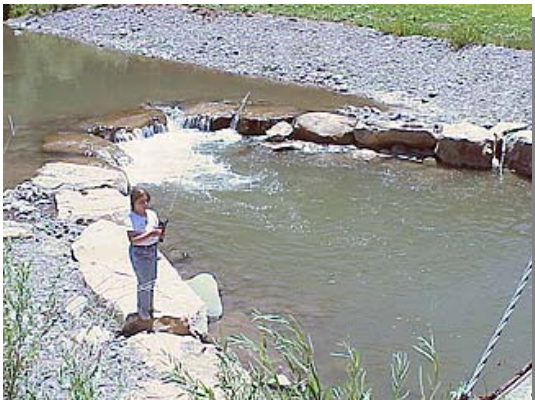
Aquatic habitat was improved by adding a drop structure. The pool in this area is 7 feet deep and supports trout.

- Pools within the river are now nearly 7 feet deep; previously, they were nonexistent or less than 2 feet deep.
- The channel is well defined and meanders, instead of braiding through the width of the riverbed.
- Water levels in alluvial wells have increased by 7 to 10 inches.
- Within a week of the completion of construction, children were again catching 10- to 16-inch fish in this segment of the river.
