**Figure 1.** Map of major features of Middle Main Eel river TMDL area

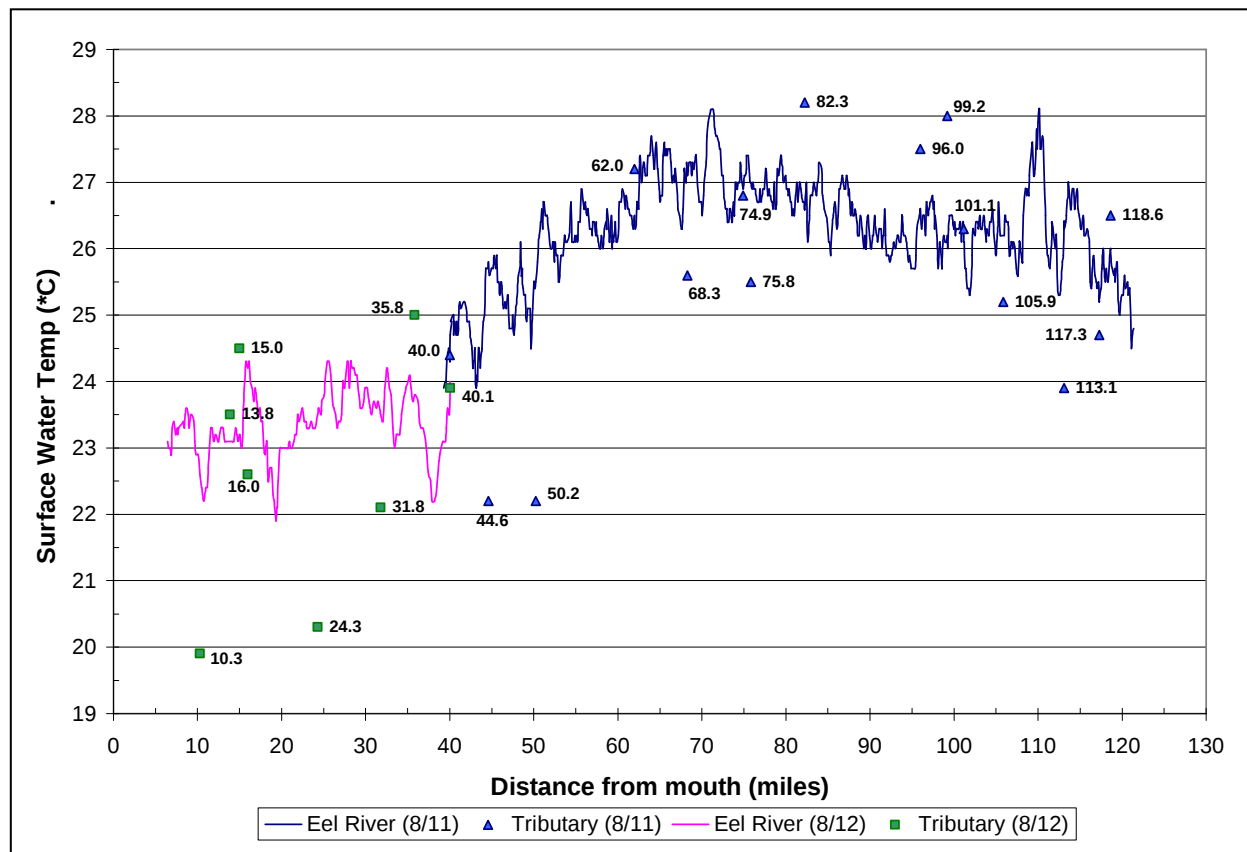
**Figure 2.** TIR Results – Median sampled temperatures by river mile for the Eel River.

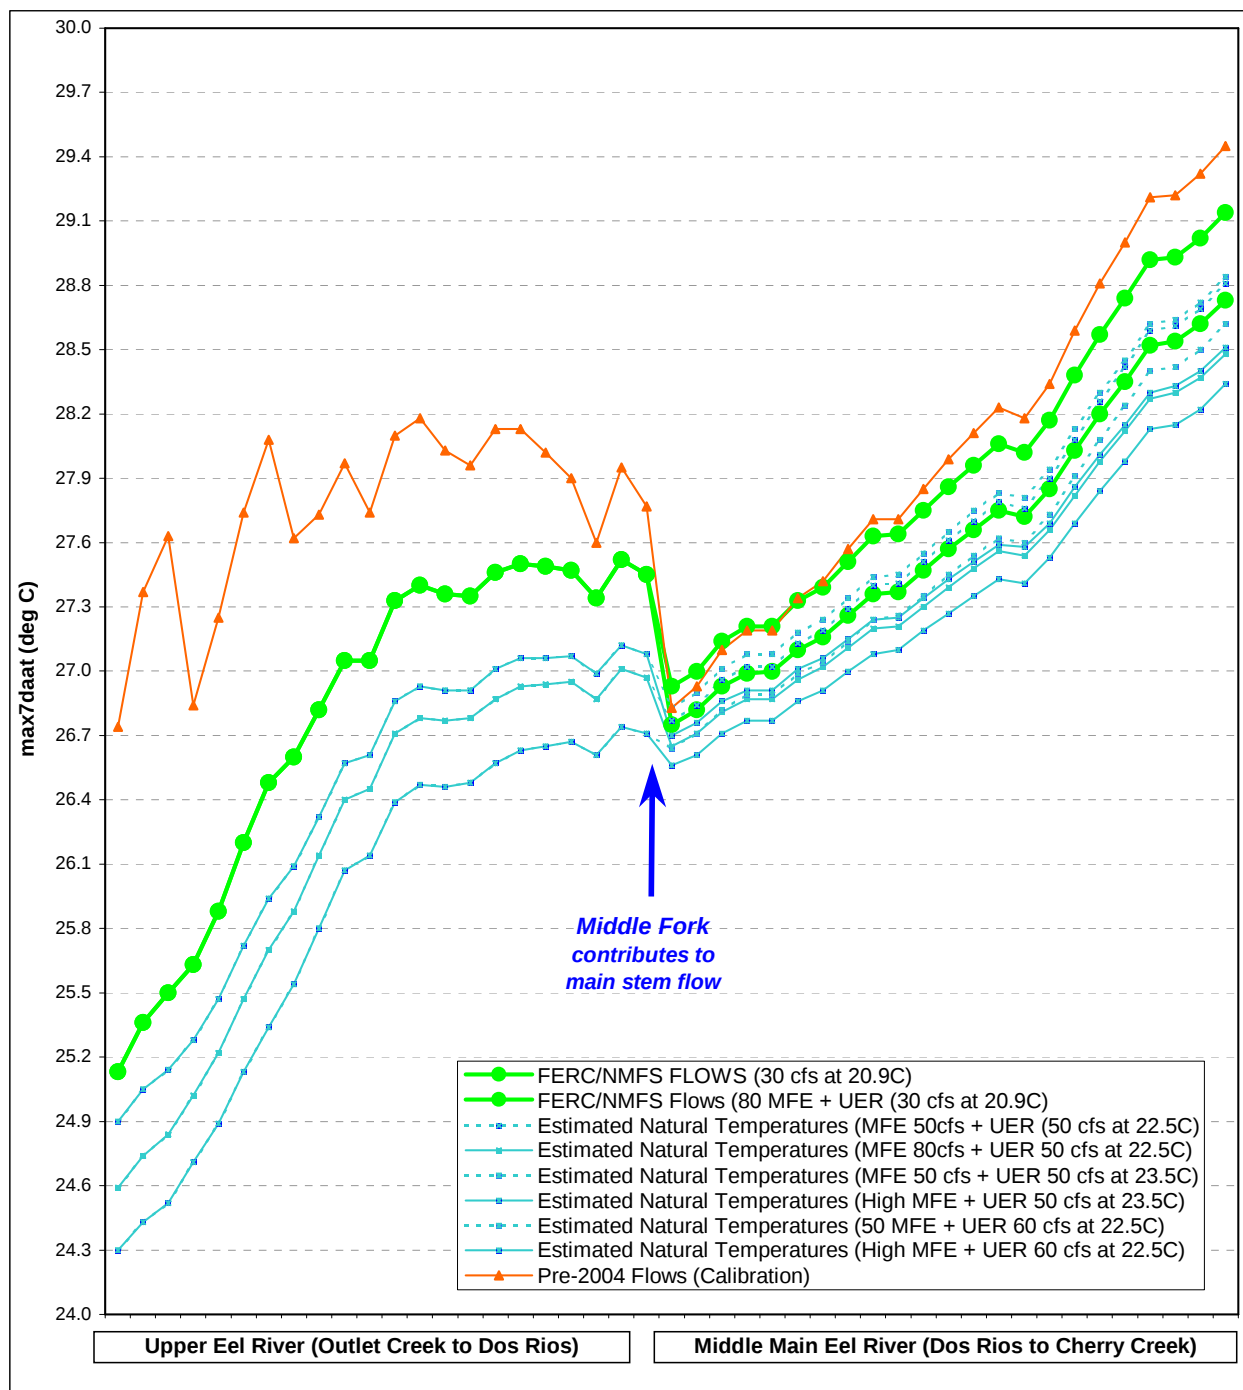
**Figure 3.** Comparison of natural stream temperatures to current flow requirements

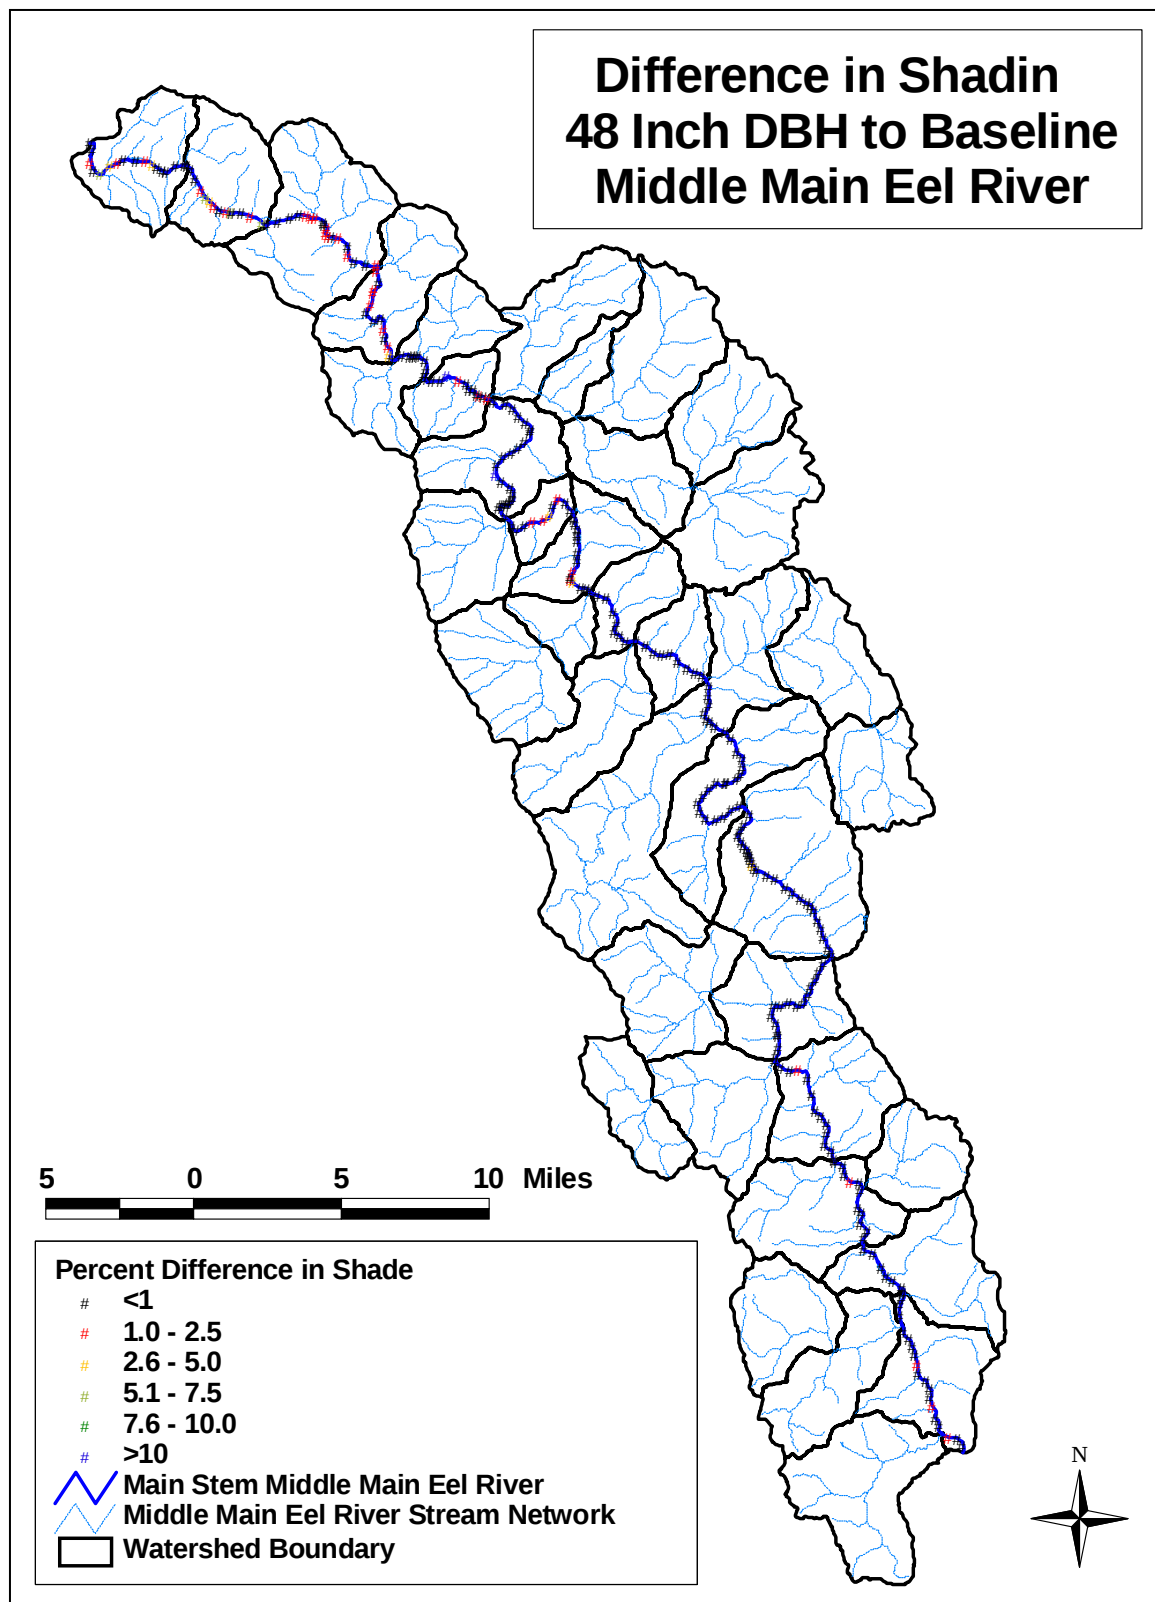
**Figure 4.** Difference in shading between natural vegetation and current conditions

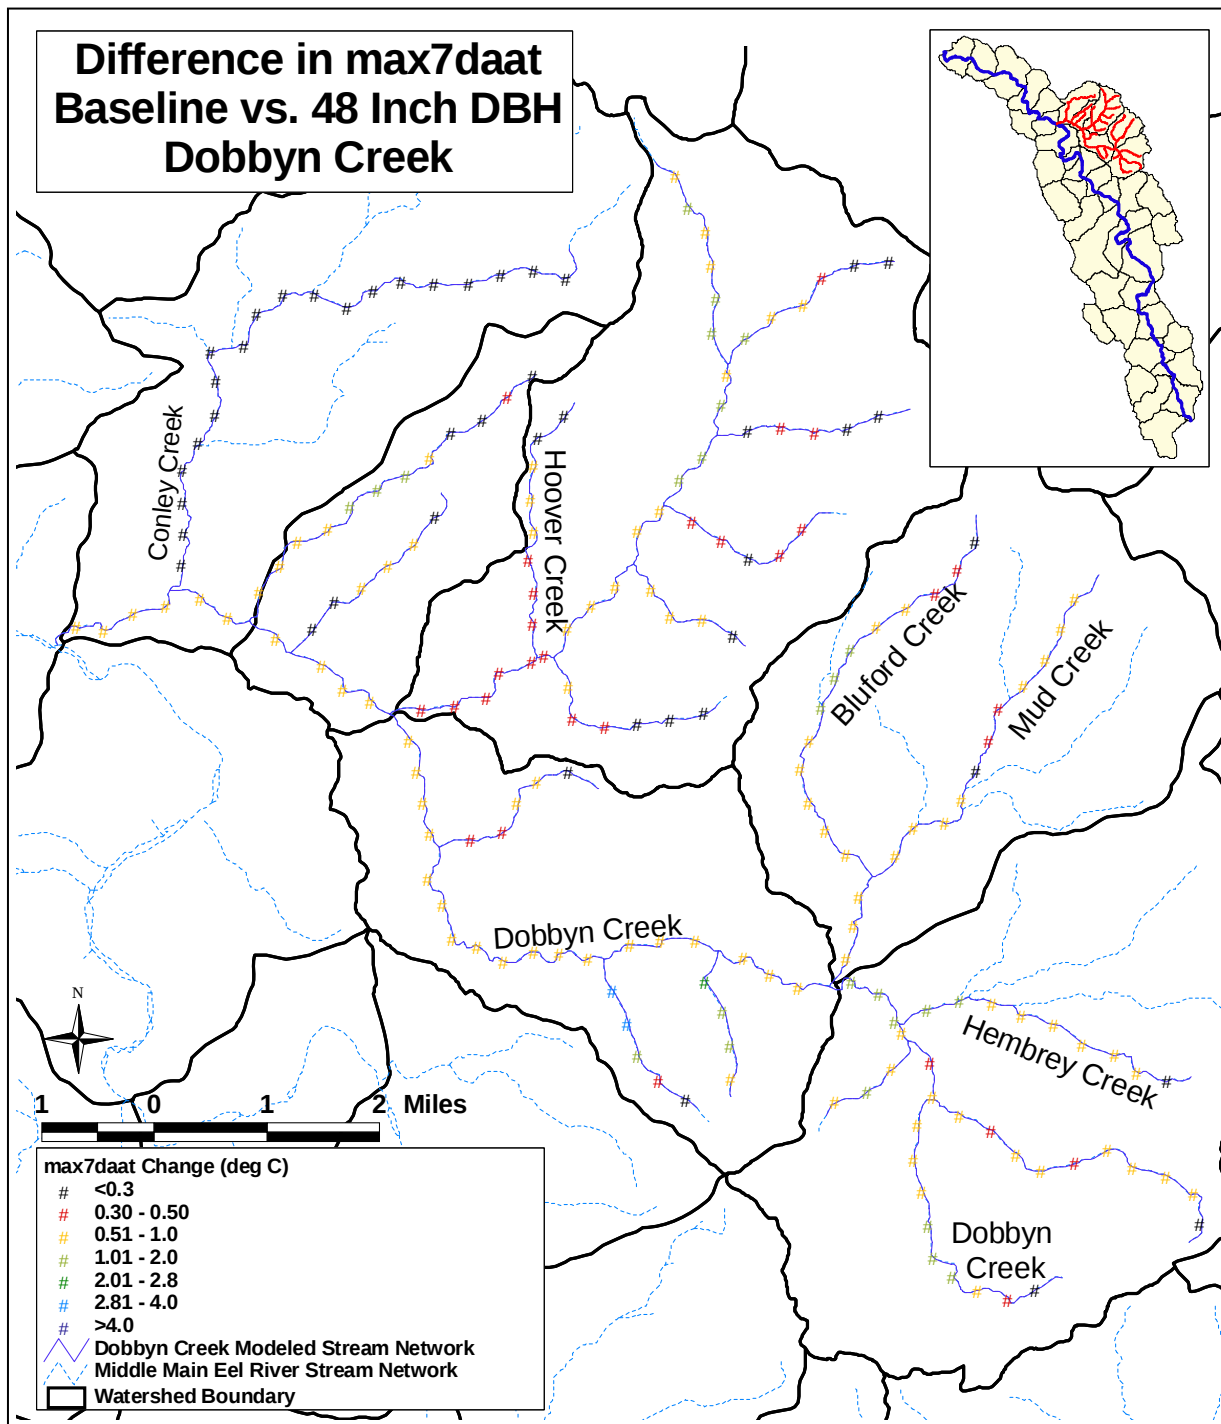
**Figure 5.** Temperature change between natural and current conditions

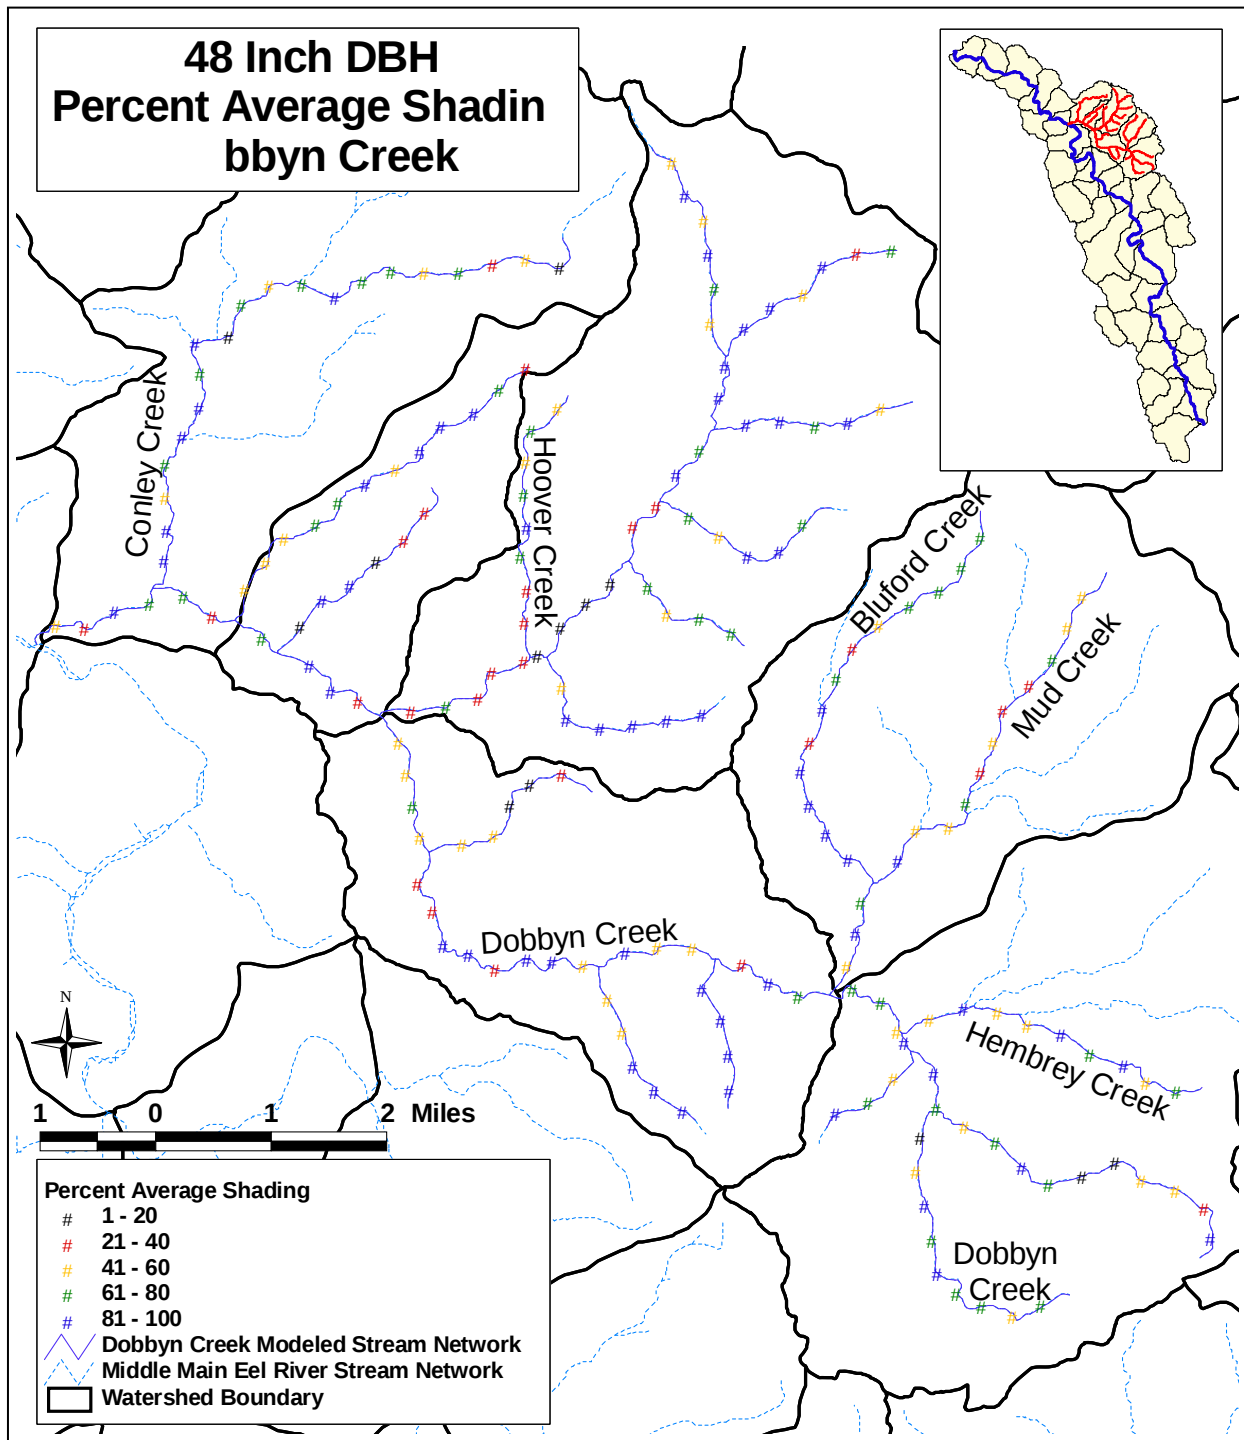
**Figure 6.** Percent average shading for natural vegetation in Dobbyn Creek

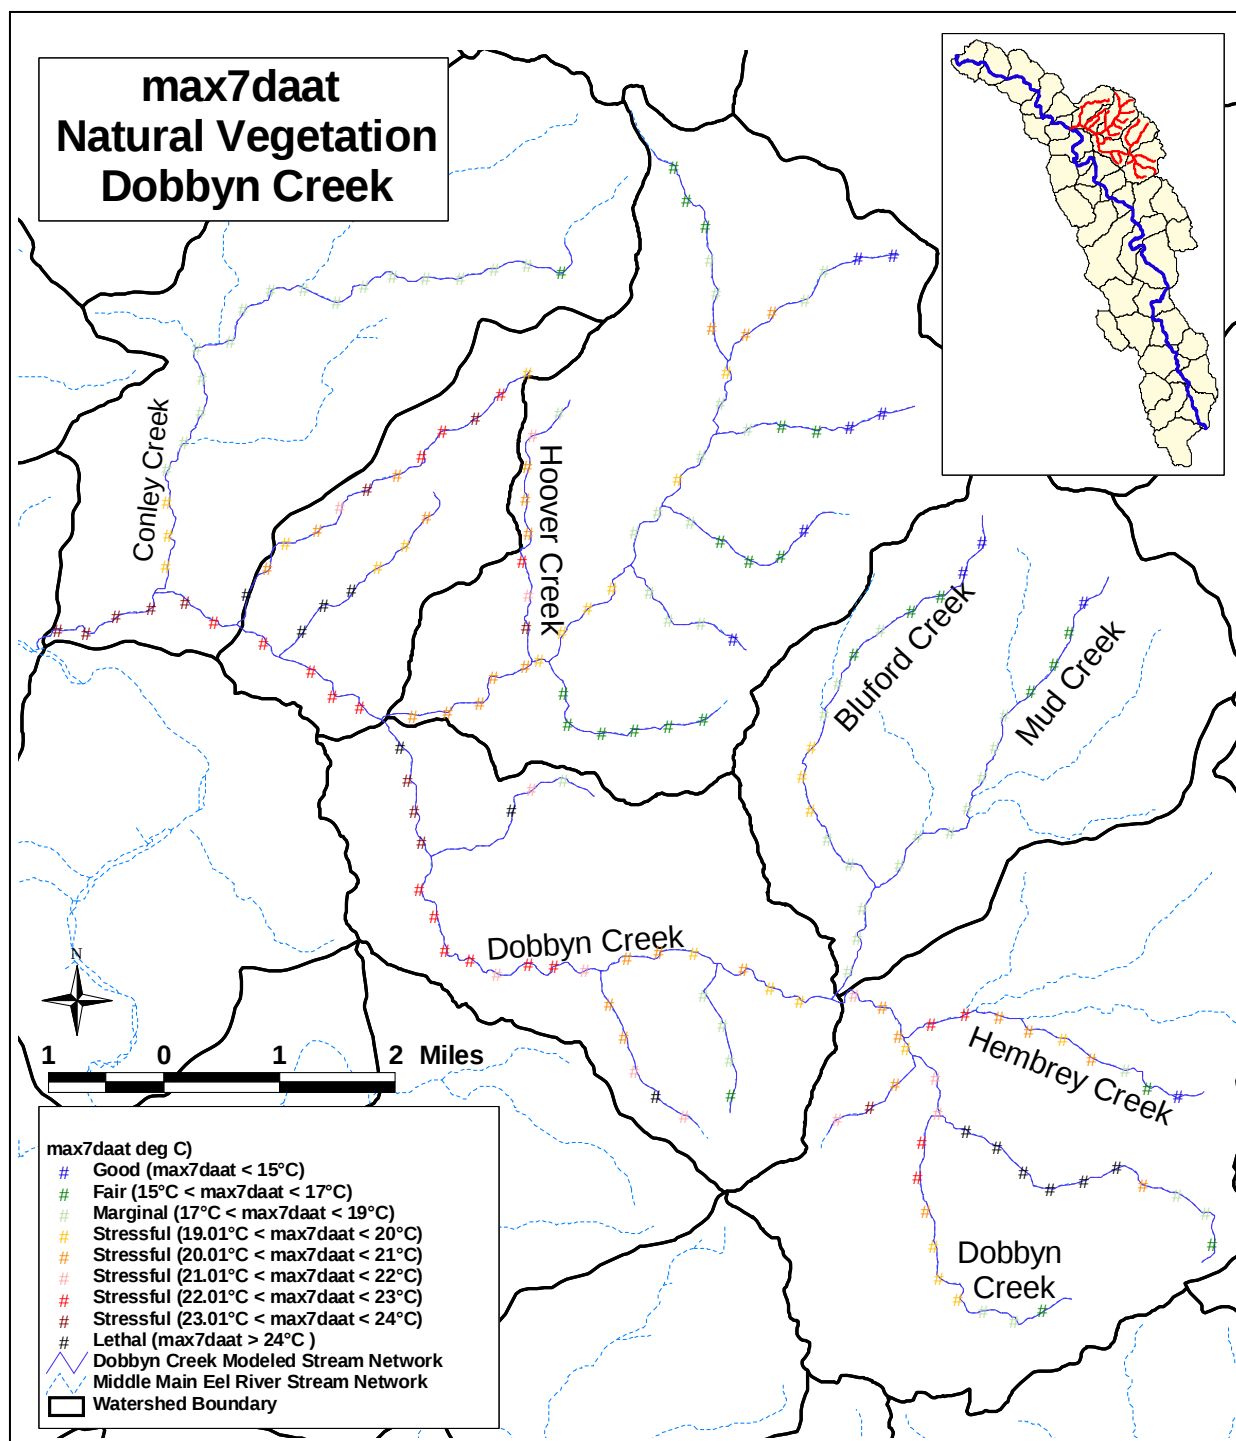
**Figure 8.** Natural stream temperatures in Dobbyn Creek

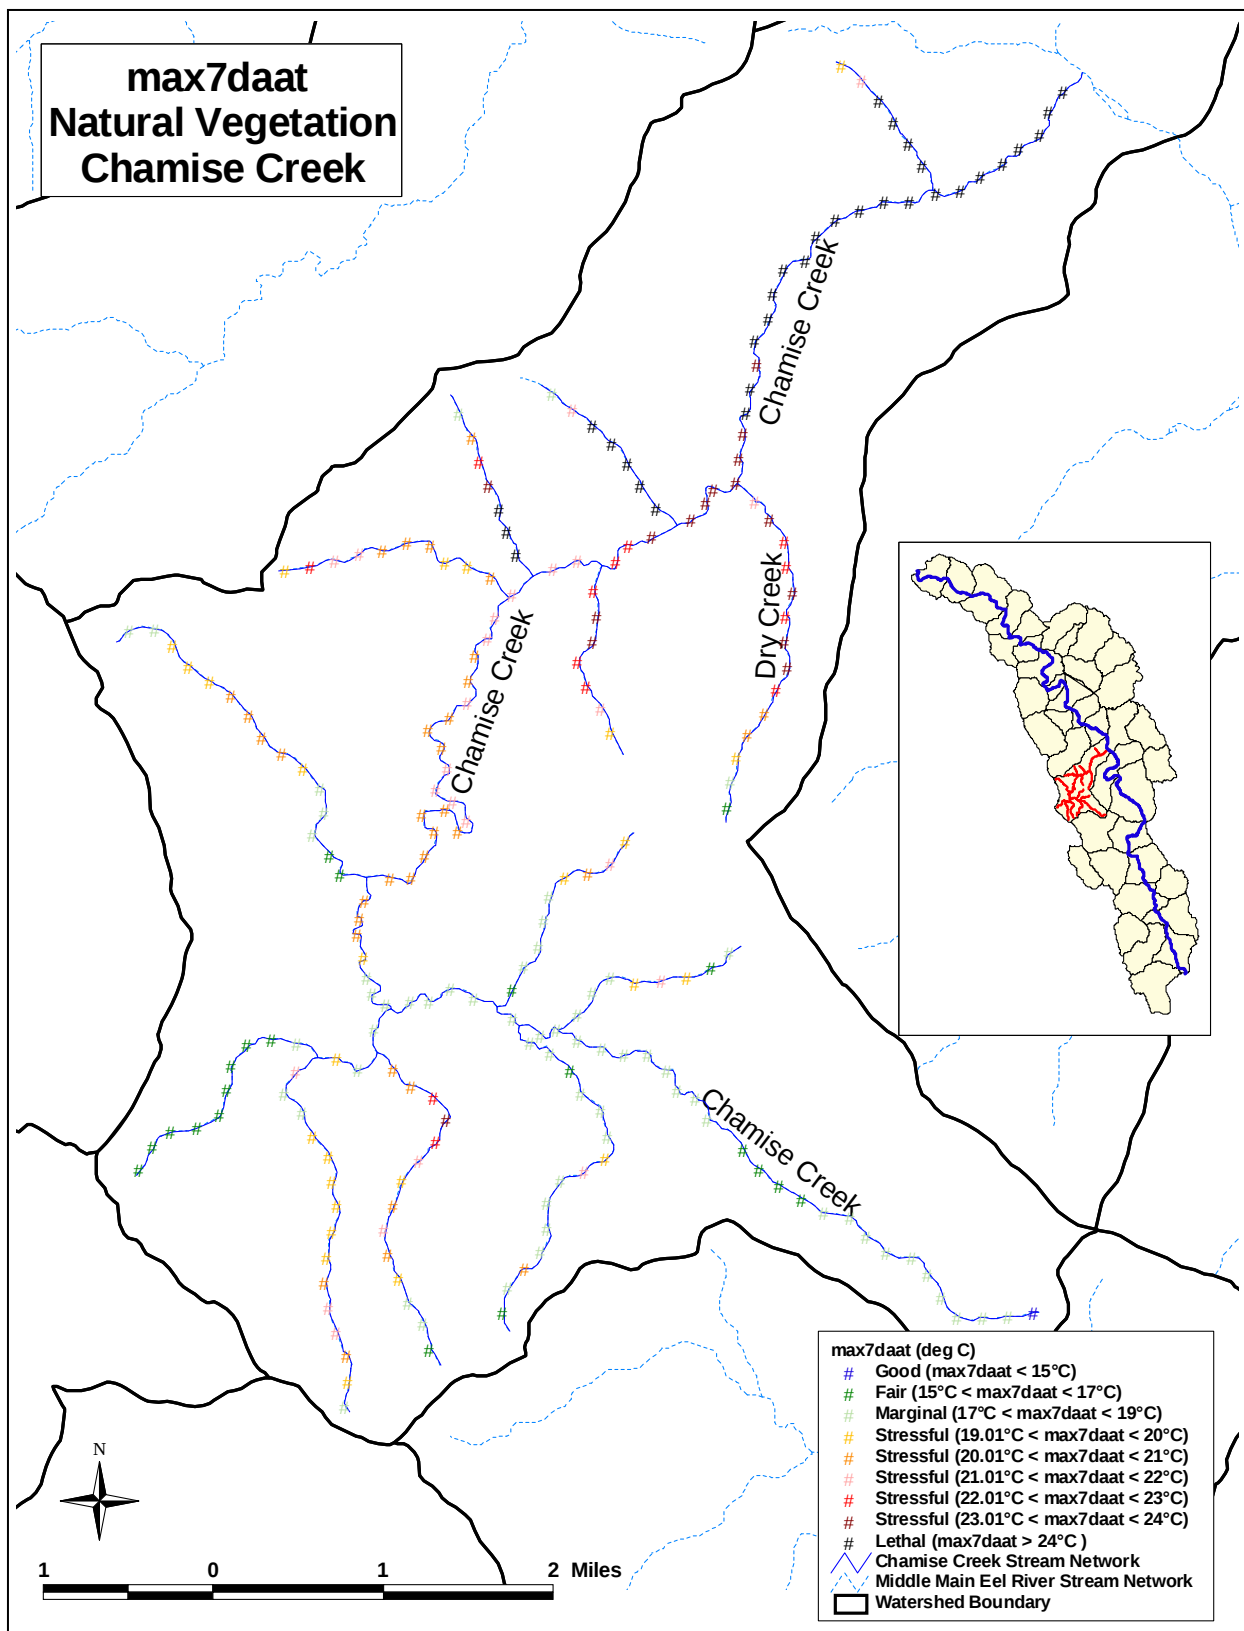
**Figure 9.** Natural stream temperatures in Chamise Creek

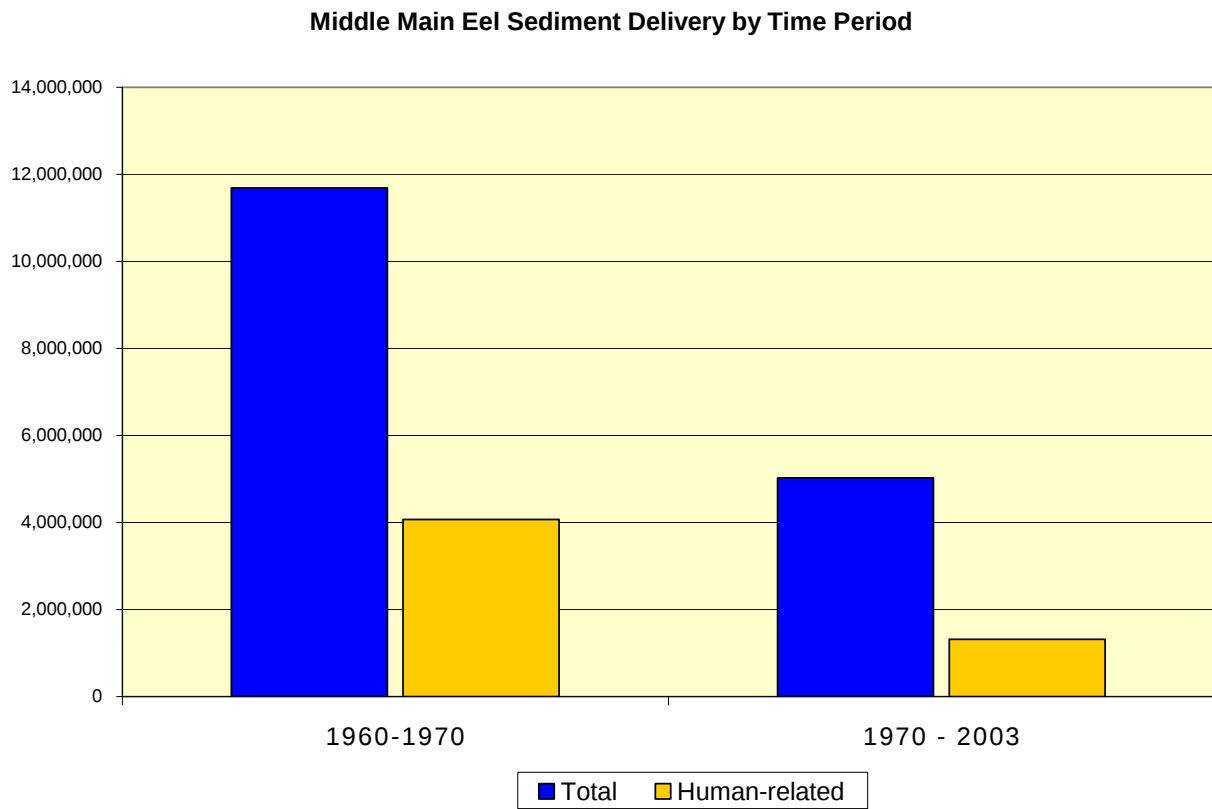
**Figure 10.** Percent sediment delivery by management association and time period
