MINING Environmental MANAGEMENT

PCBs, mining and water pollution

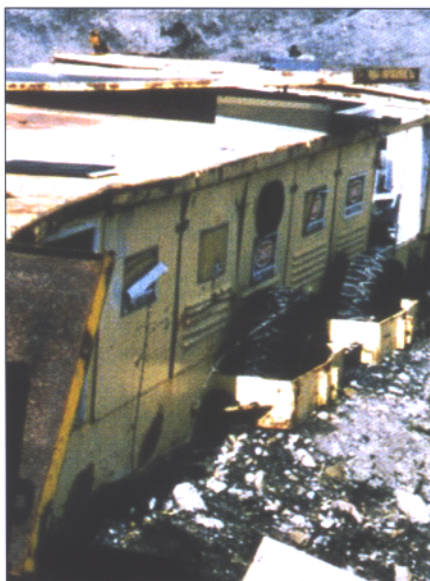
Mine Power Center Commonly Containing Capacitors

singly, or mounted on mine cars that can be transported throughout the working areas of the mine. Capacitors are generally found in locations similar to those of transformers. PCB-containing capacitors have been found in electric locomotives. In coal mines, capacitors are often in wheel or skid-mounted power centres. The regulations require these items be identified by PCB marks (or labels) if they contain 500 ppm (0.05%) or more PCBs and they are termed PCB transformers or capacitors.

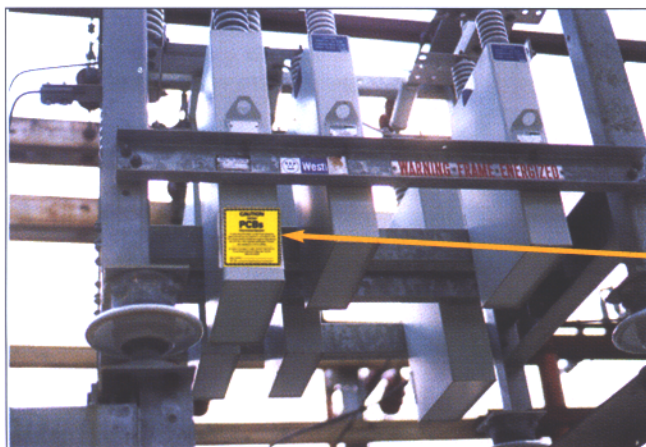
Looking up at PCB Marked Capacitor on the left (graphic below)
