PCBs, MINING, AND WATER POLLUTION

Dan W. Bench
Region 8 PCB Coordinator
U.S. Environmental Protection Agency
999 18th Street
Denver, Colorado 80202-2466

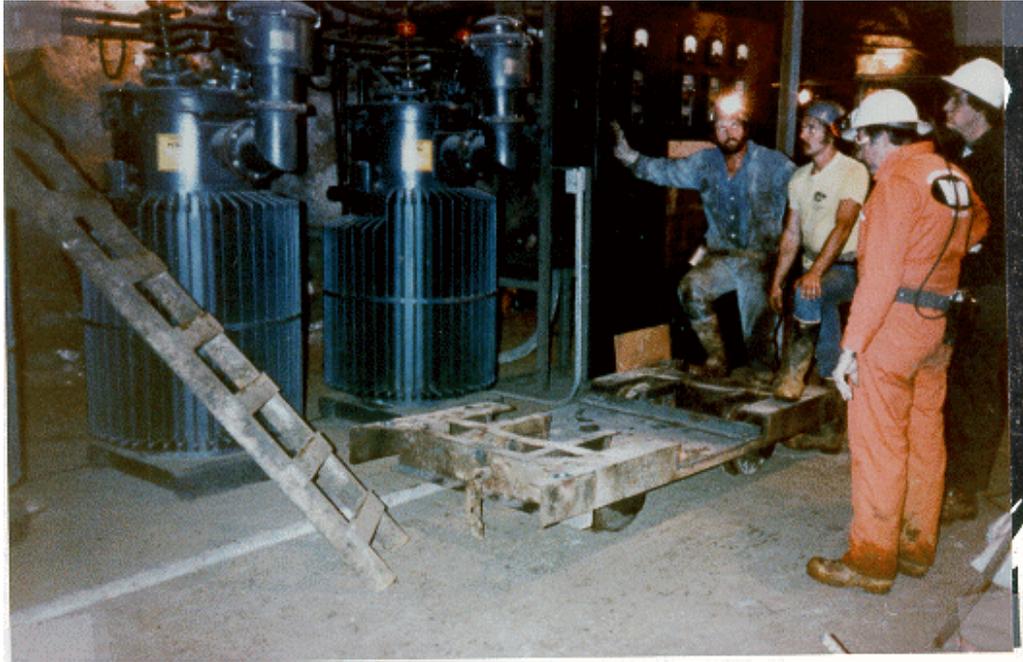
Figure 1.
76 Gallon PCB (Pyranol) Transformers (Cylindrical Objects with Cooling Fins and PCB Marks) on the 20 level of the Eagle Mine at Gilman, Colorado during an EPA removal due to abandonment and flooding.

Underground mines are emphasized here because abandoned PCB-containing equipment is likely to cause water pollution that can affect the environment and the health of downstream fish, and wildlife, and human populations. PCBs are most likely to be in transformers, as shown in Figure 1, drums of used transformer oils, capacitors, as shown in Figure 2, and fluorescent light ballasts. Transformers may be grouped in permanent substations, located singly, or mounted on mine cars that can be transported throughout the working areas of the mine. Capacitors are generally found in locations similar to those of transformers. PCB-containing capacitors have been found in electric locomotives. In coalmines, capacitors are often in wheel or skid-mounted power centers as shown in Figure 3. The PCB regulations require these items be identified by PCB marks (or labels) if they contain 500 ppm (0.05%) or more PCBs and they are termed PCB transformers or capacitors.

In 1984, Region 8 conducted an Immediate Removal Action, under the Comprehensive Environmental Response Compensation and Liability Act (CERCLA)²¹ (or the "Superfund" law) in which the author participated in the Eagle Mine at the town of Gilman, a few miles from Vail, Colorado. CERCLA regulates cleanup of uncontrolled or abandoned hazardous-waste sites. The mine consisted of a 400 ft vertical shaft from the surface to the 16 level, the main haulage level. From the 16 level there are two inclines, the 1620 and the 1623, both servicing the 20 level. Levels were 100 ft vertically apart. Below the 20 level, the mine was flooded to the bottom at the 28 level. The mine consisted of about 100 miles of drifts²², most of which were inaccessible due to flooding, bad air, and an active fire encompassing the 1623 incline. The entire mill with PCB-containing electrical equipment was underground, so that only concentrates destined for a smelter and tailings left the mine. The owner had been advised in writing by EPA to remove the PCB-containing electrical equipment from areas of the mine in danger of flooding before funds became insufficient to maintain the pump station at the 20 level. No action had been taken when the electrical service was discontinued. EPA assumed the electrical bills and removed three 76-gallon Pyranol (PCB) transformers and 27 large Pyranol capacitors during a three-day operation. Three previously drained 76-gallon Pyranol transformers were left at the 1623 incline substation because of the hazards and cost of removal from an active fire area. Whether or not PCB-containing electrical equipment

remains in the accessible portions of the mine and below the 20 level is unknown. This lack of information is typical of abandoned or flooded portions of mines. Although this operation may appear hazardous, the risks were known and controlled, and MSHA inspectors were present throughout the entire removal. If there had not been an EPA mine inspection program, the PCB transformers and capacitors would have been undetected, and today would be under more than 700 ft of water that drains into the Eagle River.

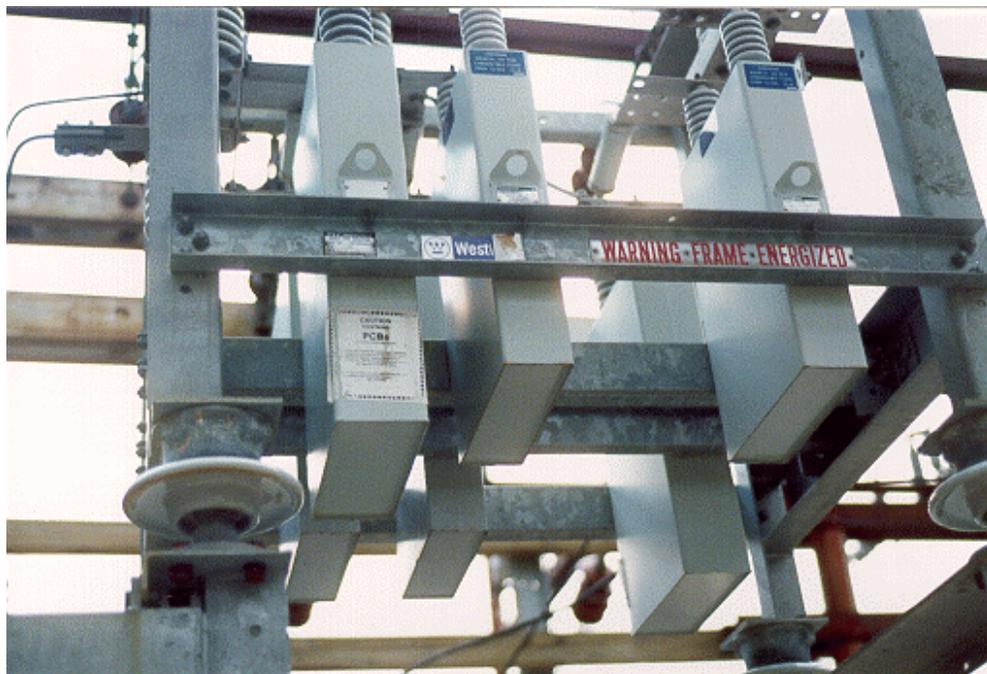
Figure 2.
Looking up at PCB Marked Capacitor on the left

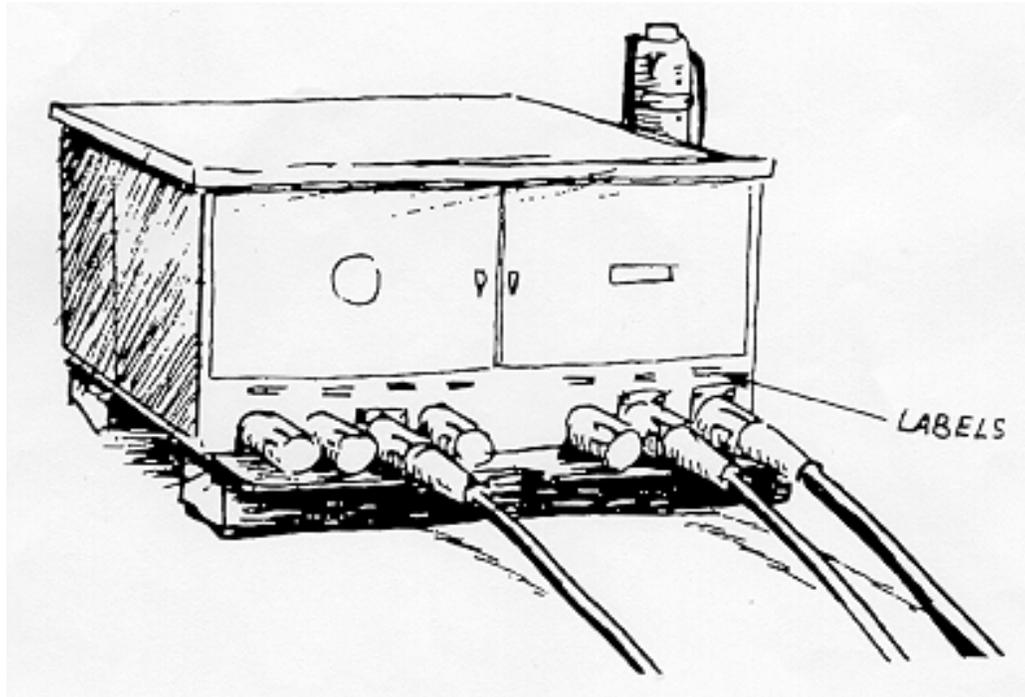
Figure 3.
Mine Power Center Commonly Containing Capacitors

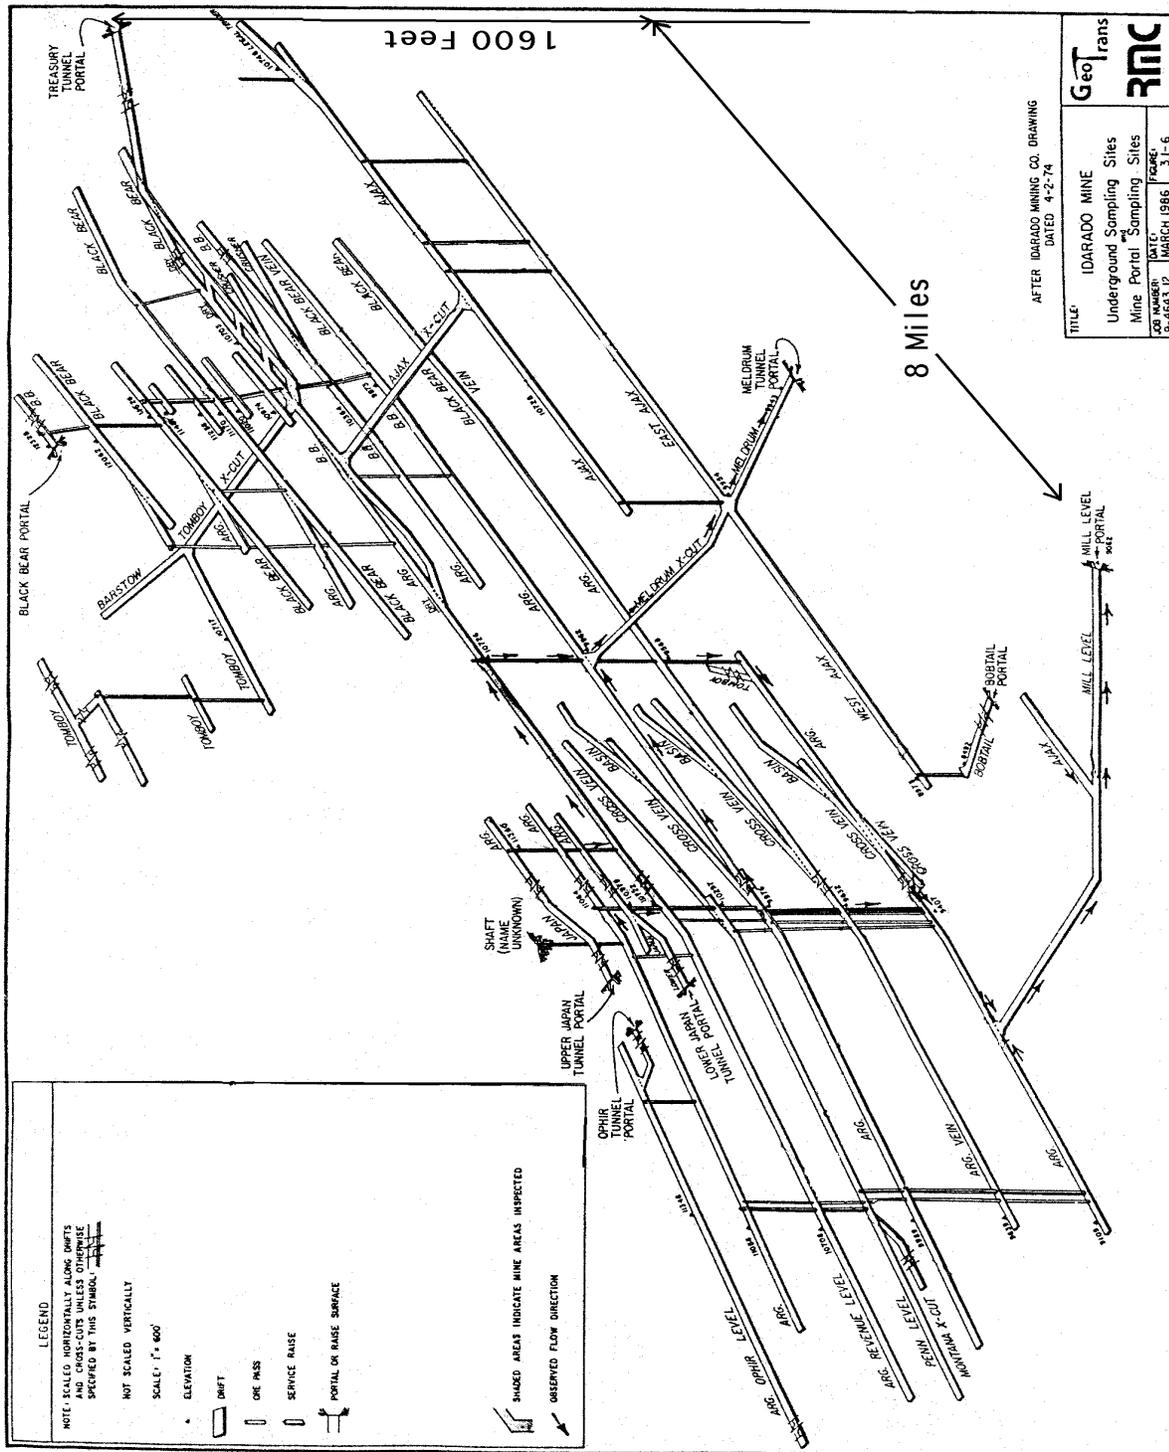
Figure 4.
Idarado Mine, Telluride, Colorado

[Note water drains from the upper levels to the Meldrum, Bobtail, and Mill Level Portals which contribute to the San Juan River. There are no shafts or winzes with bottoms for PCBs to sink to.] The distance "as the crow flies" between the Treasury Tunnel Portal, at the top of Red Mountain Pass on the Million Dollar Highway, in the upper right-hand corner, and the Mill Level Portal at Telluride, near the bottom center, is about eight miles. Only entries, major haulage drifts, and winzes appear on the map. The mining areas are not shown. This mine was confirmed to have PCB-containing electrical equipment underground during an EPA inspection in 1984.

Mines can be very extensive and complex. To illustrate this, Figure 4 is a map of the Idarado Mine
