## **Appendix D**

### **Construction Program Site Visit Reports**

### **Thomes Creek Bridge Project Site Visit Date: 10/13/2009**

**Caltrans MS4 (SWRCB Order No. 99-06-DWQ)**  
**Thomes Creek Bridge Project**  
**Caltrans District 2**

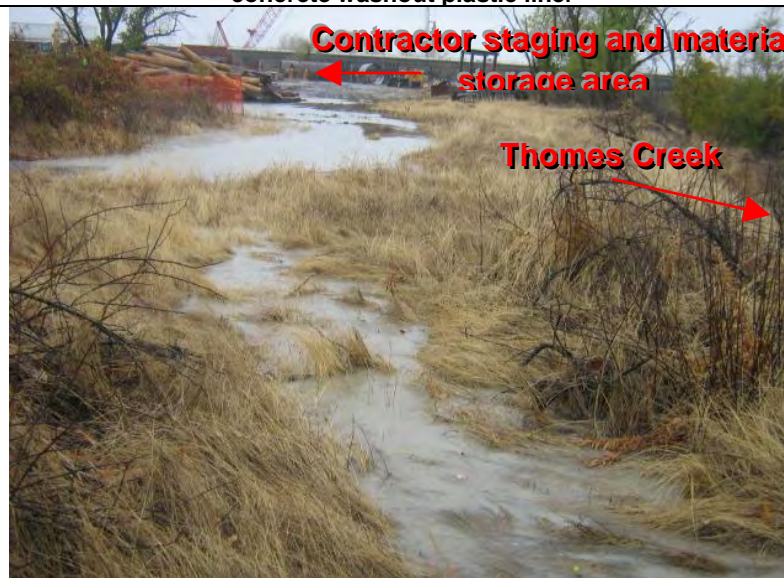
Prohibition A.1 of the Permit states the “discharge of runoff from construction sites containing pollutants which have not been reduced using BAT for toxic pollutants and BCT for conventional pollutants to waters of the United States is prohibited.” Adequate BMPs were not implemented for the contractor’s staging and material storage areas located up-gradient and adjacent to Thomes Creek. Specifically, adequate BMPs or perimeter controls had not been implemented for the areas of disturbance associated with the contractor staging and material storage areas. For example, a concrete washout was improperly implemented and lined with plastic that had been torn and badly deteriorated (see Photographs 1 and 2), and uncontained concrete waste was observed on the ground surface directly adjacent to the concrete washout (see Photograph 3). Jeff Blin (Caltrans District 2, Resident Engineer), explained that the concrete washout area had been present for a long period of time and was not identified in the project SWPPP. Moreover, a visible discharge of sediment and/or other pollutants was observed leading from the contractor staging and material storage areas to Thomes Creek (see Photographs 4 through 7).

Photograph 4 – Evidence of the discharge of pollutants from the contractor staging and material storage areas

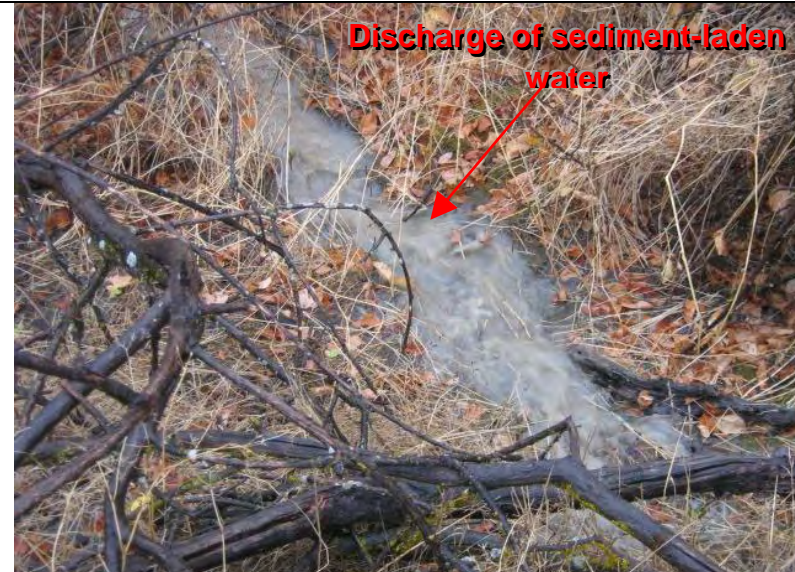
Photograph 6 – Close-up of Photograph 5 depicting the discharge of pollutants flowing to Thomes Creek

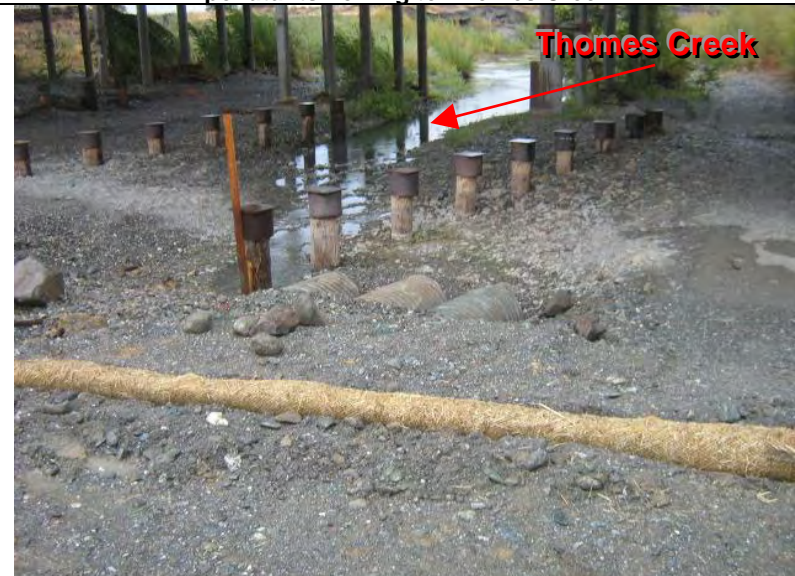
Additionally, adequate BMPs had not been implemented for areas of disturbance located directly adjacent to the flowing Thomes Creek. Although erosion log BMPs had been implemented, the erosion logs were not staked and a discharge of sediment was observed bypassing the BMPs and leading to Thomes Creek (see Photographs 8 and 9).

Photograph 8 – Erosion log BMPs were not adequately installed (e.g., not properly staked) adjacent to the flowing Thomes Creek

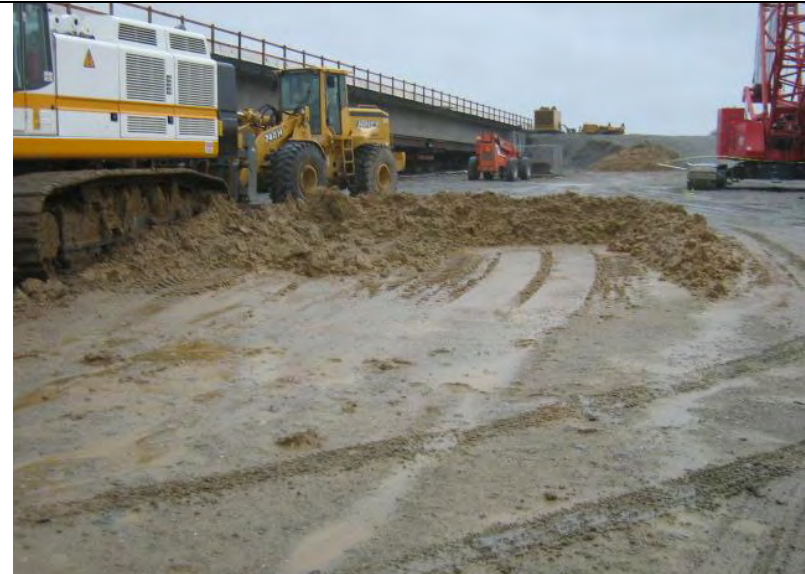
**Photograph 10 – Unconsolidated soils without BMPs**

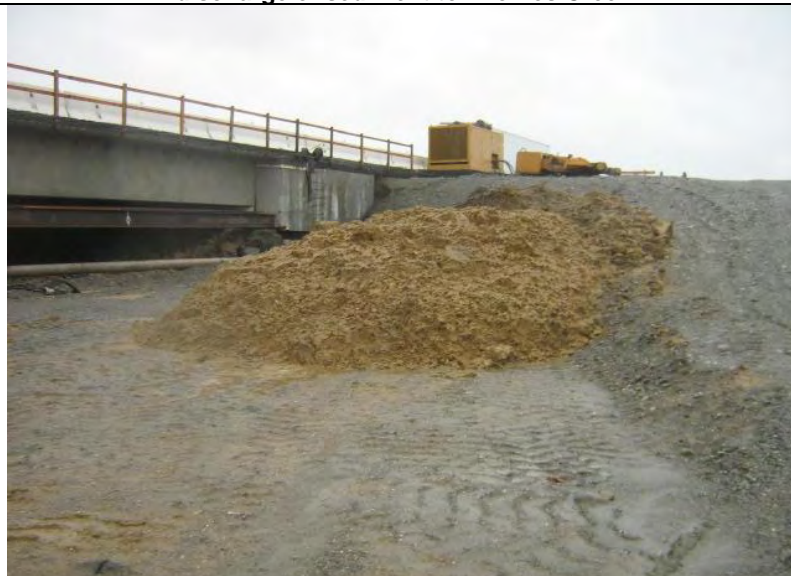
**Photograph 11— Soil stockpile without BMPs**

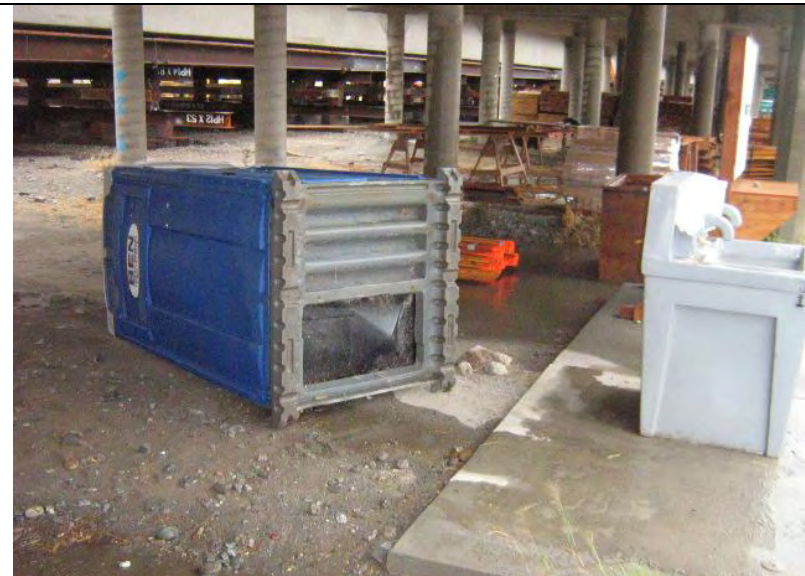
**Photograph 12 – View of portable toilet blown over under Thomes Creek bridge**

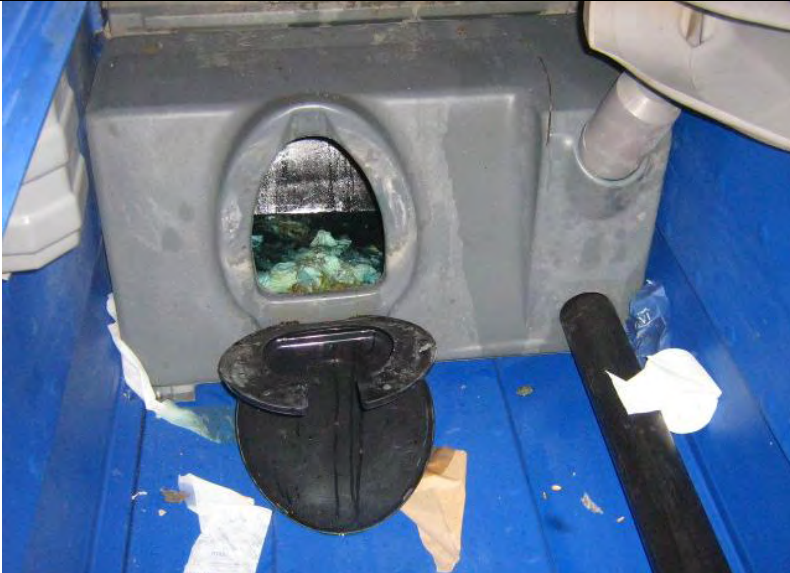
Photograph 13—View inside of overturned portable toilet with visible chemical and sanitary waste present

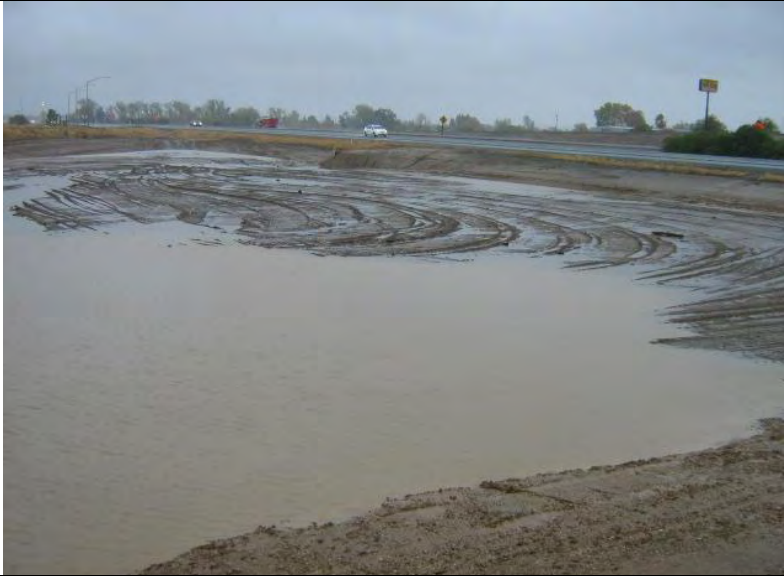
**Photograph 1 – View of unstabilized sediment basin and embankment slopes**

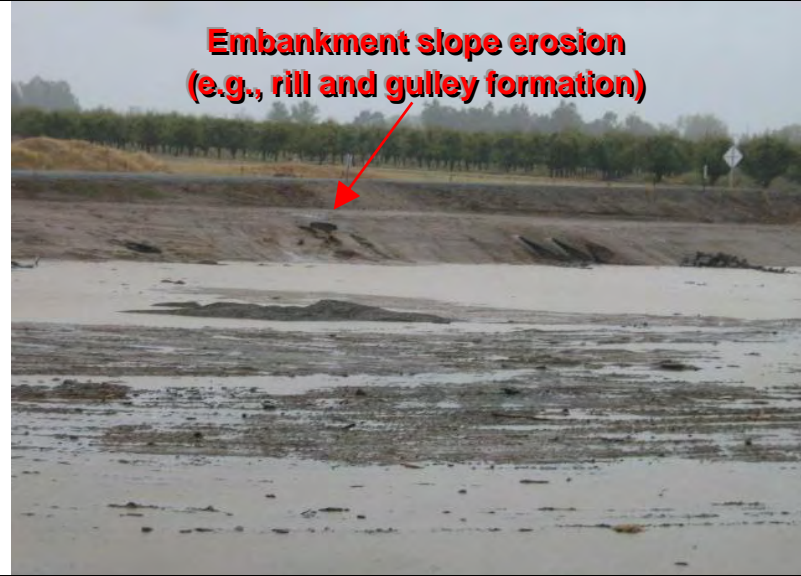
**Photograph 2 – Erosion of unstabilized sediment basin and associated embankment slopes**

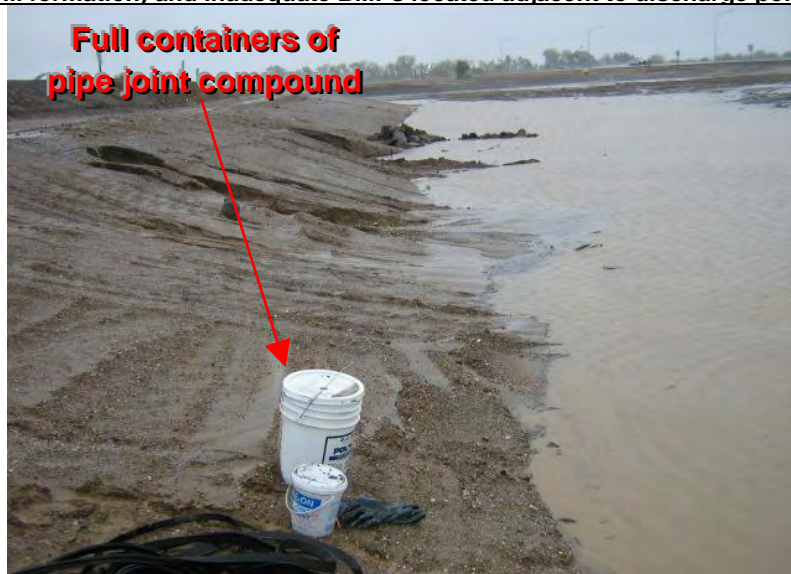
Adequate structural and non-structural BMPs also had not been implemented for material storage. Specifically, full containers of pipe joint compound were observed adjacent to the standing water in the eastern sediment basin (see Photographs 7 and 8). As a result, there was a potential for the contribution of pollutants to storm water runoff.

Photograph 7—Pipe joint compound located in the eastern sediment basin

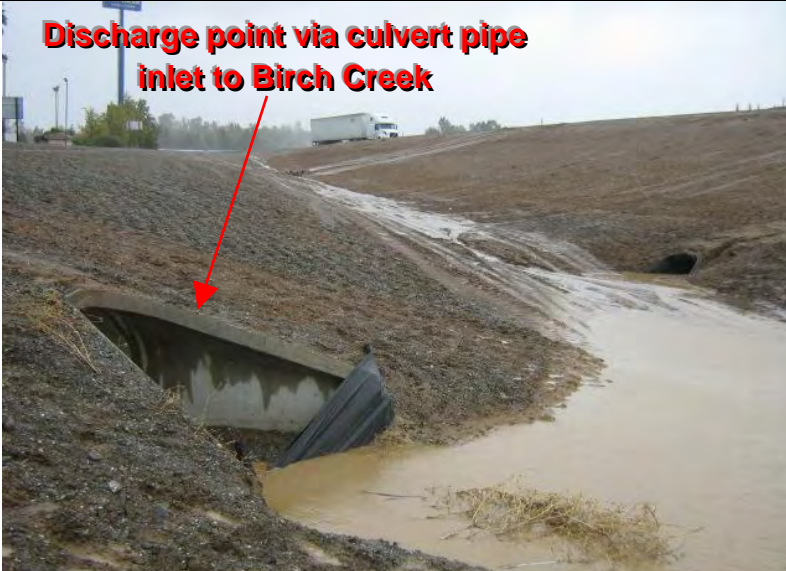
**Photograph 9—Discharge point, culvert inlet and drainage pipe leading to Birch Creek**

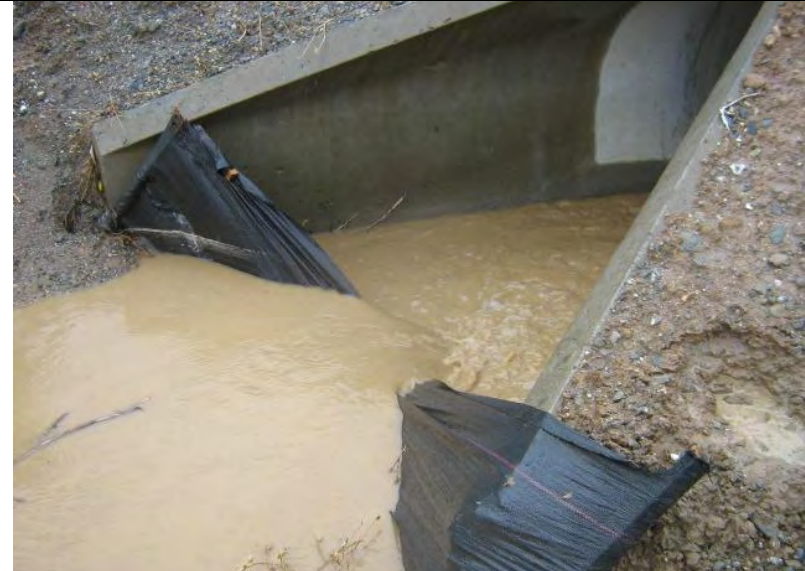
Additionally, inappropriate and inadequate BMPs had been implemented for the interconnected sediment basin discharge point, a culvert pipe inlet and drainage pipe leading to Birch Creek. Specifically, a silt fence BMP had been implemented in an area of concentrated flow at the culvert inlet, and had therefore collapsed (see Photographs 9 through 11). As a result, there was a discharge of sediment from the unstabilized up-gradient areas (e.g., sediment basins and disturbed slope areas) to the culvert pipe inlet and discharge pipe which ultimately flows to Birch Creek (see Photographs 12 through 14).

**Photograph 10 – Inappropriate BMP selection (e.g., silt fence implemented in area of concentrated flow) and discharge of sediment laden runoff**

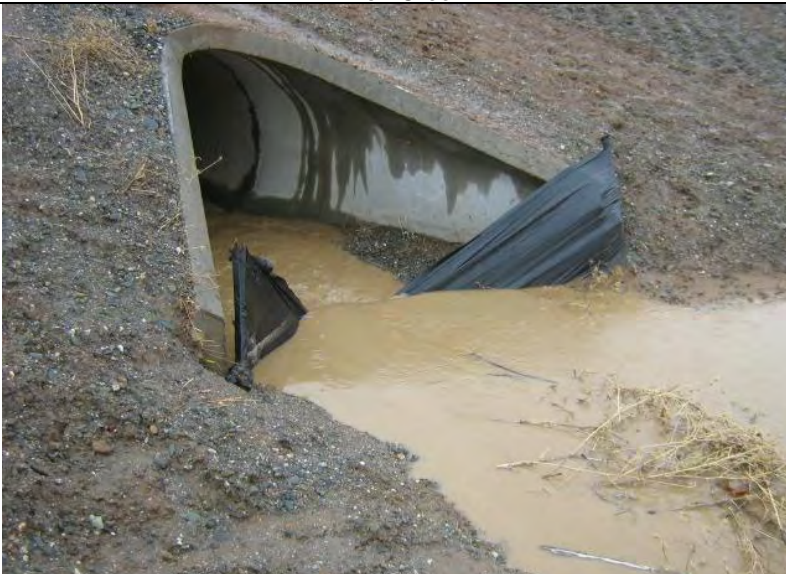
**Photograph 11— Collapsed silt fence BMP and discharge of sediment laden runoff**

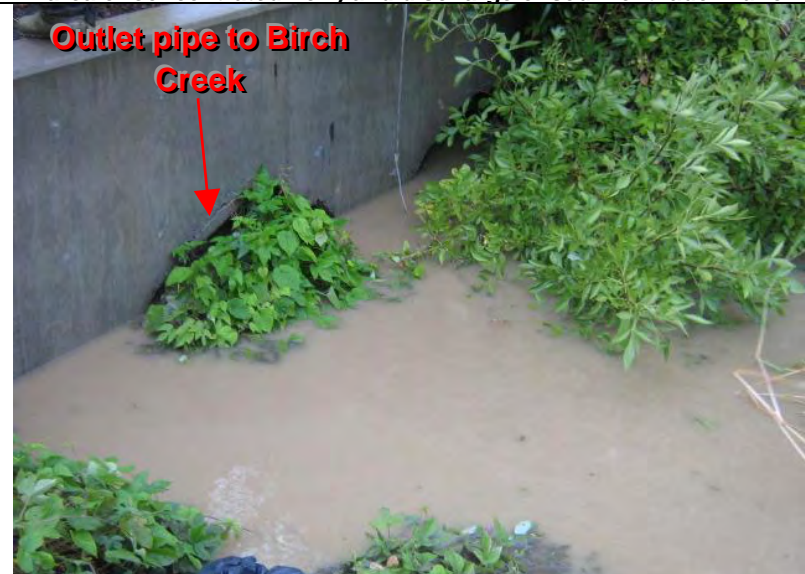
**Photograph 12 – View of outlet pipe from Photograph 11 leading to Birch Creek**

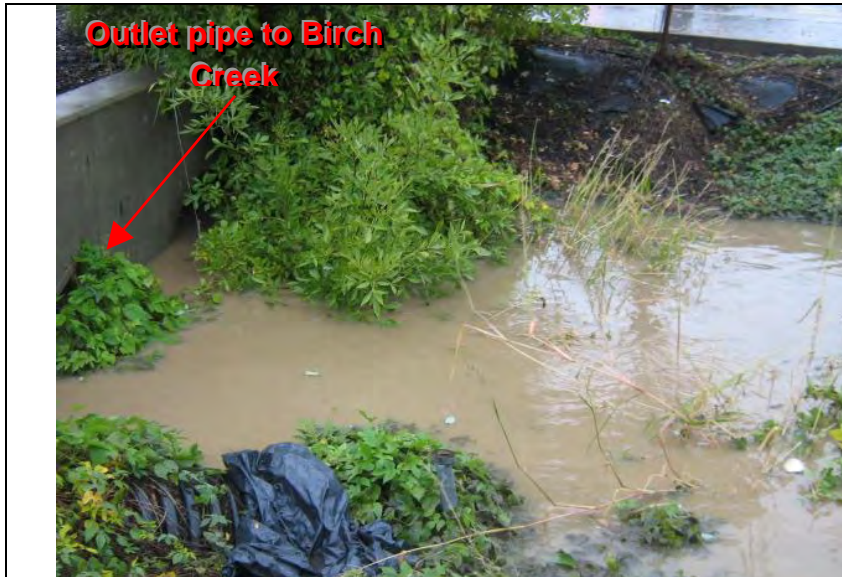
Photograph 13—Evidence of the discharge of sediment leading to Birch Creek

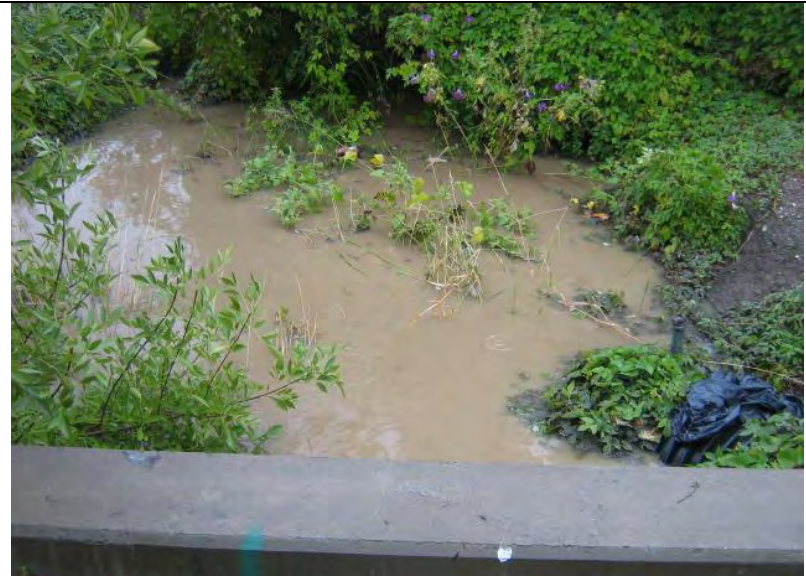
Photograph 14 – Evidence of the discharge of sediment leading to Birch Creek

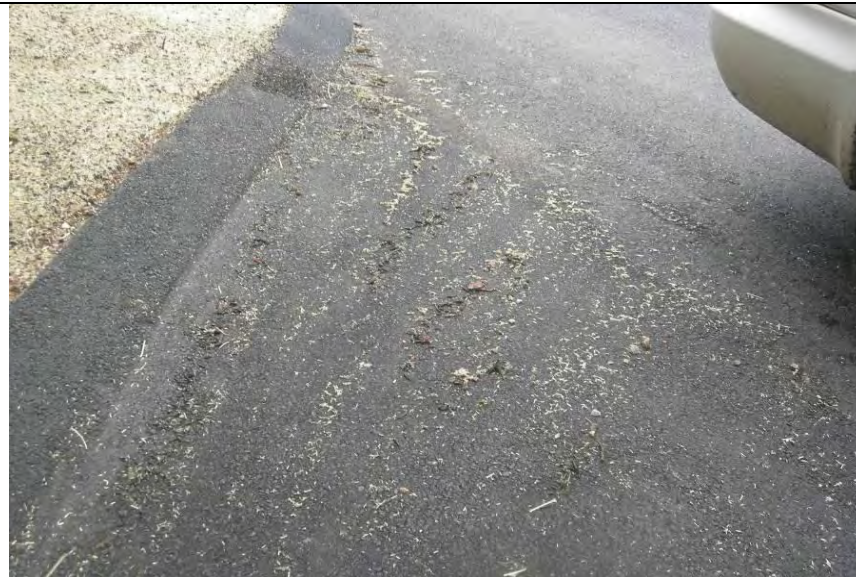
Specifically, BMPs were not adequately implemented and maintained along the perimeter of the disturbed area associated with the former construction site staging area. The Audit Team observed a visible flow path and erosion causing sediment and debris accumulation to surpass the straw wattles utilized along the southern perimeter of the former staging area (see Photograph 1). Erosion had caused the discharge of sediment and debris from several portions of the roadway drainage area adjacent to the sound wall into a storm drain inlet located along the west side of the highway shoulder (see Photographs 2, 3, and 4).

Photograph 2 – Run-off causing erosion along the highway shoulder

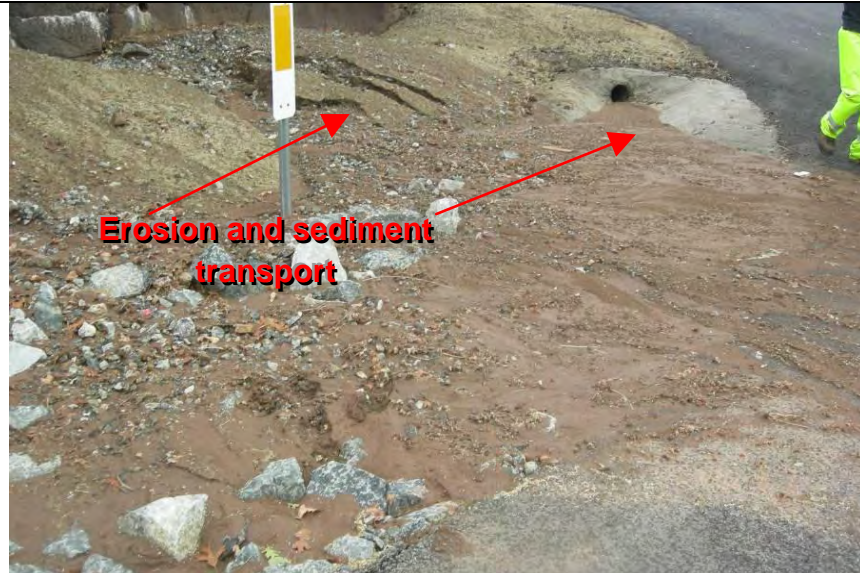
In addition, BMPs were not adequately implemented on the disturbed slope along the south side of the sound wall to prevent sediment discharge (see Photographs 5 and 6). Furthermore, sediment accumulation was observed along the flow path of a rock lined drainage swale leading to a down-gradient drainage pipe (see Photographs 7 and 8). The straw wattles utilized at the down-gradient drainage pipe inlet were not adequately maintained.

Photograph 5 – Lack of adequate BMPs to prevent discharge of sediment to the roadway

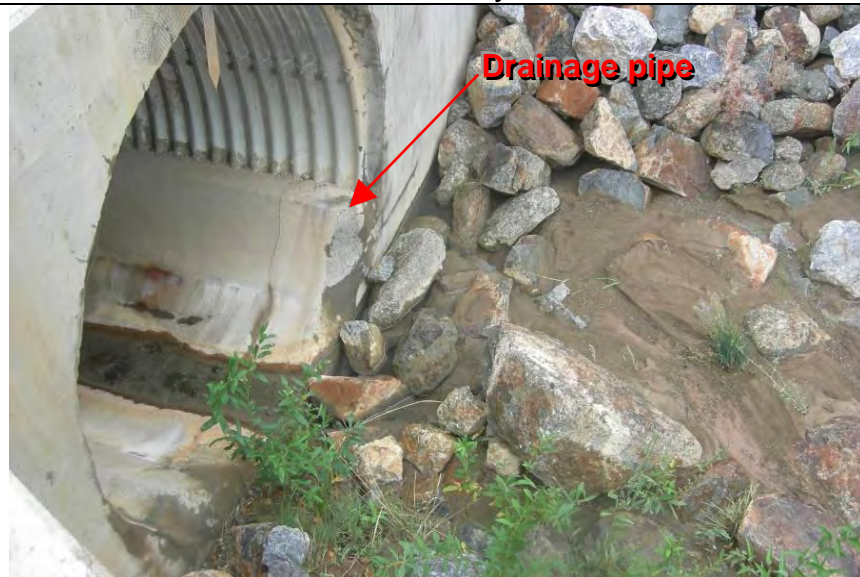
Photograph 7 – Sediment accumulation at down-gradient drainage pipe inlet

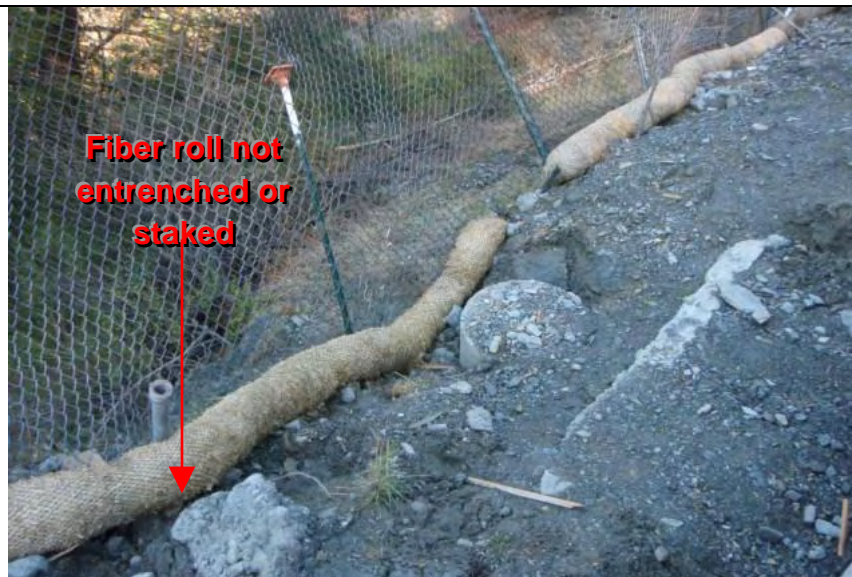
Photograph 3 – Example of fiber roll not entrenched or staked into the ground

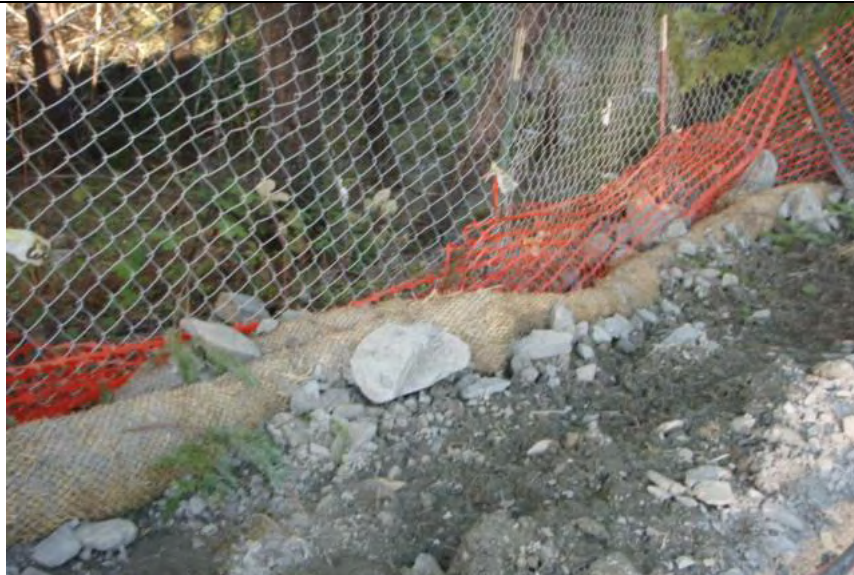
**Photograph 5— Example of sediment and debris accumulation against straw wattle BMP**

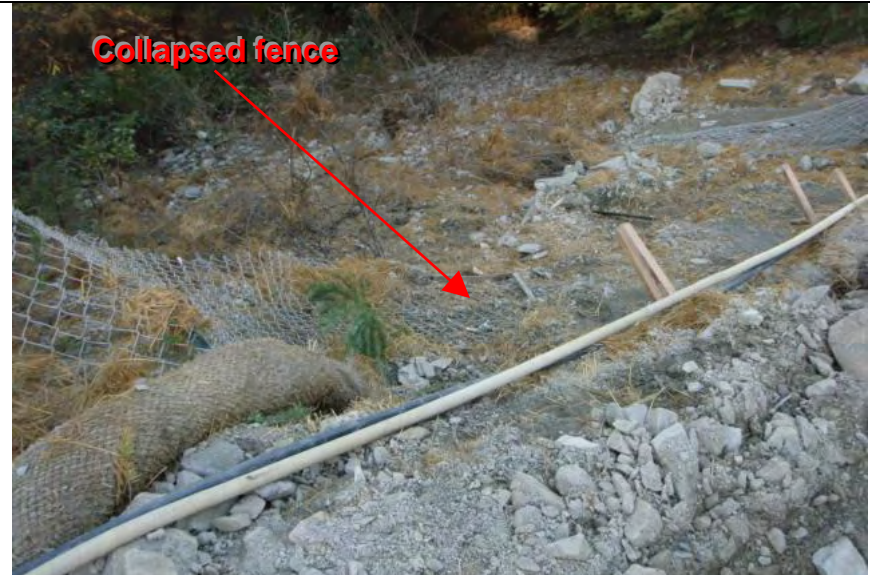
**Photograph 6 – Example of collapsed section of metal fence**

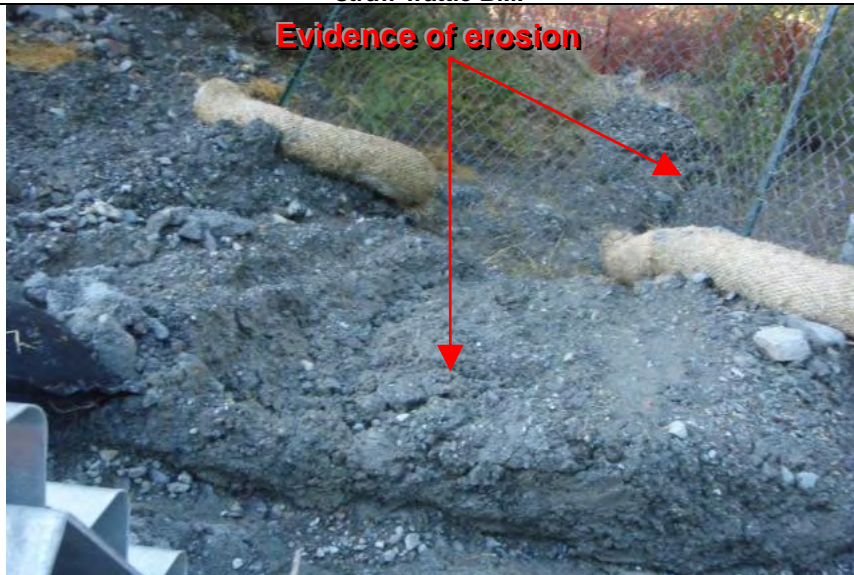
**Photograph 7— Undercut section of straw wattle BMP and evidence of erosion**

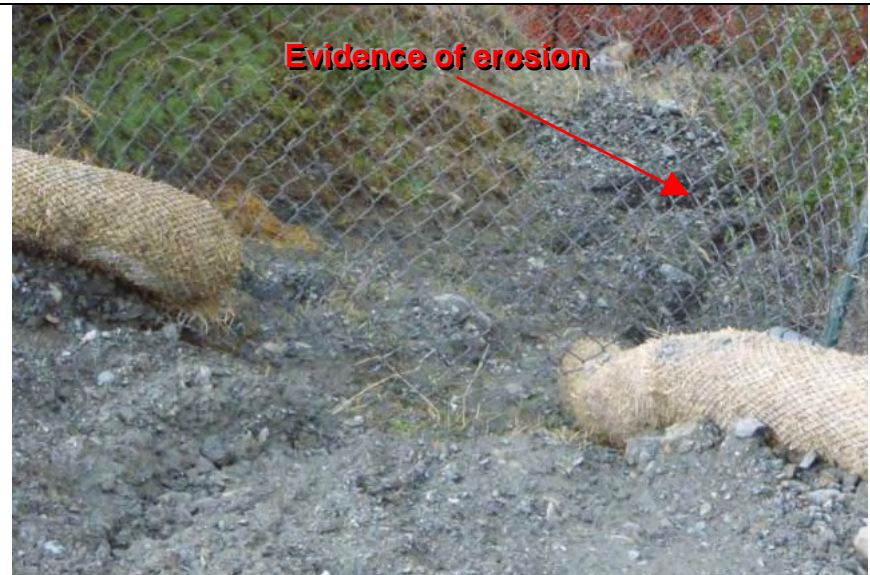
**Photograph 8 – Closer view of straw wattle and erosion pictured in Photograph 7**

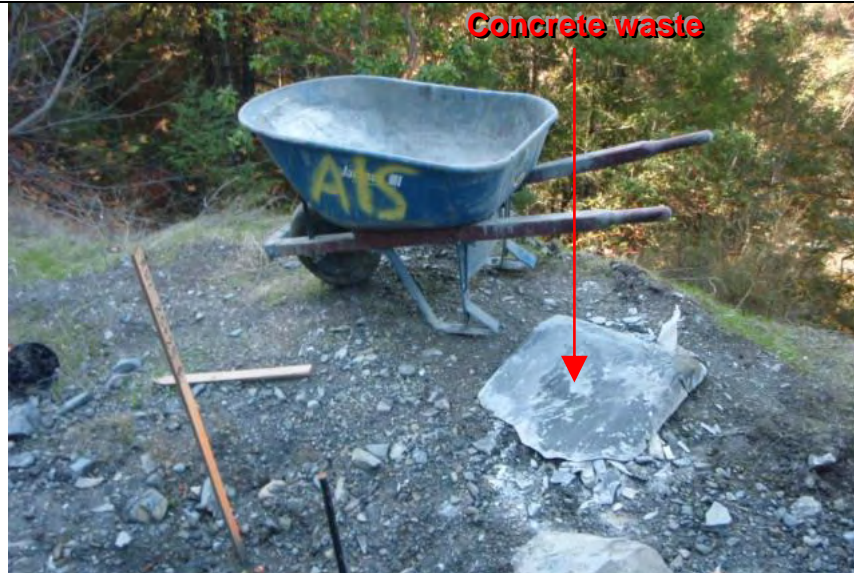
Adequate BMPs were not implemented at the construction site for good housekeeping to properly manage the disposal of concrete waste. Specifically, concrete waste was observed on the ground surface near the edge of a steep slope toward the western end of the project (see Photograph 9) and adjacent to what appeared to be a dedicated concrete waste container in the staging area near the eastern end of the project (see Photographs 10 and 11). In addition, a material stockpile was observed in the staging area that did not have BMPs for coverage or containment (see Photograph 12). Furthermore, the straw wattle BMPs implemented in the staging area were not staked or entrenched into the ground to retain pollutants and prevent failure (see Photographs 10, 11 and 12). The Resident Engineer explained that he had approved the use of straw wattle BMPs at the site that were not staked or entrenched into the ground; however, the SWPPP had not yet been amended to include this alternative installation method for straw wattle BMPs.

Photograph 9— Concrete waste on ground surface adjacent to steep slope

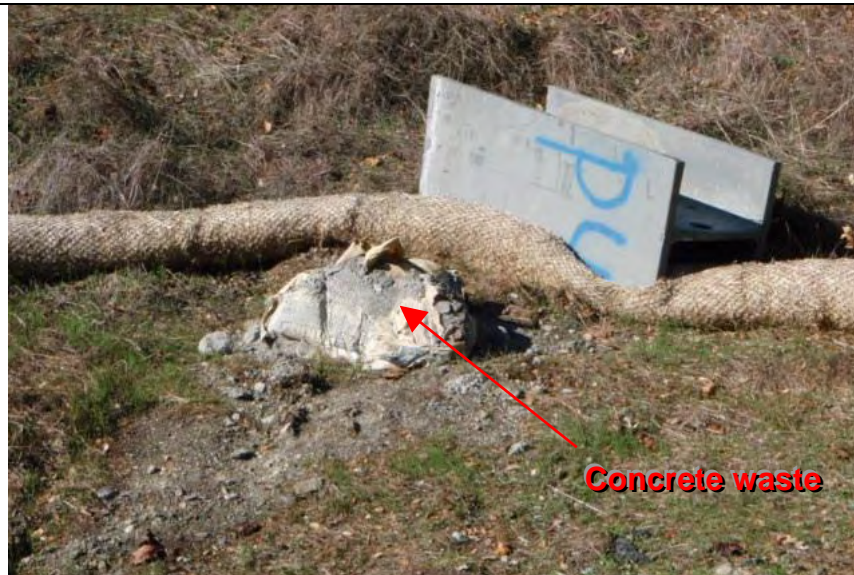
Photograph 11— Concrete waste near concrete waste container in staging area (Note: Straw wattle BMP not staked or entrenched into ground)

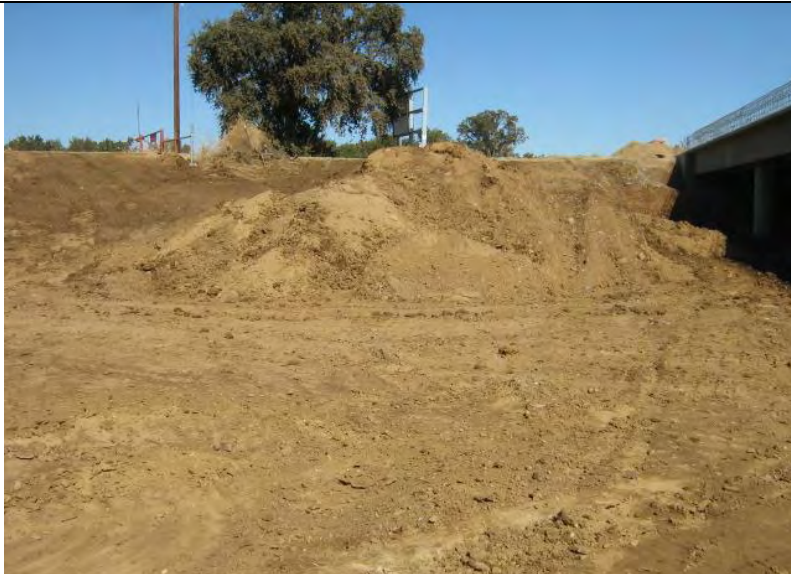
**Photograph 5 – Soil stockpile with no perimeter controls or temporary stabilization located just upgradient of Bear River crossing.**

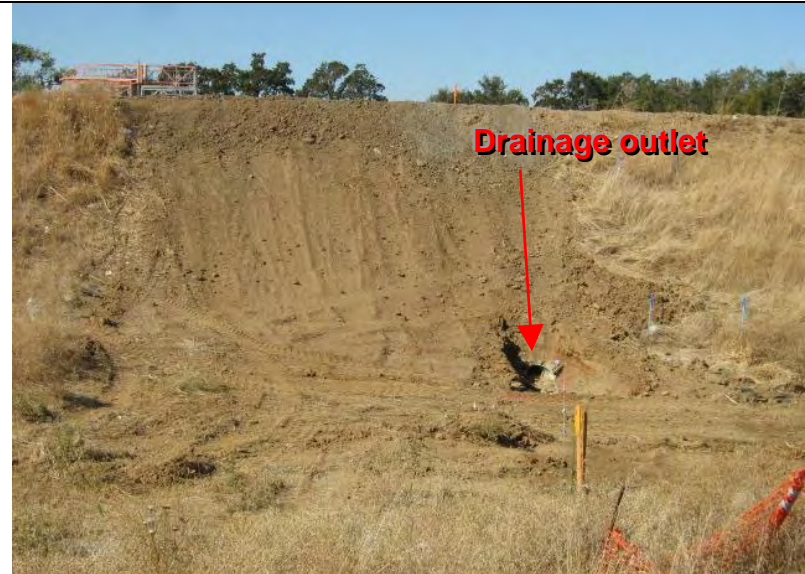
**Photograph 6 – Drainage outlet below unstabilized embankment slope adjacent to the highway.**

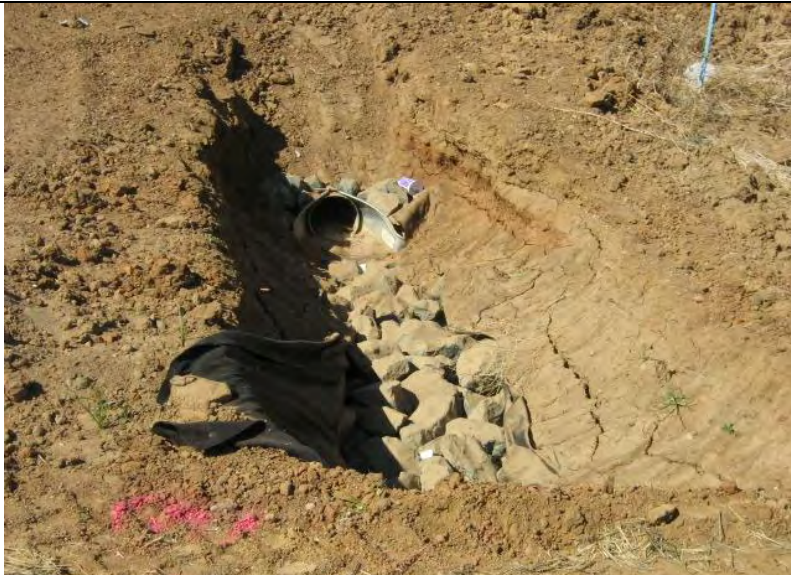
**Photograph 7 – Drainage outlet at base of unstabilized slope shown in Photograph 6.**

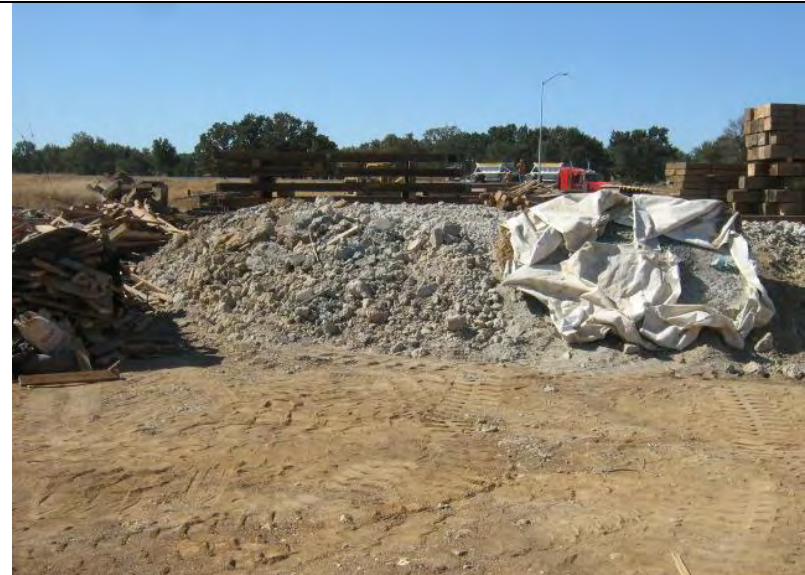
**Photograph 8 – Uncontrolled/uncontained concrete waste**

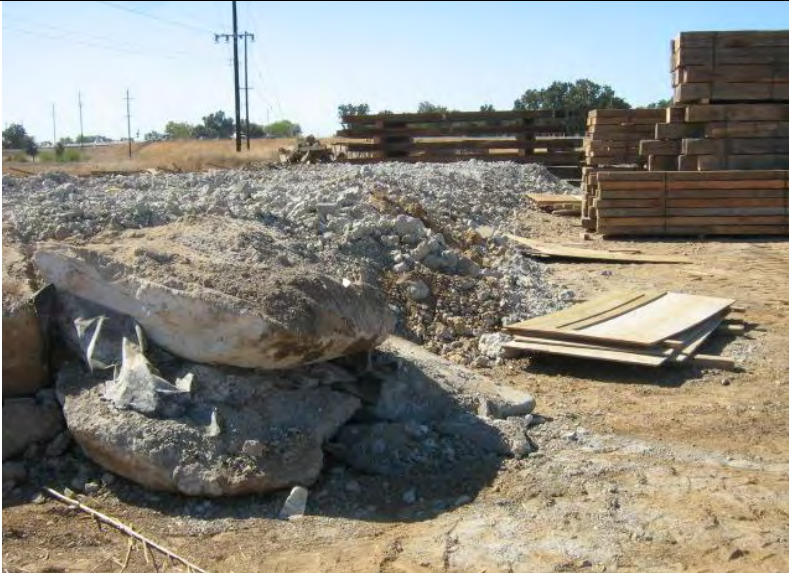
**Photograph 9 – Uncontrolled/uncontained concrete waste**

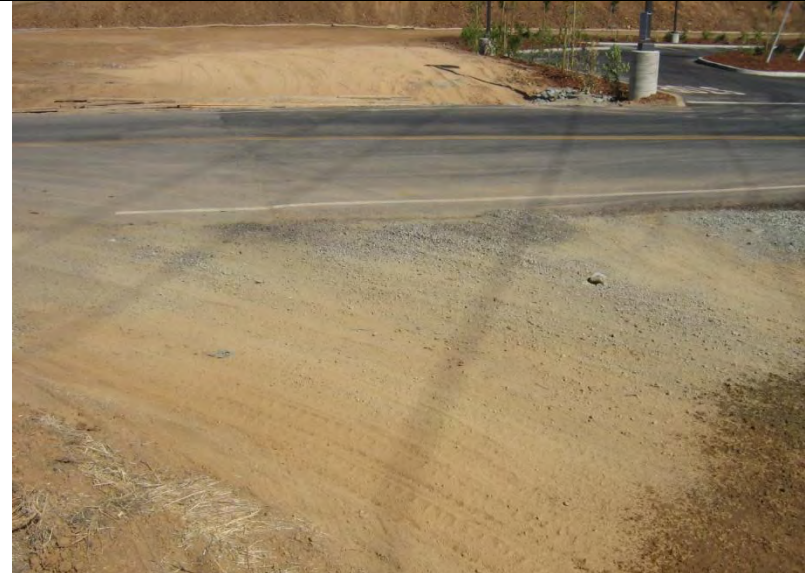
**Photograph 10 – Tracking control BMPs not adequately maintained (e.g., sediment in rock pad and rock sparse in areas)**

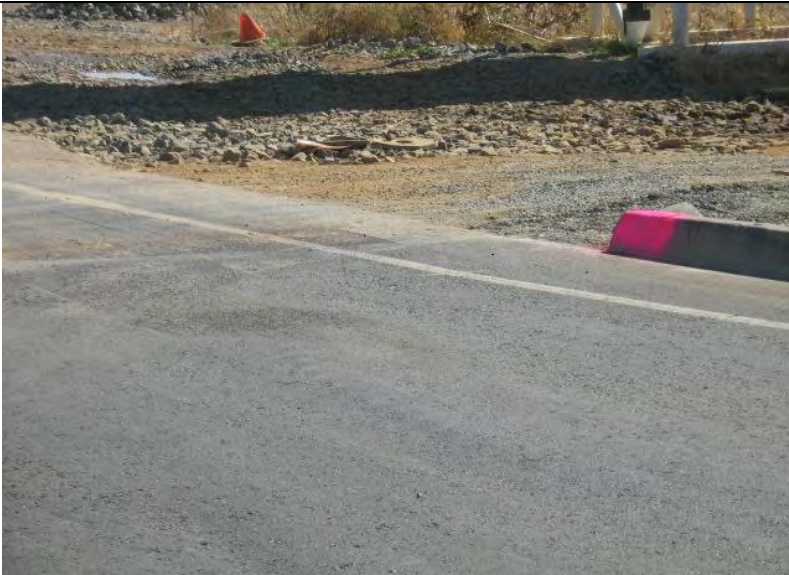
**Photograph 11 – Tracking control BMPs not adequately maintained (e.g., sediment in rock pad and rock sparse in areas)**

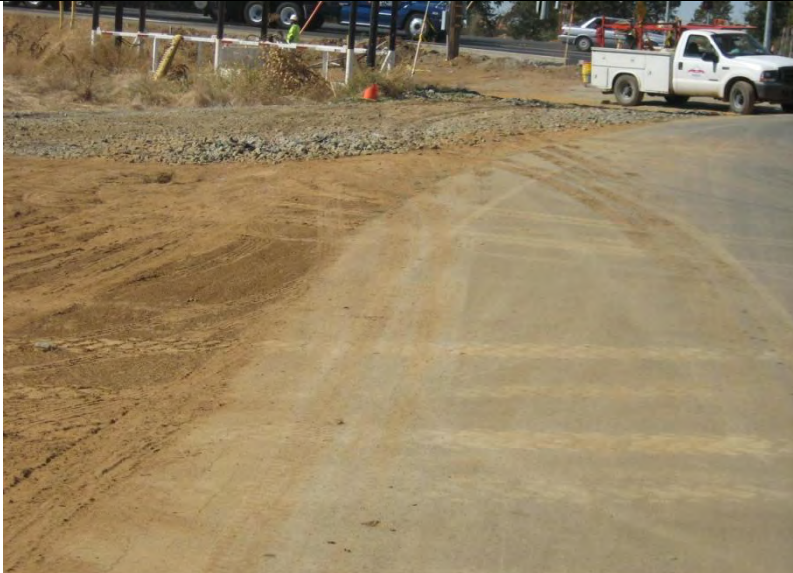
**Photograph 13 – Sediment transport from areas of disturbance onto Feather River Boulevard, a public roadway.**

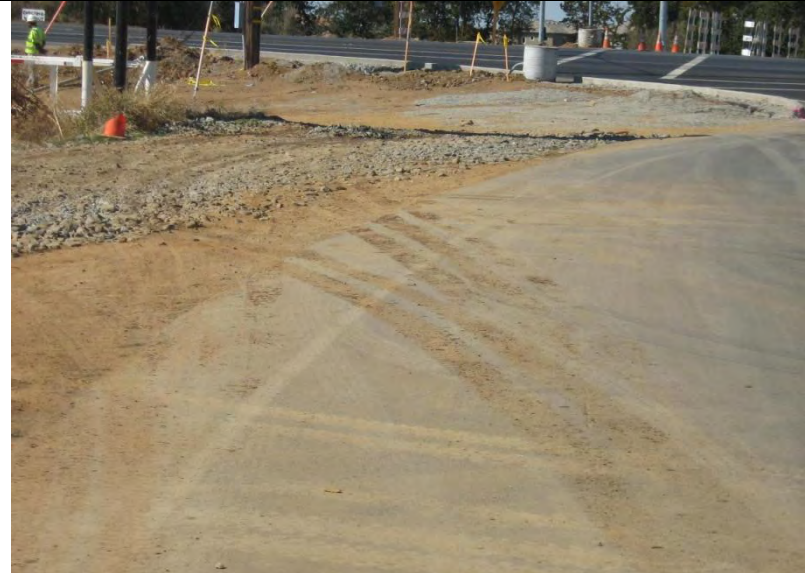
**Photograph 14 – Sediment transport from areas of disturbance onto Feather River Boulevard, a public roadway.**

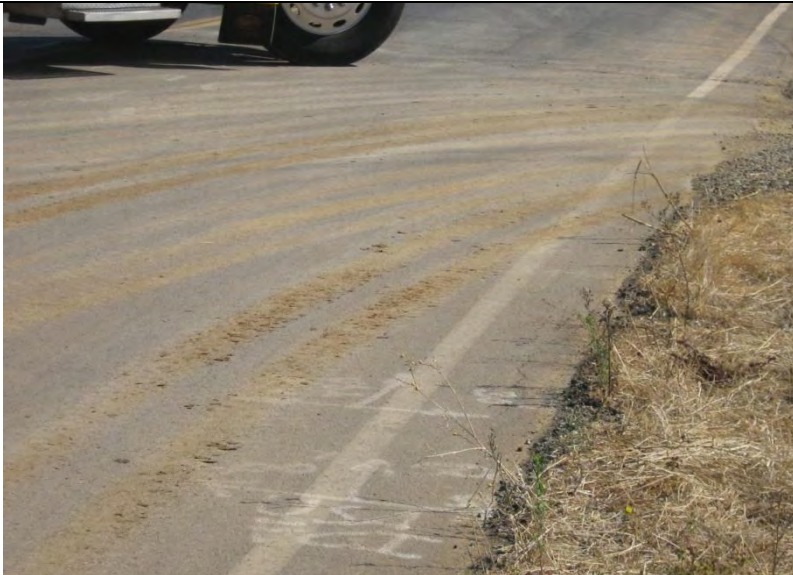
**Photograph 15 – Sediment transport from areas of disturbance onto Feather River Boulevard, a public roadway.**

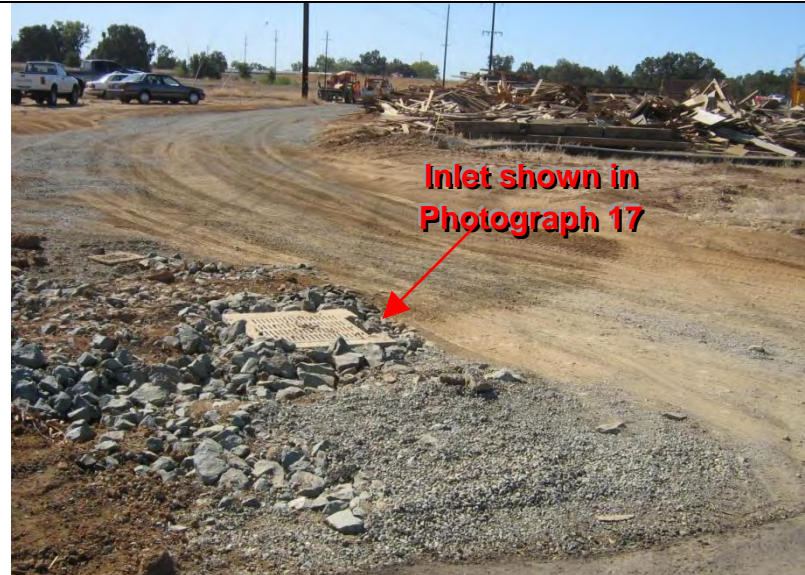
**Photographs 16 – Adequate inlet protection and vehicle tracking control BMPs had not been implemented adj. to entrance off Feather River Blvd.**

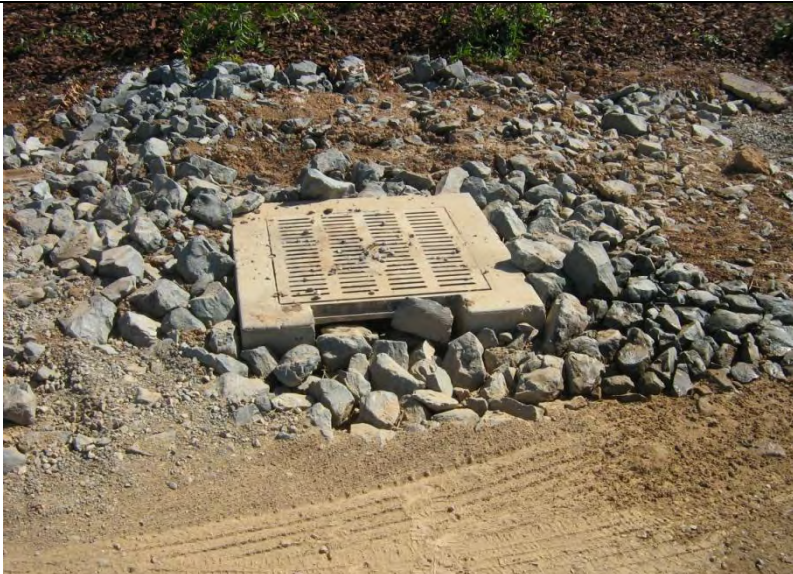
Photograph 17 – Close-up of Photograph 16. Adequate inlet protection had not been implemented.

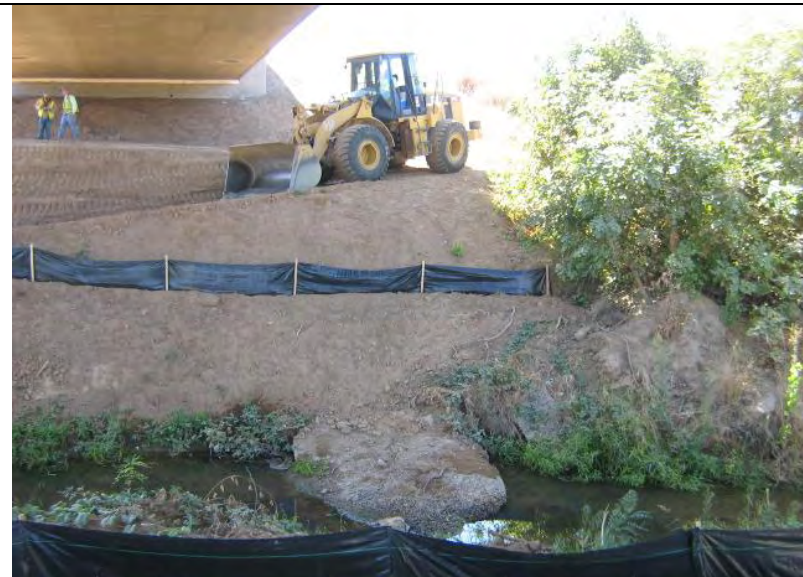
Adequate BMPs were not implemented to prevent the discharge of sediment from disturbed slope areas adjacent to Yankee Slough waterway. Specifically, BMPs had not been implemented for disturbed slope areas adjacent to Yankee Slough (see Photographs 19 and 20), and silt fence BMPs implemented at the toe of the disturbed slope adjacent to Yankee Slough had collapsed and were no longer effective at preventing the discharge of sediment to Yankee Slough (see Photographs 21 through 24). As a result, there was a potential for the discharge of sediment from the disturbed slope areas adjacent to Yankee Slough waterway.

Photograph 20 – Differing vantage point for Photograph 19

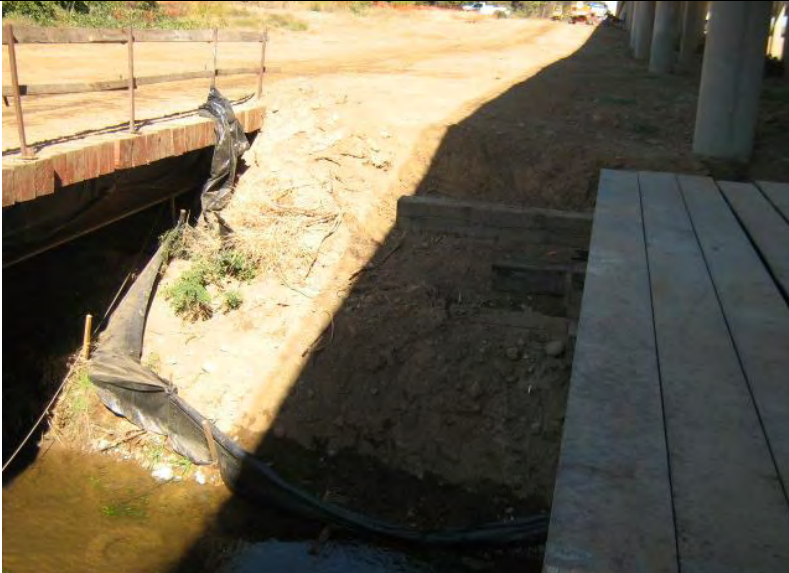
**Photograph 21 – Silt Fence BMP not properly maintained (e.g., collapsed) adjacent to Yankee Slough. Note area of disturbance up-gradient.**

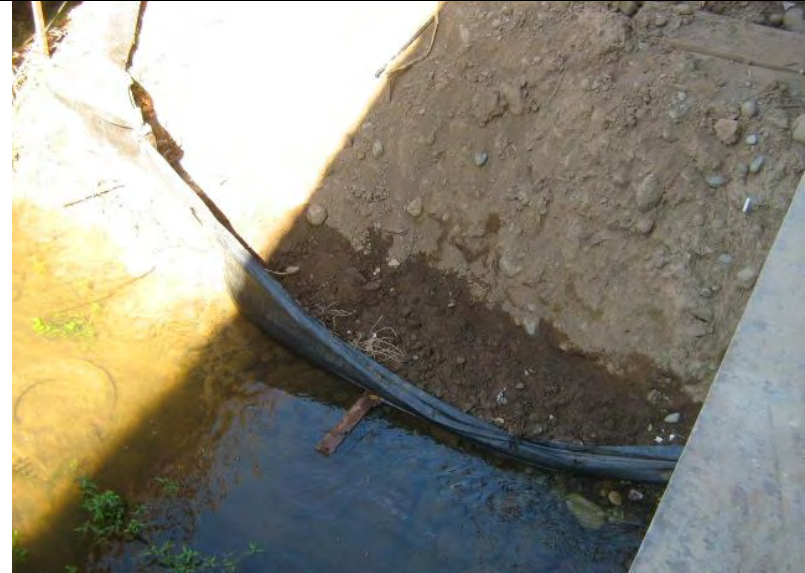
**Photograph 22 – Close-up view of Photograph 21.**

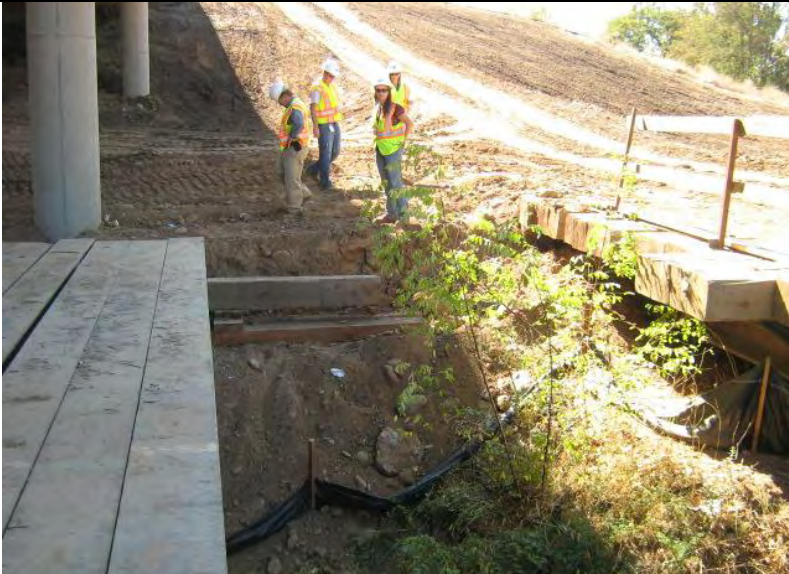
**Photograph 23 – Silt Fence collapsed in areas and not properly maintained. Note large unstabilized slope area upgradient.**

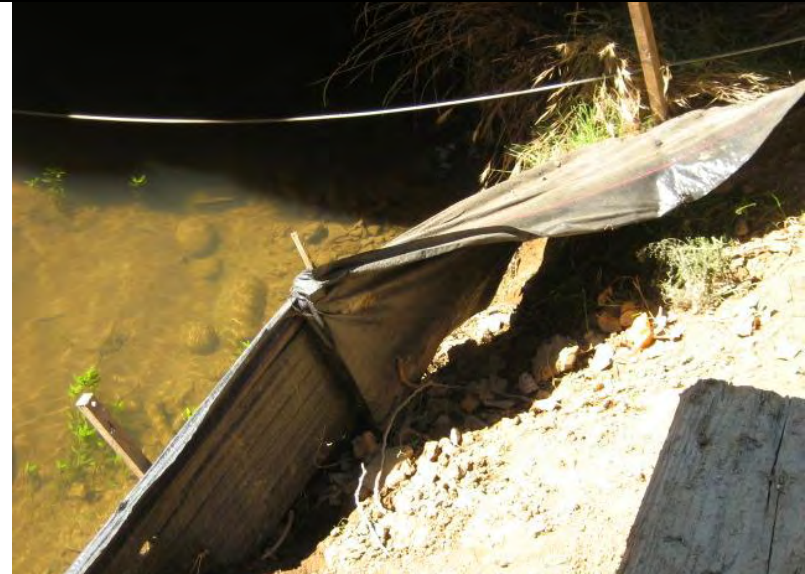
**Photograph 24 – Silt Fence not properly entrenched to retain sediment adjacent to Yankee Slough waterway**
