## **Appendix D**

### **Construction Program Site Visit Reports**

### **Thomes Creek Bridge Project Site Visit Date: 10/13/2009**

**Caltrans MS4 (SWRCB Order No. 99-06-DWQ)**  
**Thomes Creek Bridge Project**  
**Caltrans District 2**

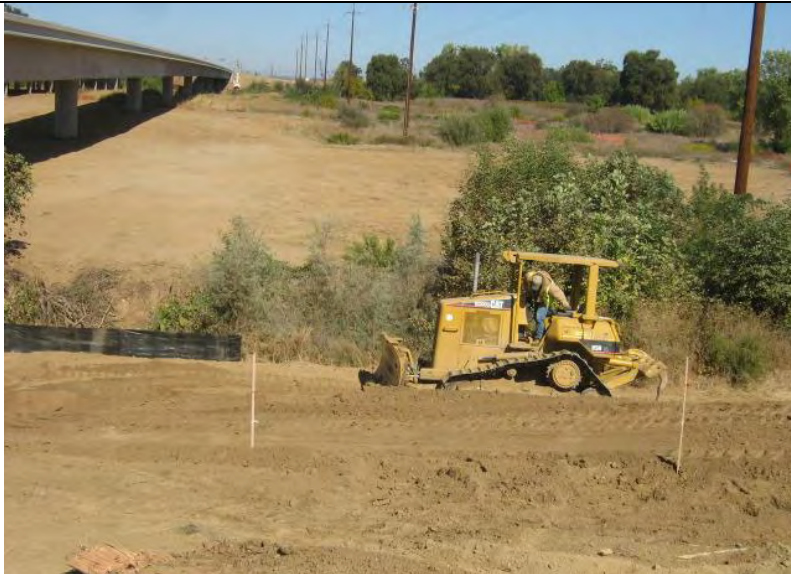
**Photograph 25 – SF not adequately implemented for all land disturbing activities to prevent the discharge of sediment to Yankee Slough**

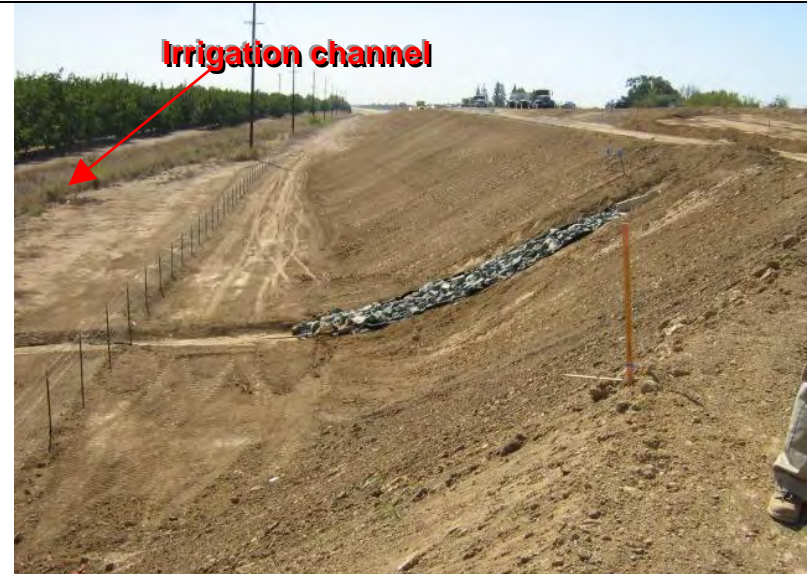
**Photograph 26 – Large expanse of disturbed slope area with only rock and no perimeter BMPs.**

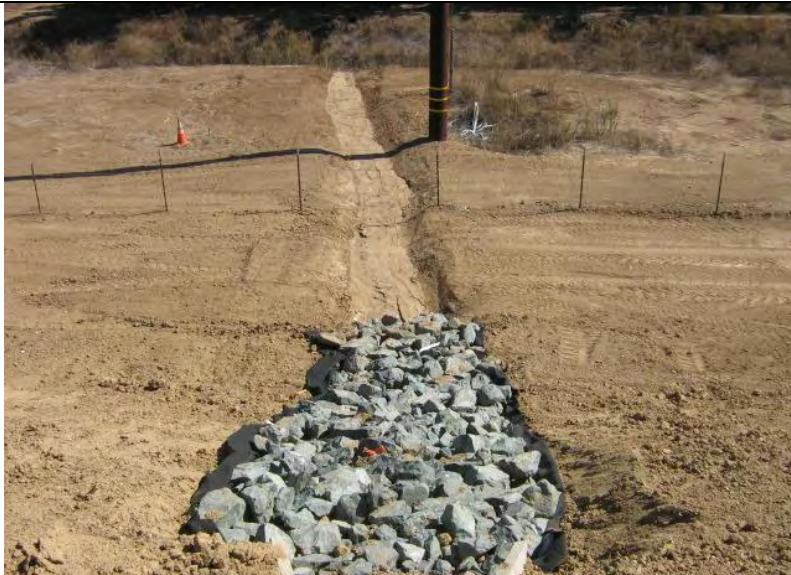
**Photograph 27 – Slope drainage channel which drains to irrigation channel**

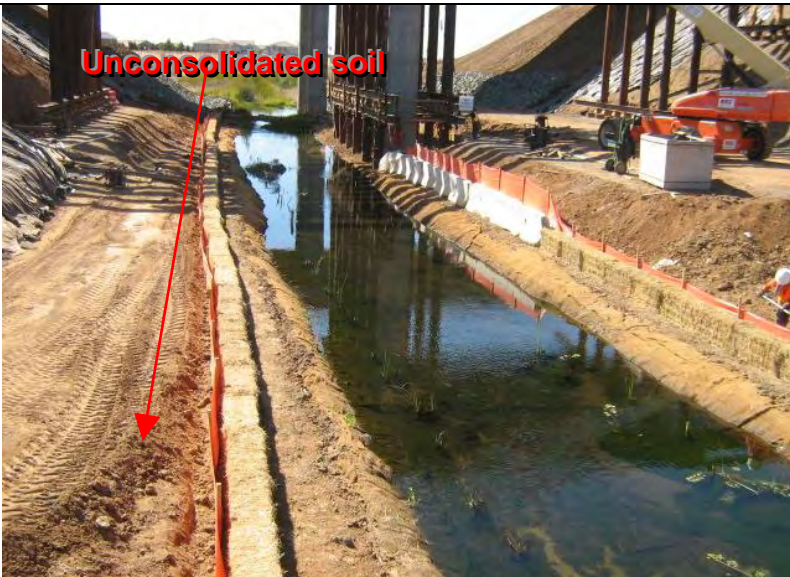
Photograph 3 – Unconsolidated soil placed between the toe of the slope and the perimeter control BMPs along the waterway

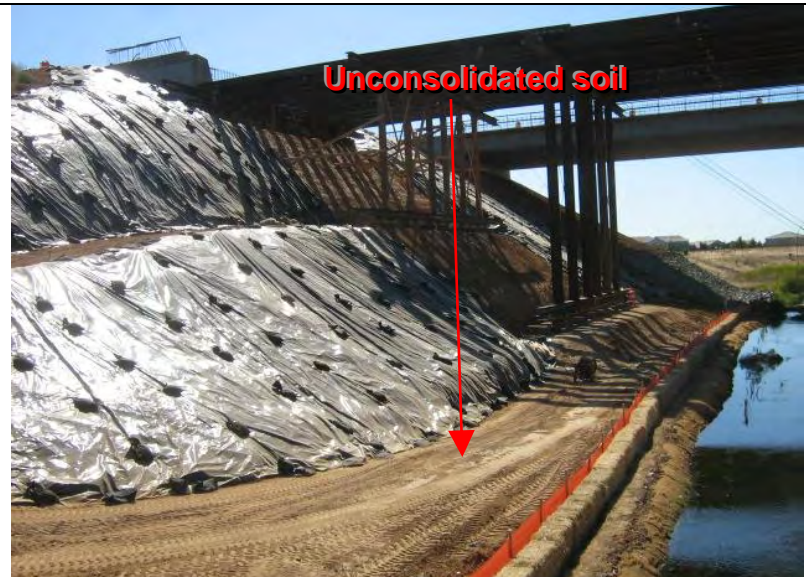
Photograph 4 – No BMPs to control concentrated flow off of the plastic and across the unconsolidated material at the toe of the slope

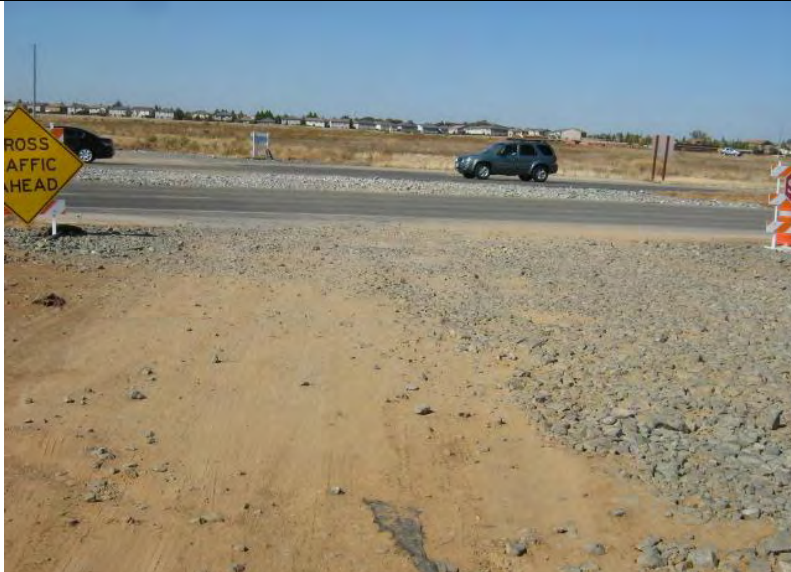
**Photograph 5 – Vehicle tracking pad BMP not adequately maintained (e.g., sediment in pad, and rock thin and sparse in areas)**

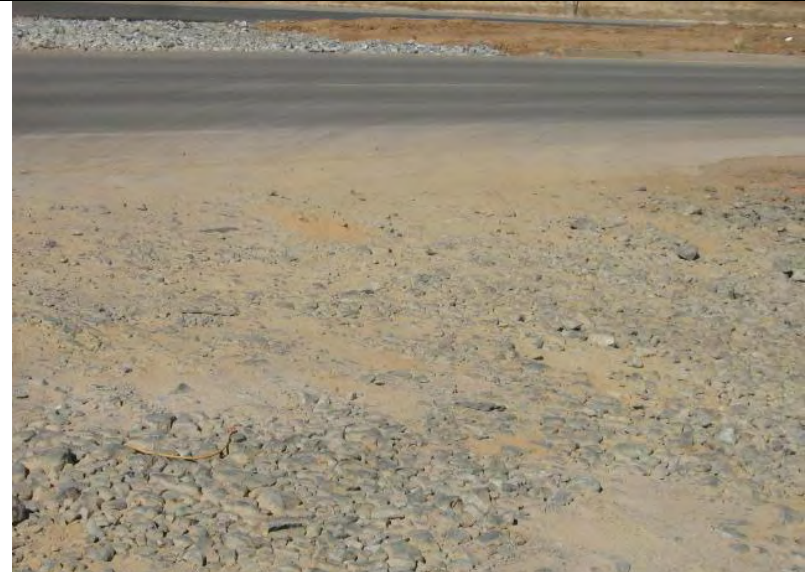
**Photograph 6 – Close-up of Photograph 5 depicting sediment in VTC pad, and rock which was thin, sparse and compacted in areas**

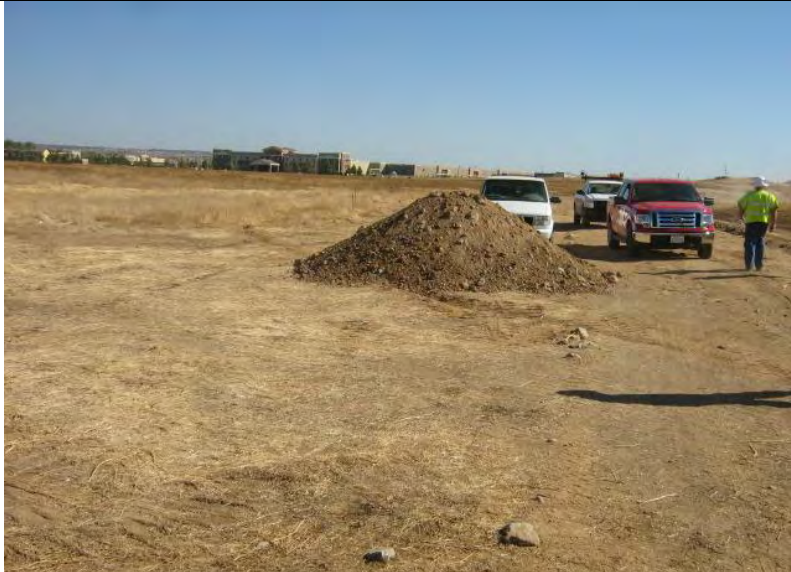
**Photograph 9 – No BMPs implemented for stockpile management near the North Ingram Slough bridge crossing**

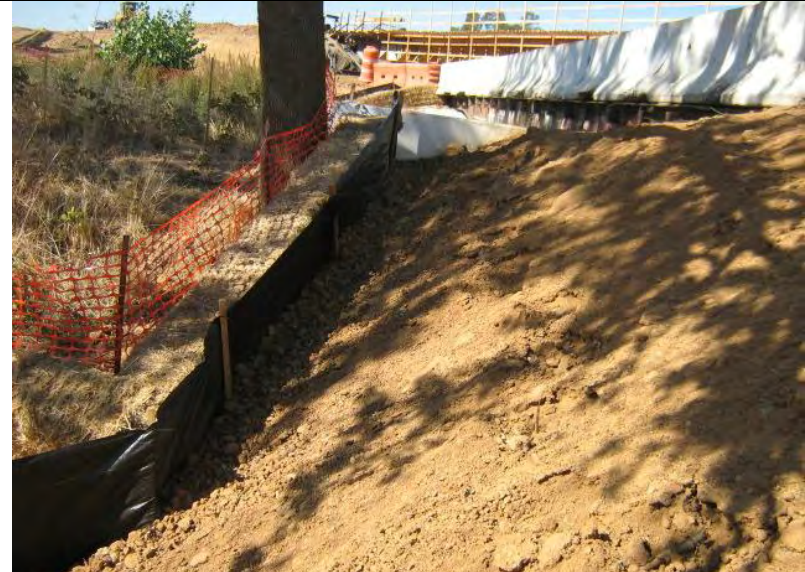
**Photograph 10 – Silt fence BMPs installed backwards (e.g., stakes on the upgradient side of the fabric)**

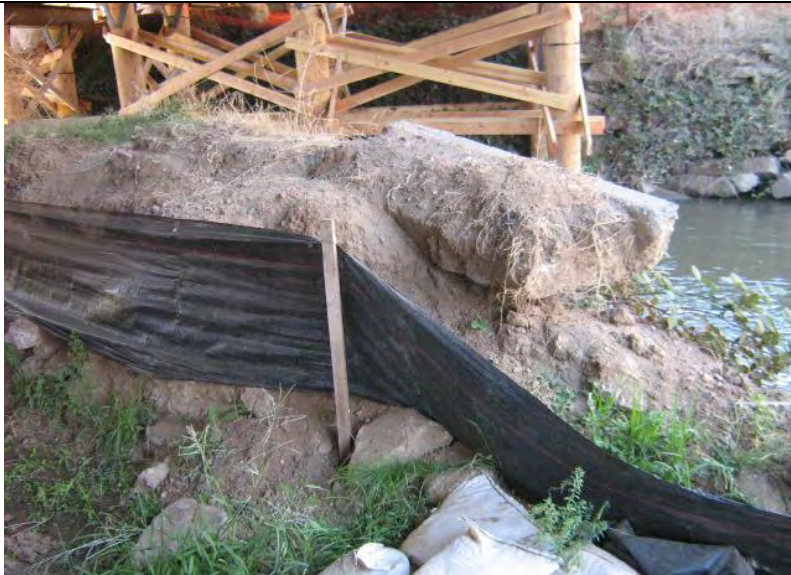
**Photograph 11 – Silt Fence BMPs not properly installed (e.g., not entrenched) or maintained (e.g., collapsed) adjacent to Auburn Ravine**

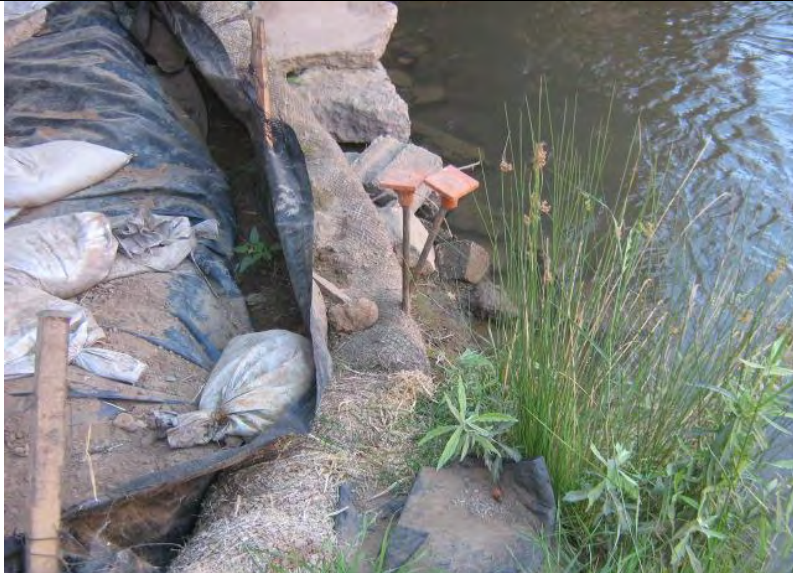
**Photograph 13 – Differing vantage point from Photograph 12 depicting unmaintained Silt Fence BMP adjacent to Auburn Ravine**

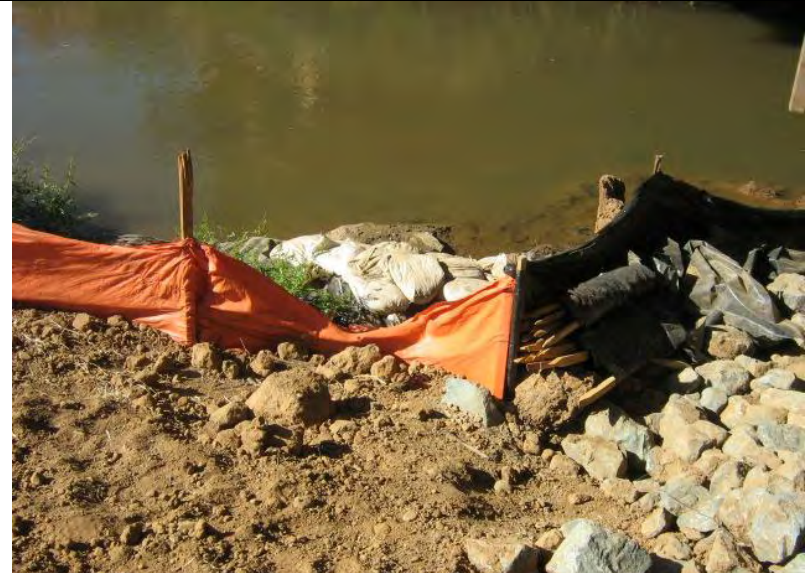
**Photograph 14 – Silt Fence BMP not adequately maintained (e.g., down in areas) adjacent to Auburn Ravine**

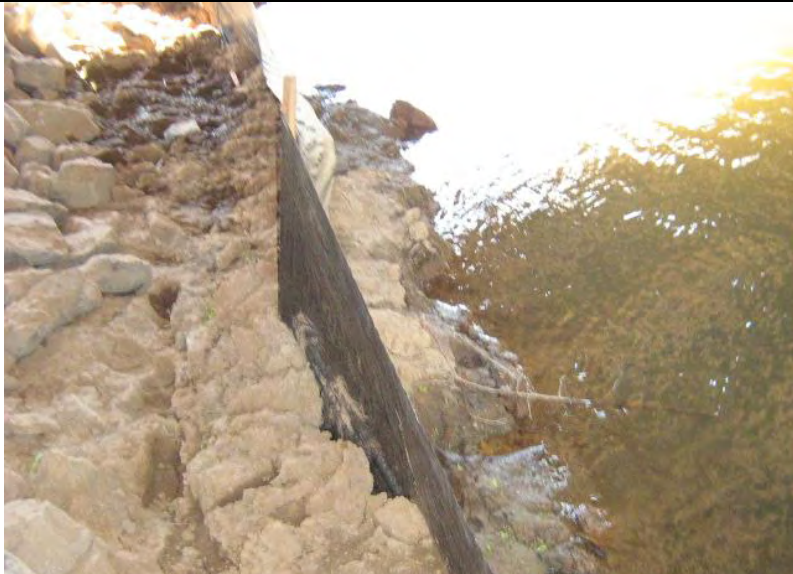
**Photograph 15 – SF BMP not adequately maintained (e.g., sediment placement over ½ the effective height) adjacent to Auburn Ravine**

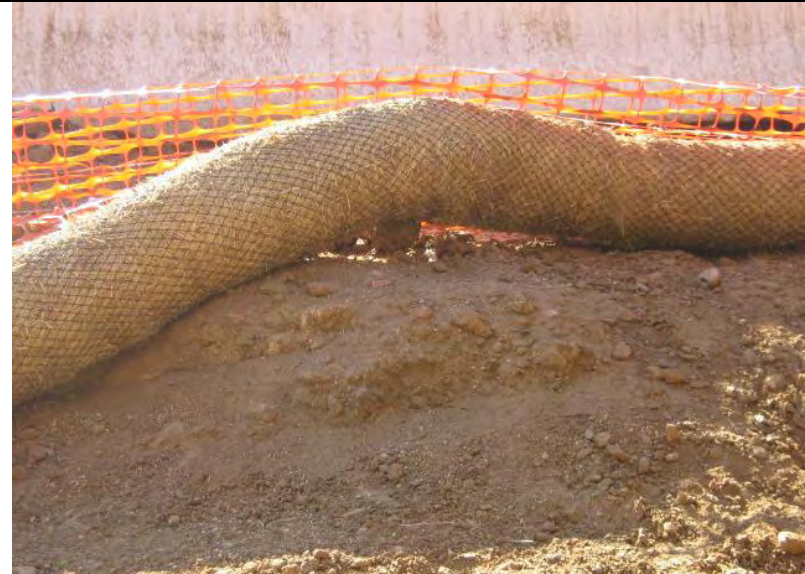
**Photographs 16 – Straw wattle BMP not properly installed (e.g., not entrenched) up-gradient of Auburn Ravine**

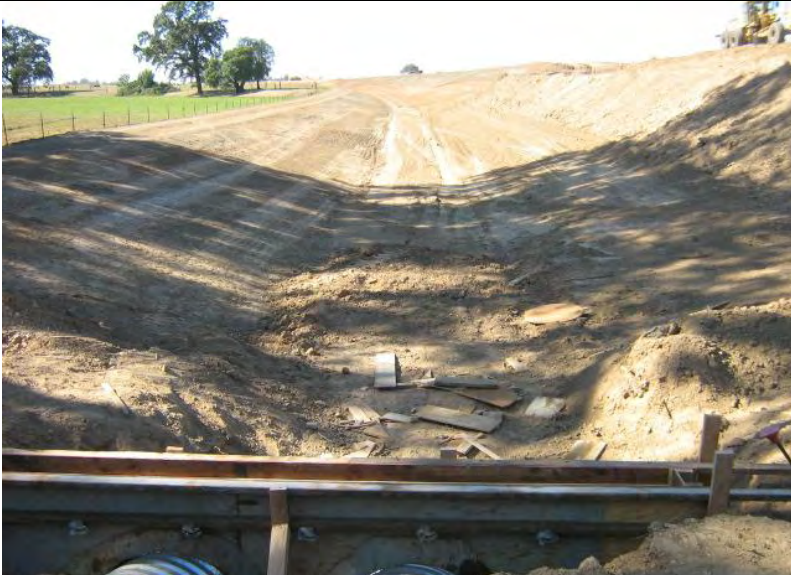
Adequate structural and non-structural BMPs were not implemented in the drainage swale conveyance channels located up-gradient of South Ingram Slough (see [Photograph 8](#)) and Auburn Ravine (see [Photograph 17](#)). BMPs had not been implemented to prevent erosion from run-on to the swale slopes, and concentrated flow along the bottom of the swale. As a result, there was a potential for erosion and subsequent discharge from these drainage swale conveyance channels to South Ingram Slough and Auburn Ravine, respectively.

**Photograph 17 – Upgradient areas of disturbance associated with pollution prevention BMP unstabilized. Drains to Auburn Ravine.**

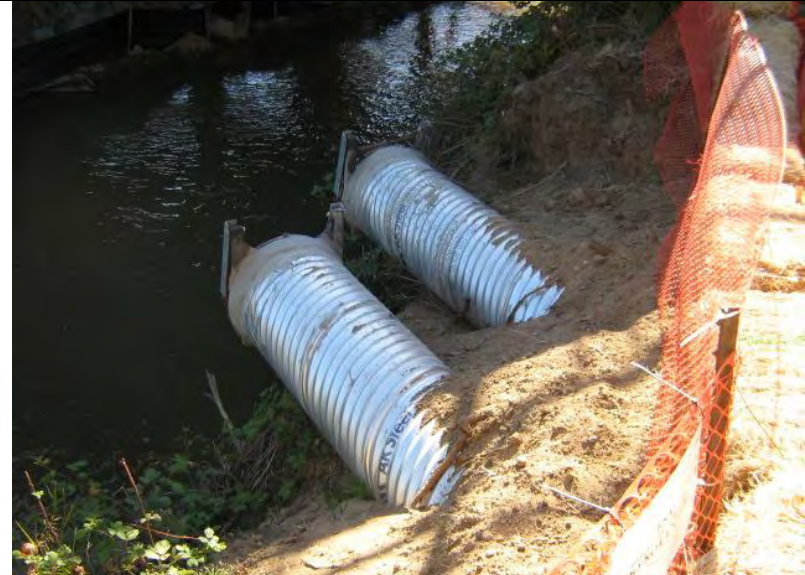
**Photograph 18 – Disturbed slope area adjacent to pollution prevention BMP outlet pipes adjacent to Auburn Ravine.**

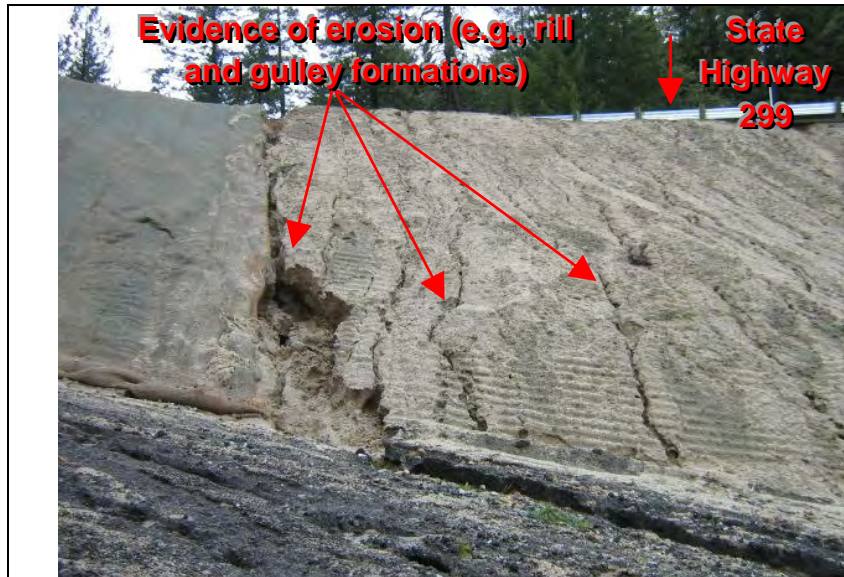
Photograph 1 – Disturbed slope areas adjacent to State Highway 299 with evidence of erosion (e.g., rill and gulley formations)

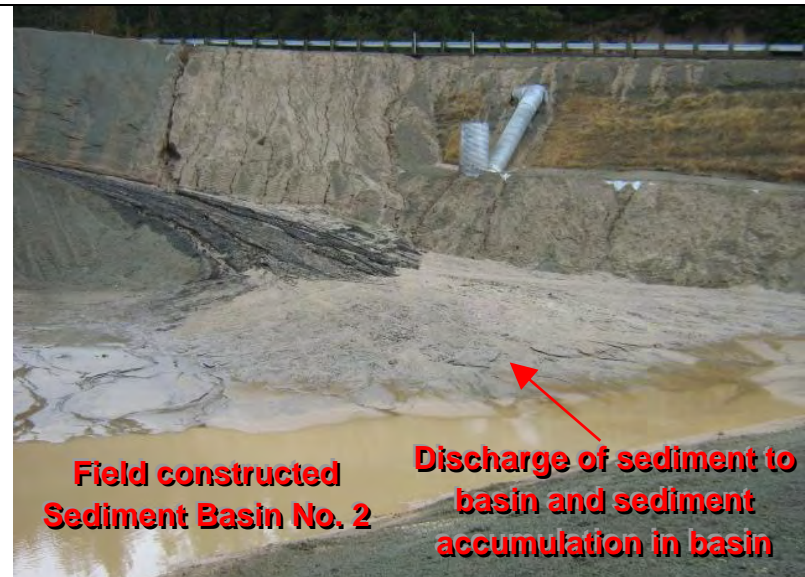
Photograph 2 – Discharge of sediment from disturbed slope area to field constructed sediment basin and sediment accumulation in the basin

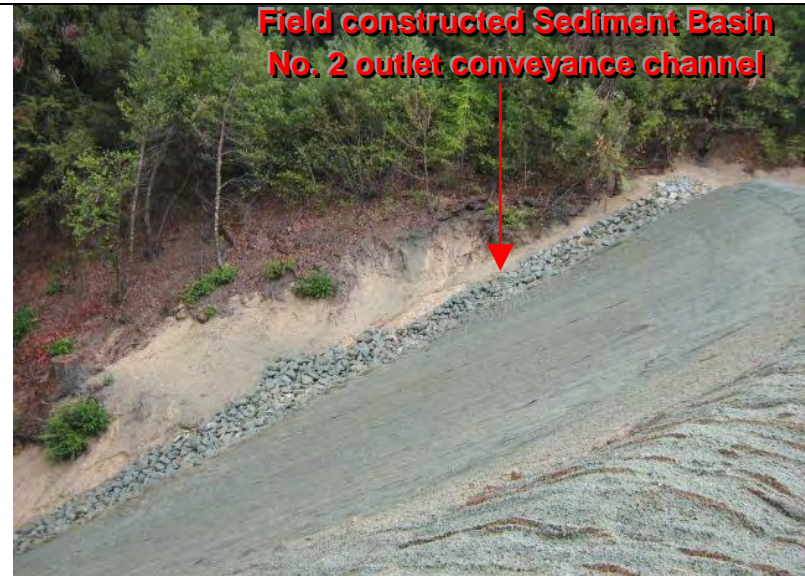
Photograph 4 – Vantage point of the outlet conveyance channel for the field constructed sediment basin No. 2

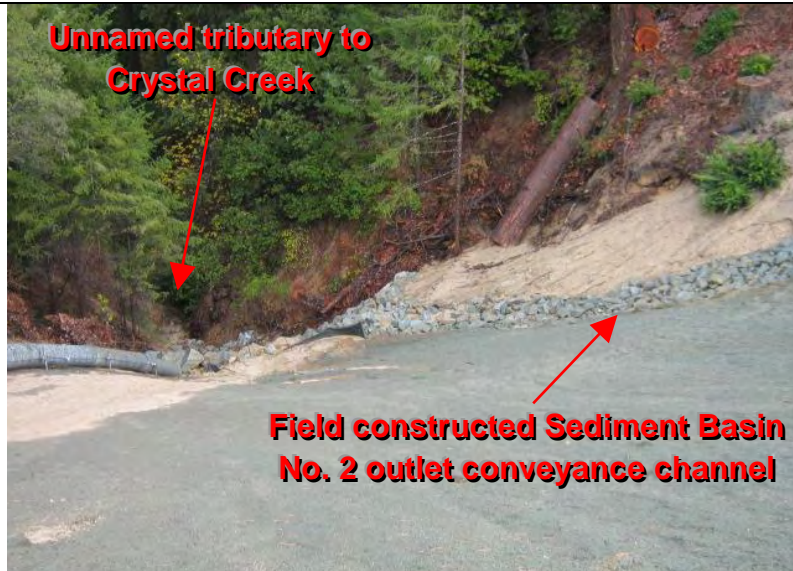
Photograph 5— View of sediment basin No. 2 outlet conveyance channel and confluence with the unnamed tributary to Crystal Creek

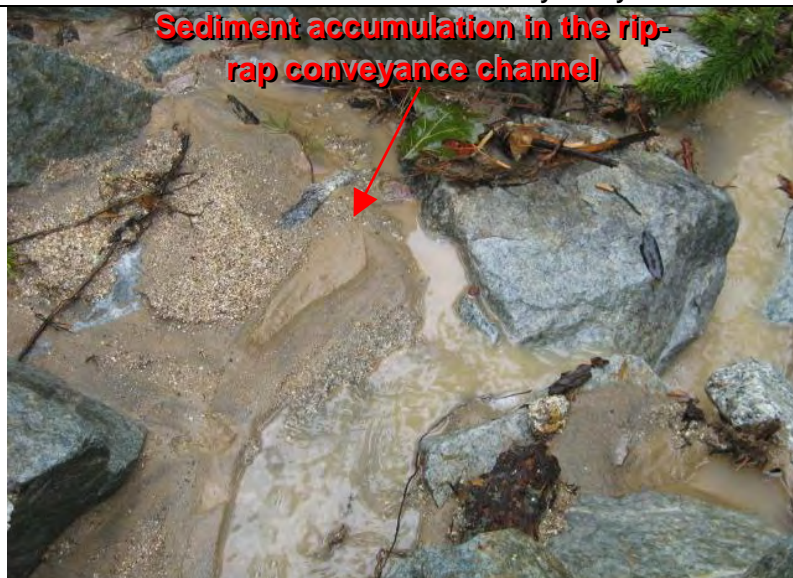
Photograph 7—Visible evidence of sediment accumulation in the rip-rap outlet conveyance channel which drains to the unnamed tributary

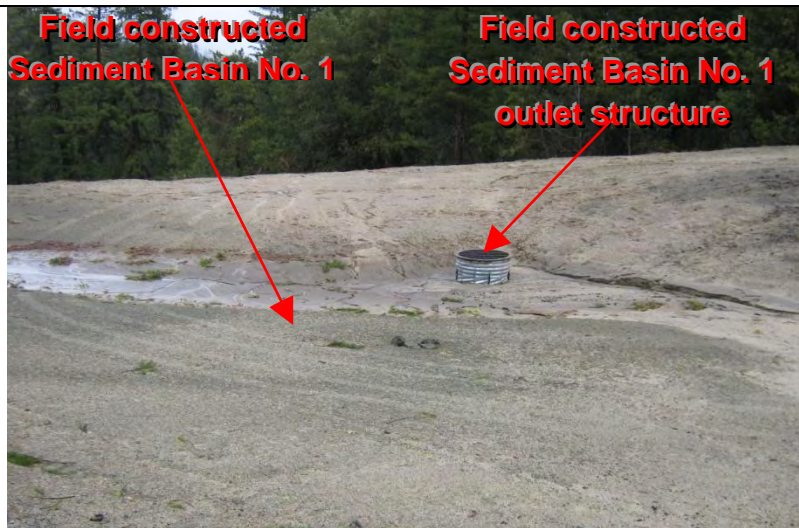
Photograph 11—Evidence of the discharge of sediment to and accumulated in the basin No. 1 which subsequently flows to basin No. 2 and the unnamed tributary to Crystal Creek

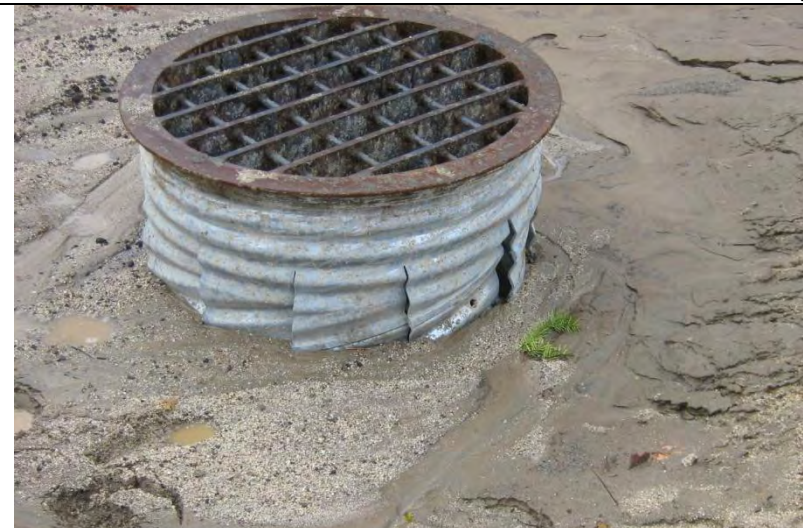
Photograph 12 – Close-up view of sediment basin No. 1 outlet structure with sediment accumulation

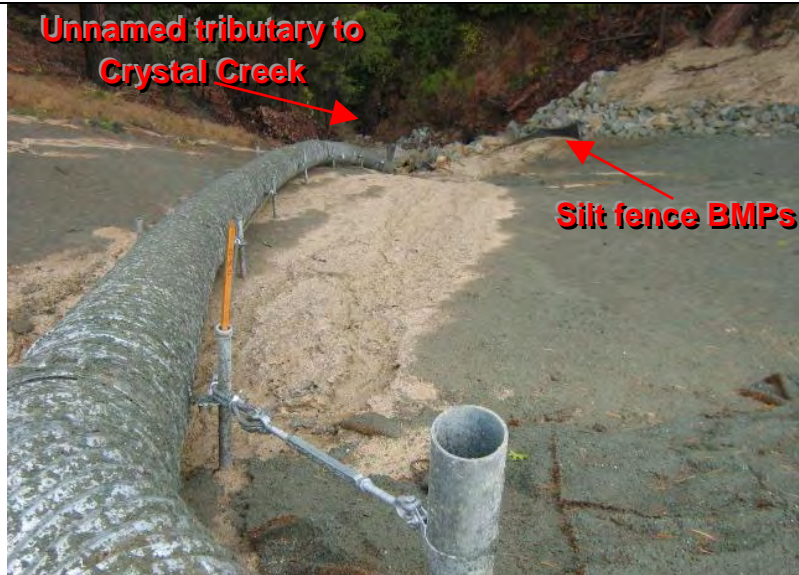
Photograph 13—Adequate BMPs were not implemented to prevent the discharge of sediment from upgradient disturbed slope areas

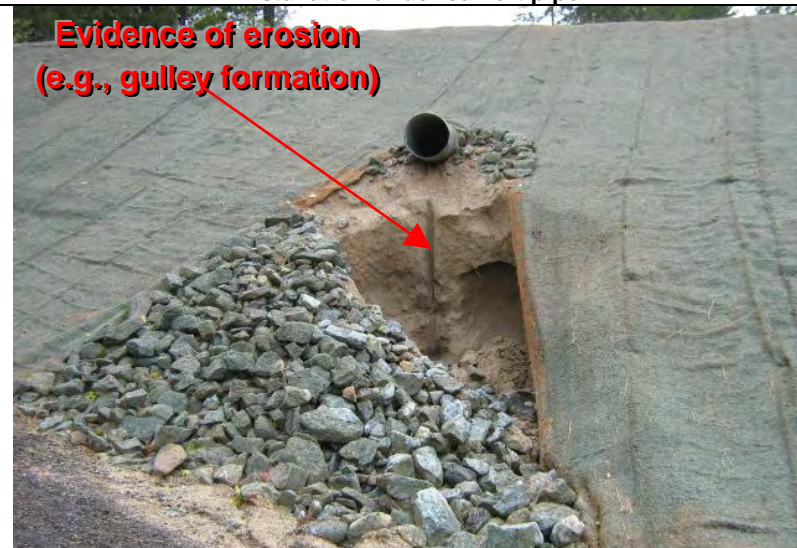
Photographs 16 – Adequate BMPs were not implemented below field constructed sediment basin No. 1 culvert outlet pipe.

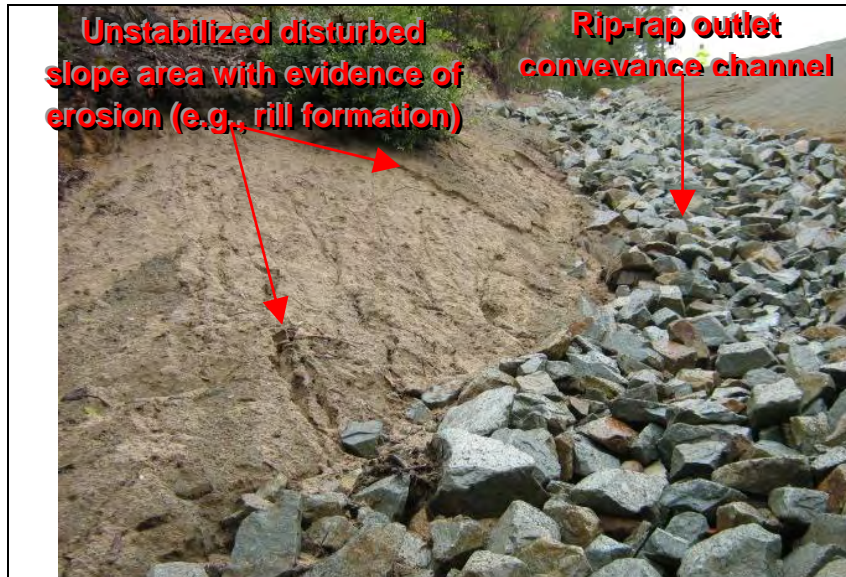
Photograph 17—Adequate BMPs were not implemented to prevent the discharge of sediment from disturbed slope area adjacent to the rip-rap conveyance channel which drains to the unnamed tributary.

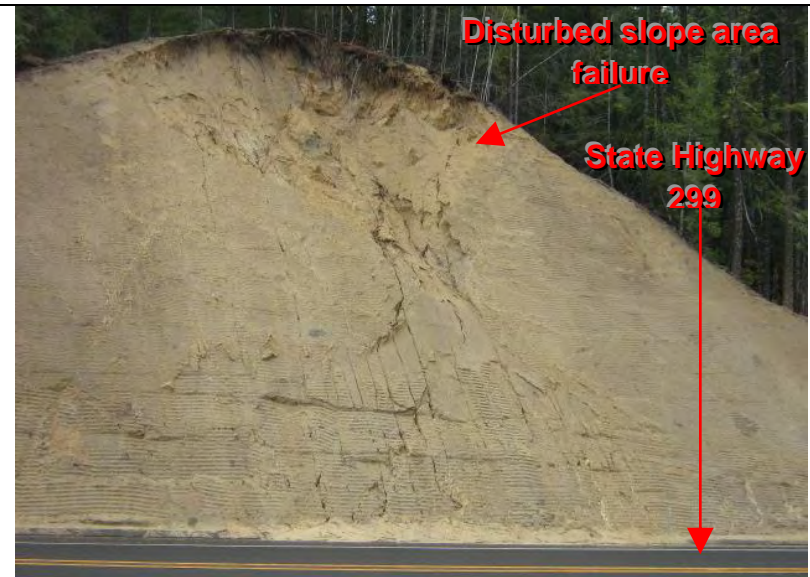
Adequate BMPs were not implemented for disturbed cut slope areas located adjacent to State Highway 299, which ultimately drain offsite via a culvert pipe inlet and drainage pipe leading to unnamed tributary to Crystal Creek. Specifically, adequate structural and non-structural BMPs had not been implemented for the disturbed cut slope areas (see Photograph 18), and evidence of erosion, cut slope failure and sediment transport were observed (see Photographs 18 through 20). As a result, there was evidence of sediment transport from the disturbed cut slope area to the adjacent State Highway 299 drainage swale which drains to the culvert pipe inlet area (see Photograph 20).

Photographs 18 – Adequate BMPs were not implemented to prevent the discharge of sediment from a disturbed cut slope area adjacent to State Highway 299.

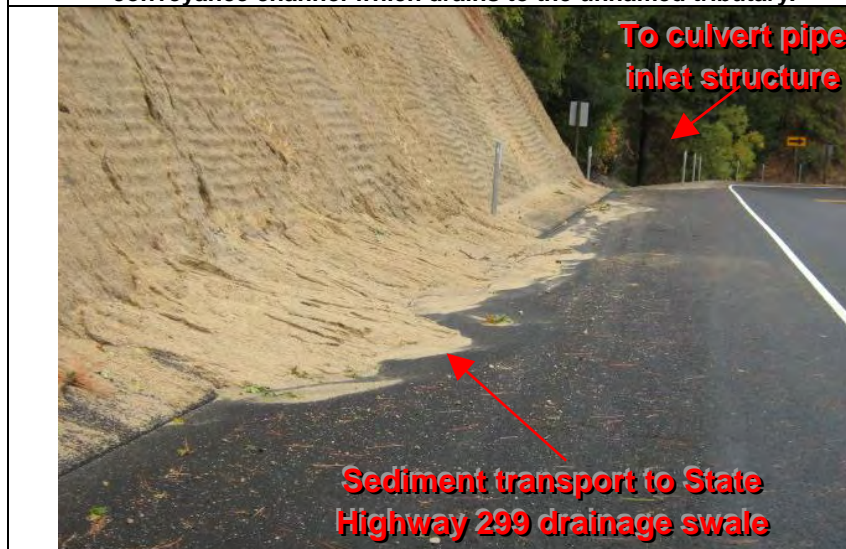
Photograph 19—Evidence of sediment transport to State Highway 299 drainage swale from the adjacent unstabilized disturbed cut slope area.

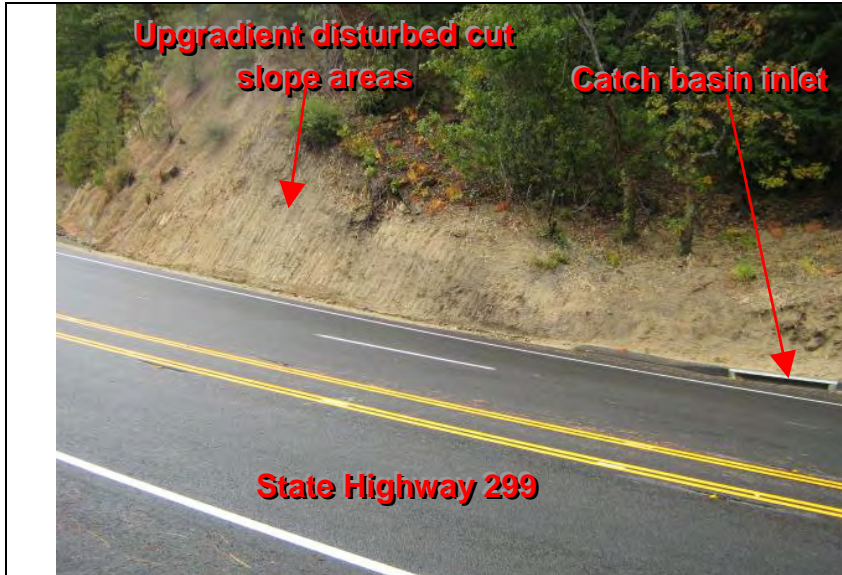
BMPs had not been implemented for catch basin inlets located in the flowline of the drainage swale associated with State Highway 299 roadway. Specifically, BMPs were not implemented to prevent the discharge of sediment to the catch basin inlets from up-gradient disturbed cut slope areas (see Photographs 21 and 22). As a result, there was a potential for the discharge of sediment to the catch basin inlet and associated culvert drainage pipe which subsequently drains to the unnamed tributary to Crystal Creek.

Photograph 21—BMPs were not implemented to prevent the discharge of sediment from up-gradient disturbed cut slope areas to catch basin inlets.

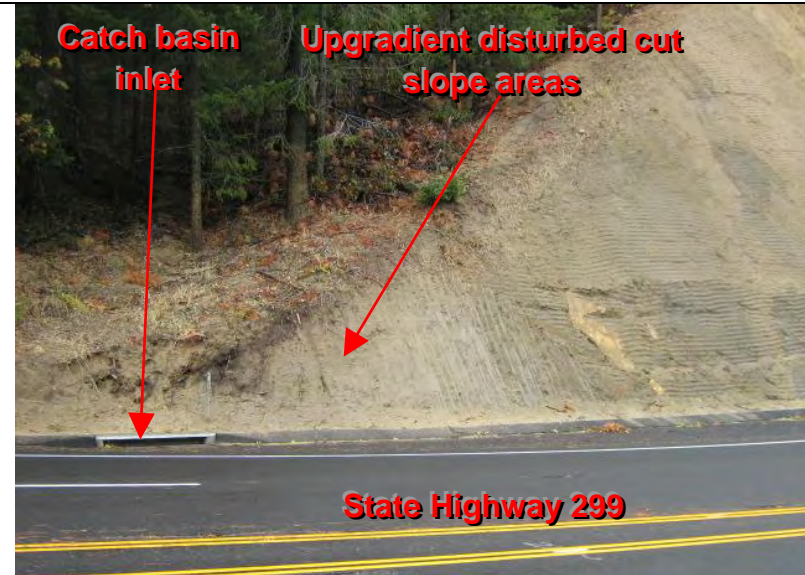
Photographs 22 – BMPs were not implemented to prevent the discharge of sediment from upgradient disturbed cut slope areas to catch basin inlets.

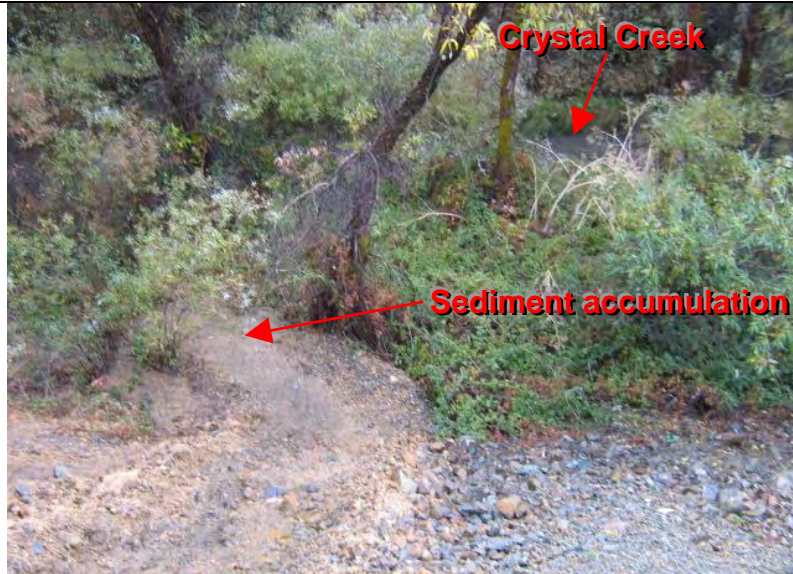
Photograph 5—Discharge of sediment and sediment accumulation in Crystal Creek

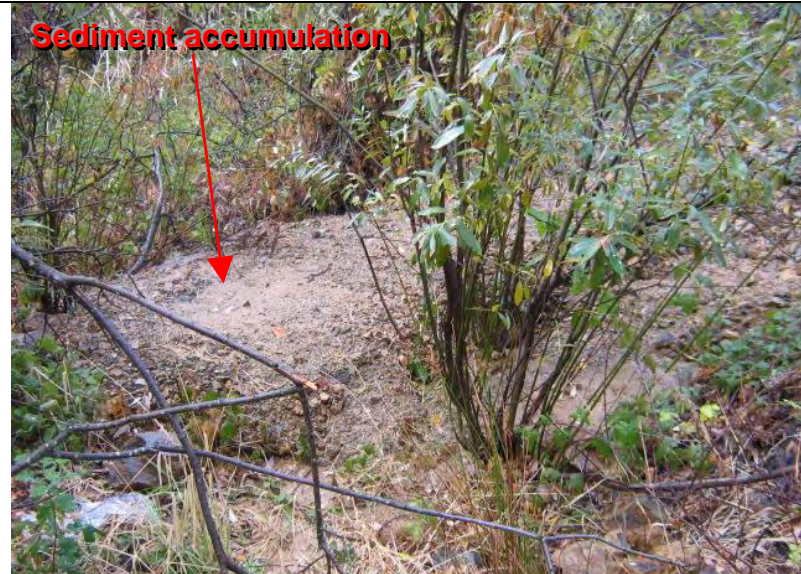
Photograph 6 – Close-up of sediment accumulation shown in Photograph 5

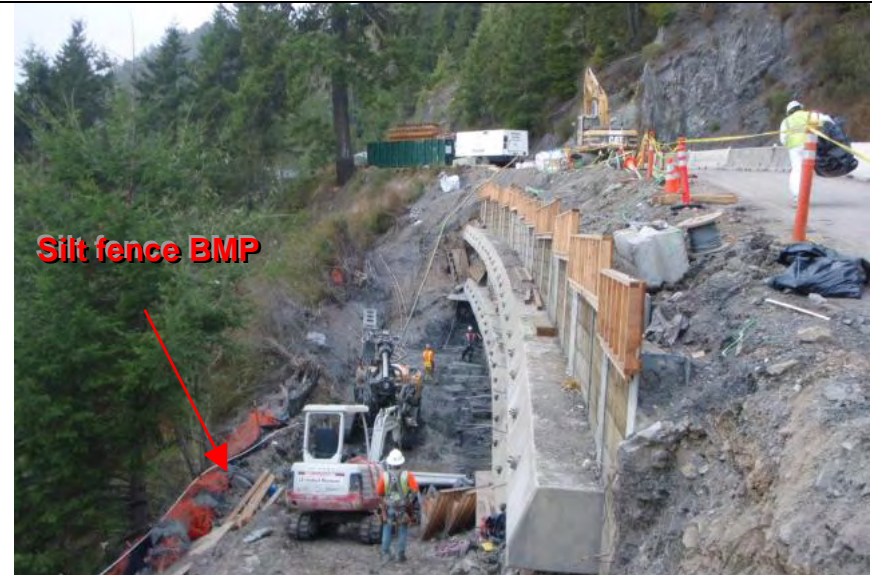
Photograph 2 – Example of silt fence BMP implemented down-gradient of disturbance and retaining wall construction

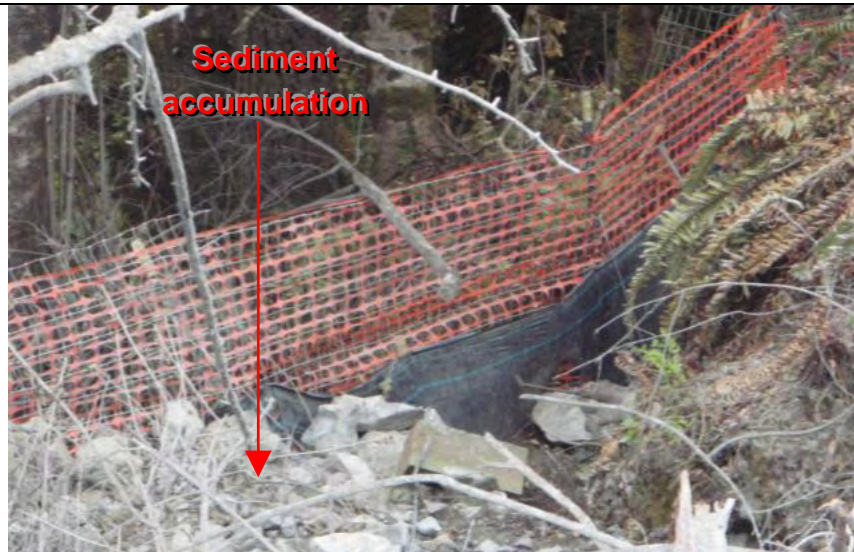
Photograph 3 – Example of sediment accumulation against silt fence BMP

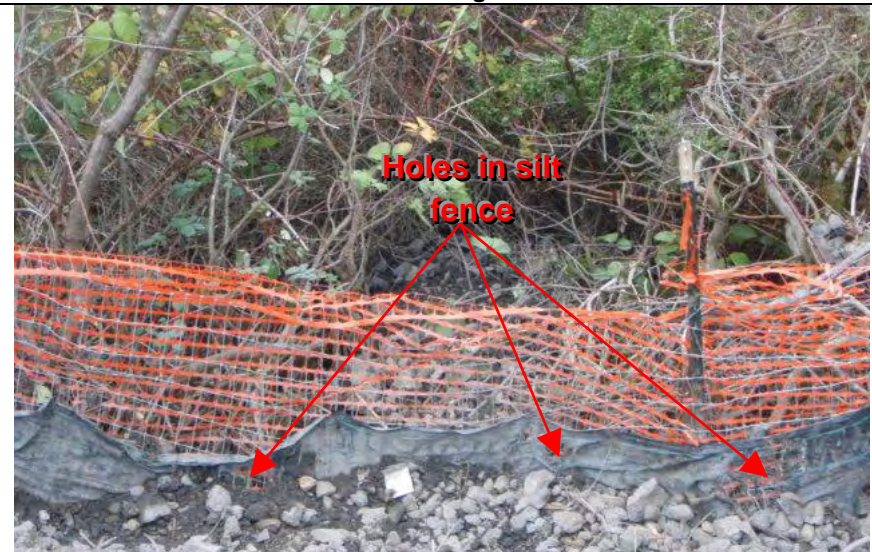
Photograph 4 – Another example of sediment accumulation and unmaintained silt fence

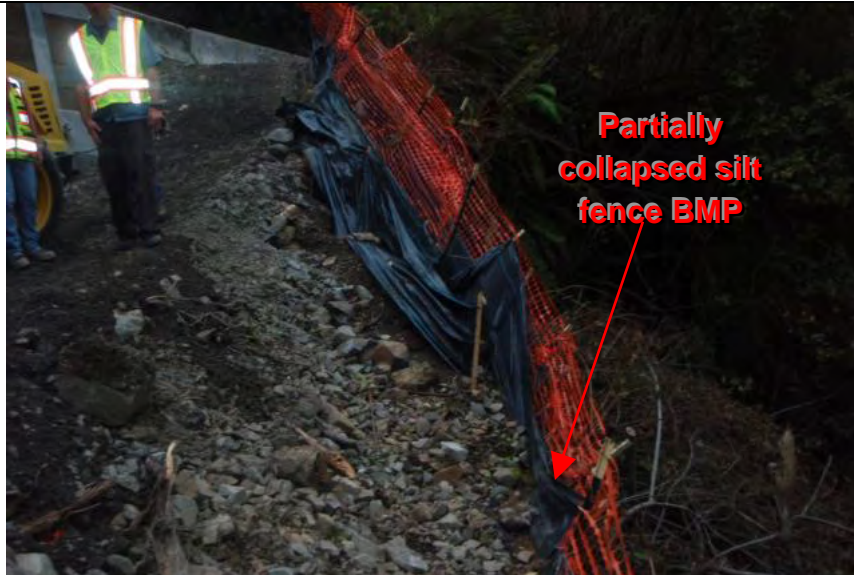
**Photograph 5— Another example of sediment accumulation and unmaintained silt fence**

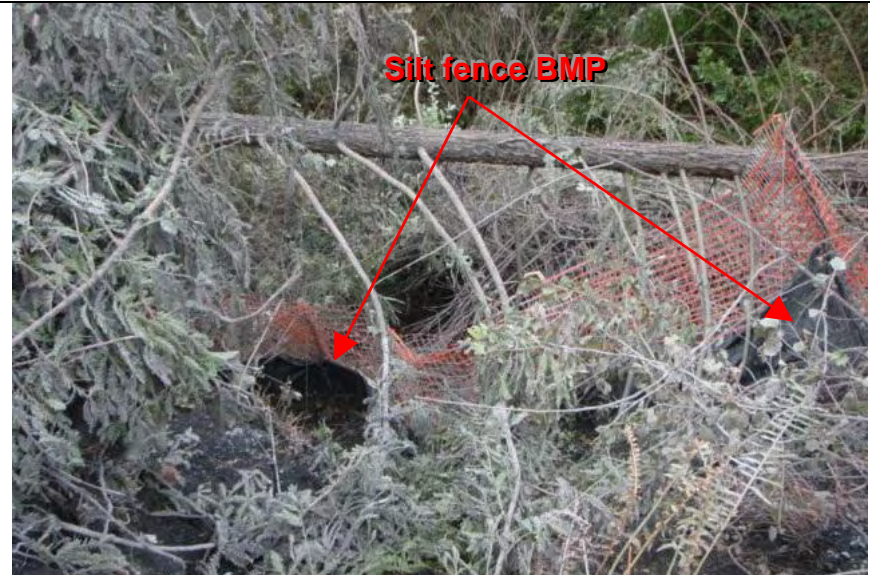
**Photograph 6 – Example of silt fence BMP partially covered by collapsed vegetation**

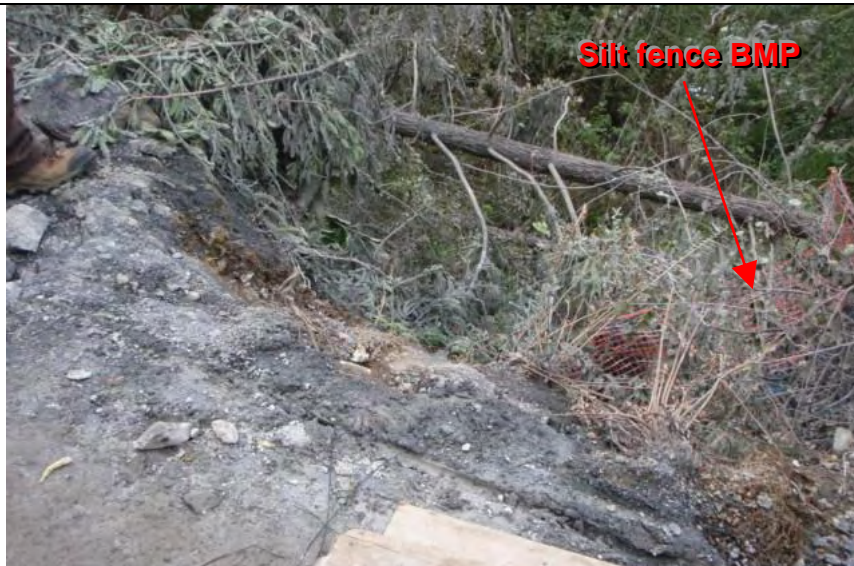
**Photograph 7— Another example of silt fence BMP partially covered by collapsed vegetation - view down slope to silt fence BMP**

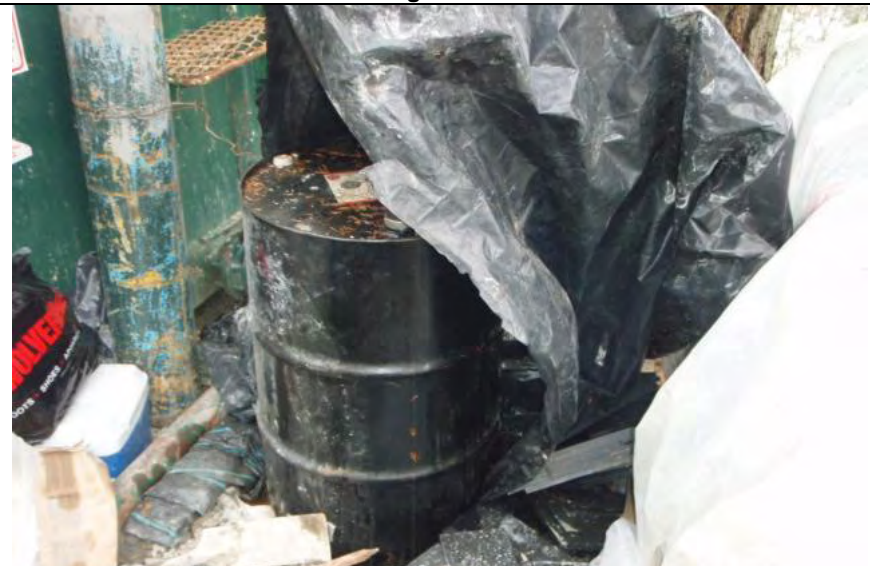
**Photograph 8 – 55-gallon drum of "Rock Drill 150" that is partially covered and not within adequate secondary containment**

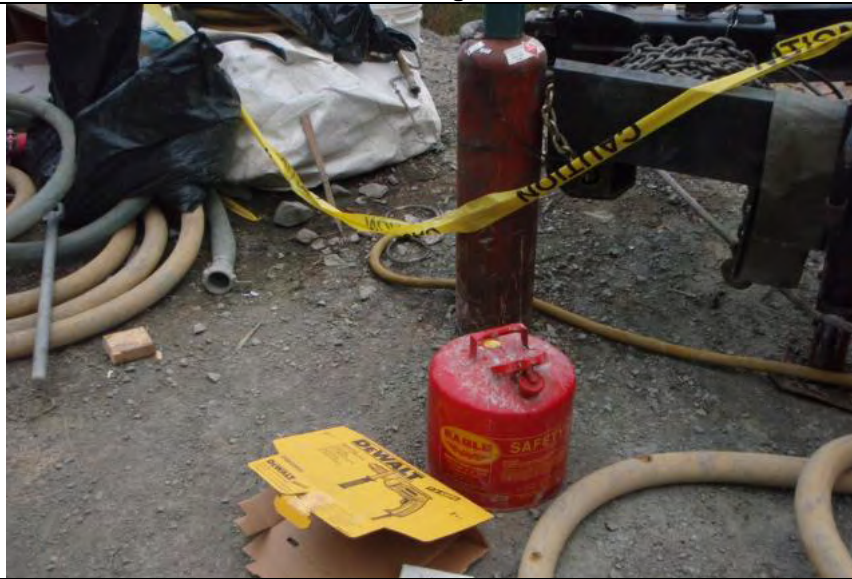
Photograph 11— Example of gas container not stored within secondary containment

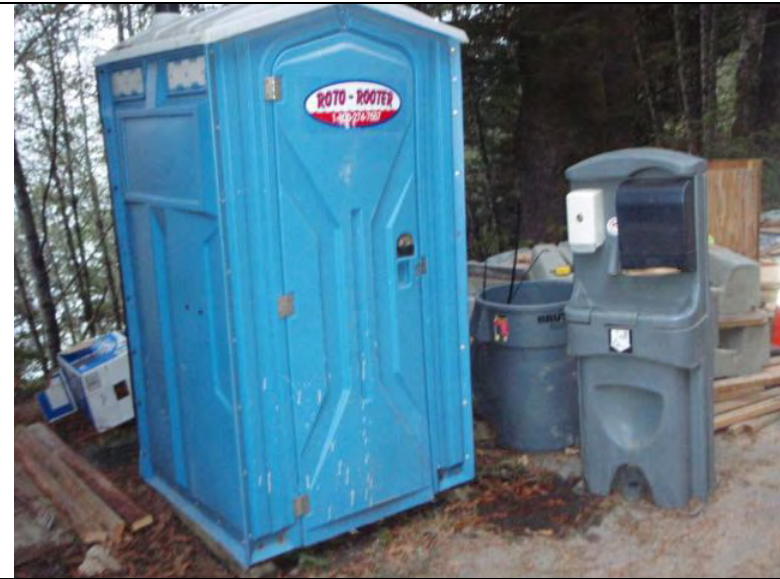
Adequate BMPs were not implemented at the construction site for good housekeeping to properly manage the storage of chemicals and materials on-site. Containers of various chemicals, including a form release agent and petroleum products, were improperly stored without secondary containment or coverage (see Photographs 8, 9, 10 and 11). In addition, a portable toilet was not staked into the ground or otherwise secured and was located adjacent to a steep slope (see Photograph 12).

Photograph 12— Portable toilet adjacent to steep slope

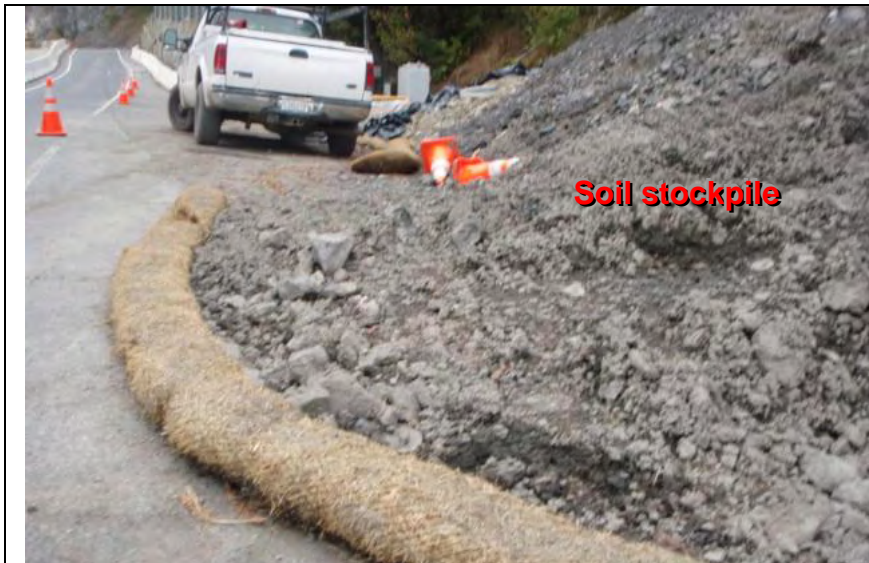
In addition, straw wattle BMPs used for stockpile management were improperly installed on impervious surfaces at the facility, and therefore were not properly entrenched in the ground to retain the stockpiled materials (see Photographs 13 and 14). As a result, there was a potential for the discharge of sediment to the roadway and off-site to the west. The Resident Engineer explained that the SWPPP had been amended to include the use of straw wattle BMPs on impervious surfaces; however, this was not confirmed by the EPA Audit Team.

Photograph 13— Straw wattle not staked or entrenched into ground. Inappropriate application of wattles on impervious surface

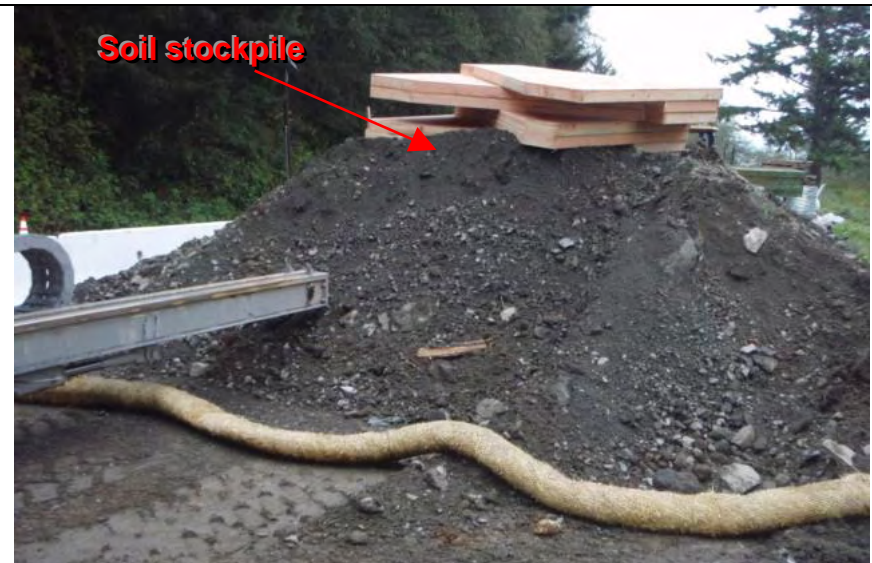
Photograph 14— Another example of straw wattle not staked or entrenched into ground. Inappropriate application of wattles on impervious surface.

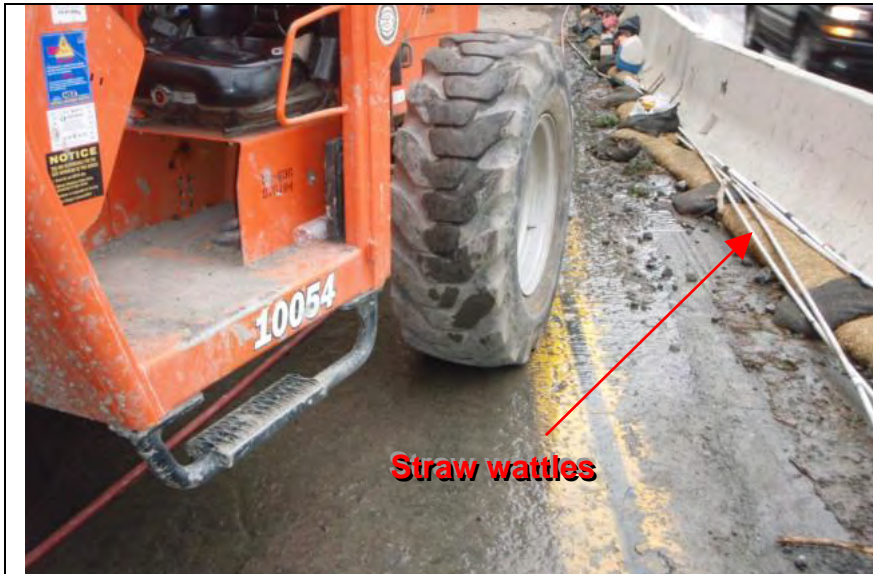
Photograph 17— View down-gradient from water container (Note: Wetness on impervious surface and placement of straw wattles)
