## **Appendix D**

### **Construction Program Site Visit Reports**

### **Thomes Creek Bridge Project Site Visit Date: 10/13/2009**

**Caltrans MS4 (SWRCB Order No. 99-06-DWQ)**  
**Thomes Creek Bridge Project**  
**Caltrans District 2**

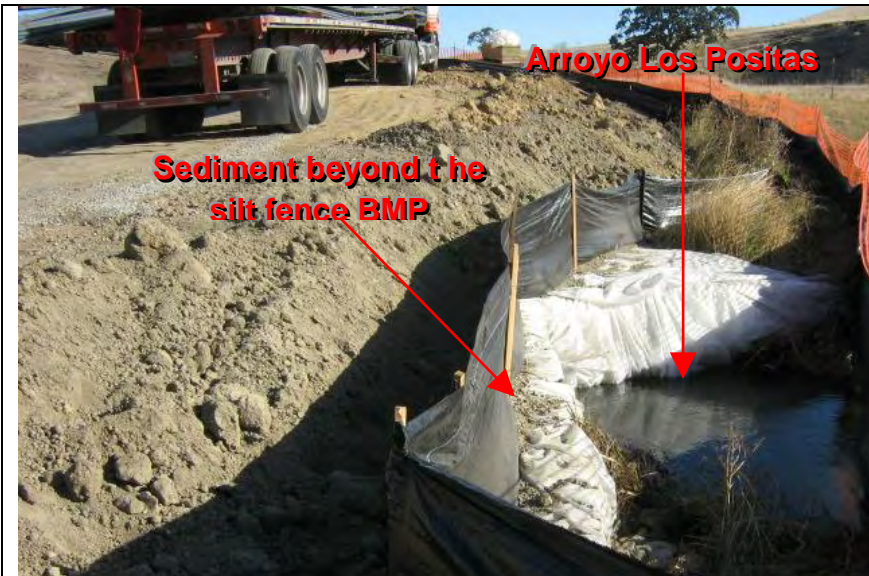
Photograph 1 – View of constructed Arroyo Los Positas diversion

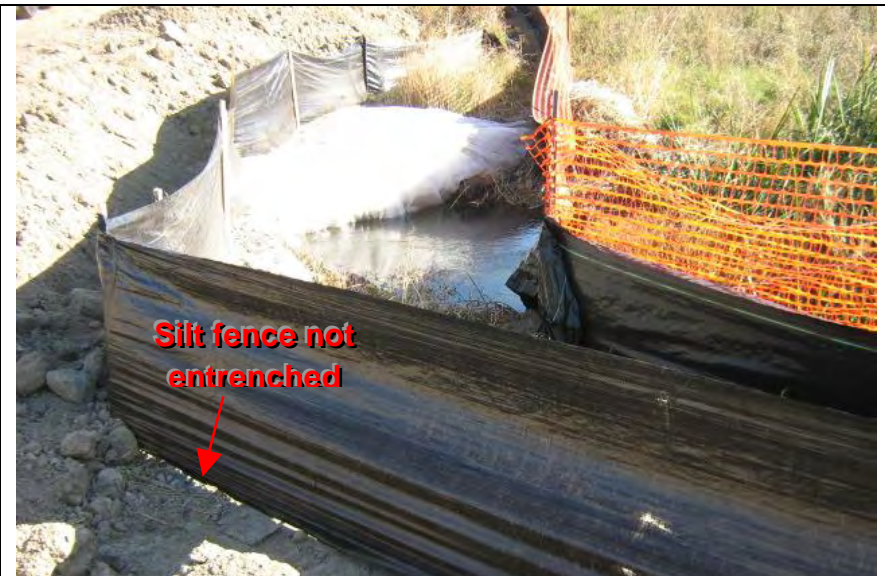
Photograph 2 – View of constructed Arroyo Los Positas diversion

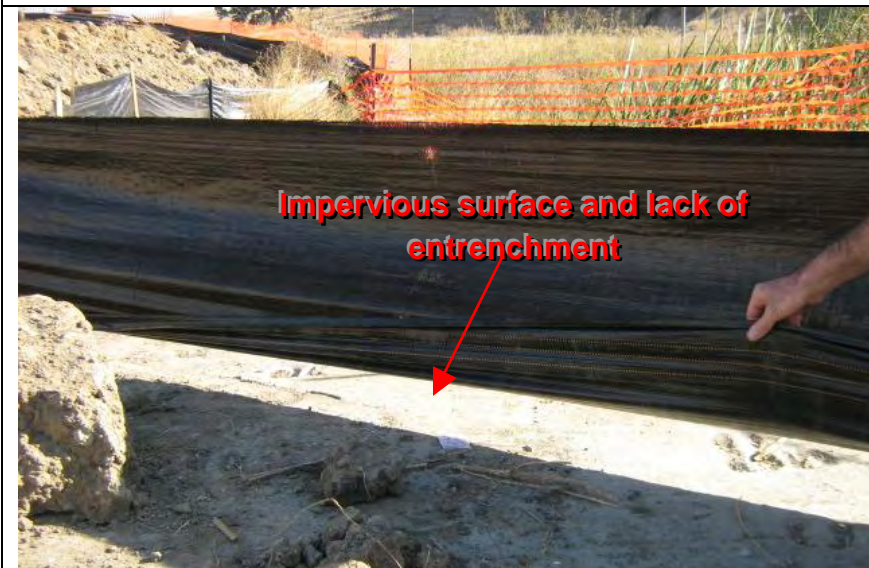
Photograph 3 – Close-up view of area shown in Photograph 2

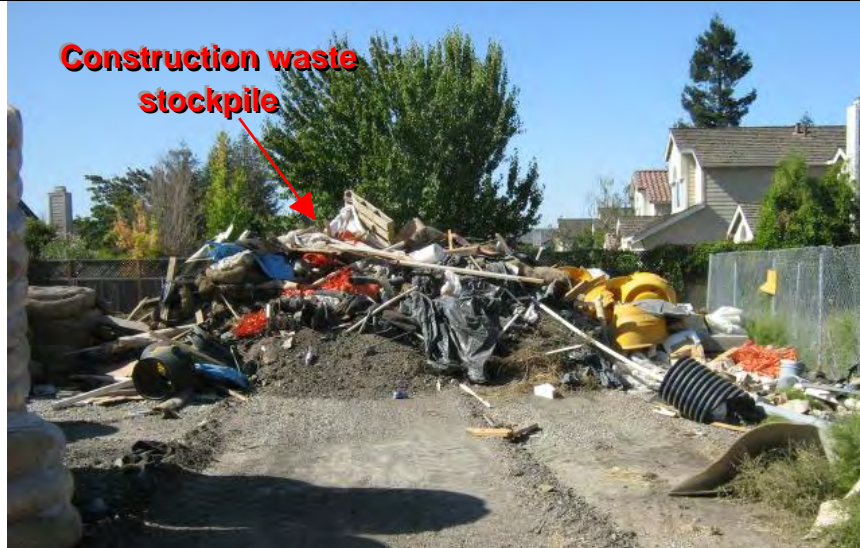
Photograph 5— Uncovered and uncontained construction waste

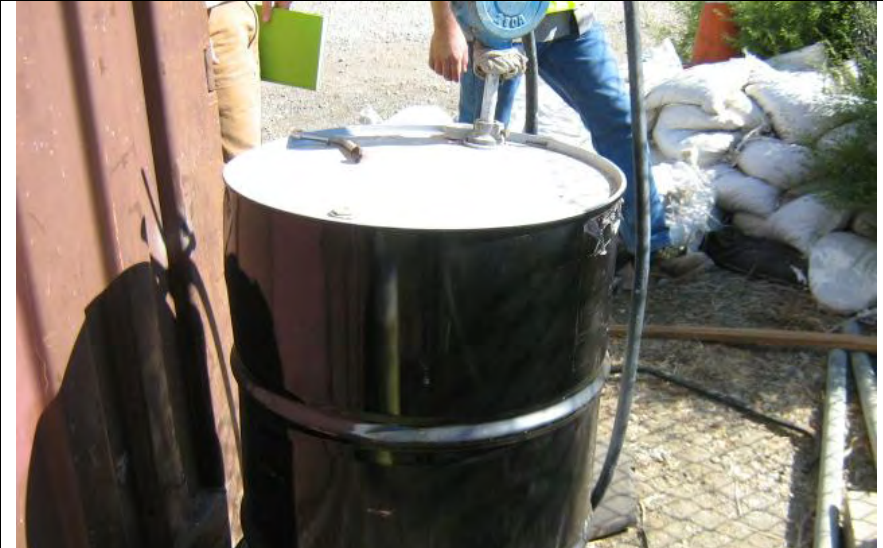
Photograph 6 – Asphalt release agent without secondary containment

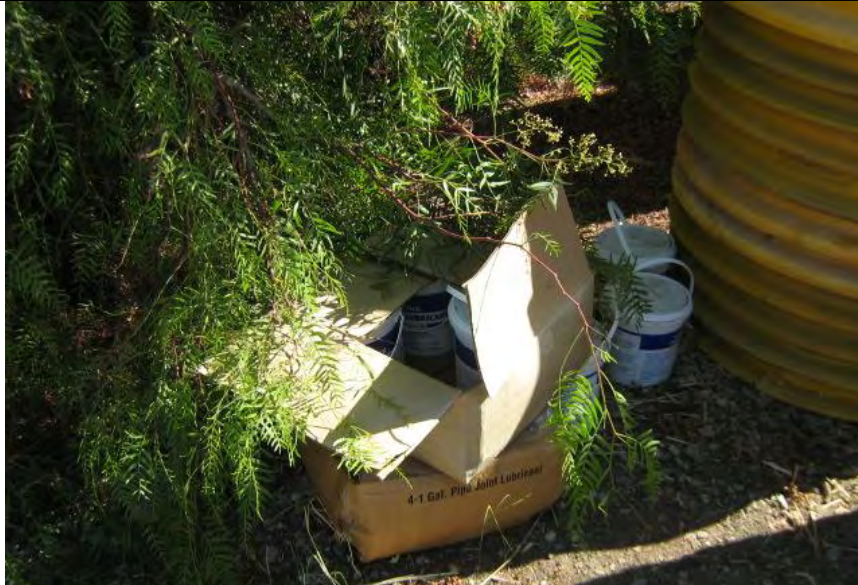
Photograph 9— Pipe joint lubricant

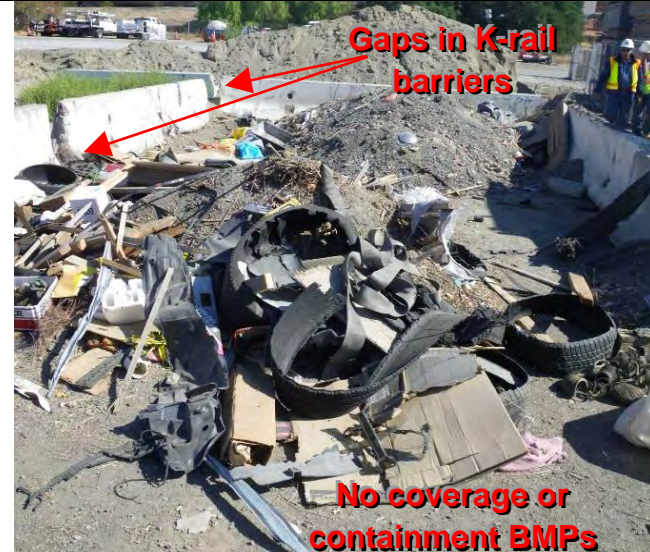
Photograph 10 – Sweeper and roadway waste stockpile

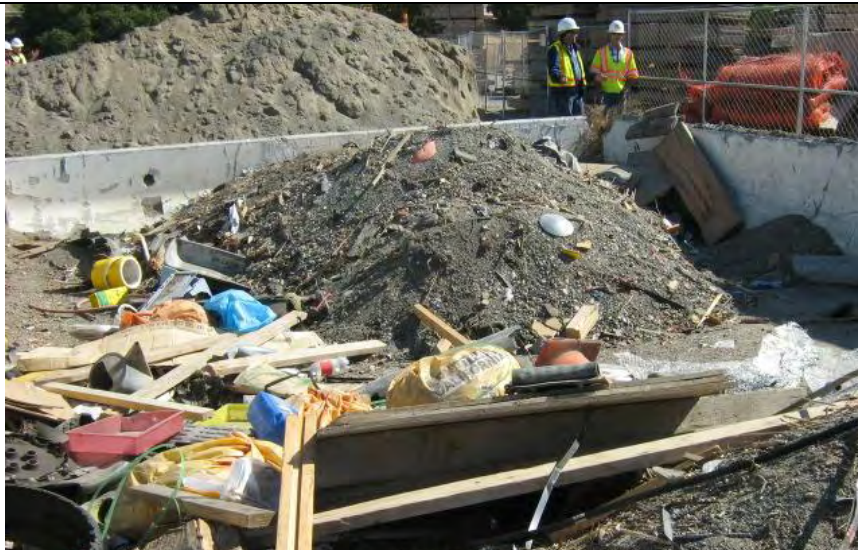
Photograph 11— Close-up view of sweeper and roadway waste stockpile

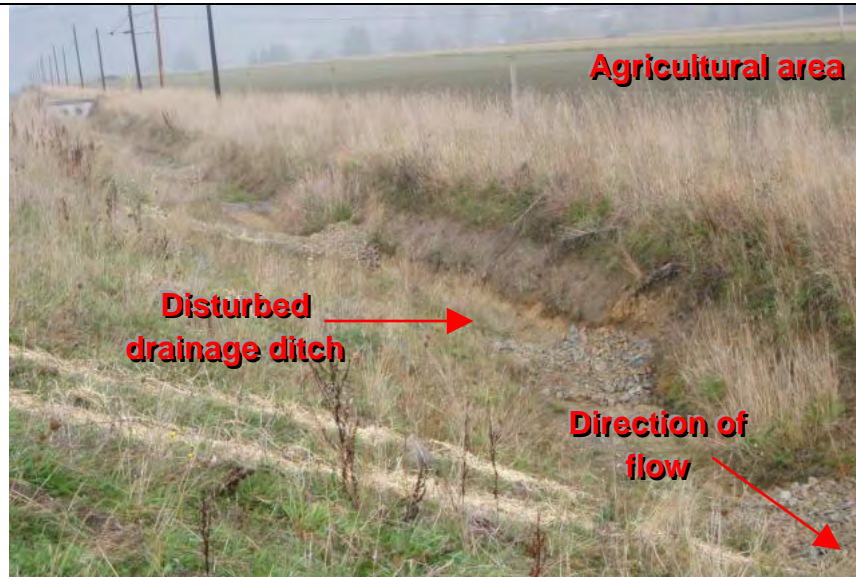
Photograph 1 – View of disturbed drainage ditch looking to the northeast

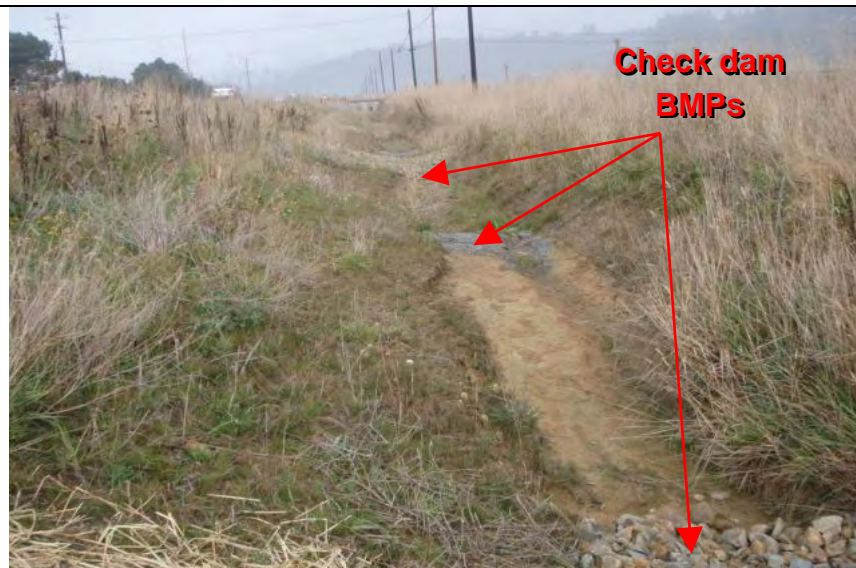
Photograph 3 – View up drainage channel

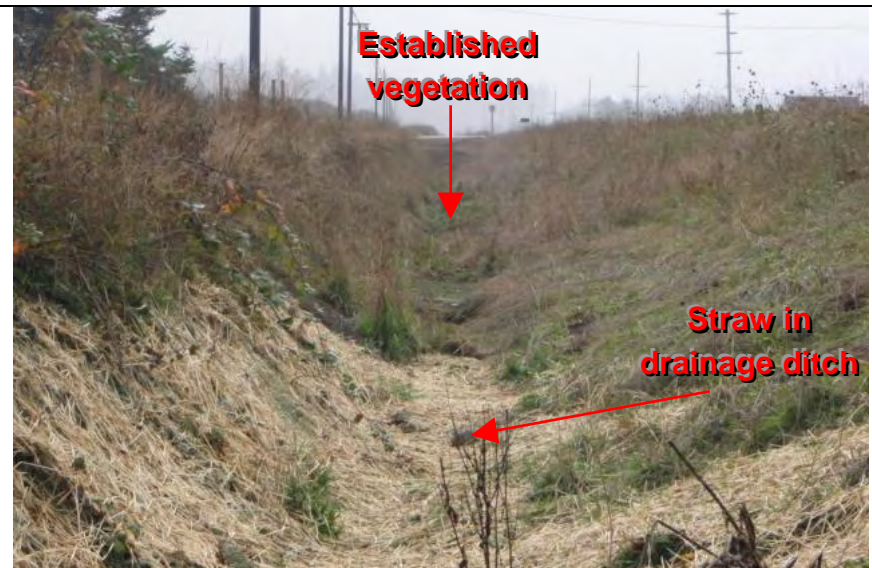
Photograph 4 – View of drainage ditch south of the culvert inlet

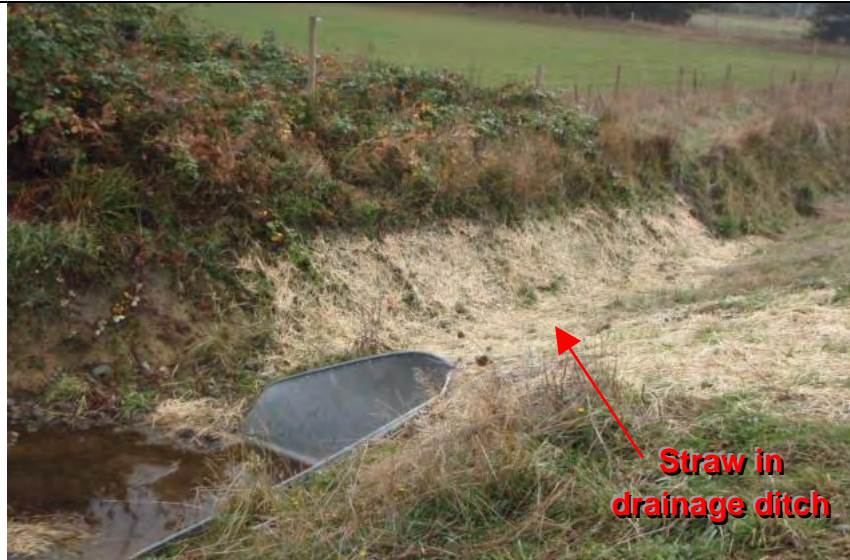
Photograph 5— View of drainage ditch south of the culvert inlet

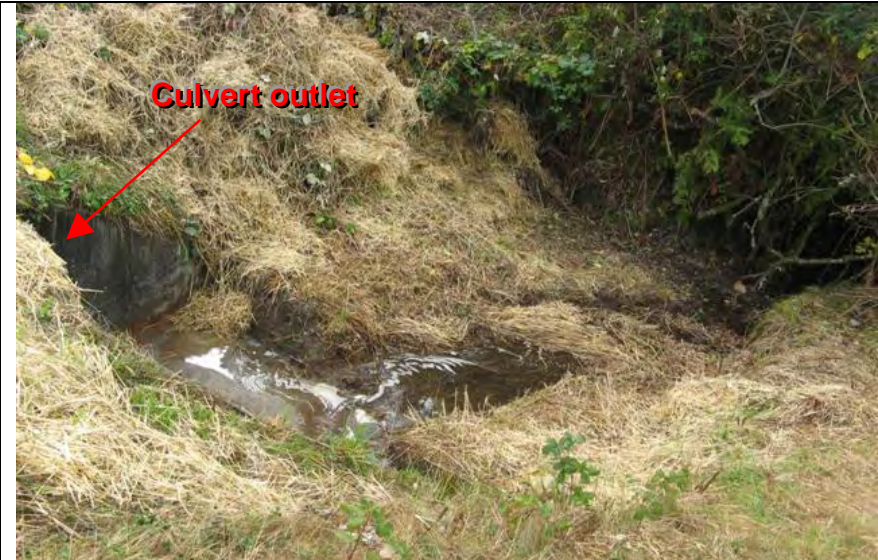
Photograph 6 – West side of culvert outlet (Note: Straw around and within drainage channel)

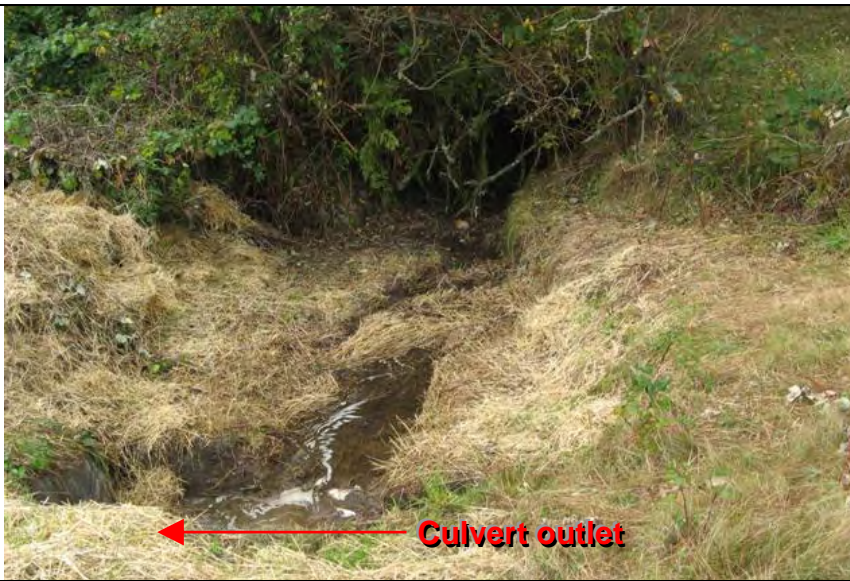
Photograph 7— Another view of the west side of culvert outlet

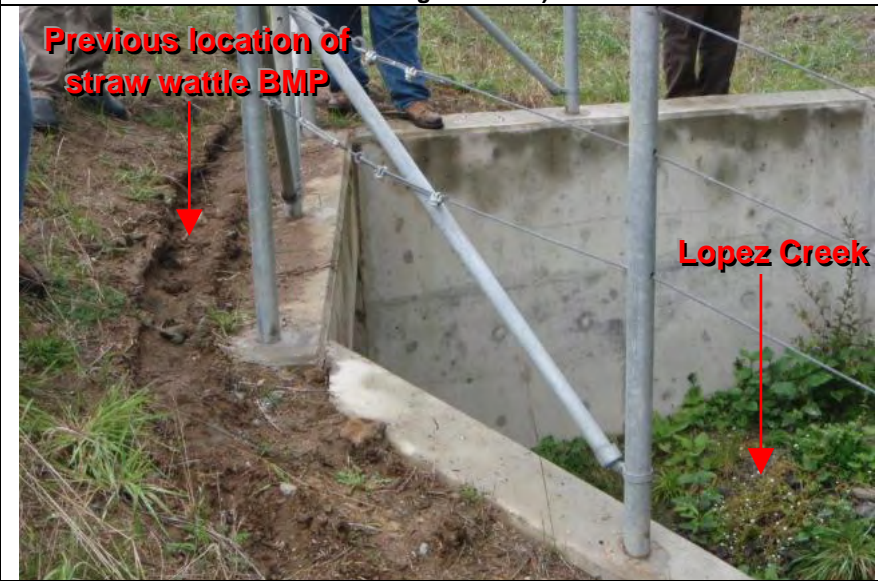
Photograph 8 – Area above culvert crossing of Lopez Creek

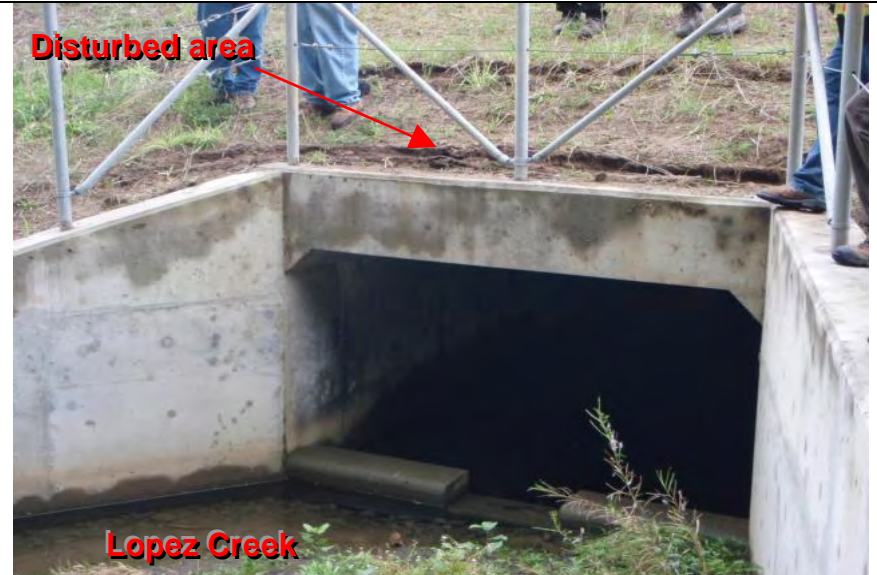
Photograph 10— Culvert crossing of Lopez Creek

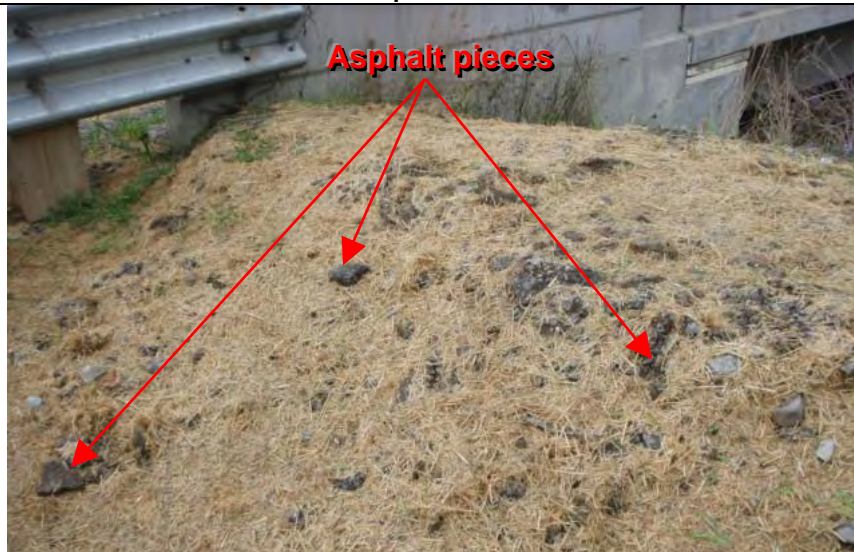
Photograph 11— Sidecast asphalt pieces along side of roadway at northern end of construction project

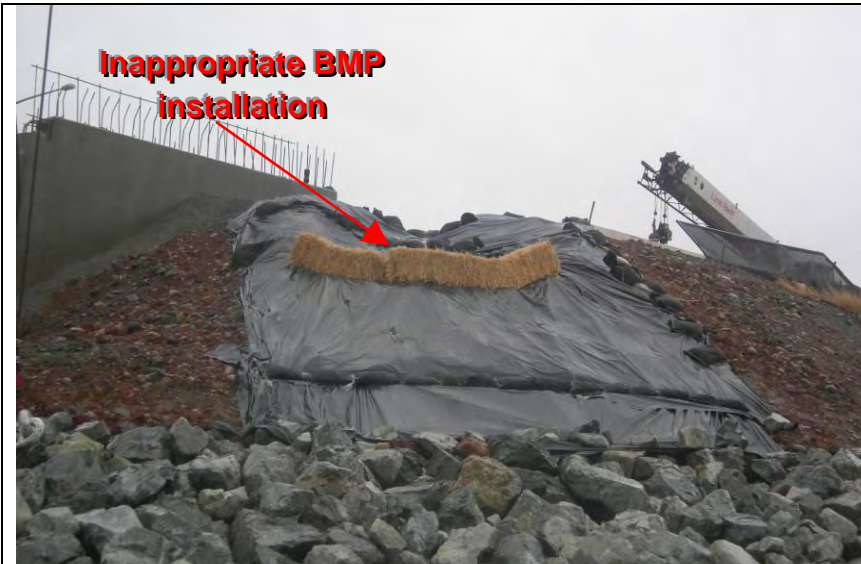
Provision H.1.b of the Permit requires Caltrans to implement a program to control all construction in the rights-of way and states that “program must include requirements of structural and nonstructural BMPs.” Appendix D of the SWMP contains the “Statewide Storm Water Quality Practice Guidelines” which provide a description of each approved BMP for statewide application. Adequate BMPs were not implemented for the disturbed areas associated with the replacement construction of the Sacramento River Bridge (a four span concrete box girder bridge replacement). Specifically, portions of the disturbed slope area along the southeastern side of the bridge had been temporarily stabilized and the hay bale flow dissipation BMPs had been improperly installed on an impervious surface (see Photograph 1).

Photograph 1 – View of disturbed slope at Sacramento River Bridge

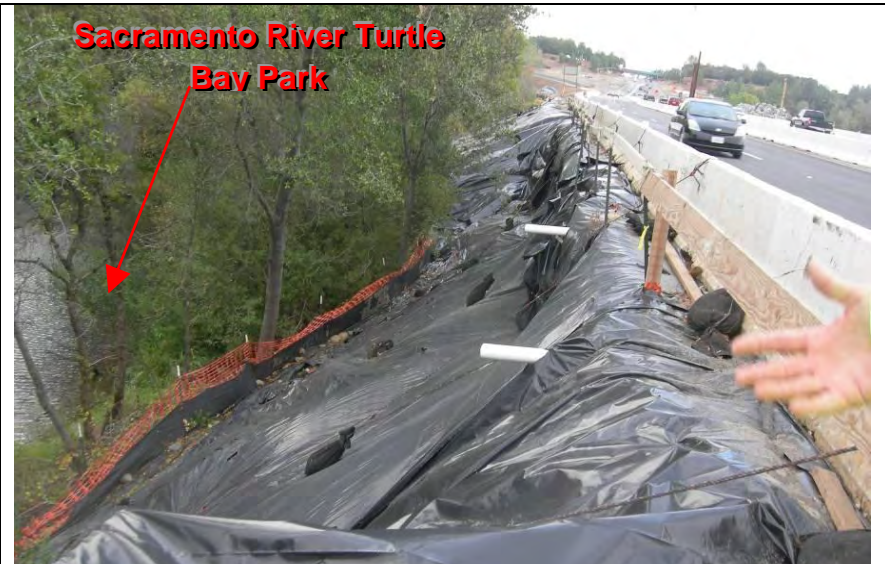
In an area along the northern portion of Interstate 5 and east of the Auditorium Drive Bridge, a perimeter control silt fence located at the toe of the slope had failed (see Photographs 2 and 3). As a result, there was potential for the discharge of sediment offsite into the Sacramento River Turtle Bay Park (see Photograph 3).

Photograph 2 – View of temporary plastic slope stabilization along the north side of I-5, at the terminus of the bike path

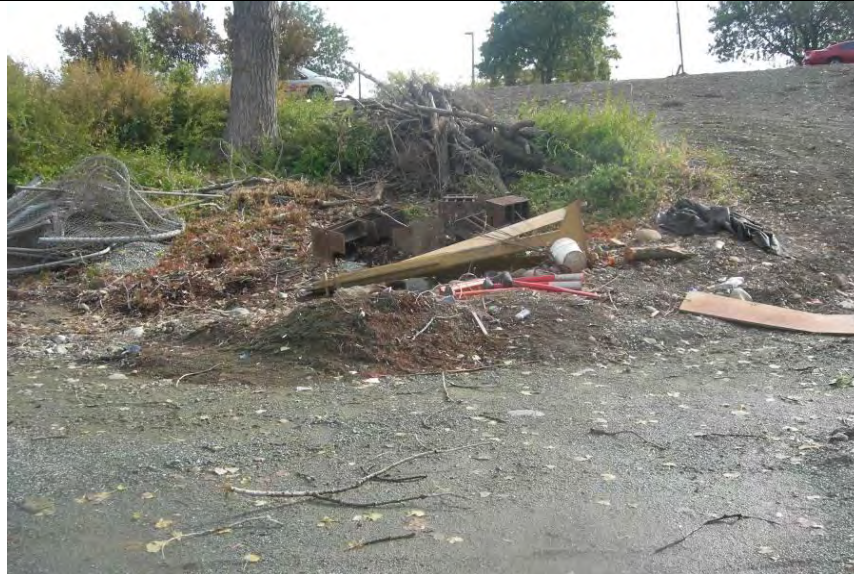
**Photograph 5 – Lack of perimeter control BMPs around a construction material disposal stockpile**

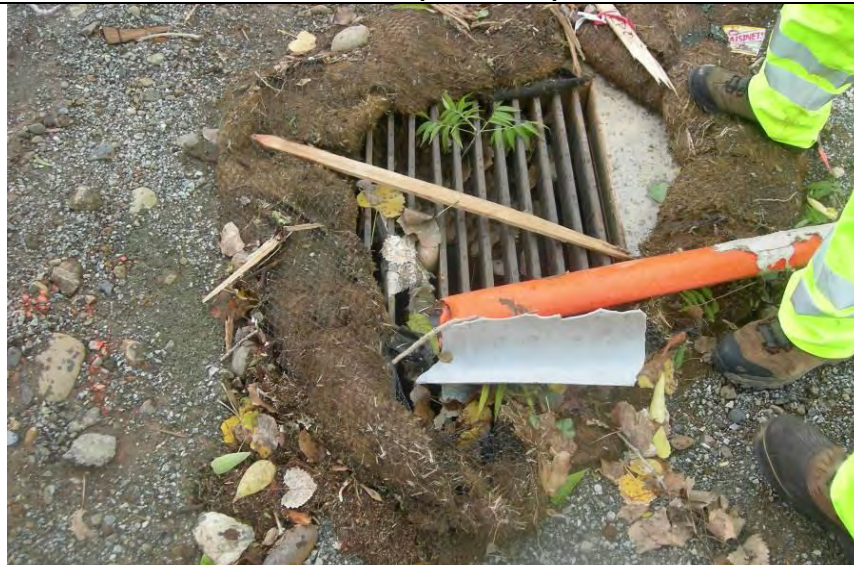
**Photograph 7 – Storm drain inlet at the northwestern portion of the Auditorium Drive Bridge temporary staging area**

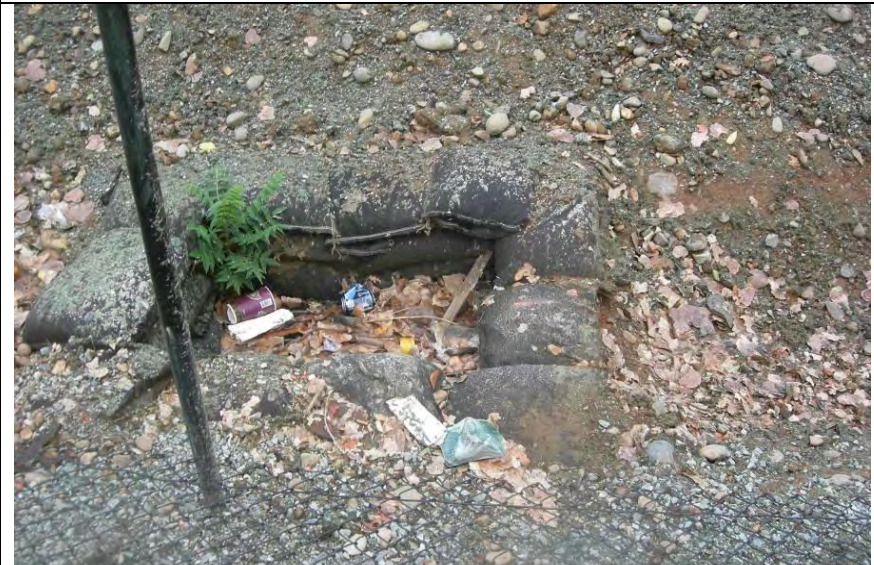
**Photograph 8 – Storm drain inlet located along the bike path adjacent to Interstate 5**

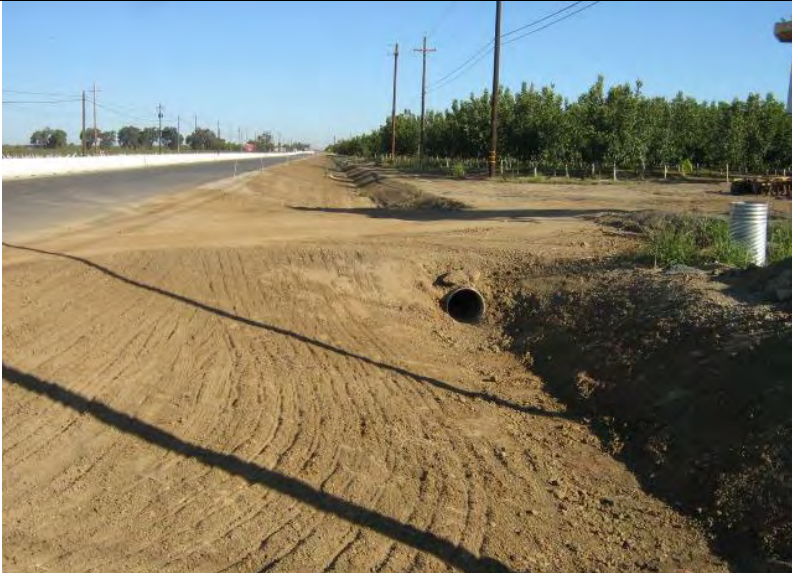
**Photograph 1 – Drainage swale adjacent to roadway without adequate BMPs implemented (Drill seeding only)**

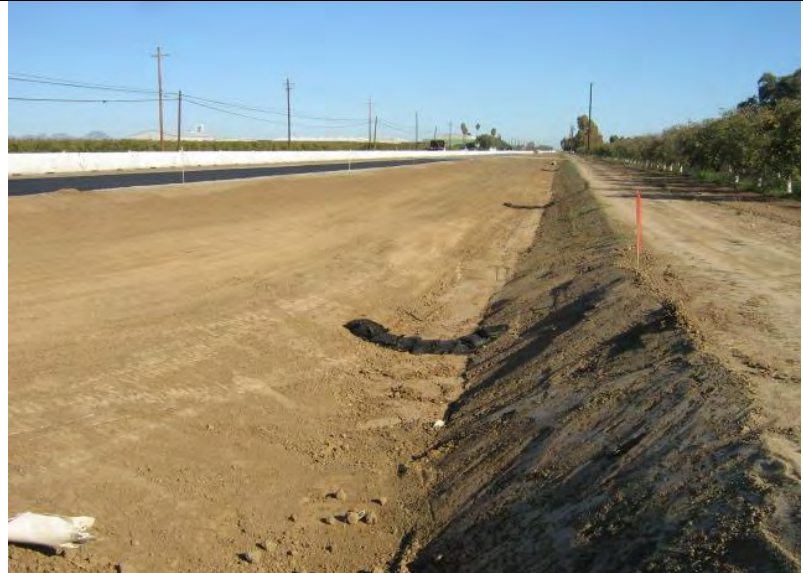
**Photograph 2 – Unstabilized drainage swale and slope adjacent to roadway**

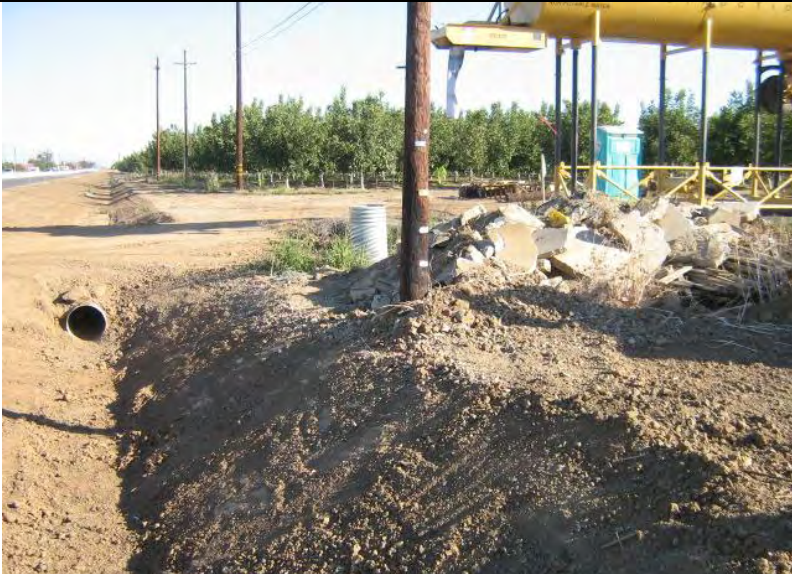
**Photograph 3 – Uncontained concrete waste adjacent to roadway drainage swale**

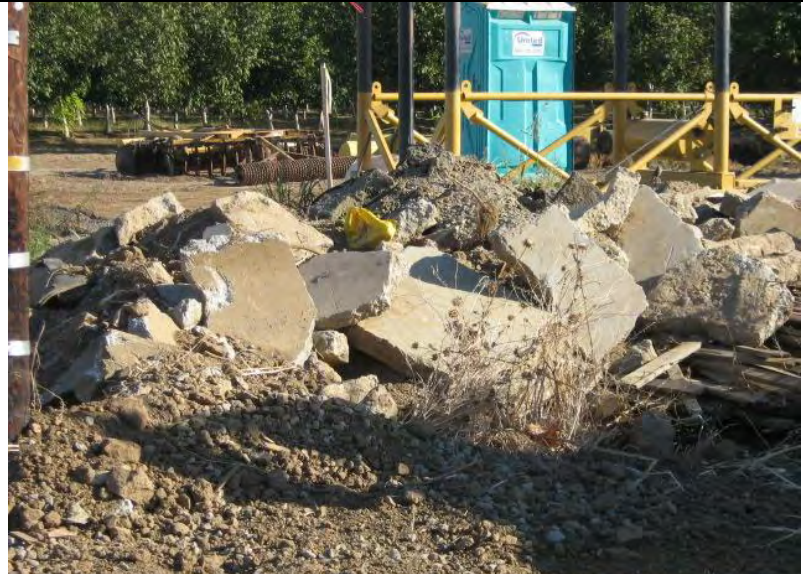
**Photograph 4 – Close-up of Photograph 3 and concrete waste**

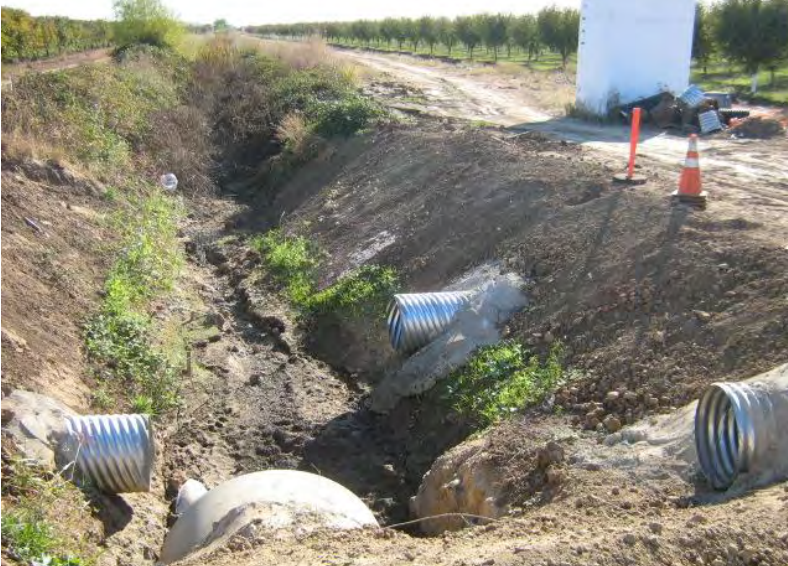
Photograph 5 – View looking upgradient on irrigation channel located adjacent to project. Note unstabilized slopes adj. to irrigation channel.

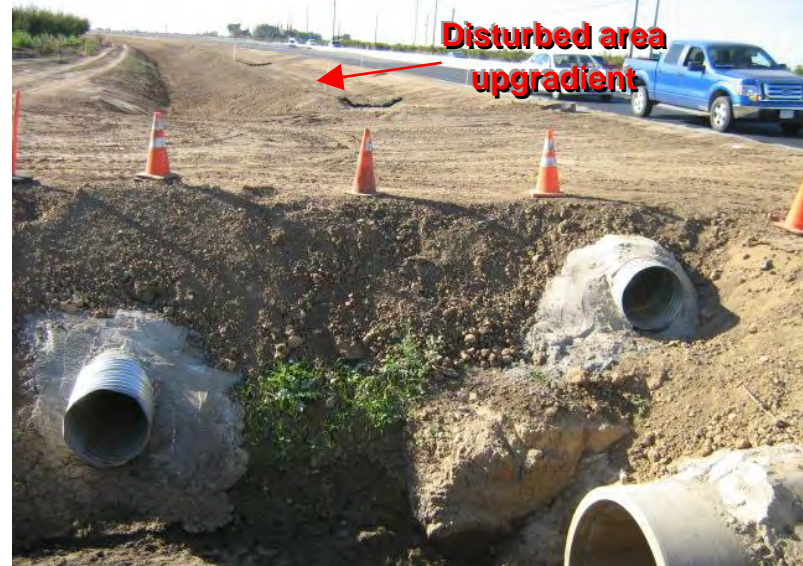
Photograph 6 – Culvert outlet pipes and disturbed embankment slope in irrigation ditch

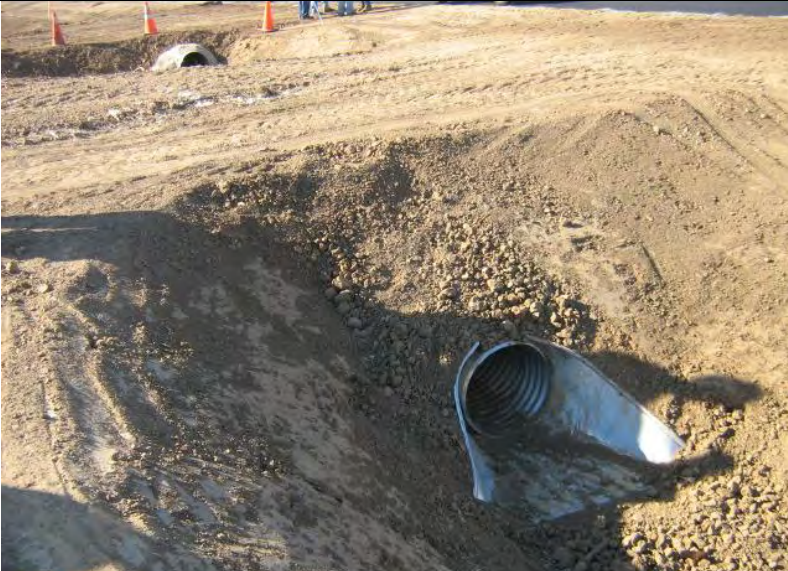
Photograph 7 – Culvert pipe inlet with no BMPs implemented – drains to irrigation ditch.

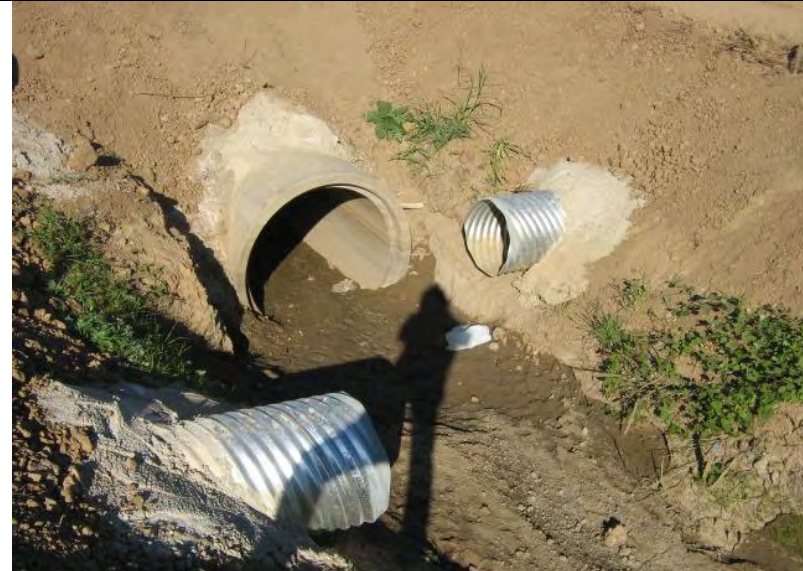
Photograph 8 – Culvert pipe outlet from Photograph 7 to irrigation channel.

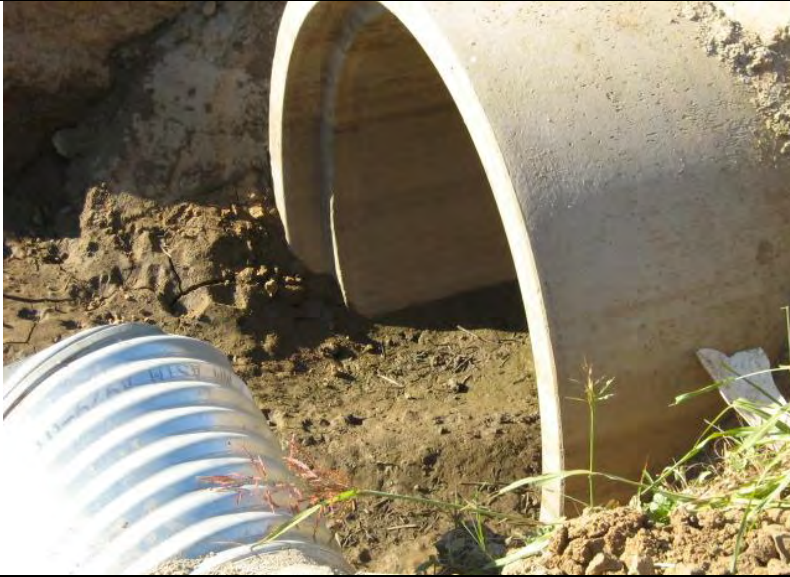
**Photograph 9 – Visible sediment accumulation in the irrigation channel and associated culvert pipe**

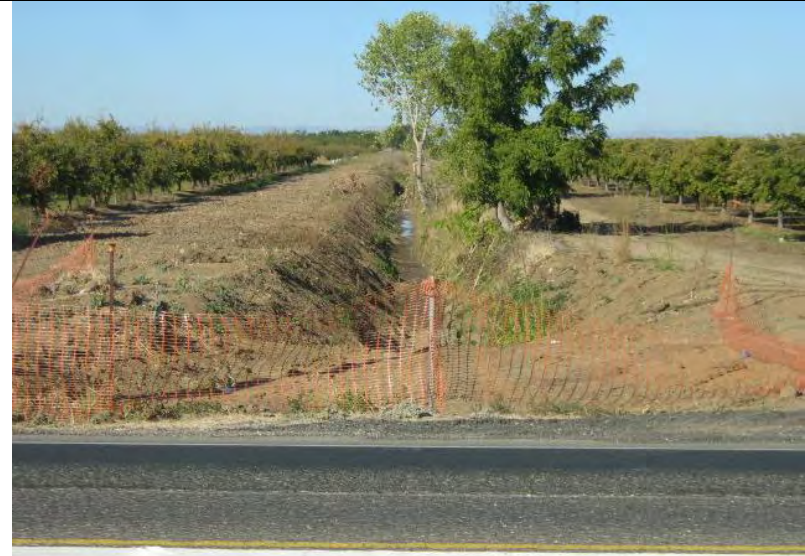
**Photograph 10- View of down-gradient irrigation channel below outlet.  
Note: Inlet to this area is shown in Photograph 9.**

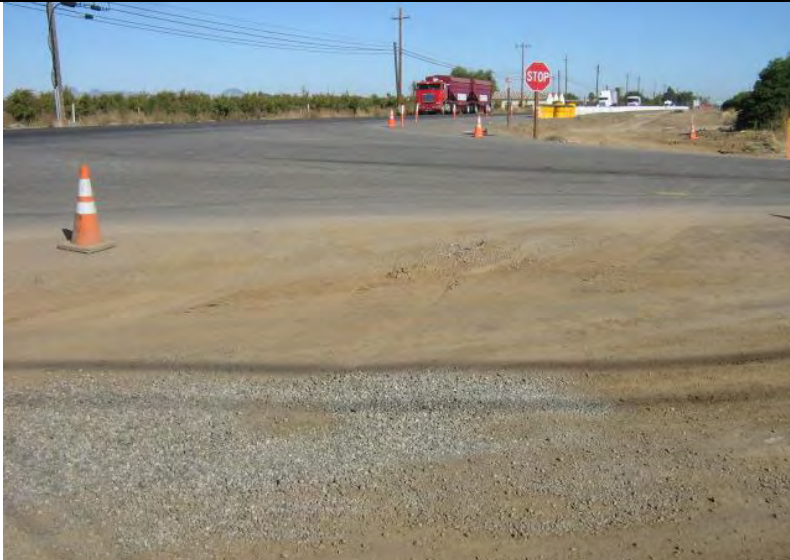
**Photograph 11 –Tracking control BMPs were not implemented near  
Station 346 + 70.**

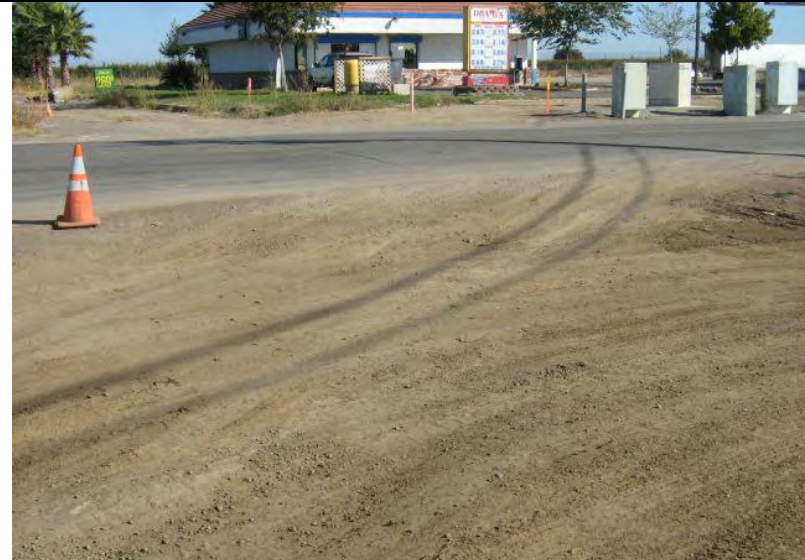
**Photograph 12 – No tracking control BMPs implemented at Sta. 346 + 70.**

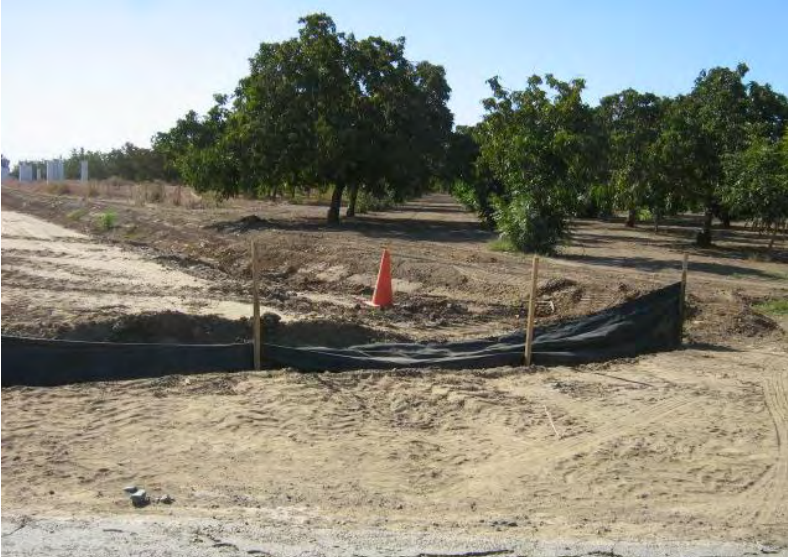
**Photograph 19 – Silt fence not adequately maintained (e.g., collapsed in areas) near the new Hwy 99 and Wilson Road intersection.**

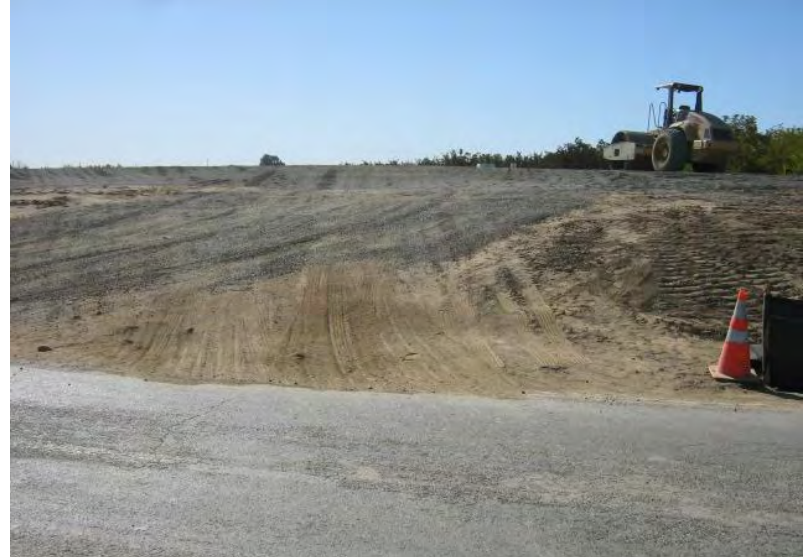
**Photograph 20 – Adequate tracking control BMPs had not been implemented at the Wilson Road intersection.**

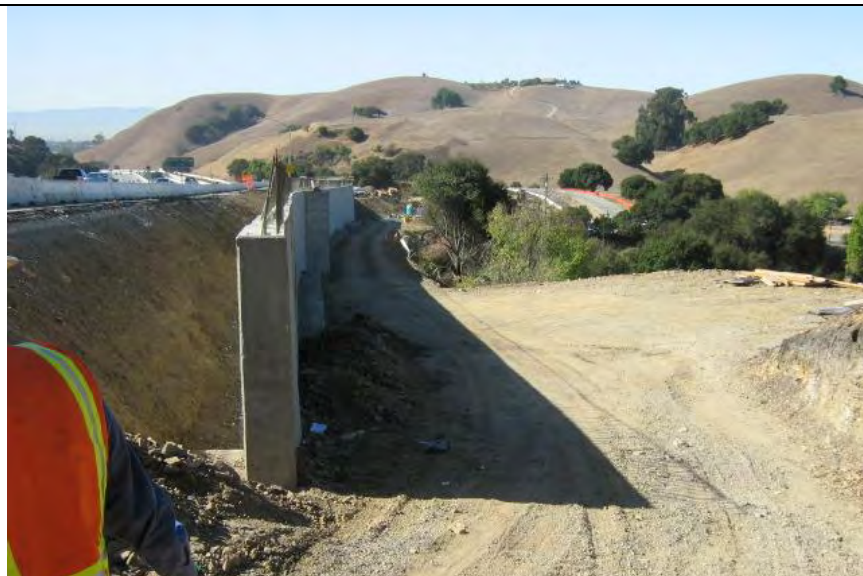
Photograph 1 – View down-gradient along access road

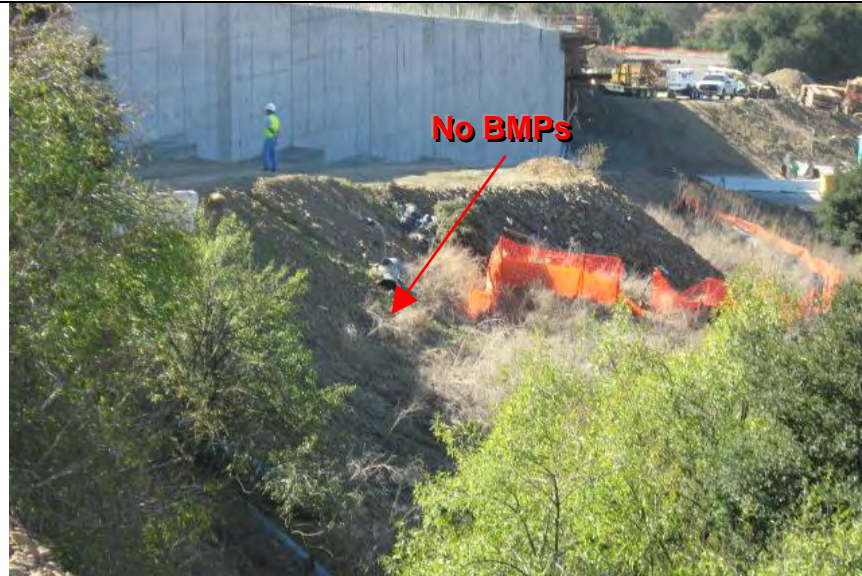
Photograph 5— Fill slope along access road without BMPs

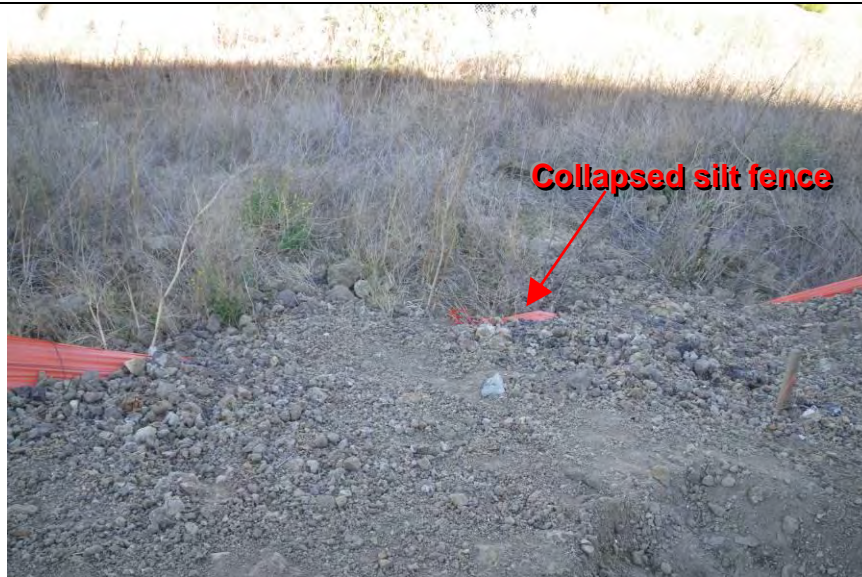
Photograph 7— Collapsed silt fence due to slide
