## **Appendix E**

### **Maintenance Program Site Visit Reports**

**Site Visit No. 16**

**Caltrans MS4 (SWRCB Order No. 99-06-DWQ)**  
**Willow Creek Highway Maintenance Facility**  
**Caltrans District 1**

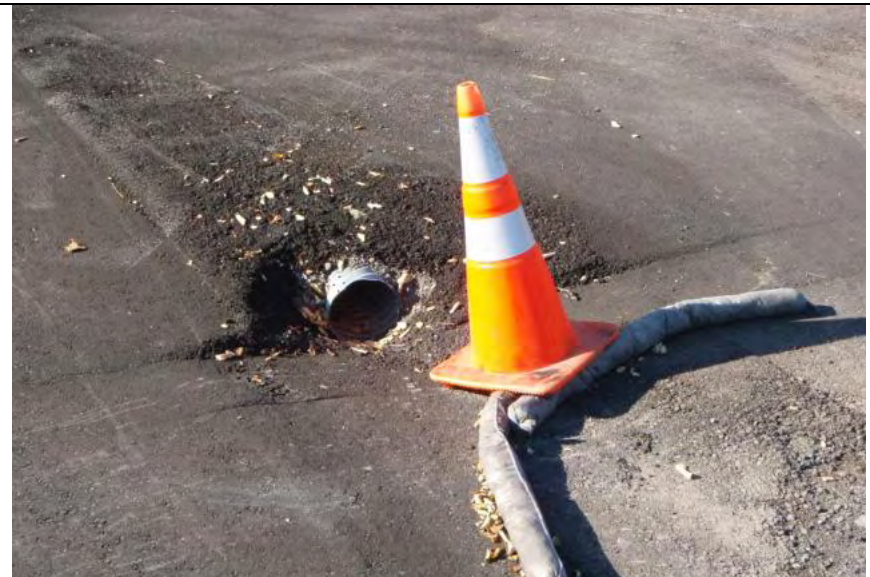
Photograph 2 – Culvert inlet that flows to northwest corner of facility

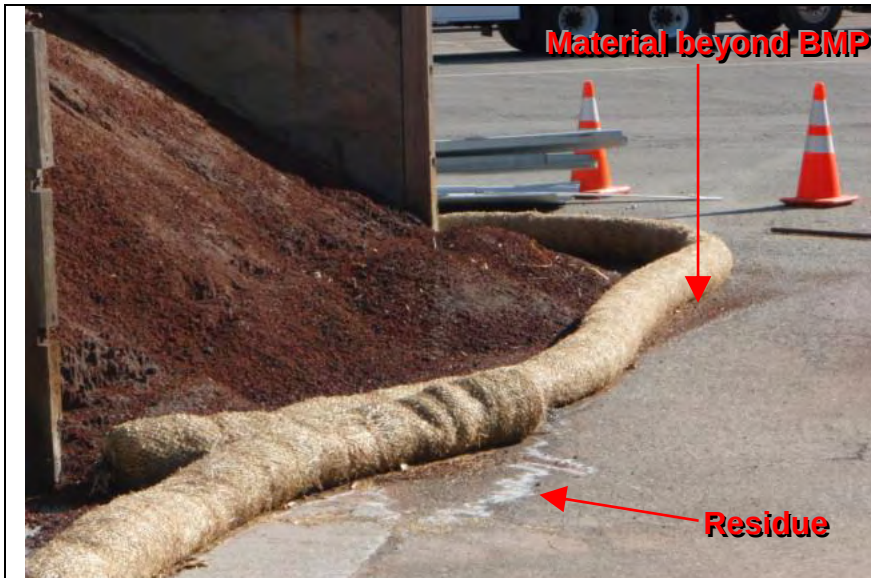
Photograph 9— Closer view of straw wattles implemented at edge of covered storage area

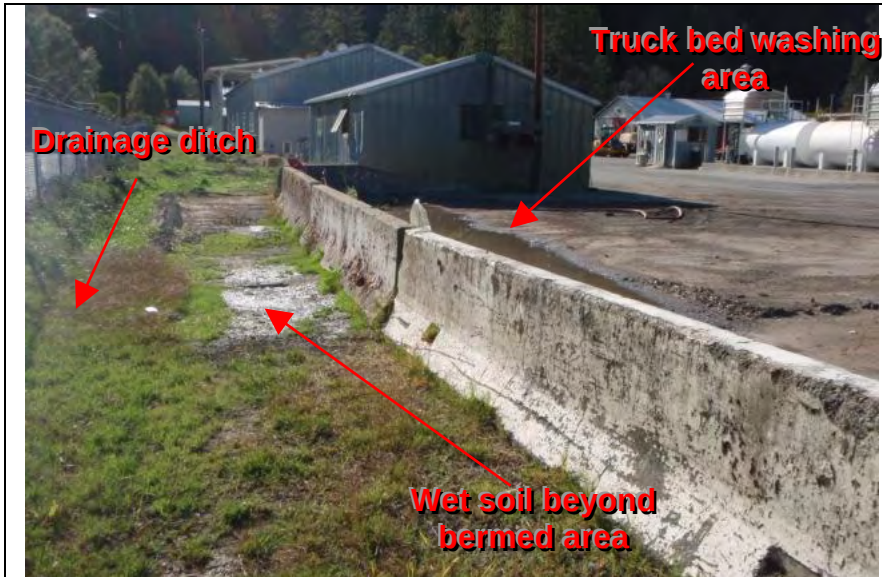
Photograph 13 – Another view of area used for truck bed washing

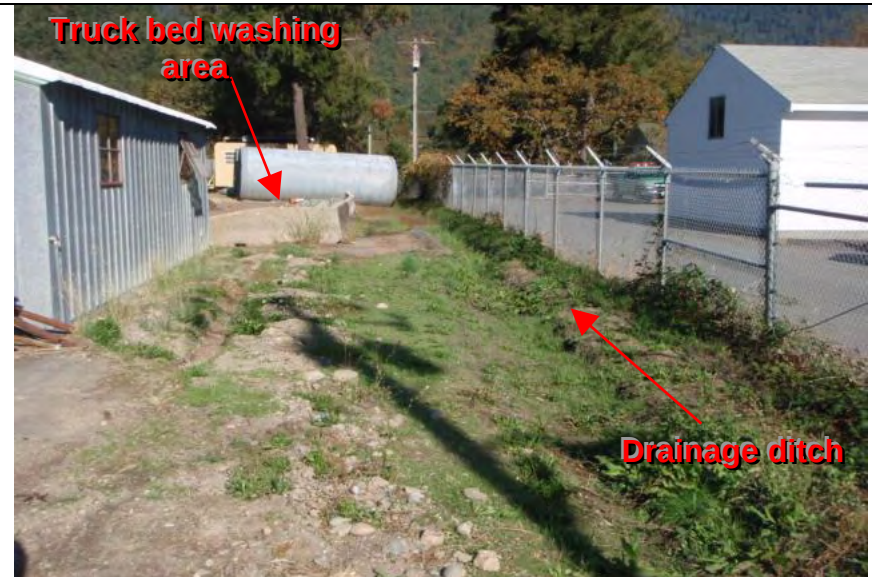
Photograph 14 – View of drainage ditch along southern edge of facility

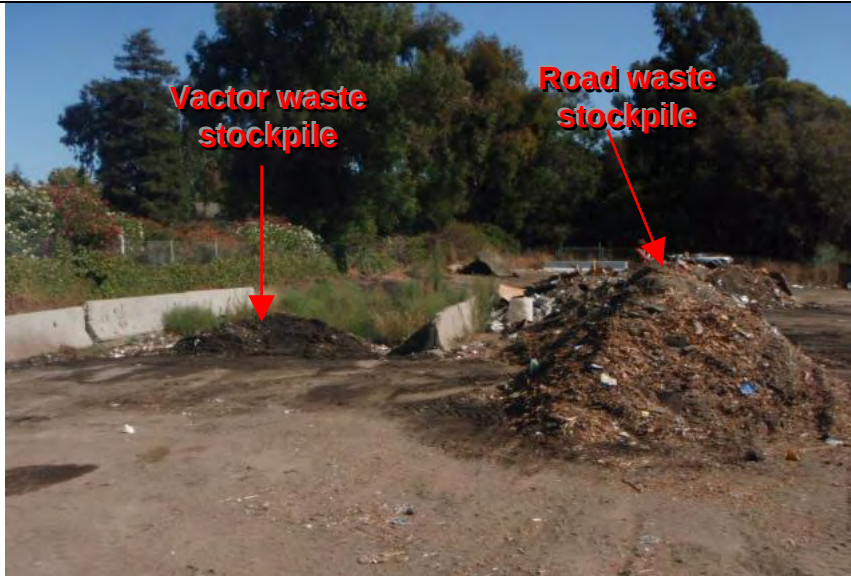
Photograph 1 –Waste stockpiles at the facility

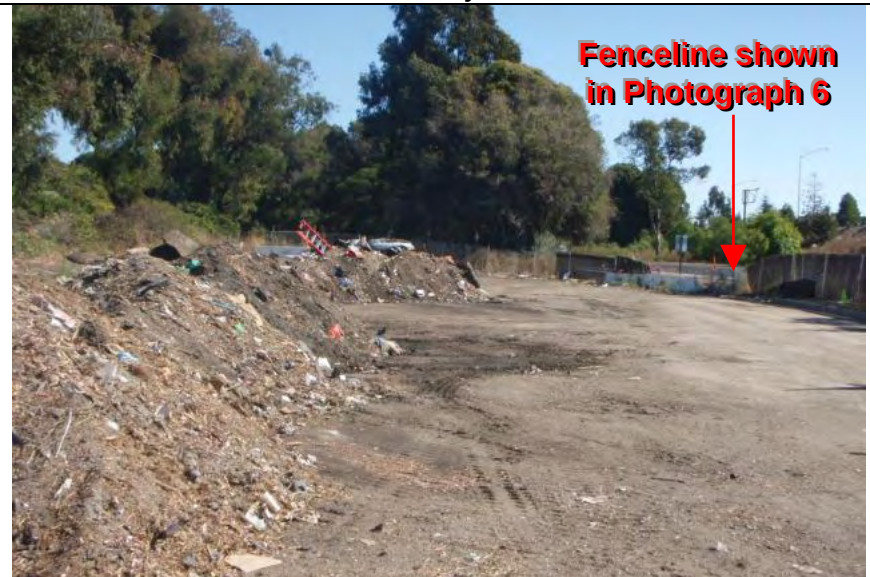
Photograph 4 – View of waste stockpiles and proximity to fenceline

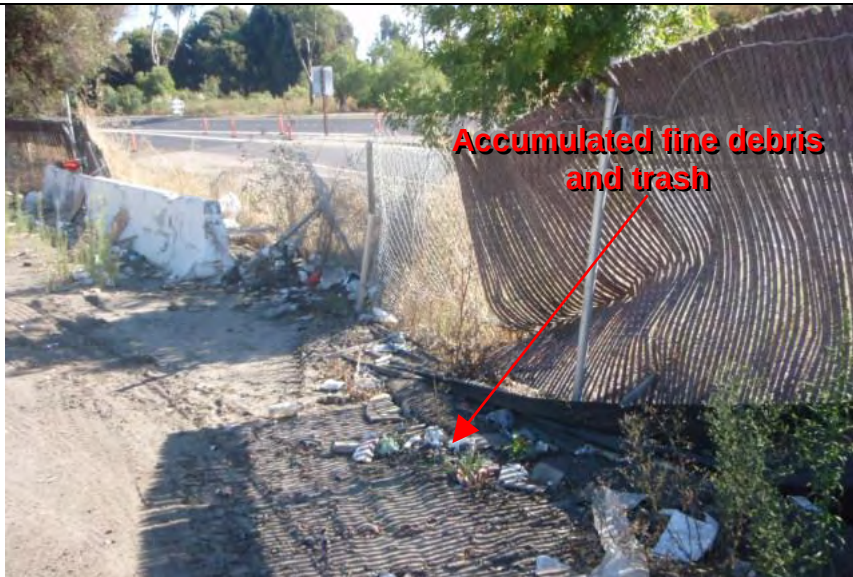
Despite the availability of a designated wash area at the nearby San Leandro Maintenance Yard, a road sweeper pre-washing area was observed along the fenceline of the facility. The pre-washing area is not equipped to properly capture, treat, re-use, or dispose of vehicle wash water and associated pollutants ([see Photographs 6 and 7](#)). As explained by a Caltrans roadway maintenance supervisor from the San Leandro Maintenance Yard, road sweepers are hosed off at the Washington Temporary Storage Site at the end of a working day before they return to the San Leandro Maintenance Yard to be cleaned in the facility’s dedicated wash area. The maintenance supervisor added that this practice is performed to remove large waste from the sweeper before it is in the wash area, so the trough drain at the maintenance yard does not fill up as quickly. It was

Photograph 7 – View of site boundary down-gradient of road sweeper pre-washing area

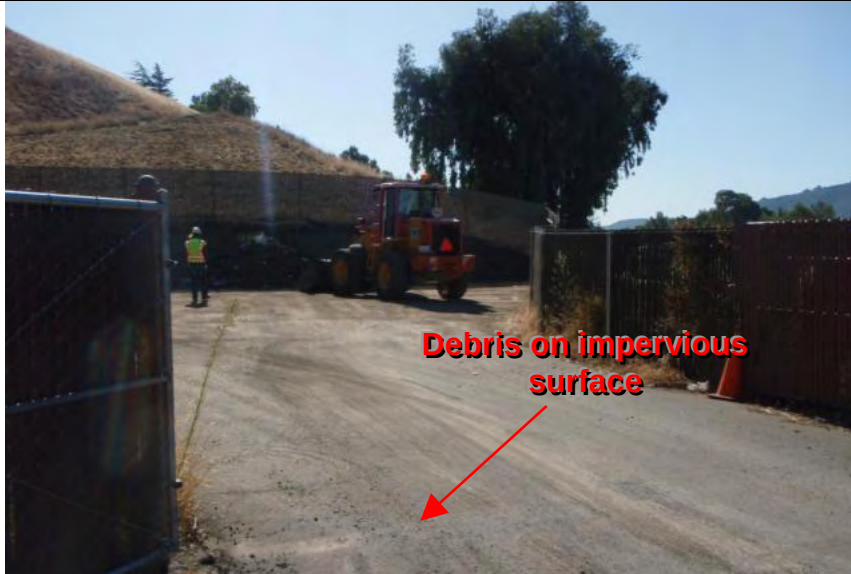
Photograph 1 – Entrance to temporary storage site. (Note: Impervious roadway entrance and tracking of debris)

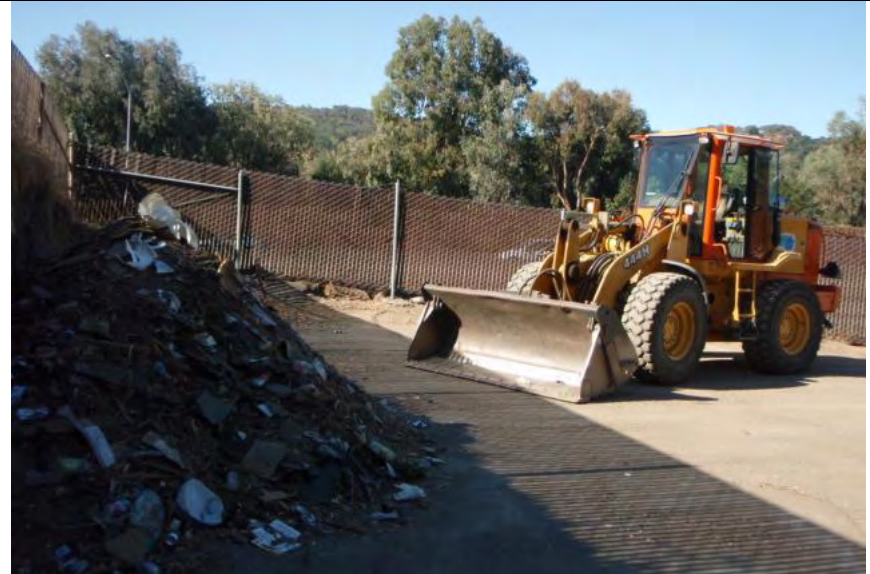
Because collected road sweepings and debris contain fine pollutant particles and non-visible pollutants, the stockpile management techniques outlined in the Maintenance Staff Guide are not adequate to contain the collected waste. In addition, the EPA Audit Team noted that BMPs were not stored at the facility for implementation in the event of precipitation prior to October 15<sup>th</sup>.

Photograph 2 – Waste from road sweeping and other road cleaning activities

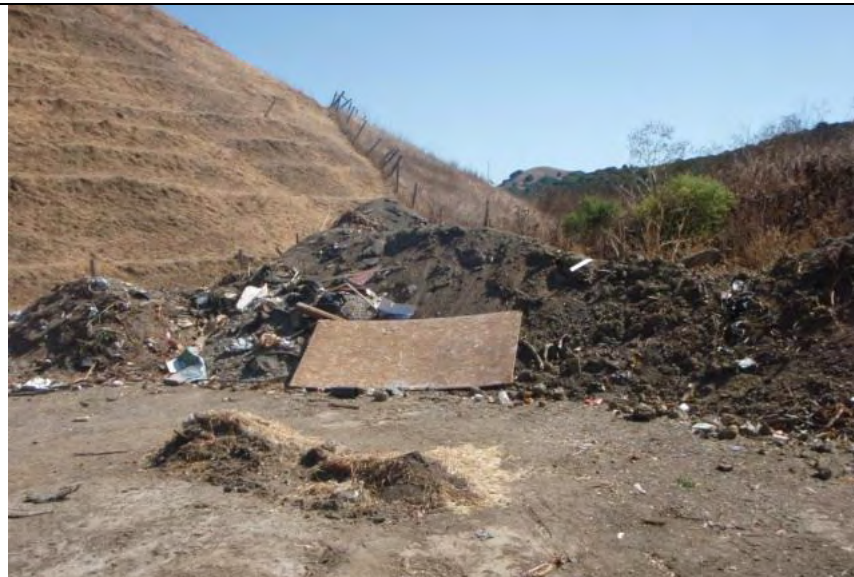
Photograph 3 – Close-up view of debris stockpile from road sweeping and other road cleaning activity

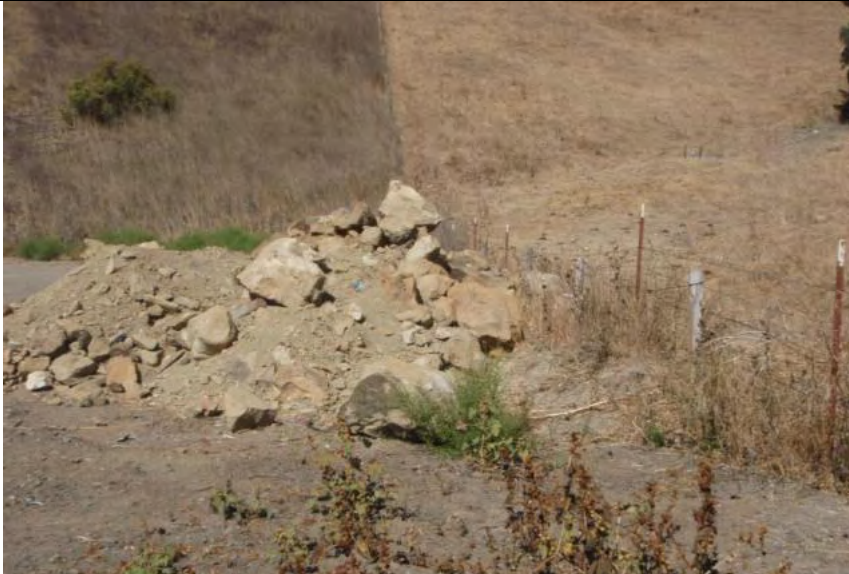
Additionally, coverage and containment BMPs had not been implemented for a sweeper and roadway waste stockpile at the Schaefer Ranch Waste Storage site and there was a potential for the contribution of pollutants to storm water runoff (see Photographs 3, 4, and 5). Specifically, the EPA Audit Team observed a culvert in the northwestern part of the site which a Caltrans staff member stated is connected to Caltrans’ storm water conveyance system (see Photograph 6). An unmaintained, collapsed silt fence BMP was observed up-gradient of the culvert inlet (see Photograph 7). A Caltrans staff member explained that perimeter control BMPs had not yet been implemented for the stockpile because at the time of the audit it was prior to the October 15<sup>th</sup> start of the rainy season. He added that straw wattles would be placed around the debris pile on the ground surface in accordance with the stockpile management techniques outlined in the Caltrans Stormwater Quality Handbook – Maintenance Staff Guide.

Photograph 5 – Note lack of BMPs for containment around stockpile and the stockpile's proximity to the fenceline

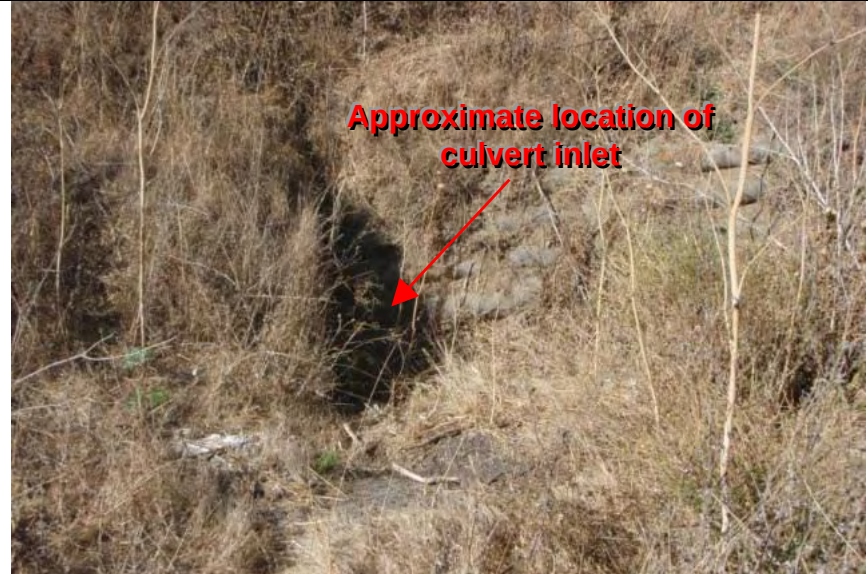
Photograph 6 – Location of culvert inlet in the northwestern portion of the waste storage site

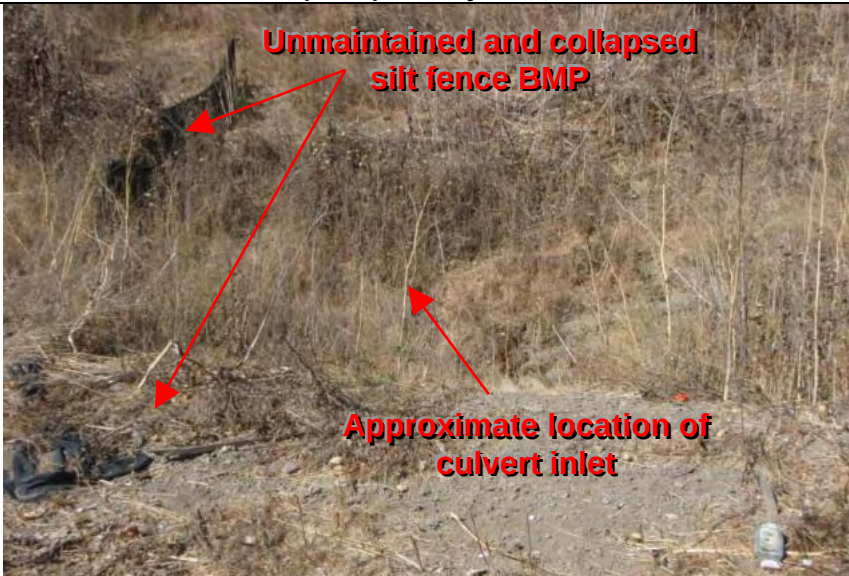
Photograph 7 – Location of culvert inlet and unmaintained and collapsed silt fence BMP up-gradient of inlet

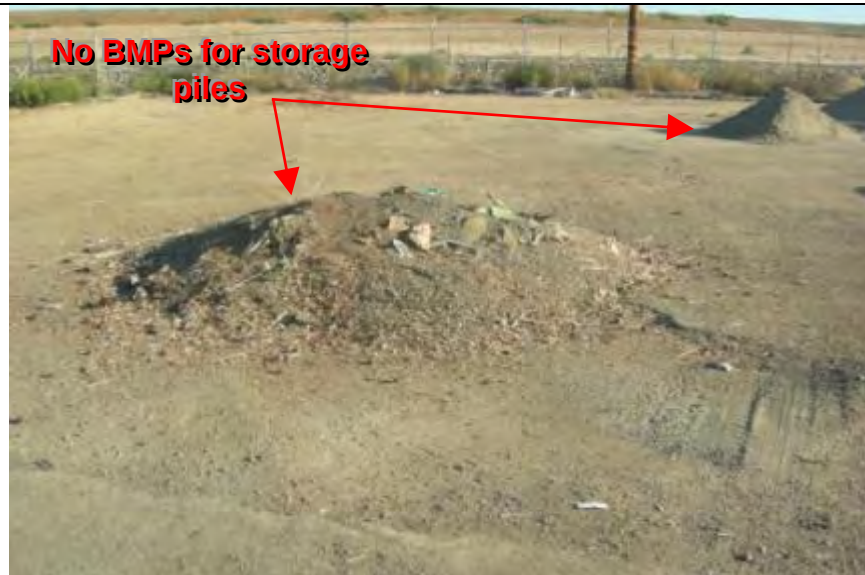
Photograph 1 – View of sweeper waste storage pile at the Marysville Maintenance Station

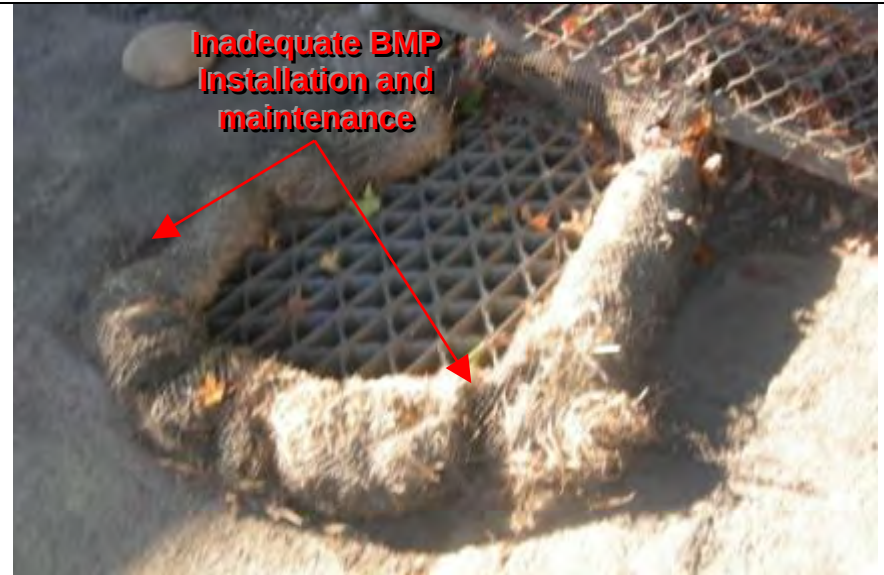
Photograph 4 – Storm drain inlet on the east side of the Marysville Maintenance Station office building

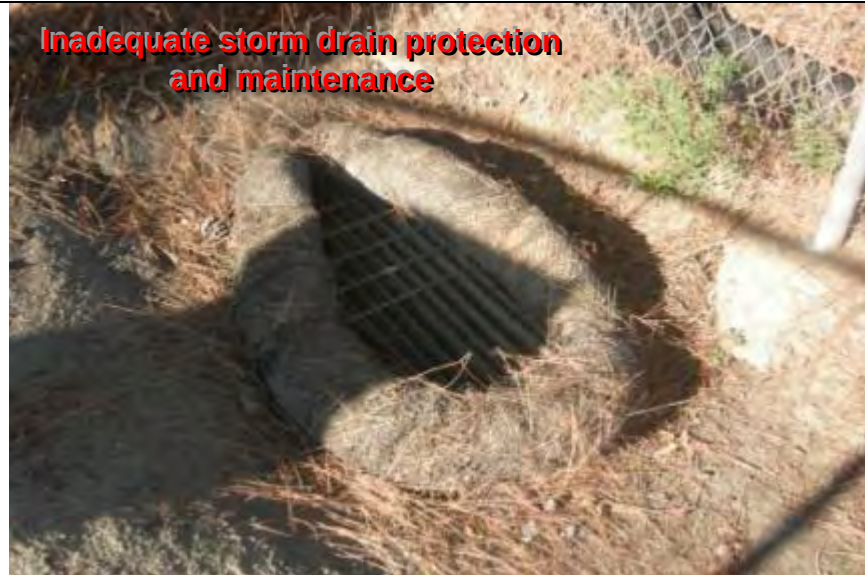
Photograph 5— Storm drain inlet to the west of the Marysville Maintenance Station office building

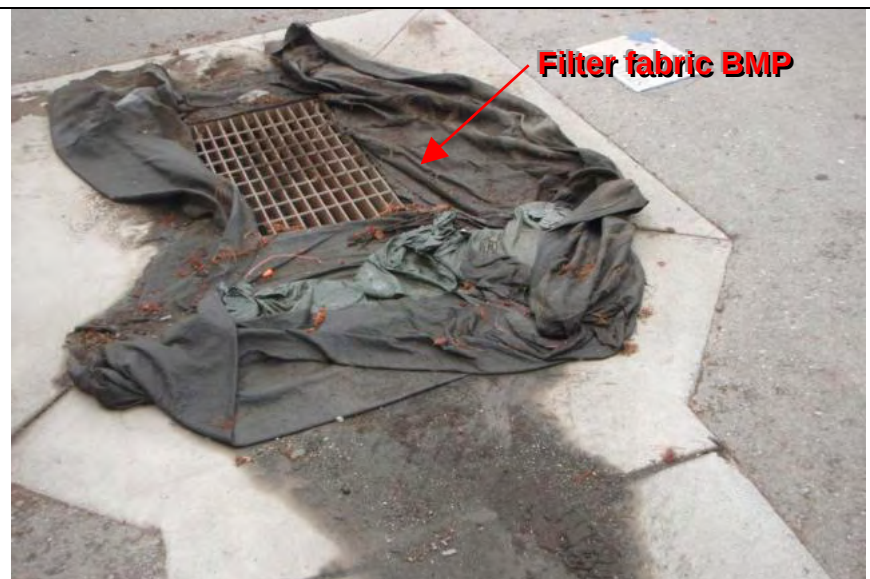
Filter fabric had been installed in one of the adjacent storm drain inlets and absorbent booms had been placed around the other inlet (see Photographs 4 and 5). However, the BMPs implemented for inlet protection were not properly maintained and significant pollutant accumulation was observed around the inlets. Furthermore, sand bags containing debris had been used for weights on top of the absorbent booms placed around one of the storm drain inlets, and several of the bags were no longer securely closed (see Photograph 6).

Photograph 4 – Second storm drain inlet near road sweeper washing area. Inlet is just out of the picture to the bottom left of Photograph 3.

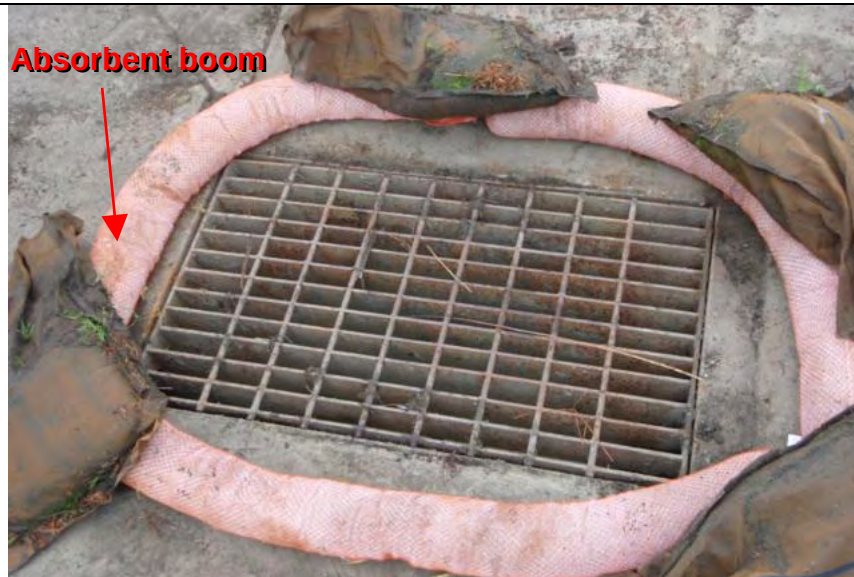
Photograph 5— Closer view of storm drain inlet shown in Photograph 3

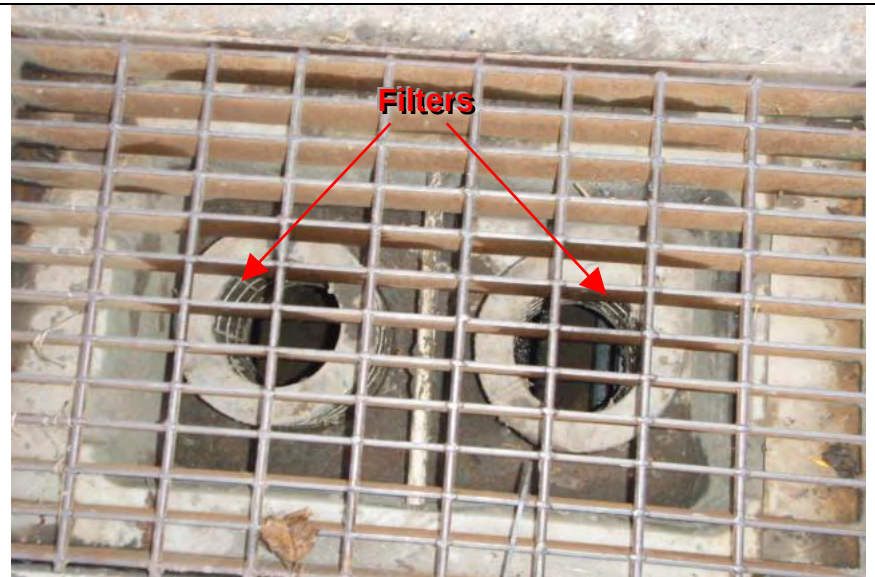
Additional storm drain inlet filters at the facility (see Photograph 8) did not appear to have been recently cleaned or maintained and debris accumulation was observed in the filter units and inlets (see Photograph 9). It was not clear when maintenance had been last performed on the filters.

Photograph 8 – View into another storm drain inlet at the facility

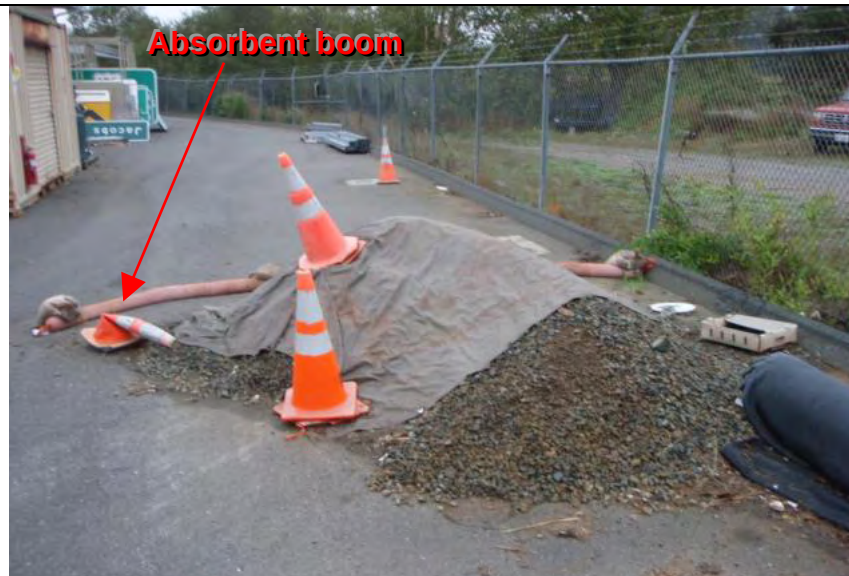
In a separate location along the eastern edge of the facility, a stockpile of gravel and sediment did not have properly selected and implemented BMPs for stockpile management (see Photograph 10). Specifically, the stockpile was only partially covered and perimeter controls had only been implemented around a portion of the stockpile. Furthermore, absorbent booms are not intended to be used on impervious surfaces as sediment control.

Photograph 10 – Partially covered and contained stockpile along eastern edge of facility

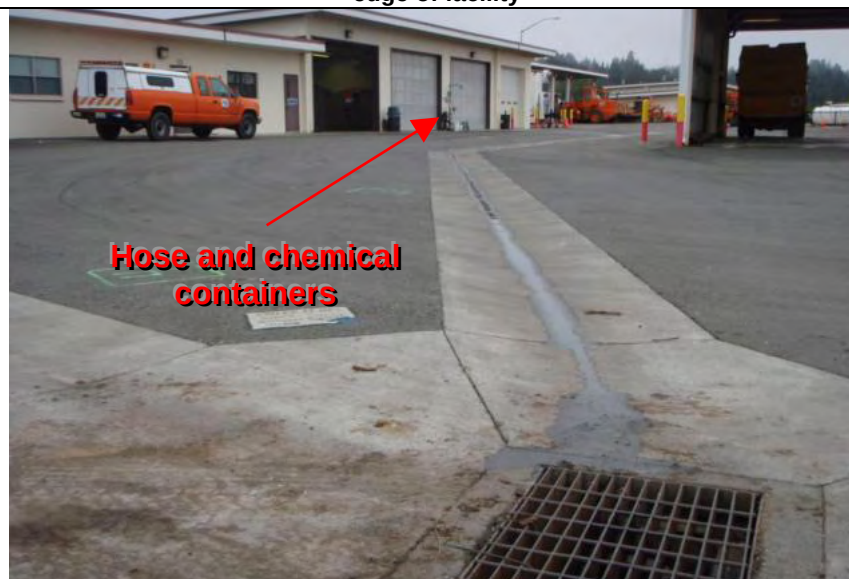
Two containers of a cleaning agent were improperly stored adjacent to a concrete drainage swale and leaking hose along the eastern side of the facility (see Photograph 11). The containers were not stored within secondary containment, and as a result, there was a potential for the contribution of wash water and pollutants to storm water runoff, and subsequently to a down-gradient storm drain inlet (see Photograph 12).

Photograph 12— View from down-gradient storm drain inlet to location of hose and chemical containers pictured in Photograph 11

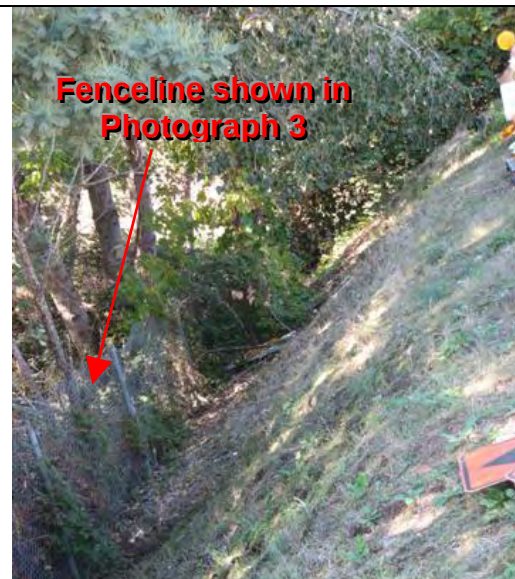
Photograph 4 – View of drainage ditch leading toward South Fork Eel River

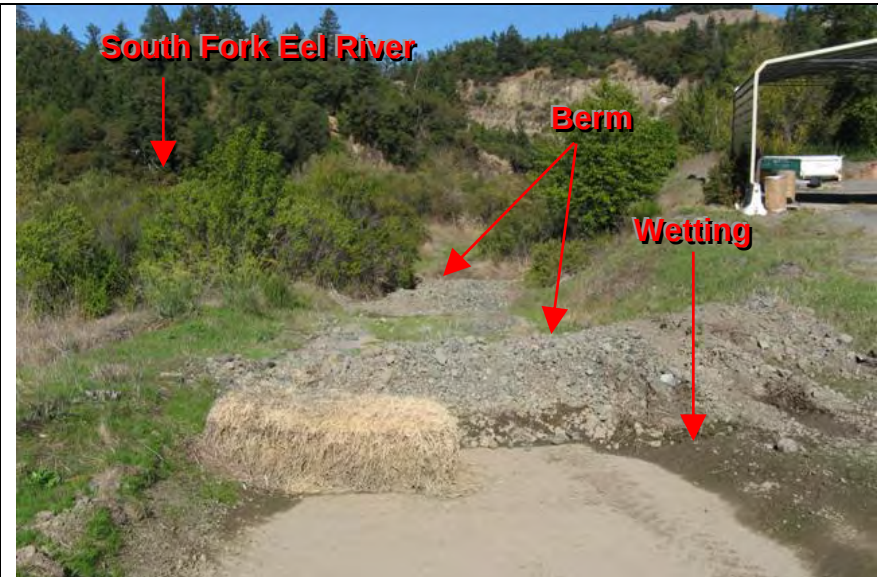
Despite the availability of the designated wash rack, a vehicle pre-washing area was observed in the lower yard (see Photograph 5). The lower yard is located west of the main office and maintenance facility, in much closer proximity to the South Fork Eel River. The pre-washing area is not equipped to properly capture, treat, re-use, or dispose of vehicle wash water and associated pollutants. Additionally, a berm installed down-gradient of the vehicle pre-washing area showed signs of standing water and had been damaged (see Photographs 6 and 7).

Photograph 6 – View down-gradient of pre-washing area

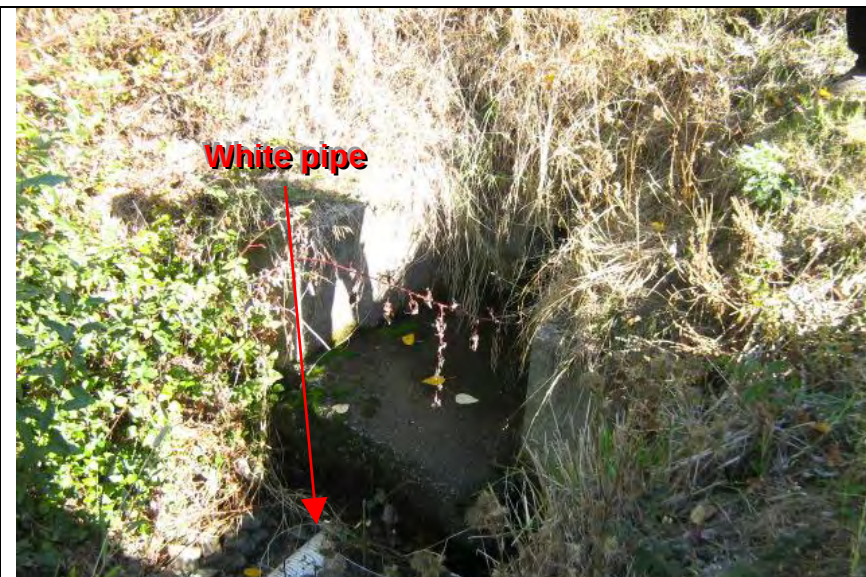
Outlet protection and flow dissipation BMPs were not in place below a drainage pipe leading from the facility (see Photograph 10). As a result, there was a potential for erosion and scouring at the pipe outlet leading to the South Fork Eel River (see Photographs 11 and 12).

Photograph 10 – Facility outfall

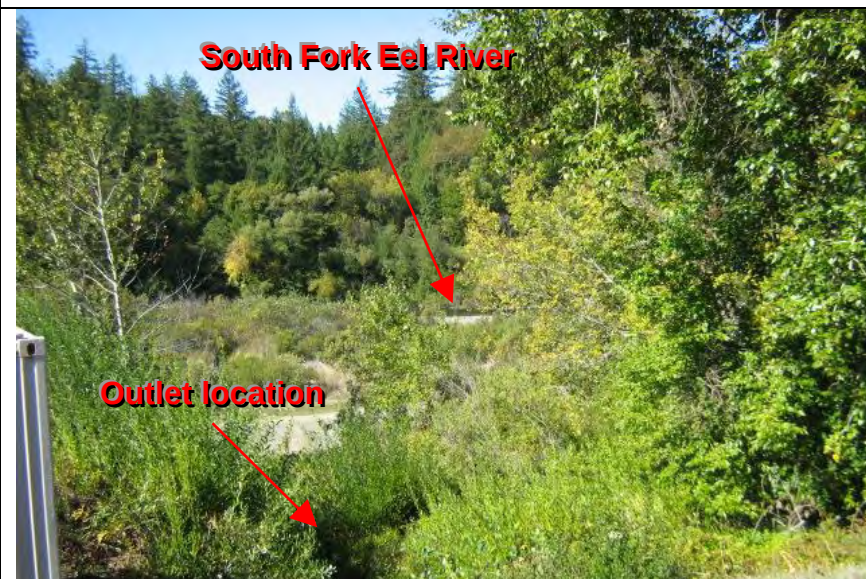
Photograph 12— Proximity of outlet to receiving water

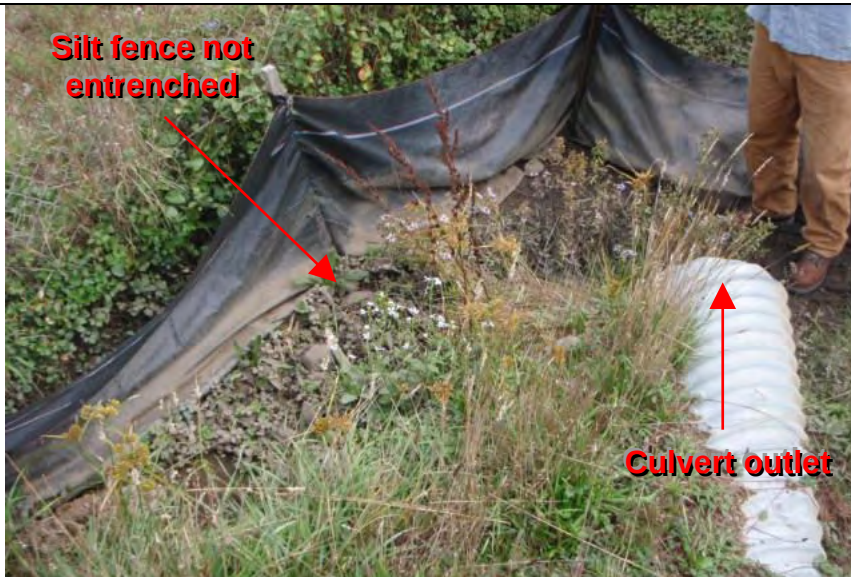
Provision I.3.b of the Permit requires Caltrans to provide appropriate site-specific BMPs for all maintenance facilities. A significant amount of sediment accumulation was observed within a storm drain inlet at the facility that did not appear to have been recently cleaned (see Photographs 1 and 2). As explained by the Highway Maintenance Supervisor, storm drain inlets at the facility flow to the drainage ditch in the southeast corner of the facility (see Photograph 3). He added that storm water runoff does not generally discharge off-site from this location but rather ponds and remains as standing water until it infiltrates into the ground. Nonetheless, evidence of sediment discharged to the drainage ditch as well as sediment accumulation within the culvert pipe that discharges to the southeast corner of the facility was observed (see Photograph 5). Furthermore, a silt fence BMP had been installed in the flow pathway of the culvert outlet and was not entrenched into the ground to retain sediment and prevent failure (see Photograph 3).

Photograph 3 – Storm drain outlet to drainage ditch in southeast corner of facility

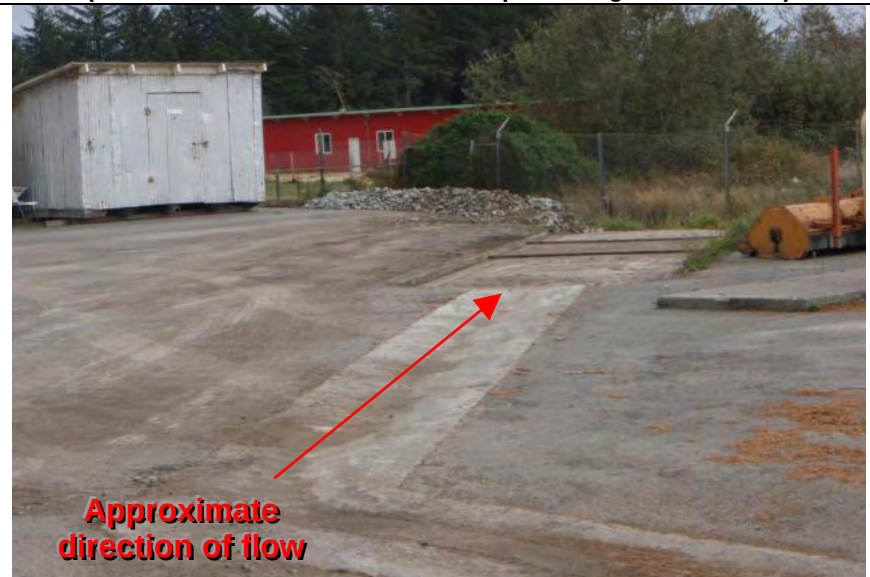
Photograph 8 – View of surface drainage system through stockpile area

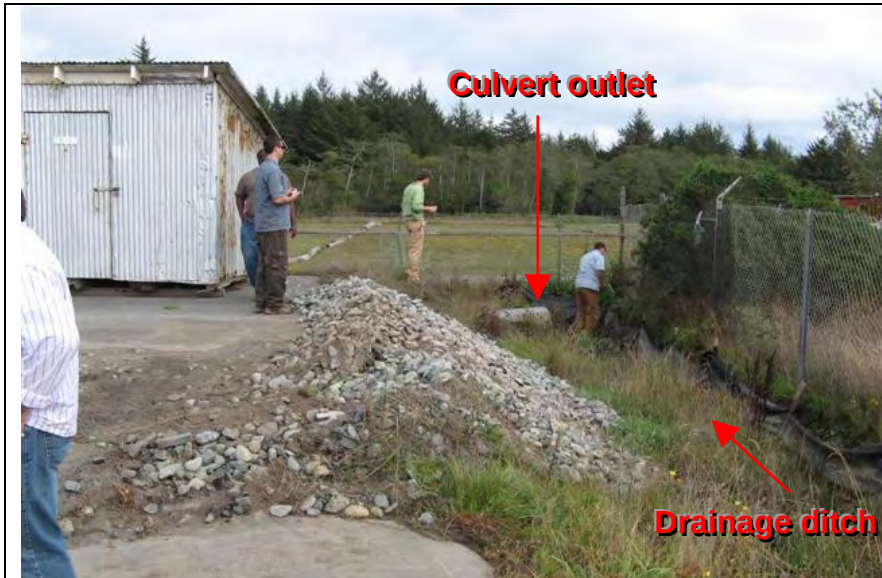
In addition, a significant amount of sediment accumulation was observed on the impervious ground surface near the southeast corner of the facility (see Photographs 6 and 7). As explained by the Highway Maintenance Supervisor, the area was used as a temporary stockpile location for washout material from front loaders and dump trucks. Whether the equipment washout operation was conducted with dry or wet processes was unclear. Appendix D of the Caltrans SWMP, Section 2.15.1, Vehicle and Equipment Cleaning, states “when possible, truck beds should be cleaned using dry cleanup technique (sweep up or shovel out).” It should also be noted that the stockpile area was located directly in the flow pathway of the surface drainage system at the facility (see Photograph 8). As a result, there was a potential for the discharge of sediment and other pollutants to the drainage ditch along the southern edge of the facility (see Photograph 9).

Photograph 9— View of drainage ditch and storm drain system culvert outlet

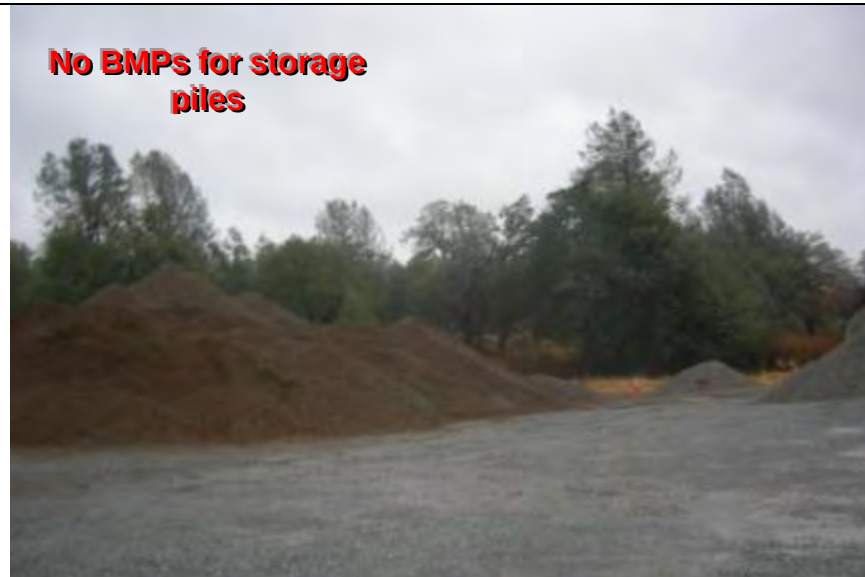
Photograph 1 – View of stockpiles

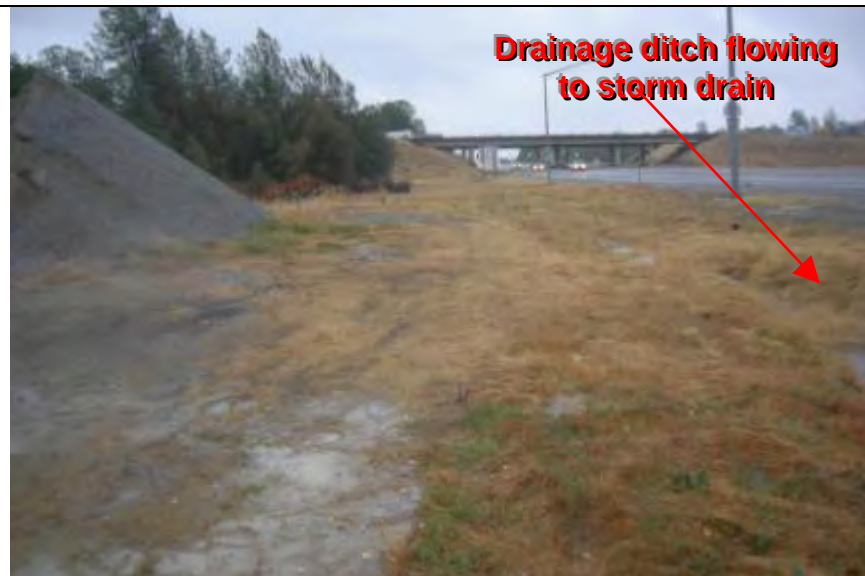
Photograph 3 – View of Photograph 2 stockpile proximity to drainage ditch

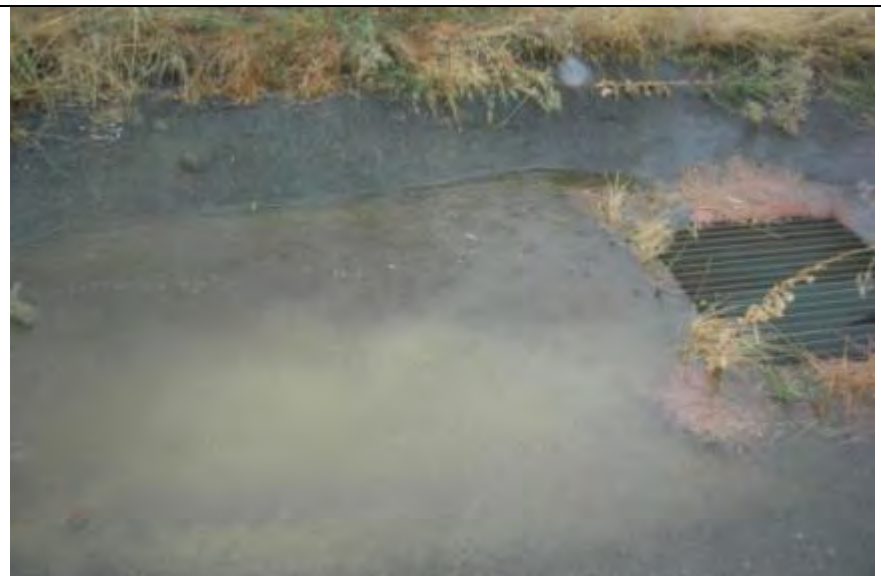
Photograph 4 – Storm drain inlet adjacent to temporary storage area

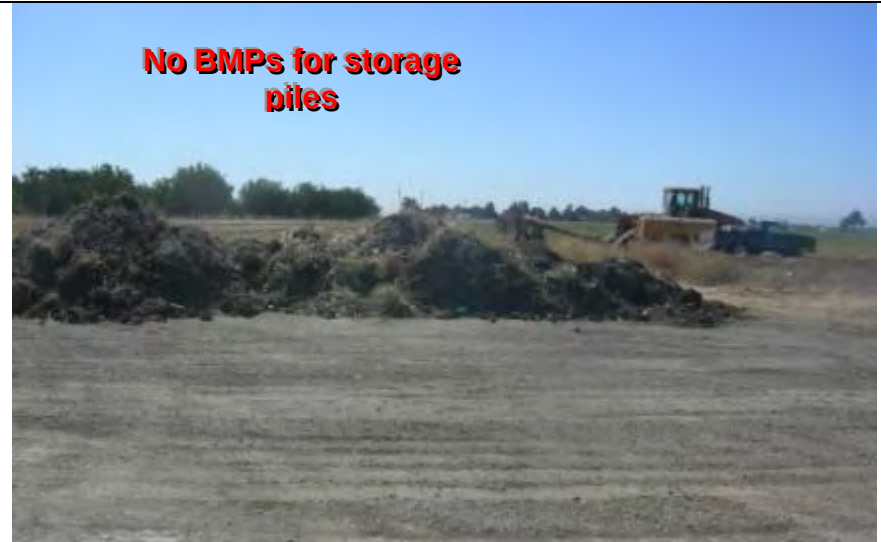
Photograph 2 – Lack of BMPs to contain stockpiled soils from tree removal

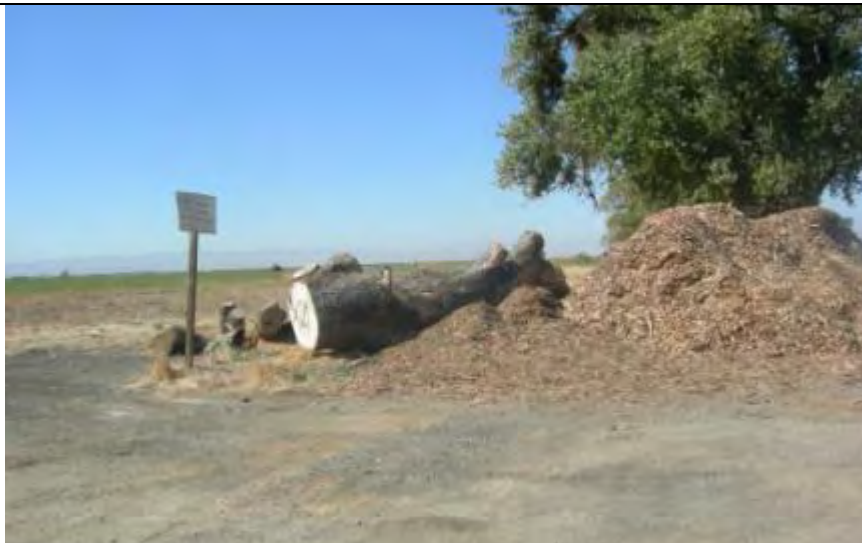
Photograph 3 – View of tree trimming debris
