Leak Detection & Repair

Blue Print to Water Resource Management

COMMONWEALTH UTILITIES CORPORATION WATER DIVISION

Leak Detection and Repair Phase II

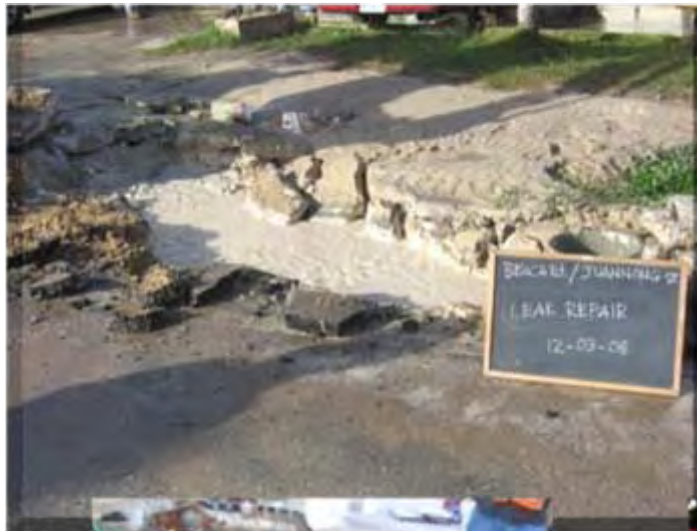
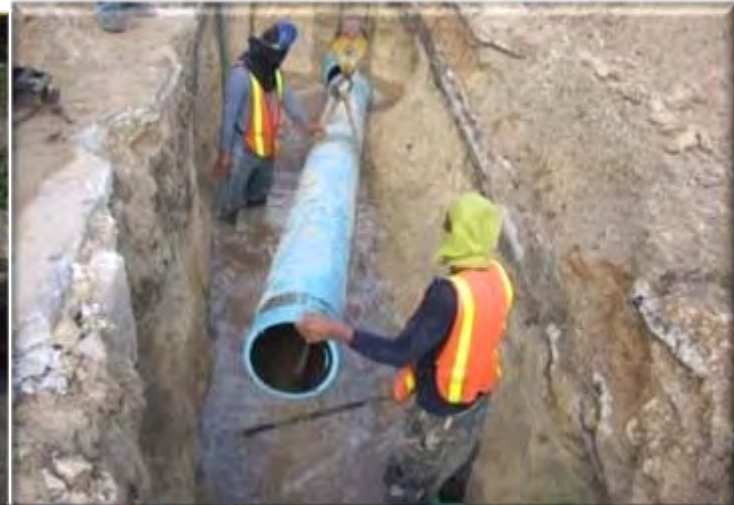
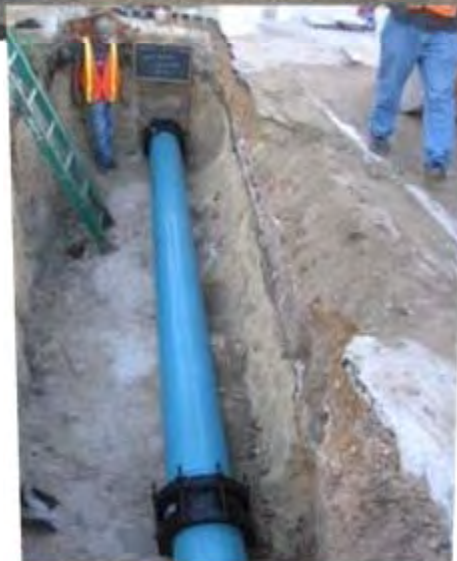
Chalan Kanoa

Leak Repair – 12" Ø PVC

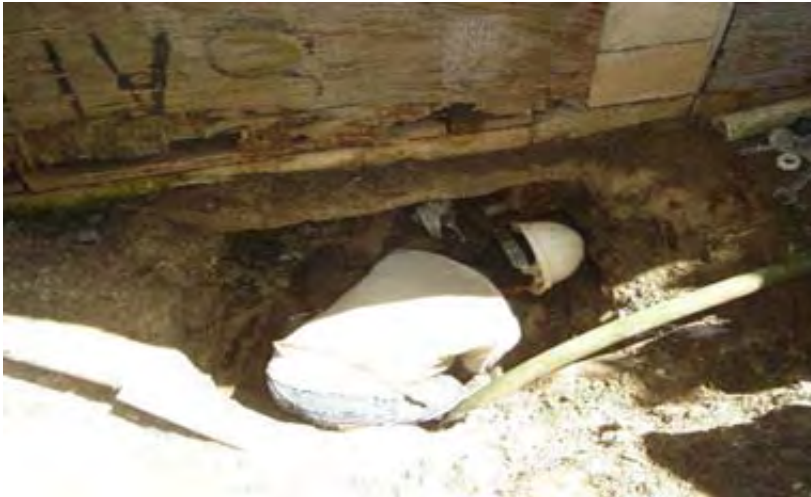
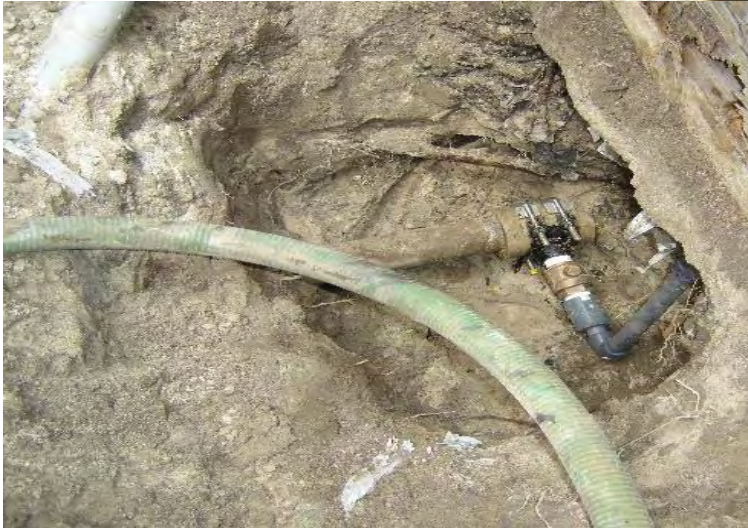
Leak Repair –6" x 2" Service Saddle and 2" Corporation Stop
San Antonio

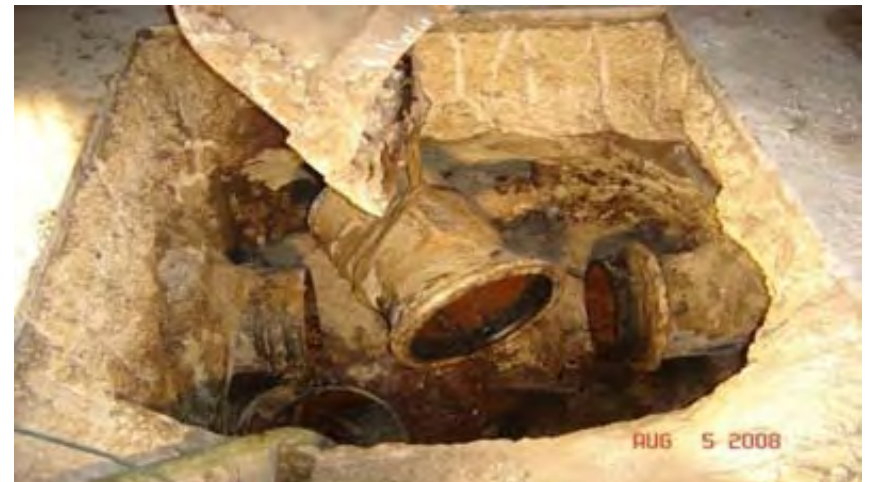
Butterfly Valve Installation—18" Ø Butterfly Valve
As Perdido

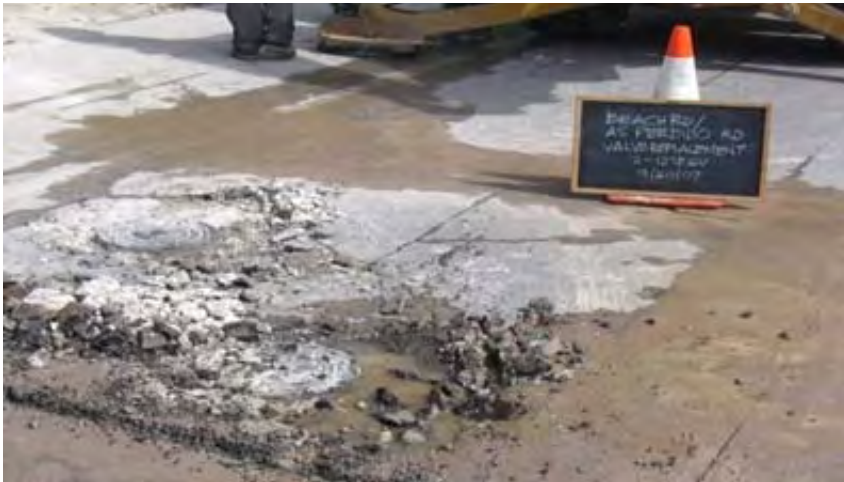
Gate Valve Replacement –12" Ø Gate Valve
As Perdido

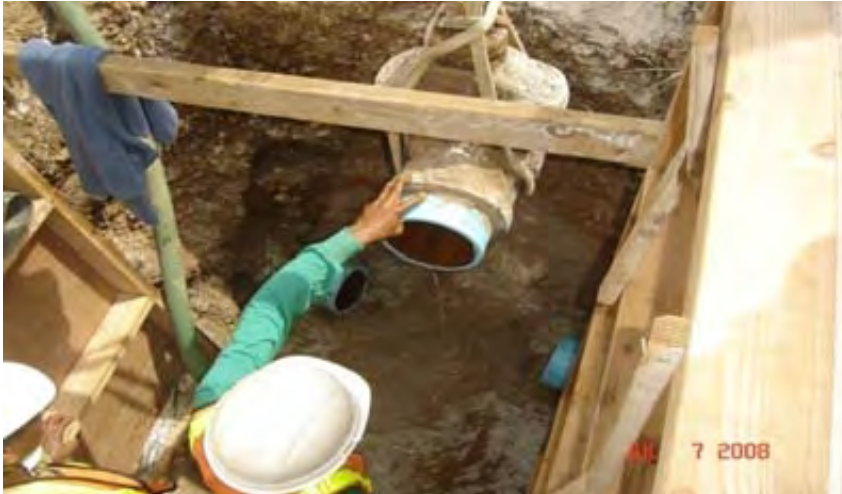
Gate Valve Replacement—8" Ø Gate Valve
Koblerville

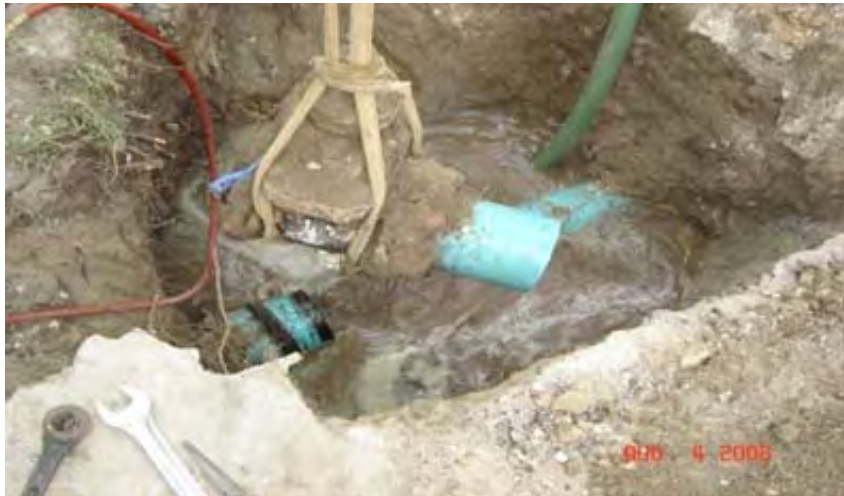
San Antonio

Gate Valve Replacement –6" and 12" Ø Gate Valve

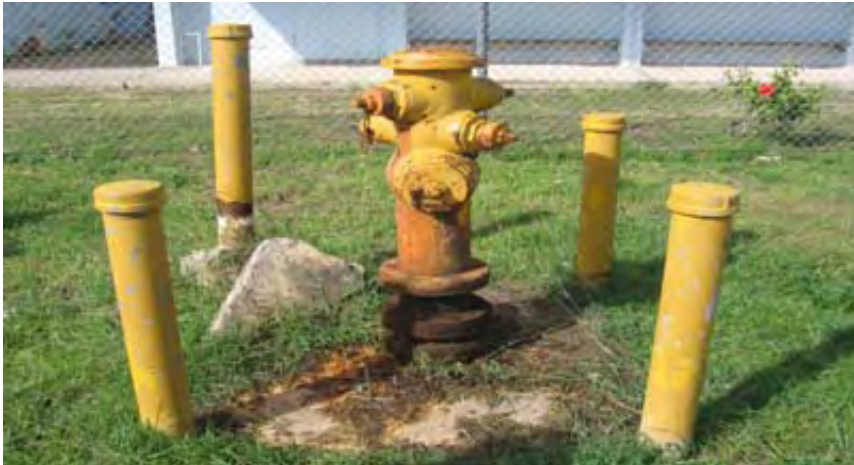
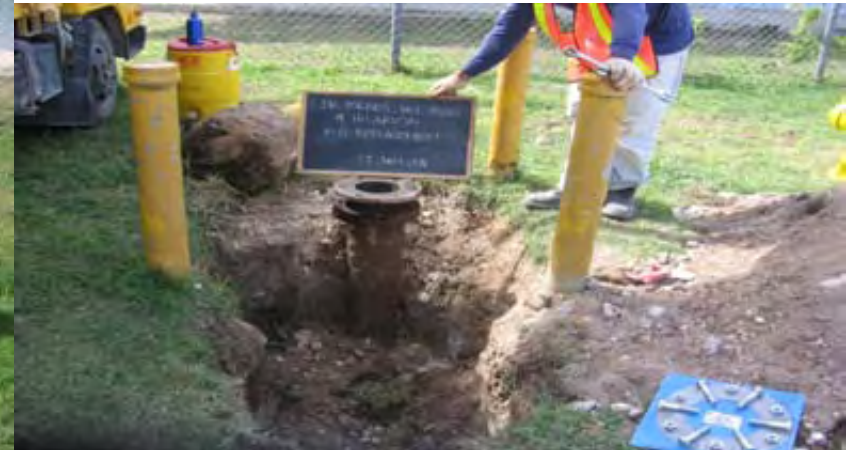
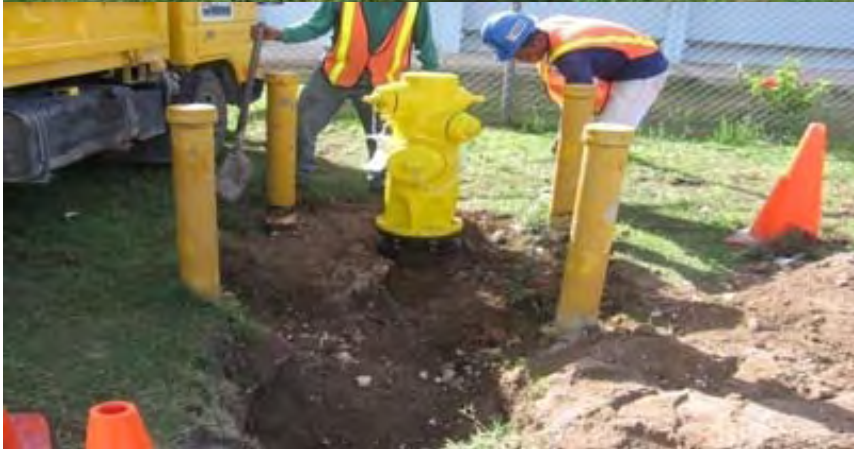
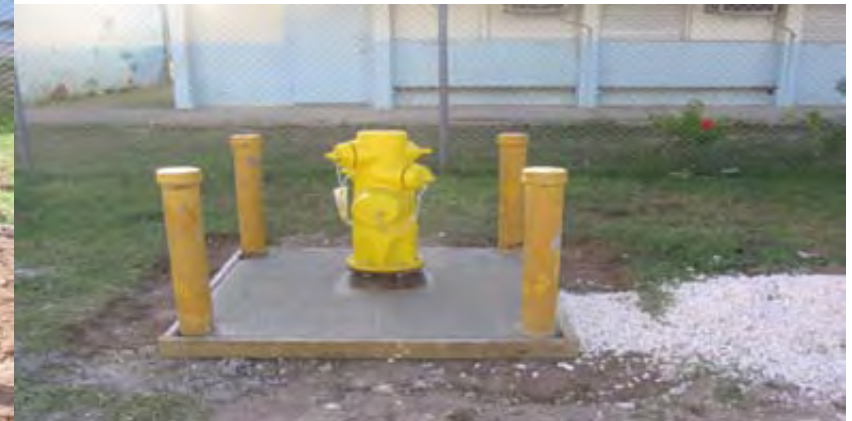
Chalan Kanoa

Replacement of Fire Hydrant & Assemblies

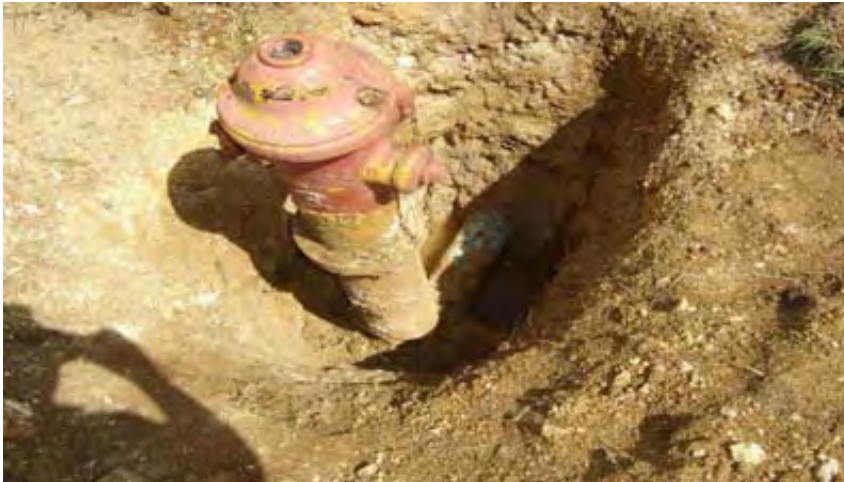
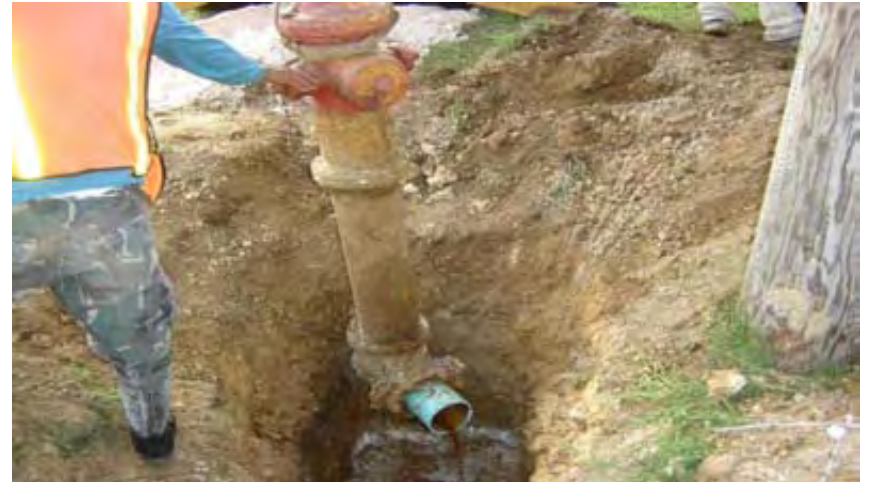
Replacement of Fire Hydrant & Assemblies
Koblerville

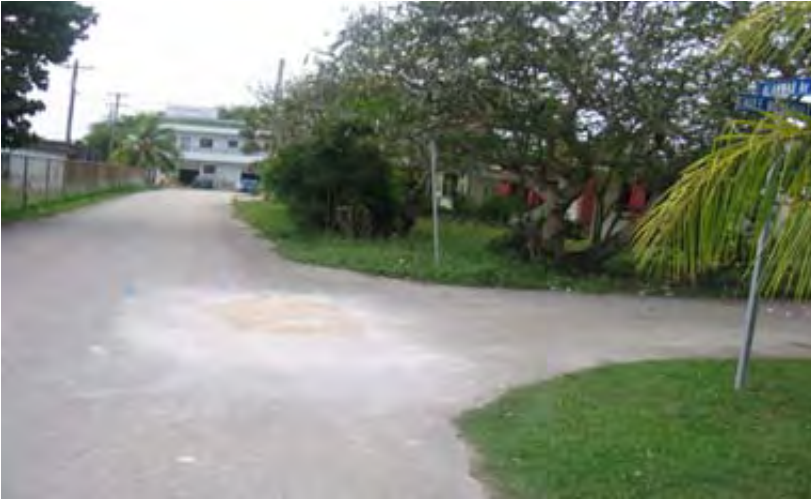
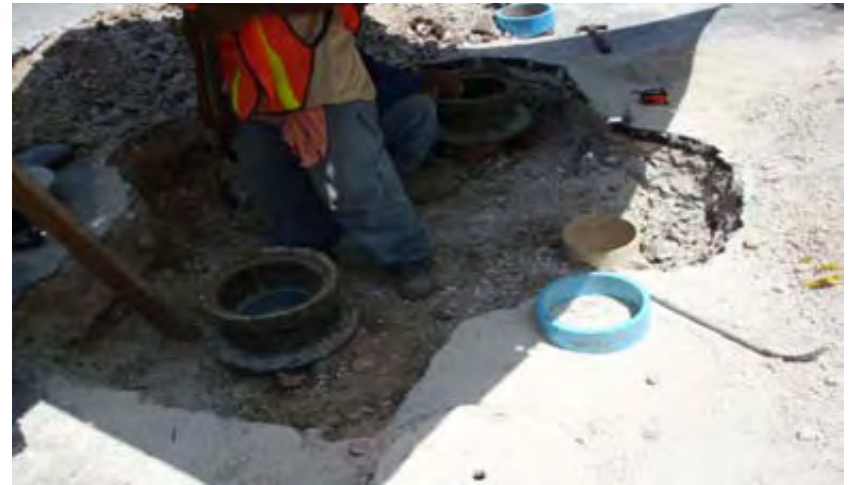
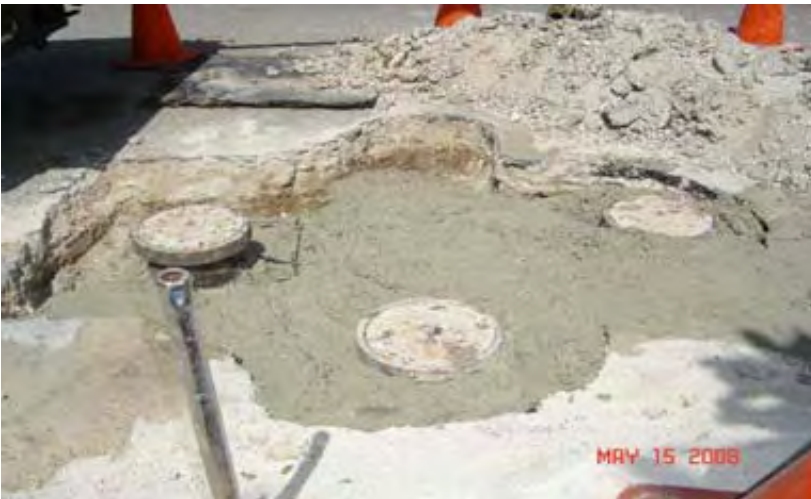
Valve Box Raising
Chalan Kanoa

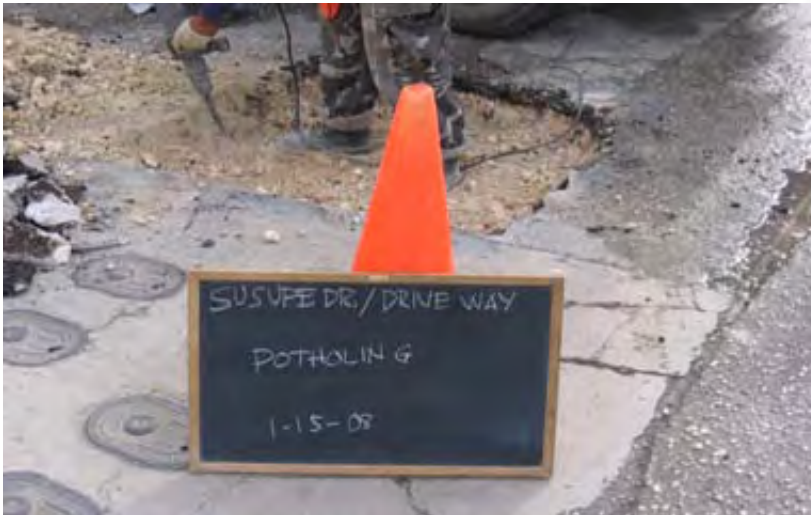
Potholing
Susupe

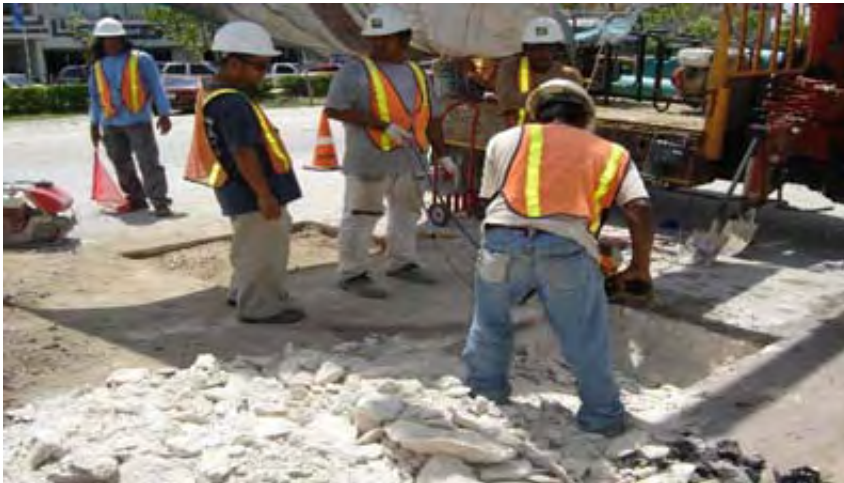
Potholing
San Antonio

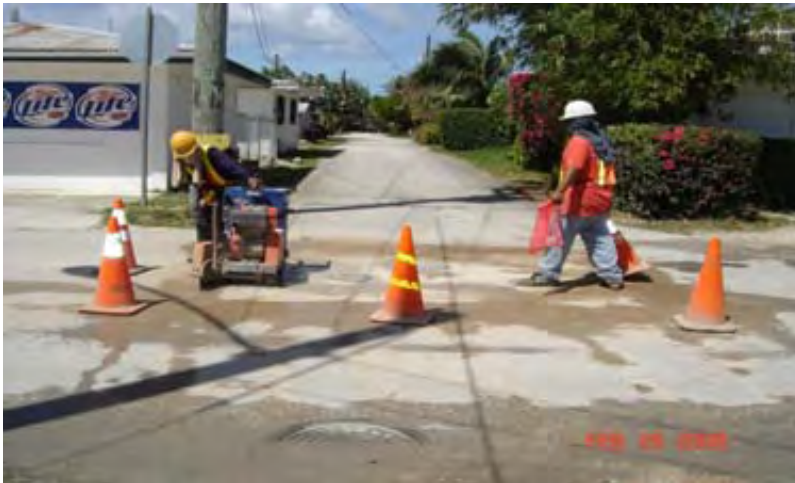
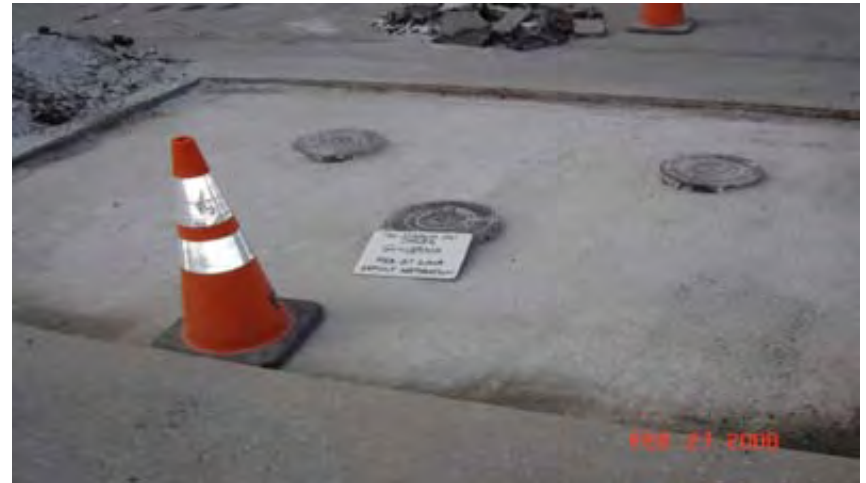
Asphalt Restoration
Chalan Kanoa

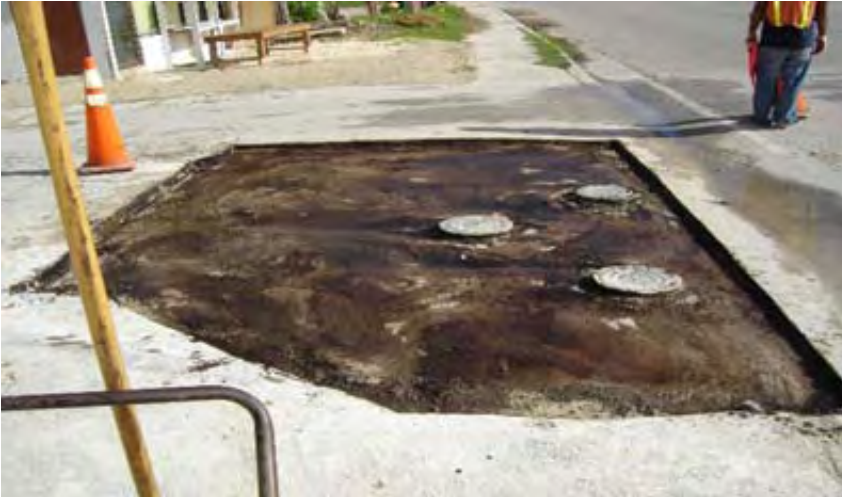
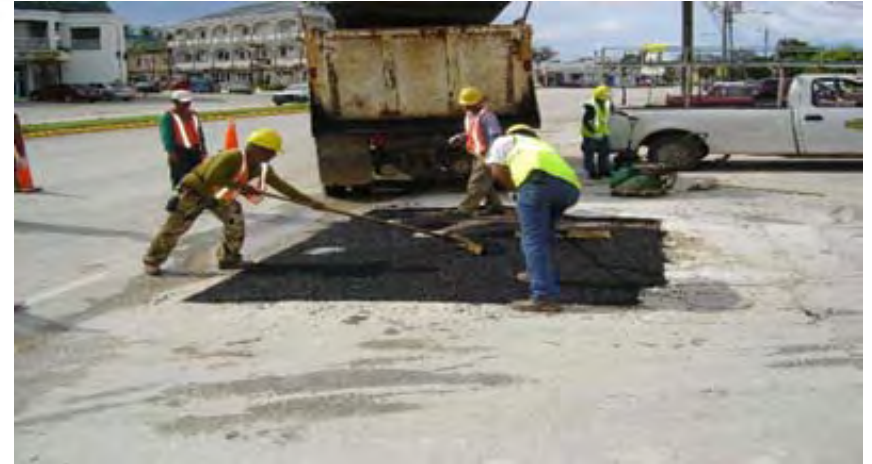
Chalan Piao

Asphalt Restoration
