Appendix A
Storm Water Management Plan: Comments from NDEP and Co-Permittee Response

Storm Water Management Plan: Comments from NDEP and Co-Permittee Response

Appendix B
Clark County

Appendix B.1
Documentation of Findings

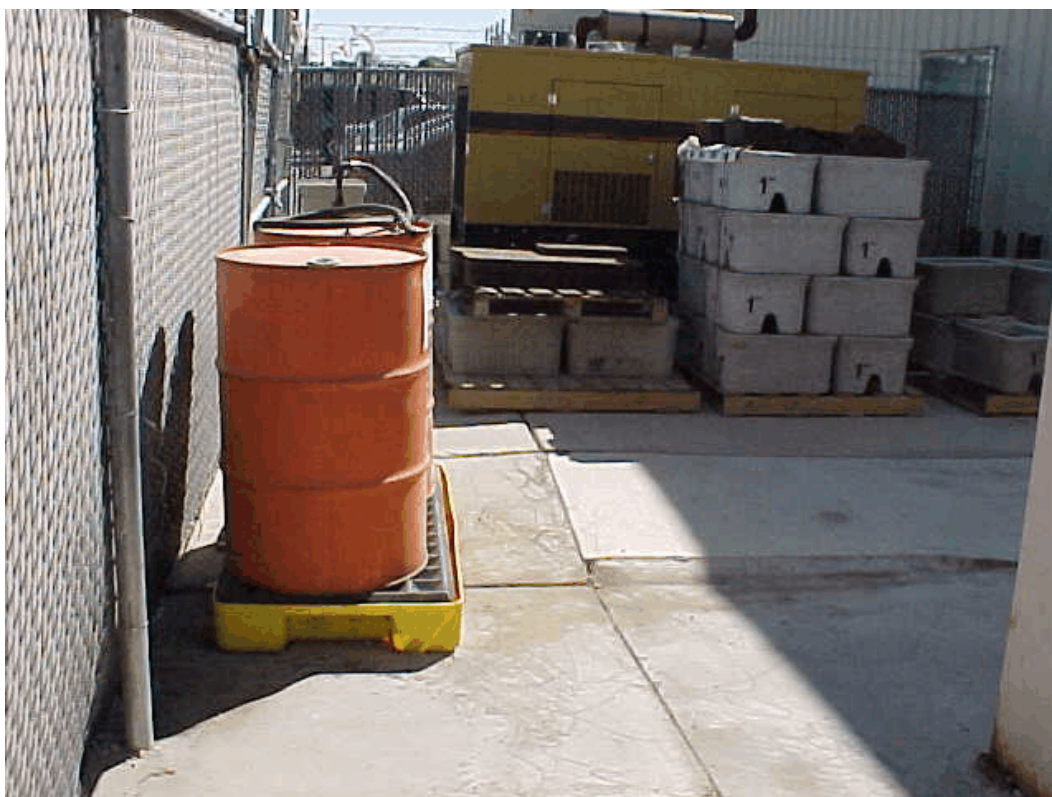
Photo 2. Fleet (primary) facility: Two uncovered 55-gallon drums of solvent.

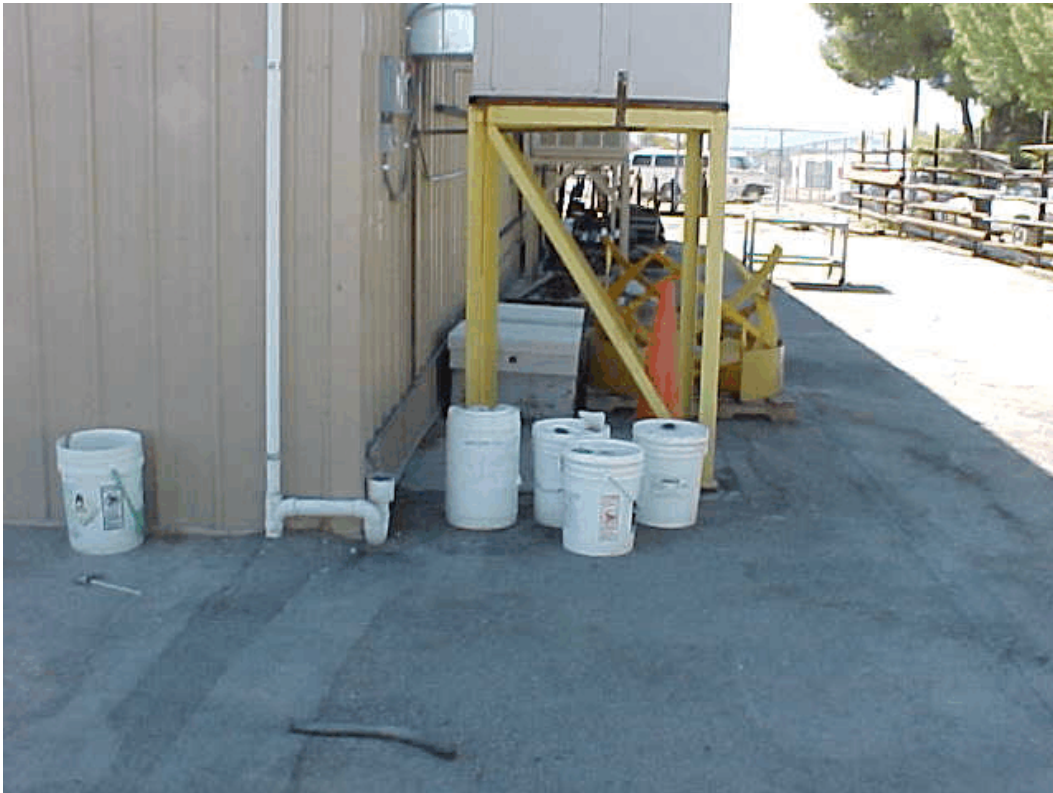
Photo 3. Fleet (primary) facility: Four uncovered and uncontained 5-gallon pails of truck wash chemical.

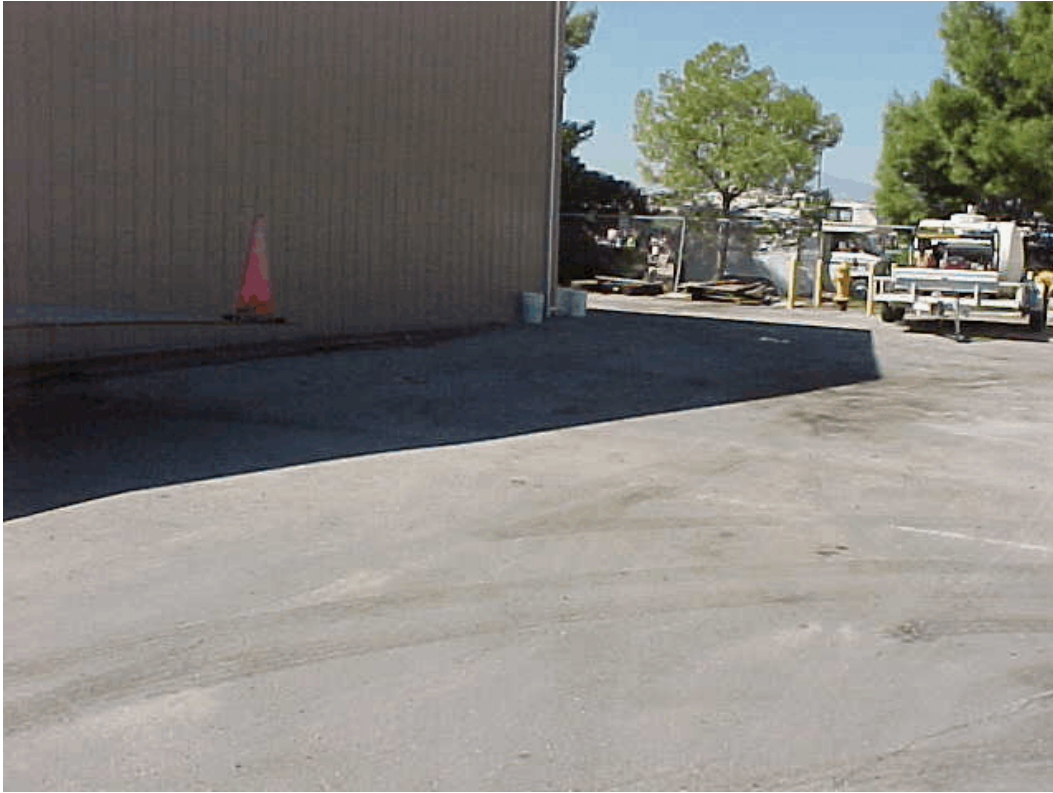
Photo 5. Fleet (primary) facility: Truck wash area is outside, uncontained, uncovered.

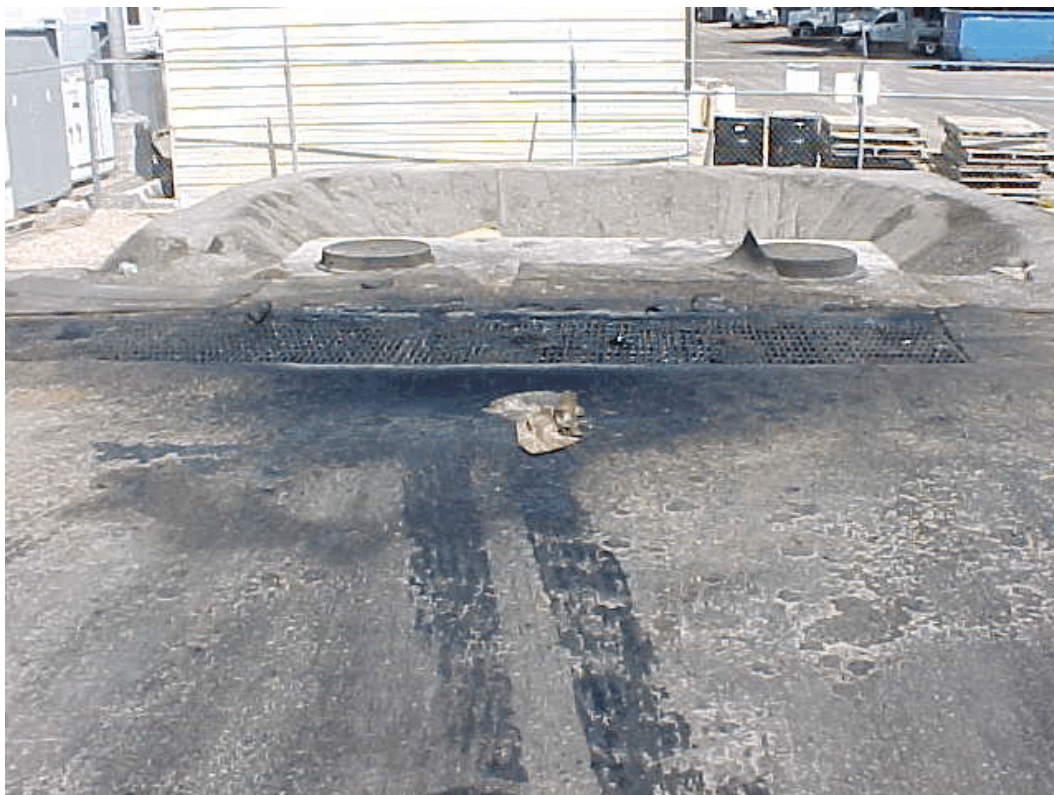
Photo 16. Fleet (secondary) facility: Abandoned asphalt washout area.

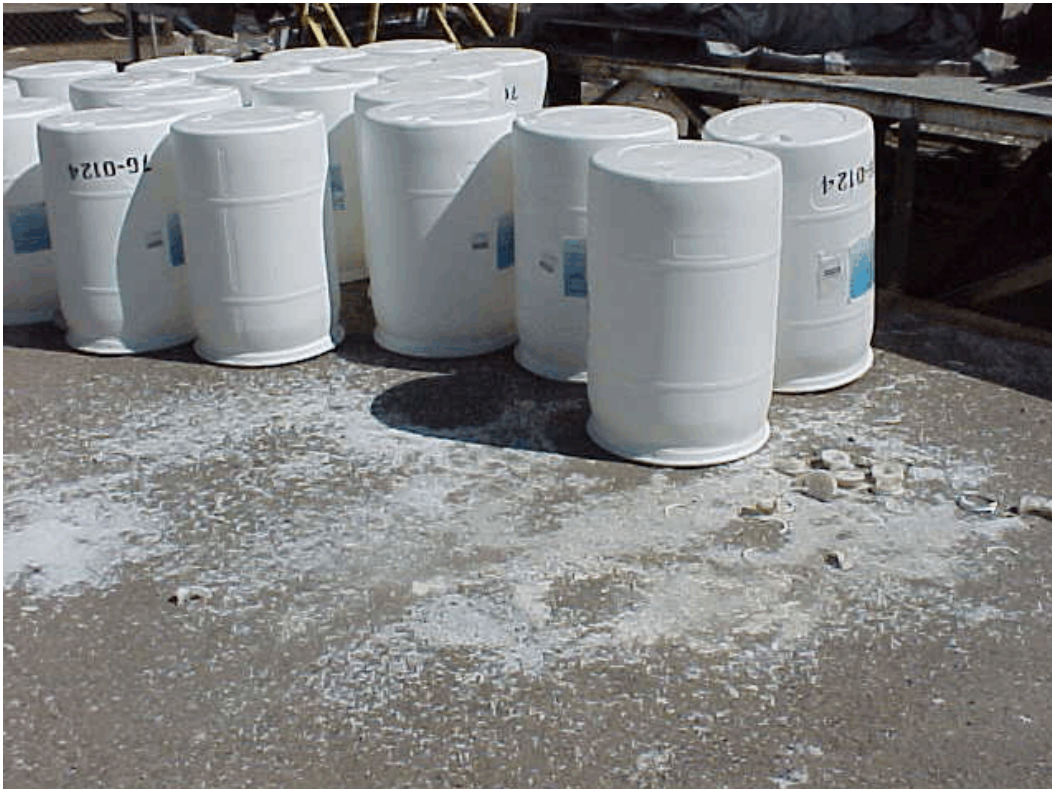
Photo 20. Vector Control facility: Empty drums of larvicide had been cut open in an uncontained location and residue spilled to the pavement.

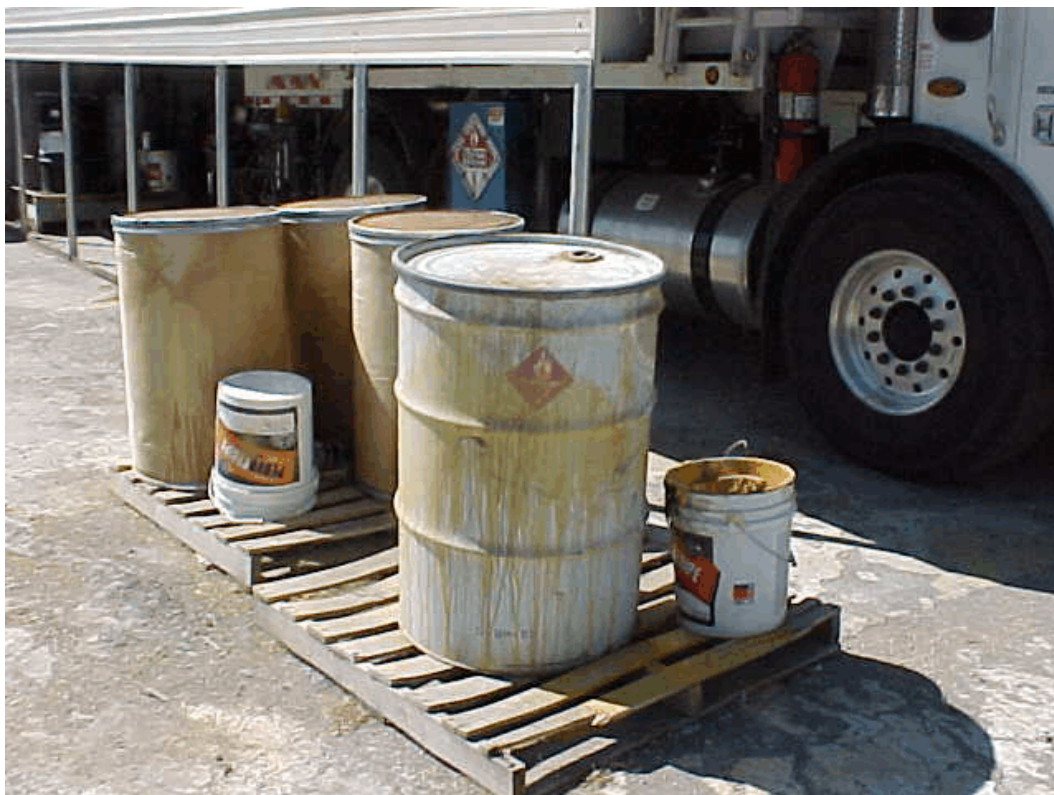
Photo 21. Traffic facility: One 55-gallon drum of flammable contents and three fiber drums of unknown contents were uncovered and uncontained.

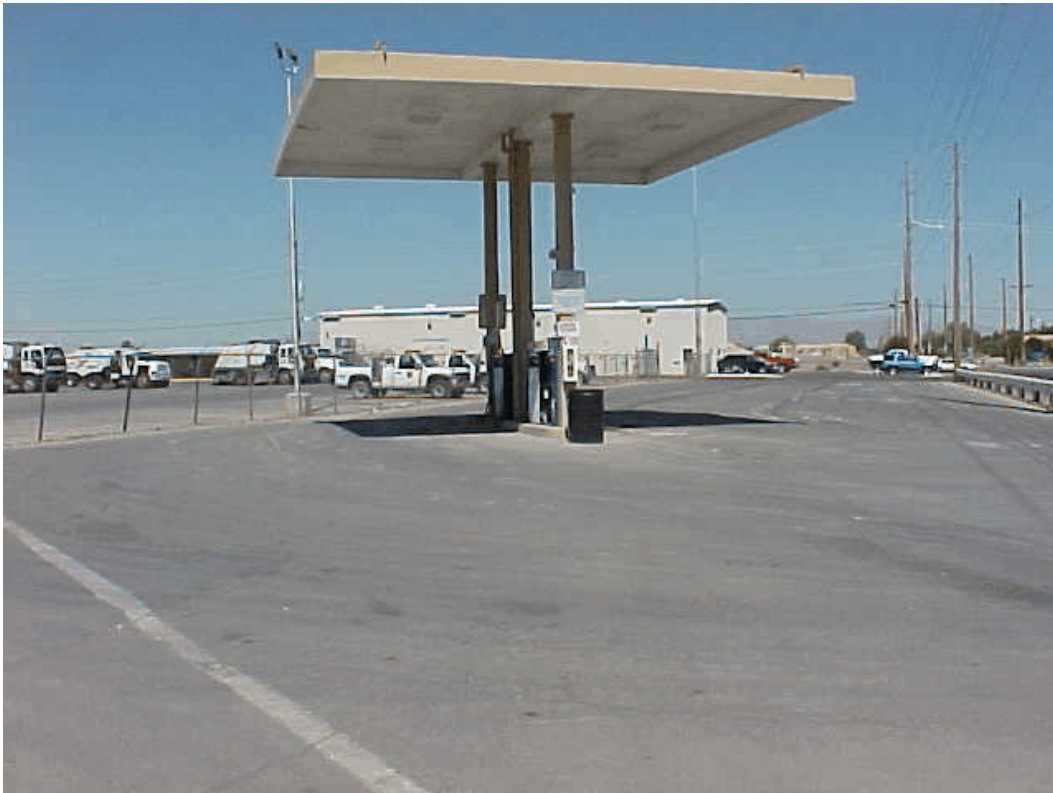
1. Exposed and uncontained used batteries at the Automotive Repair facility had the potential to lose acid to storm water runoff.
2. The spillage at the Fuel Point area was under the canopy, but had the potential to be tracked out of the canopy area and be carried to the adjacent street by storm water.

Photo 6. Spillage at fuel island.

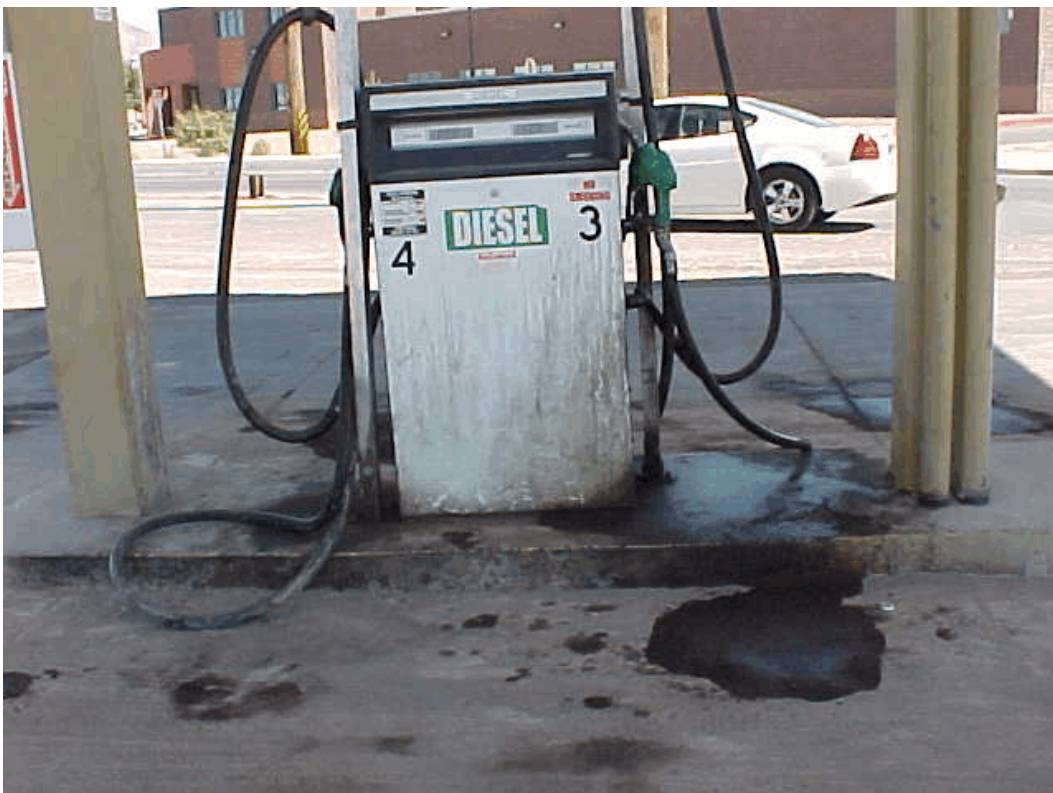
Photo 7. Spillage at fuel island.

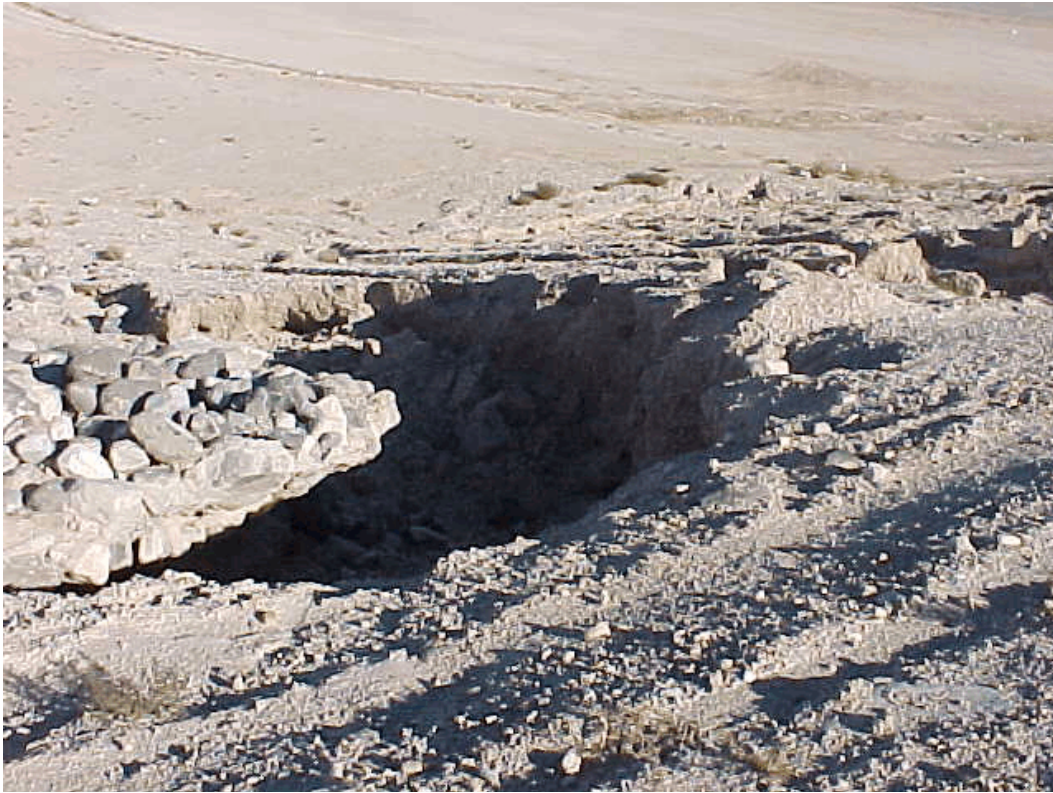
1. Erosion into the detention basin was observed at several locations. Some erosion channels in the west wall of the detention basin were at least four feet deep and six feet wide. Mr. Suckow stated that the erosion in the west wall had occurred several months ago.
2. Utility work was ongoing outside the east fence of the detention basin. The heavy equipment was parked inside a locked gate to the detention basin area. Mr. Suckow was unaware of the ongoing work.
3. An approximately 36-inch pipe for storm water discharge to the detention basin had recently been installed at the northwest corner of the detention basin. The pipe appeared to have been installed by the developer of an adjacent subdivision. Mr. Suckow was unaware of the installation.

1. Clark County is not actively repairing erosion into the detention basin and has not implemented Best Management Practices (BMPs) such as stabilization and/or riprap of the basin walls. Loose soils eroded into the basin will potentially be carried by storm water to the Duck Creek Channel when a rain event occurs.

Photo 9. Erosion on west wall of detention basin.

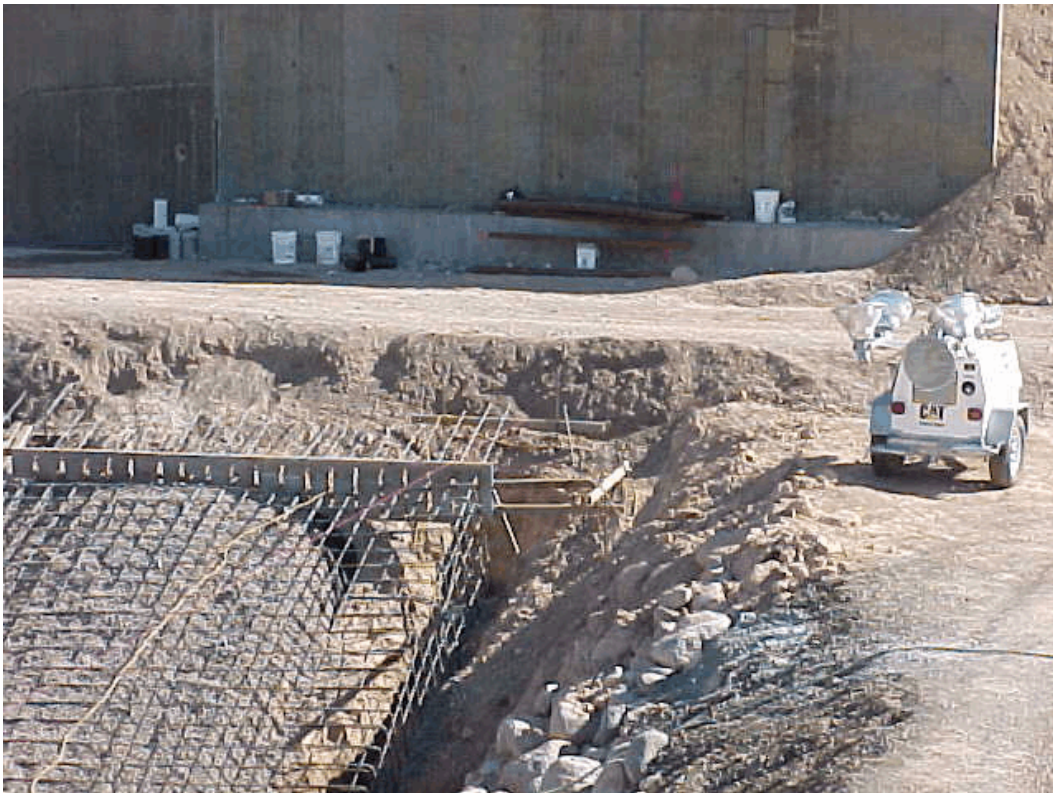
Photo 2. Downstream side of earthen dam. Note concrete runoff on face of dam. Note 5-gallon pails of chemicals along the retaining wall.

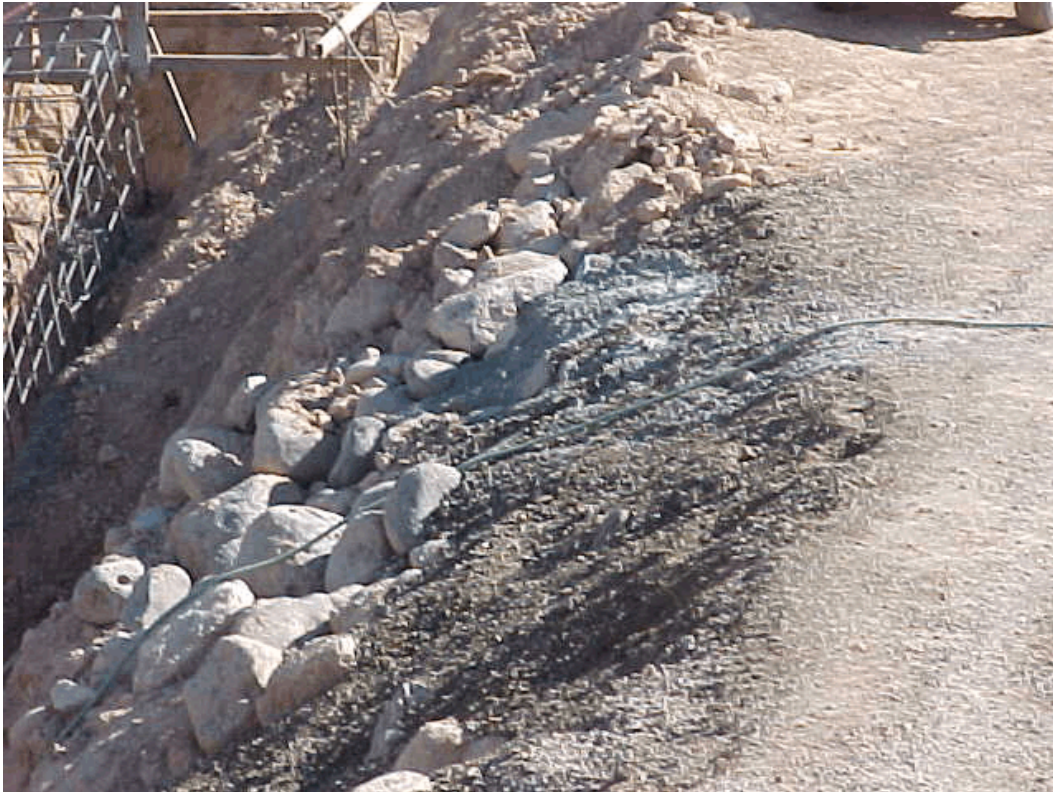
4. Concrete washout had occurred above the sump and likely concrete washout runoff was pumped to the diversion and entered the Duck Creek Channel waters below the project area.
5. Chemicals (e.g., concrete chemicals, gasoline) were not contained and/or located to minimize the potential for accidental spillage and loss to the soil or Duck Creek Channel.
6. The staging areas included disturbed soils that are part of the project and must be protected and inspected for storm water.

Photo 3. Closeup view of concrete washout on downstream face of earthen dam. A sump is located at the toe of the dam face (photo left).

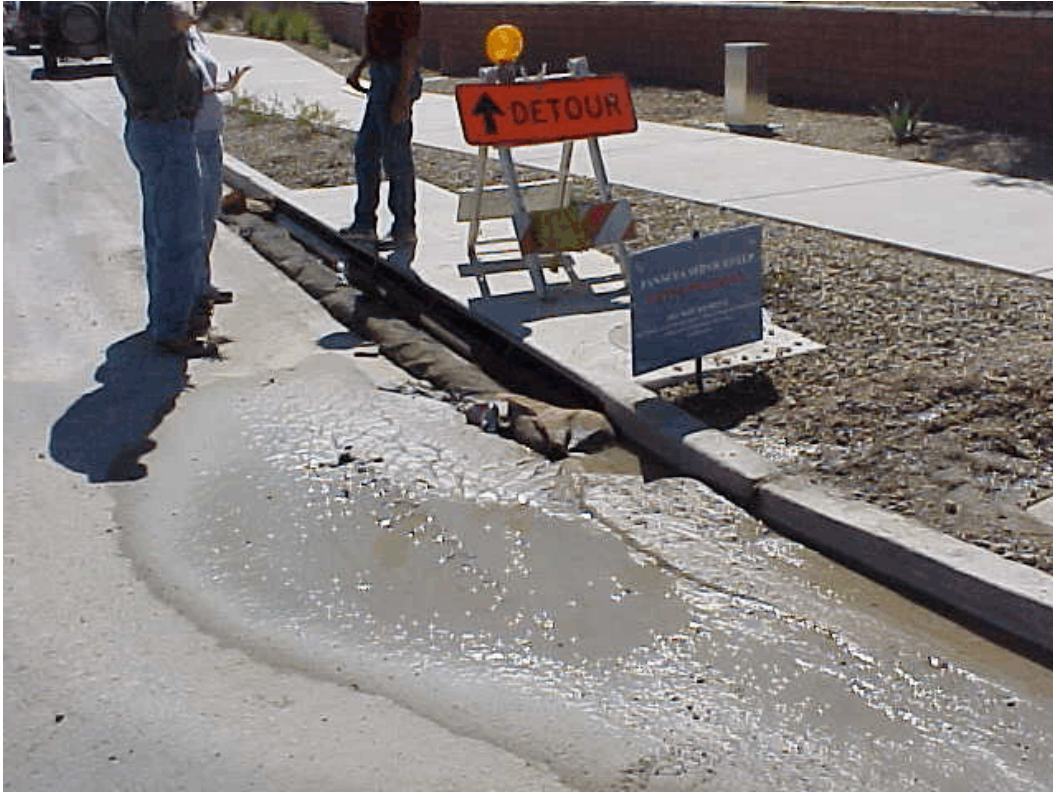
Photo 1. Street inlet protection that is poorly maintained by Landtec LLC.

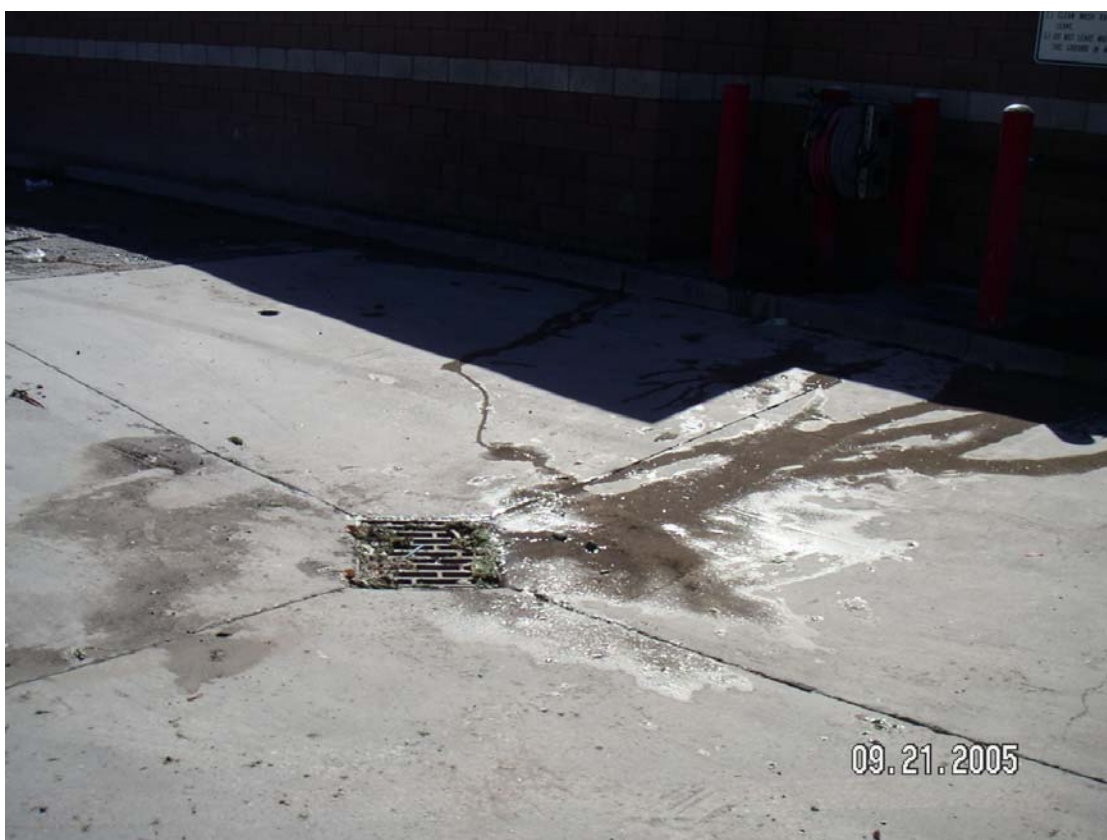
Photo 10. Grate over sand/oil interceptor.

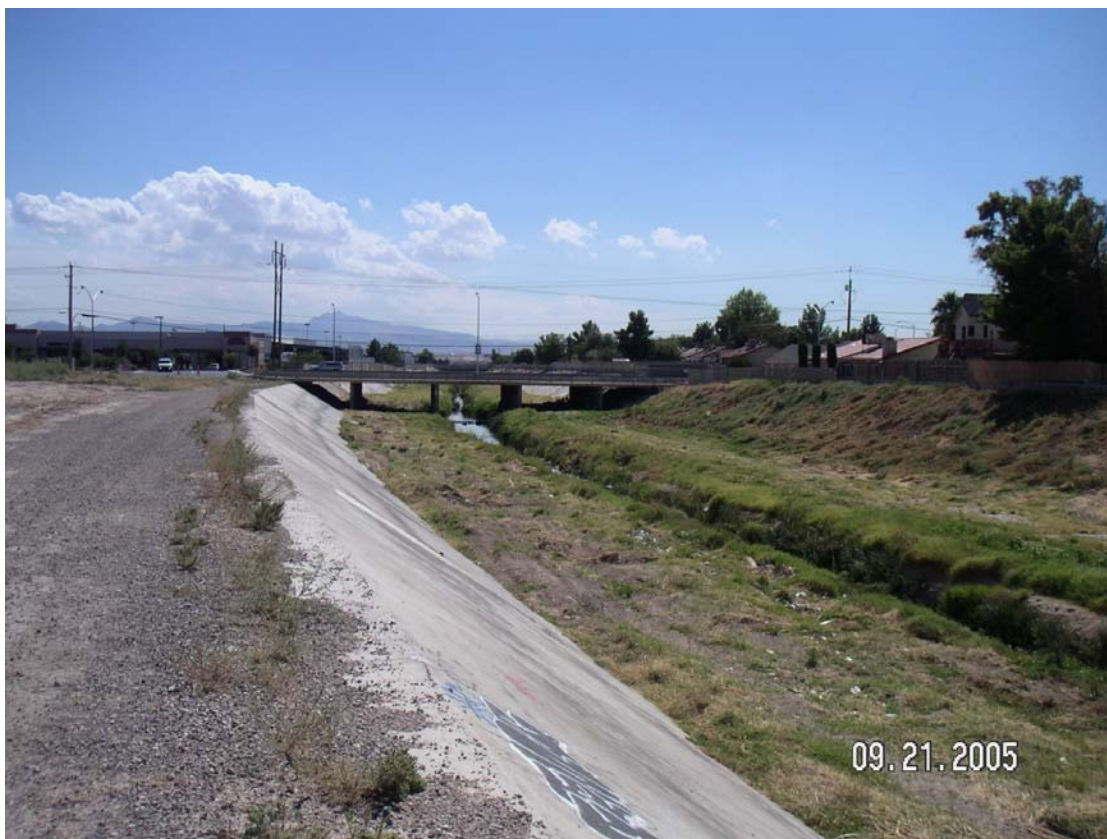
Photo 3. View of Las Vegas Wash near intersection of Stewart Avenue and Nellis Boulevard.

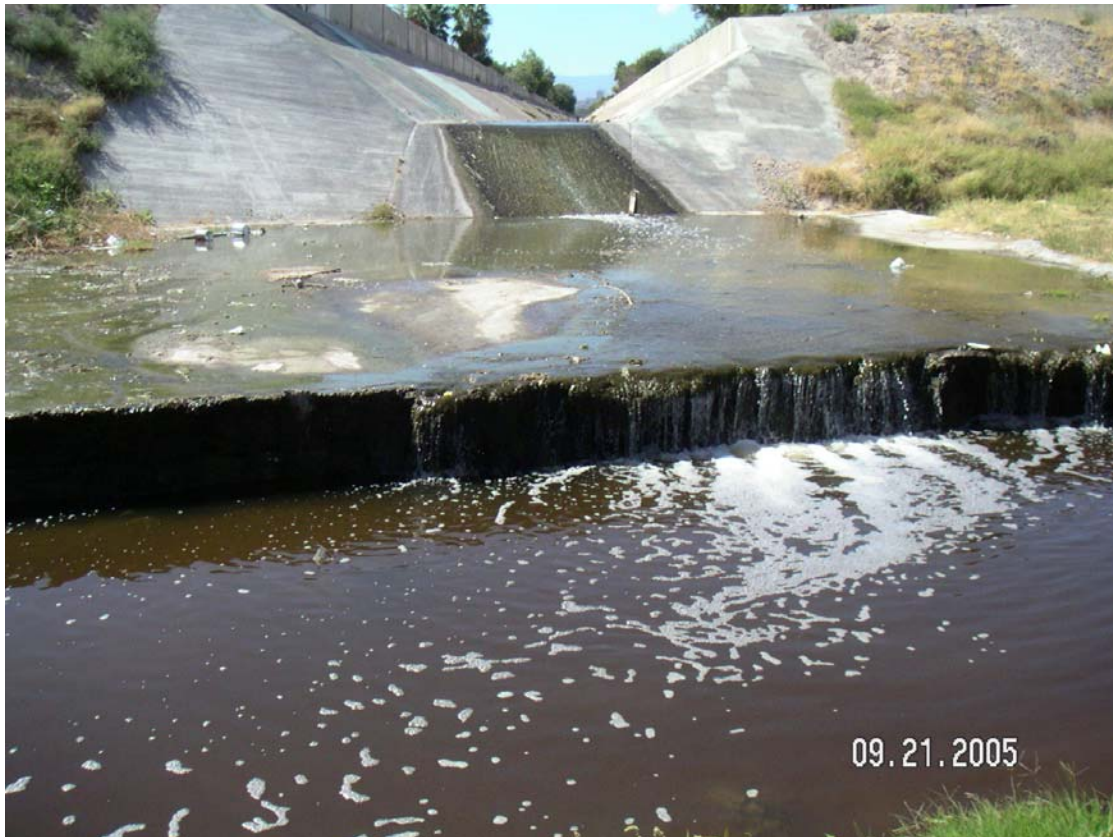
Photo 5. Cedar Creek inflow to Las Vegas Wash.

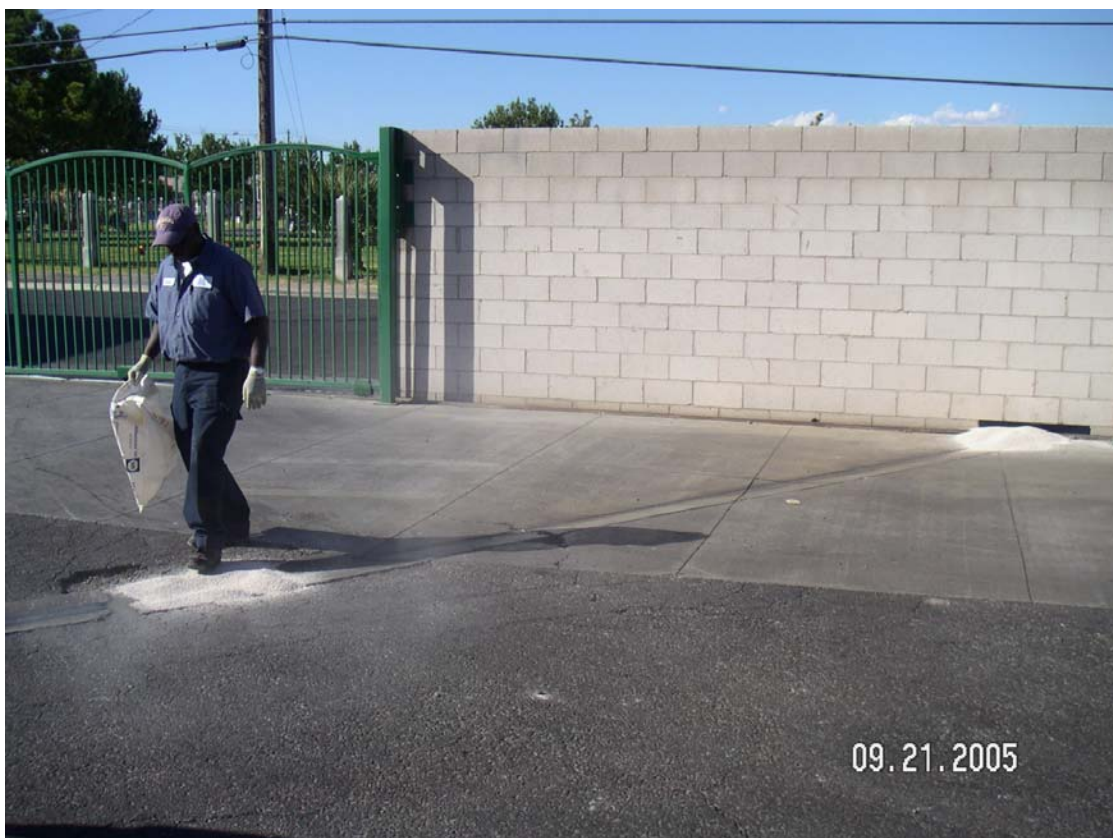
Photo 4. Worker spreading absorbent material.

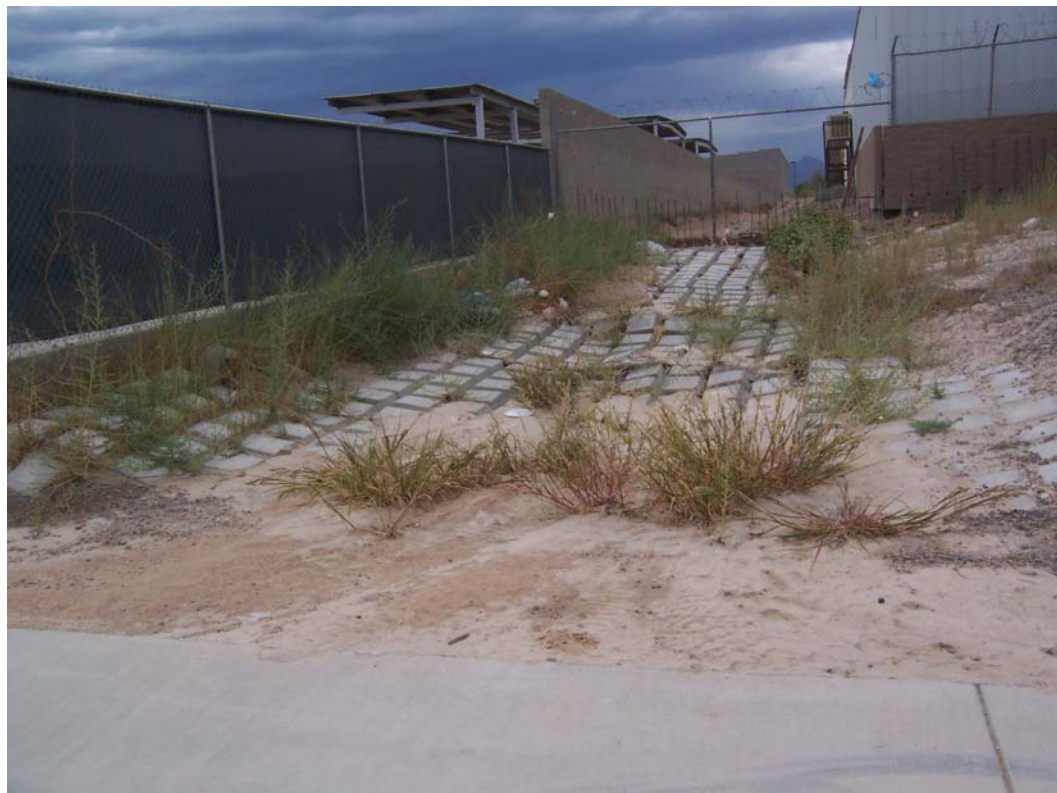
Photo 4. Riprap channel between commercial properties. Note lower end of channel appears to be clogged with sediment.

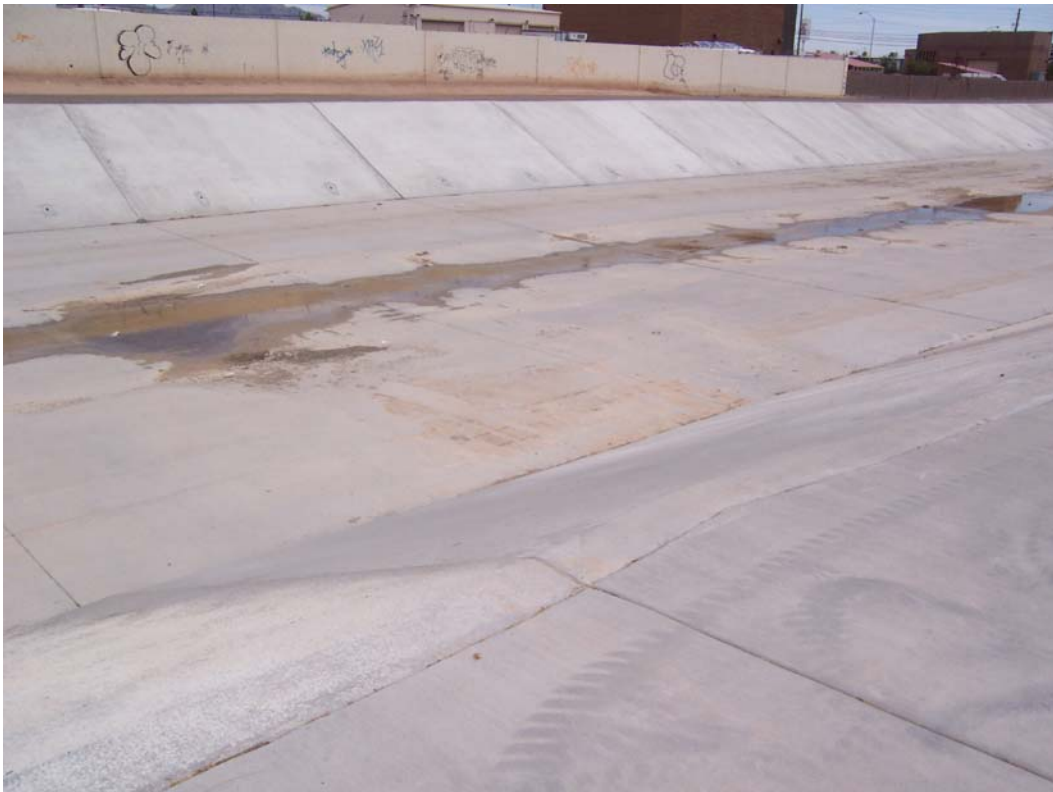
Mr. Rura did not note several areas where soil erosion appears to be entering the wash. In response to a question, he stated that soil erosion was not identified or addressed as part of the wash walks.

Photo 5. Portion of wash adjacent to the channel in Photo 4 where sediment appears to have entered the wash from the channel.

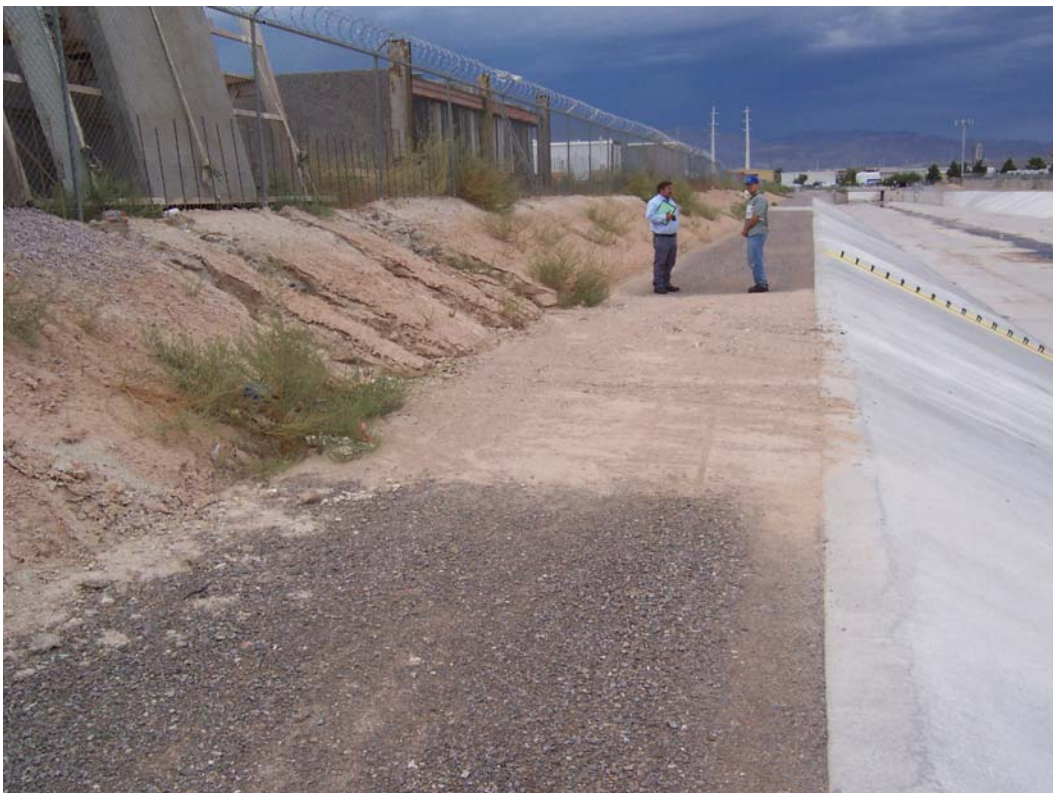
Photo 6. Area where soil erosion on the bank to the left of the wash appears to have entered the wash.

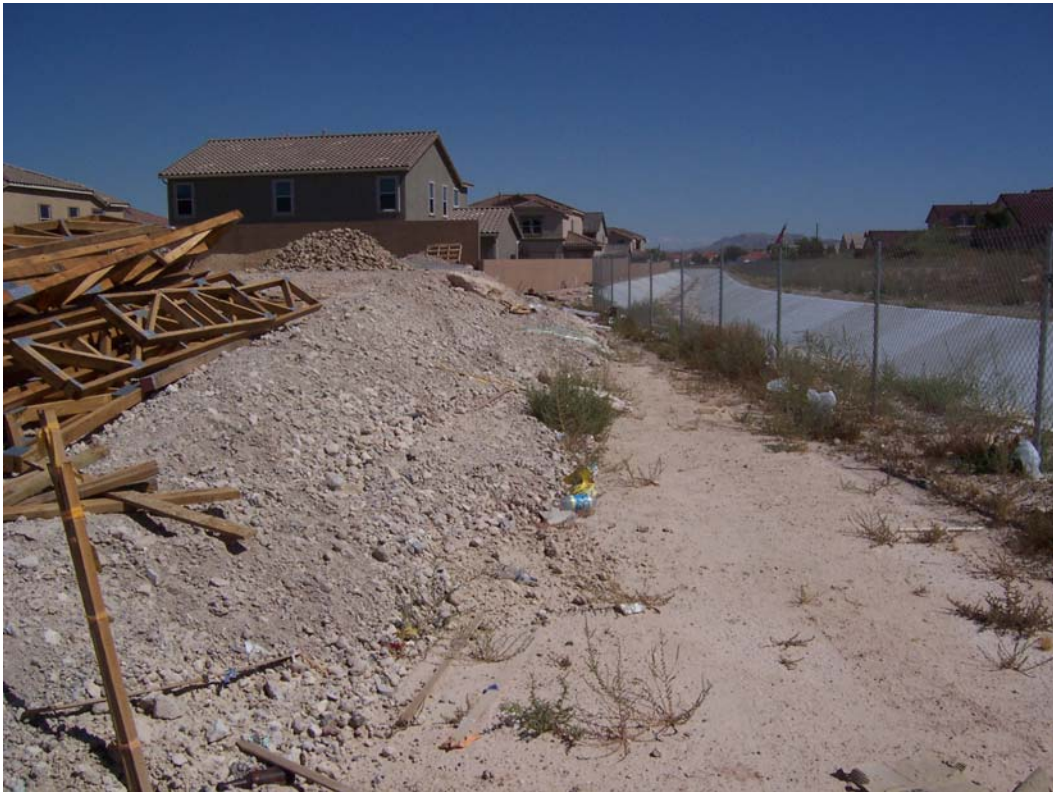
1. Mr. Melo did not comment on the presence of sediment in the wash next to the construction site.
2. Mr. Melo did not comment on the placement of a portable toilet next to a paved roadway. If knocked over by a construction vehicle, it would flow directly to a storm inlet.
3. The inspection form used asks if BMPs are in place. It is Mr. Melo's practice to check the "yes" box if any BMPs are in place, even if they are incomplete or do not cover all areas. Thus, he appears to be answering the question: Are any BMPs in place?
4. Mr. Melo indicated that he had received four hours of training in storm water control and that the subject had come up in at least two inspector meetings.
5. The audit team reviewed the SWPPP prepared for the site. It appeared complete, current, and well organized.

Photo 1. Dirt and debris piled adjacent to wash at the construction site.

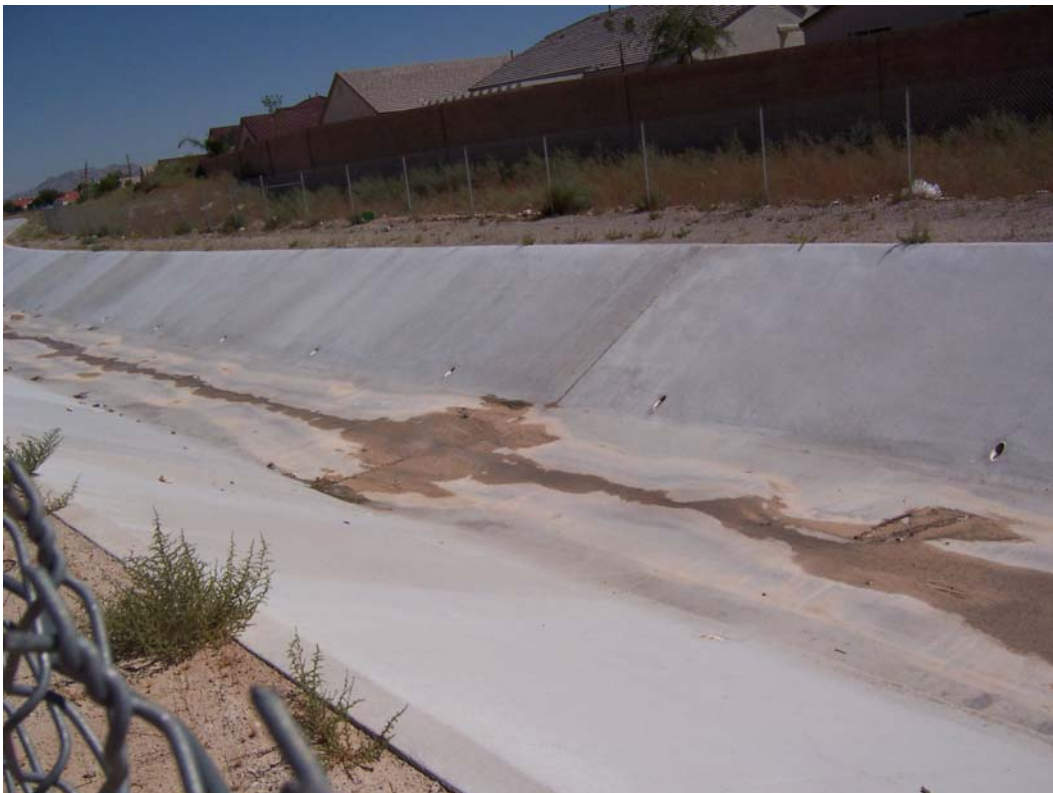
Photo 2. Wash adjacent to the construction site. Wash appears to contain sediment that may have come from the site.

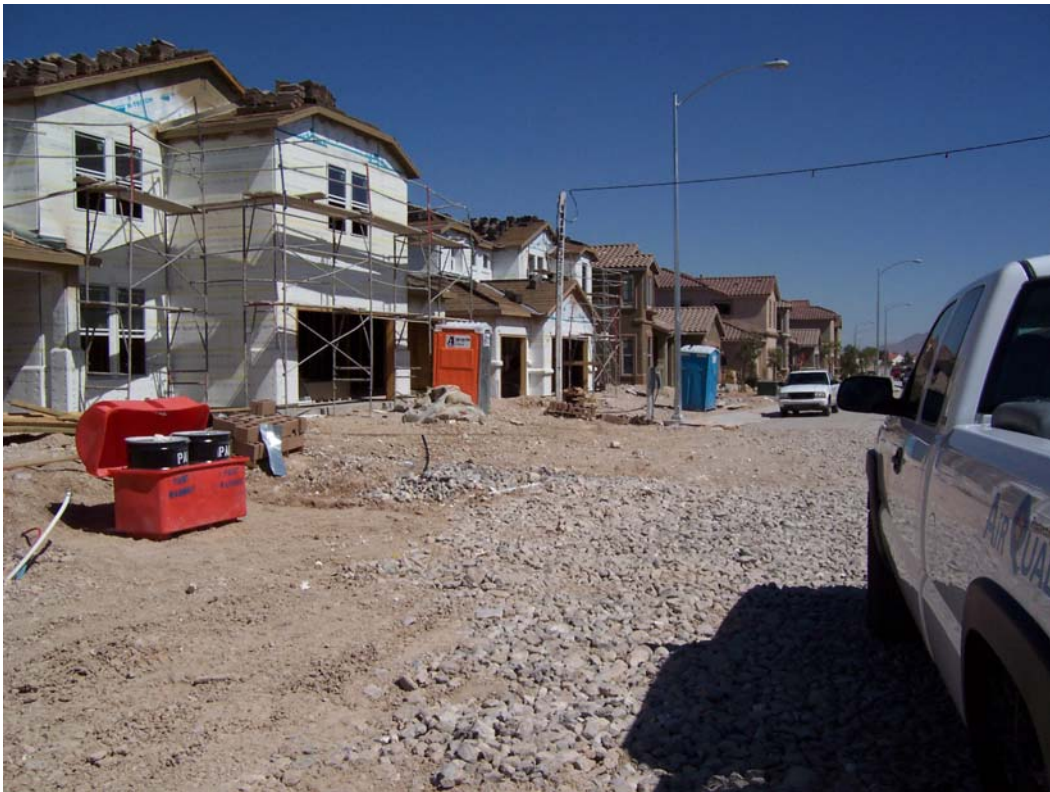
Photo 3. Note portable toilet (blue) in photo right center located immediately adjacent to the paved road upslope of inlets. Note also crush rock for trackout control located in front of pickup truck at photo right.

1. Mr. Melo did not note the presence of a portable toilet in the street not far from an inlet. If knocked over by a construction vehicle, it would flow directly to the storm inlet.
2. He did not note that several sand bags, which were placed at regular intervals along the curb apparently to catch sediment, were moved back several inches from the curb providing a gap for water to pass through, making them ineffective.

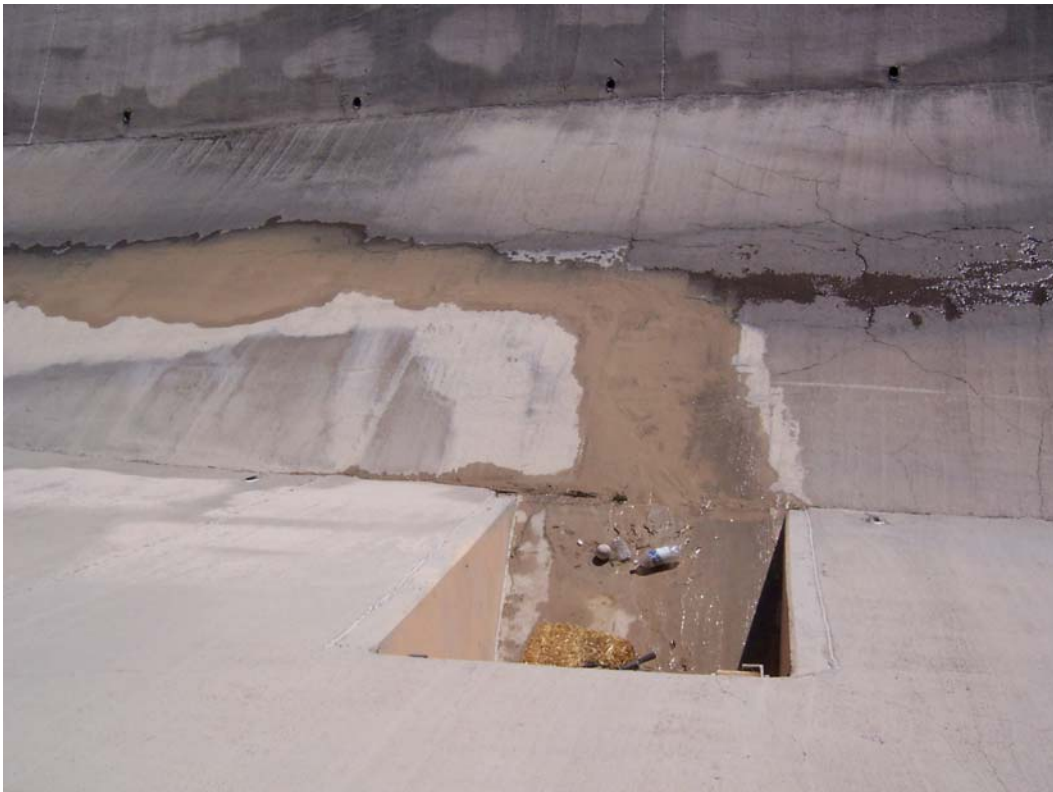
4. He noted that water and sediment were entering the wash from the storm drain that serves the paved roads of the site.
5. He noted that piles of dirt along the curb line were extended into the street. The street had recently been washed down, and sediment was entering a storm inlet through the sand bags intended for inlet protection. Sediment could also be observed entering a manhole on the street side of the inlet through the pick hole in the manhole cover.

Photo 1. Water and sediment from the construction site entering the wash.

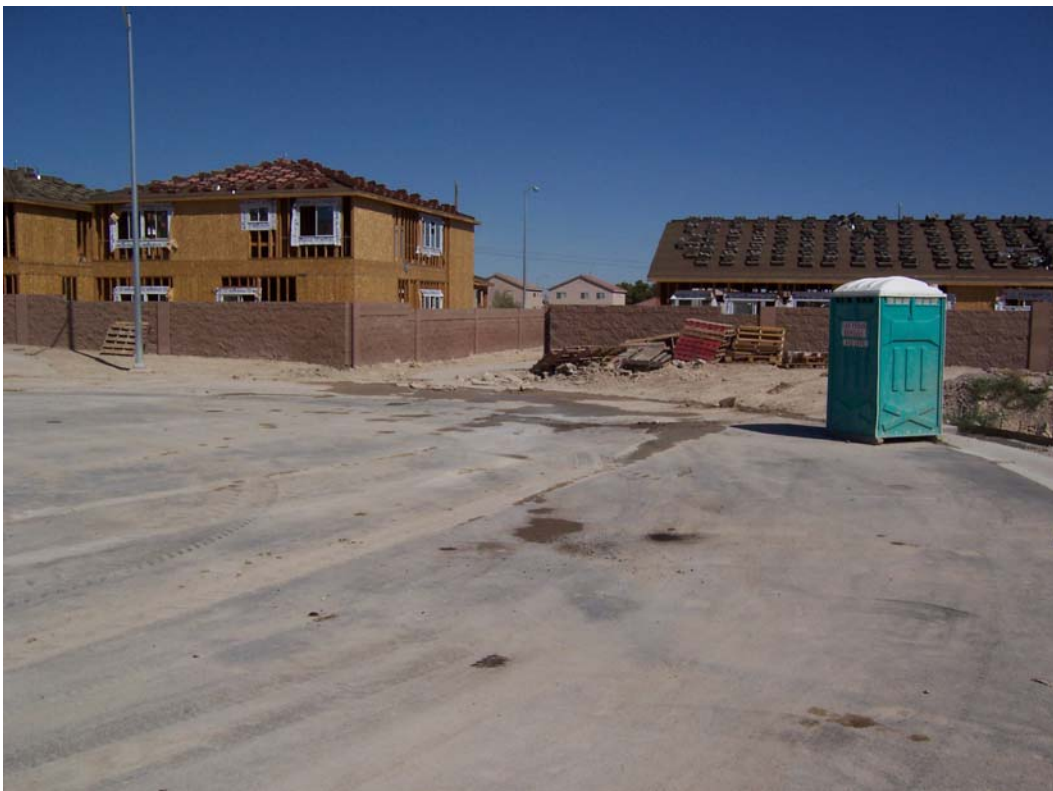
Photo 4. Portable toilet placed where spillage would go directly to storm inlet. Storm inlet is left center photo, at the end of the sidewalk to the cul-de-sac.

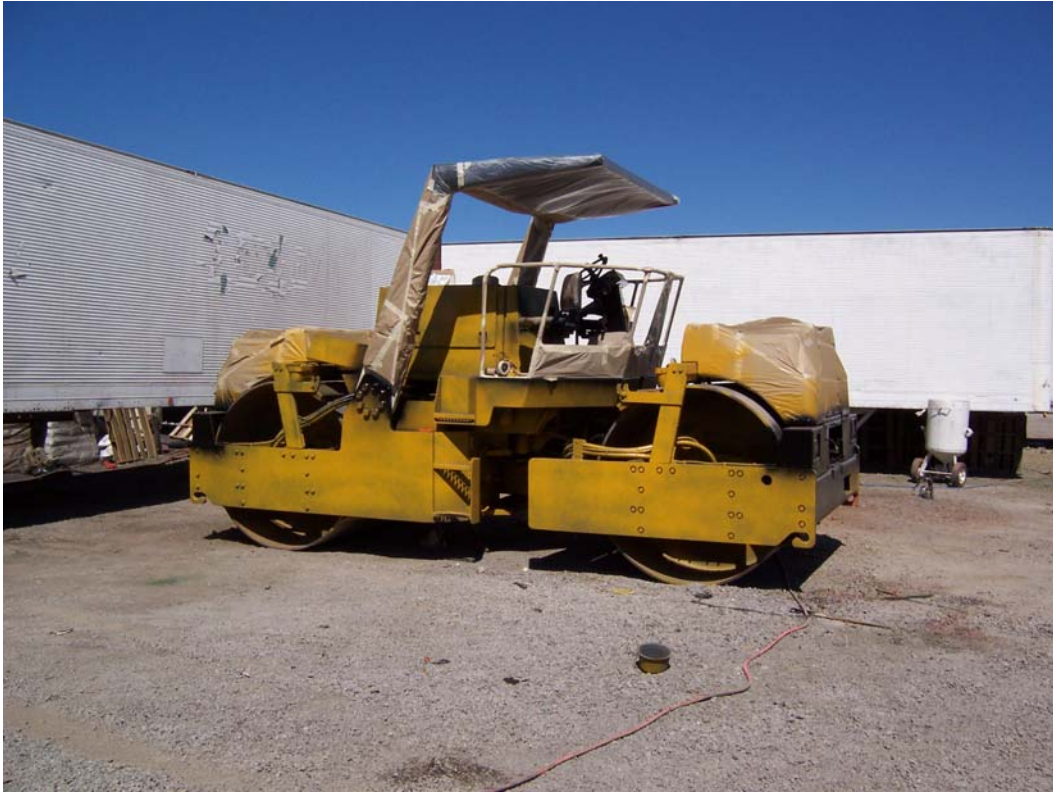
Photo 2. Roller masked for open air spray painting operation.
