Appendix A
Storm Water Management Plan: Comments from NDEP and Co-Permittee Response

Storm Water Management Plan: Comments from NDEP and Co-Permittee Response

Appendix B
Clark County

Appendix B.1
Documentation of Findings

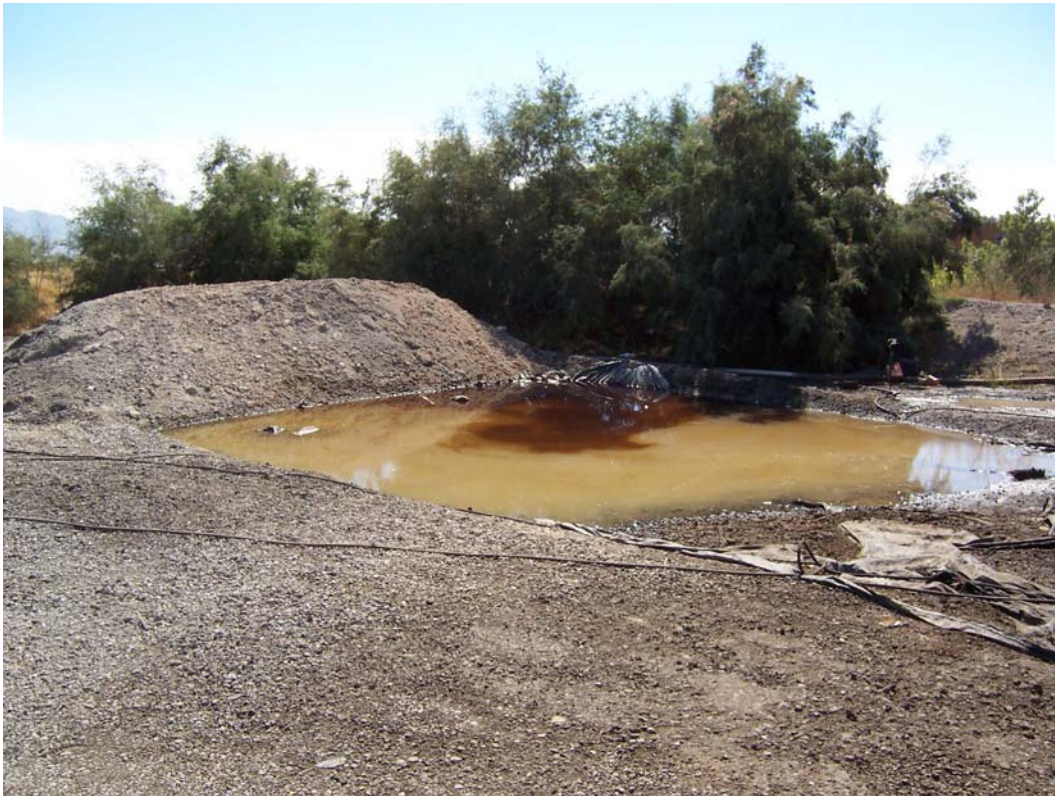
Photo 3. Temporary pit dug to contain wash water from equipment cleaning operation. Note floating oil on the surface of the water.

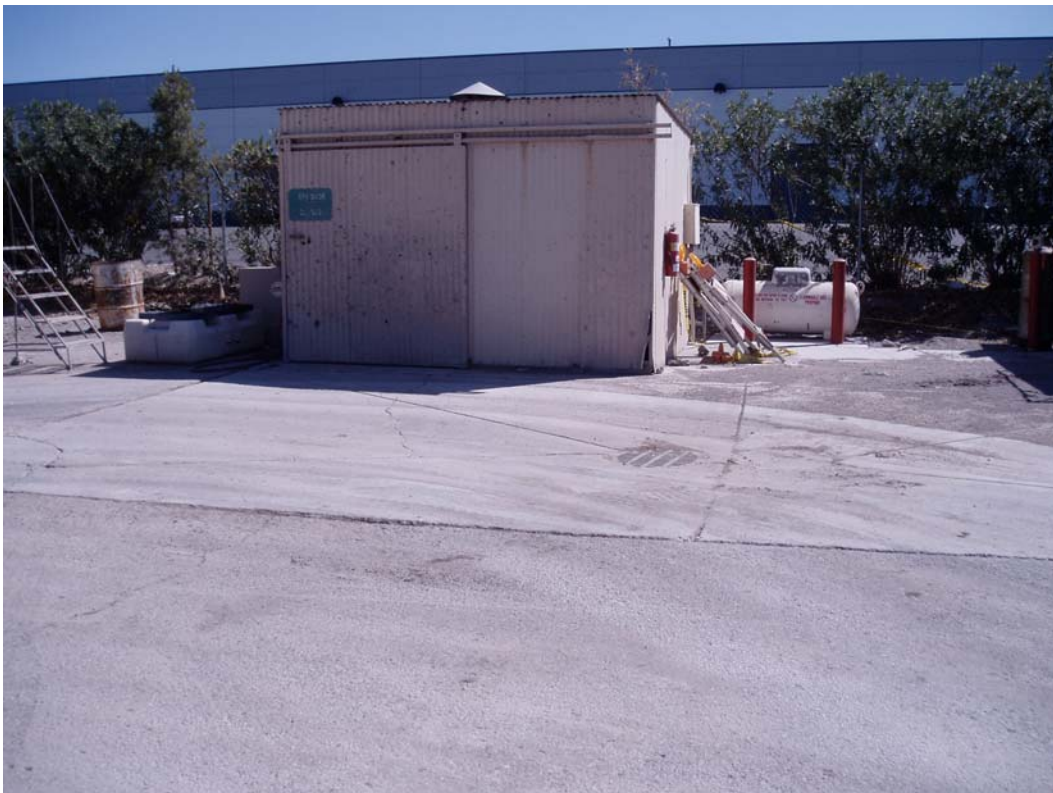
Photo 2. Car wash area. Drain flows to sanitary sewer.

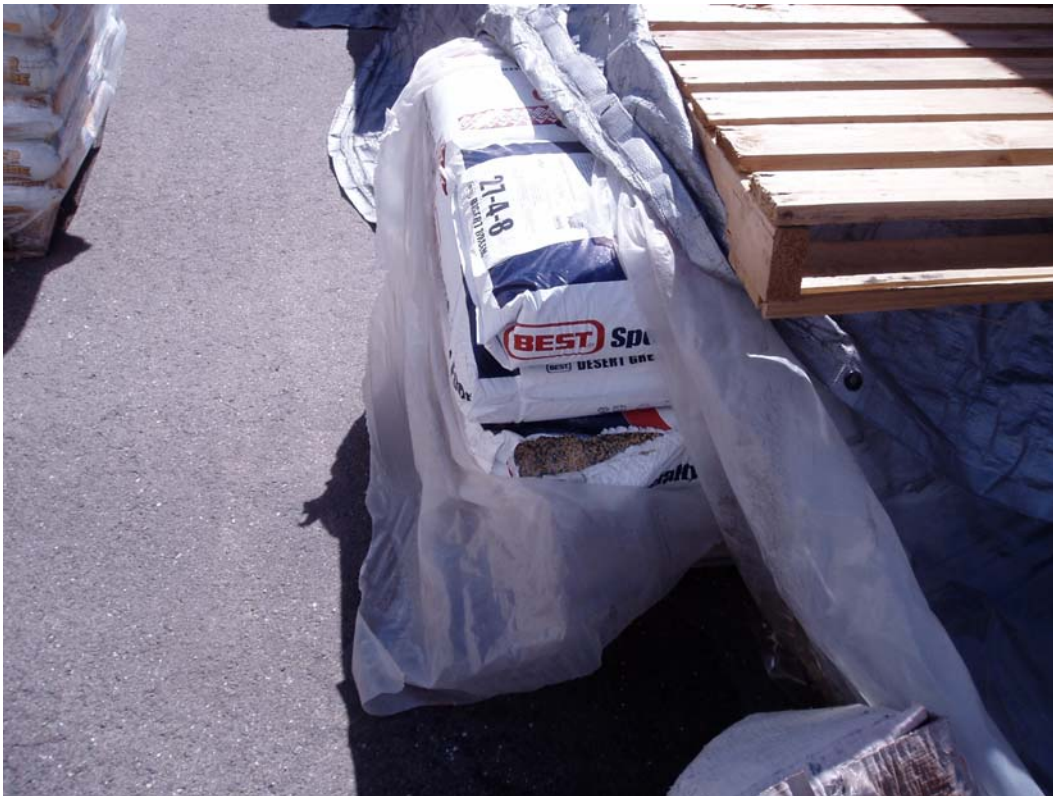
Photo 1. Fertilizer, note tear in package.

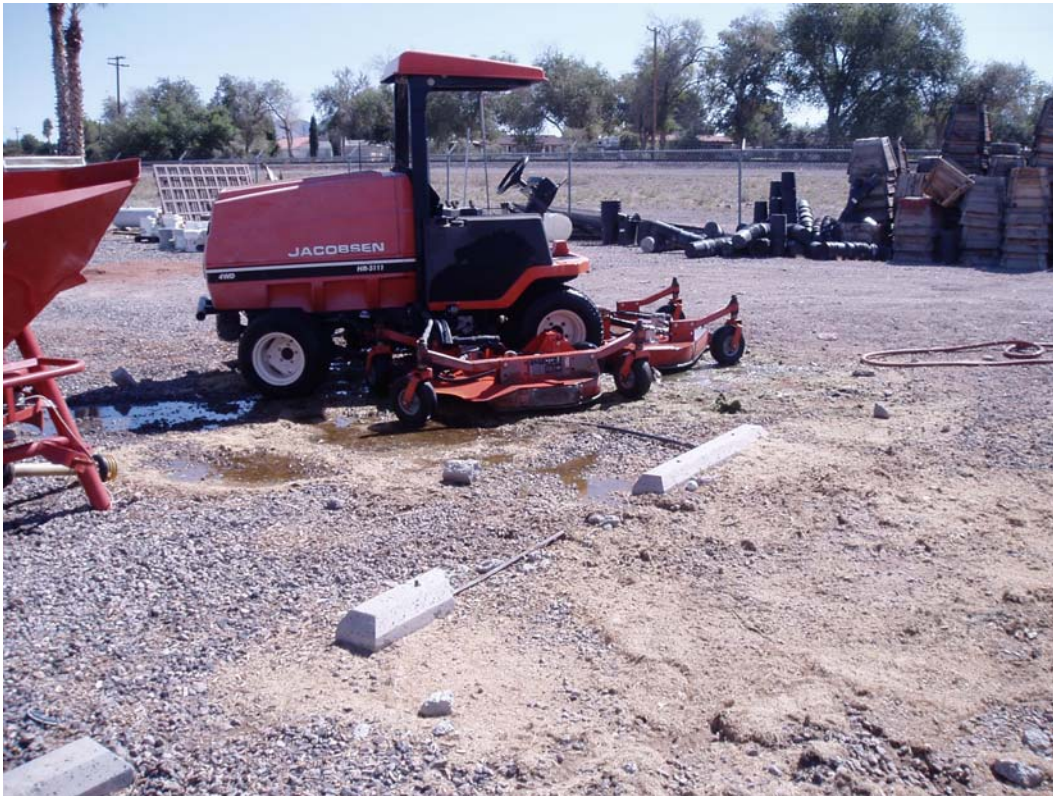
Photo 3. Vehicle that was being rinsed during the site visit. Note puddles of water.

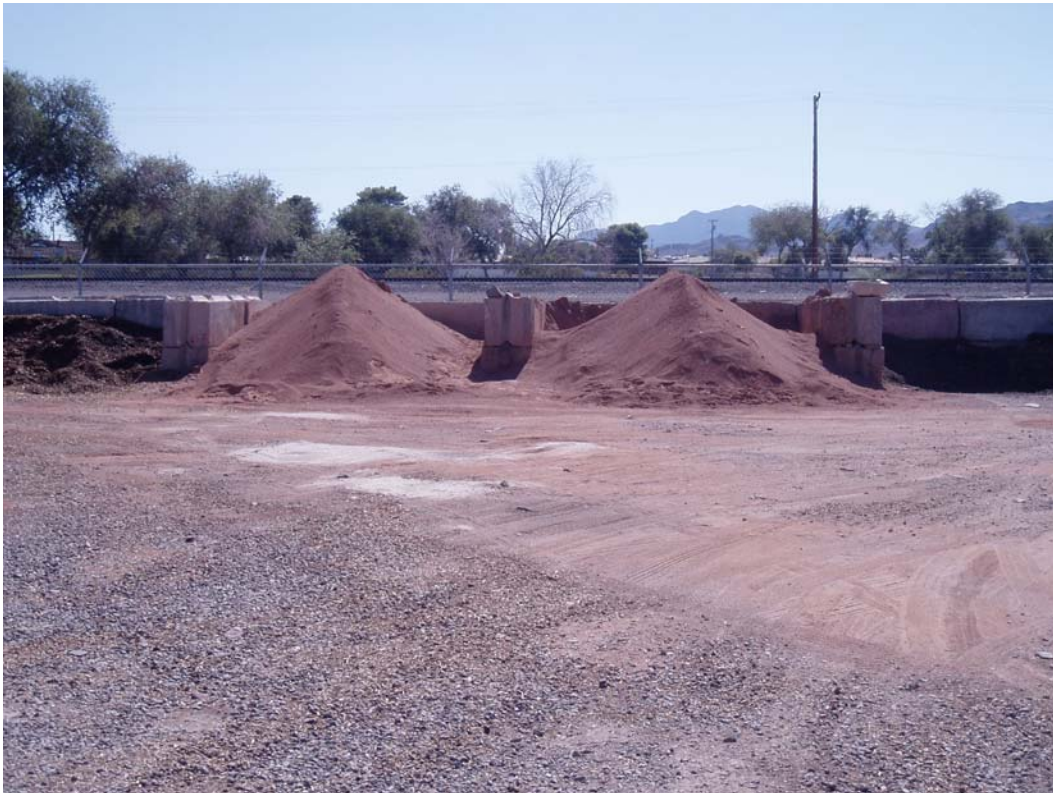
Photo 4. Sediment stockpiles. Grade is downhill toward the street.

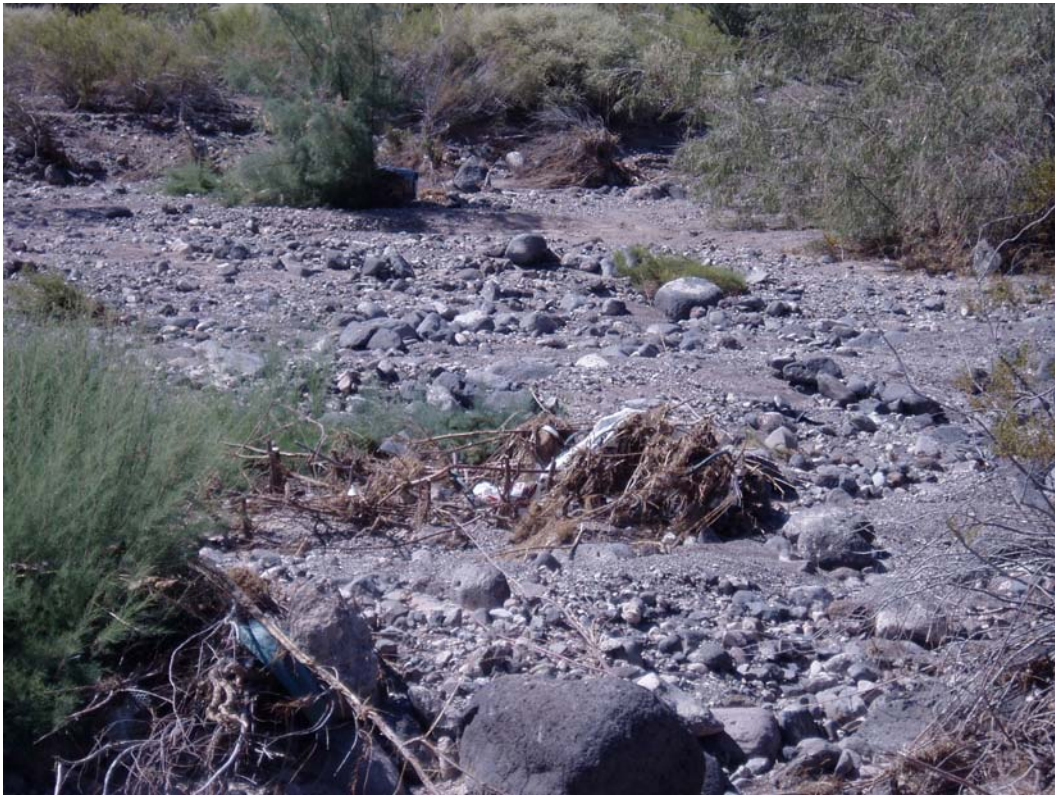
Photo 5. Tamarisk and debris in Project Green area of Pittman Wash.

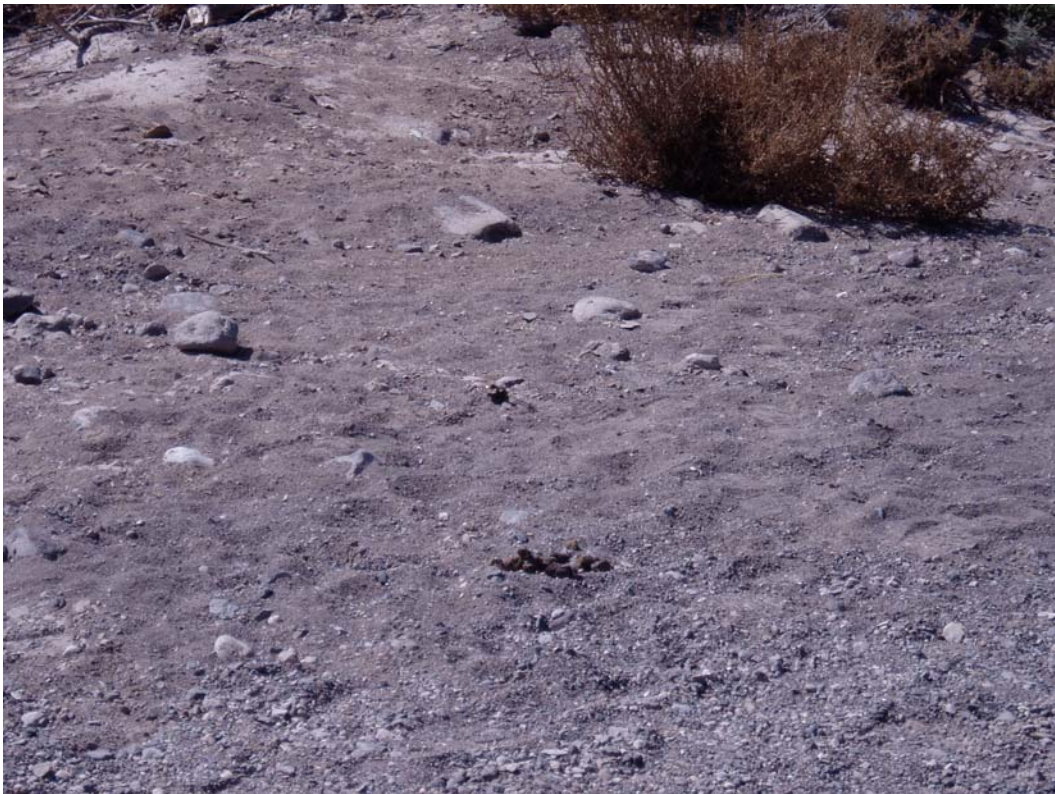
Photo 6. Pet waste (photo center towards the bottom) in Project Green area of Pittman Wash.

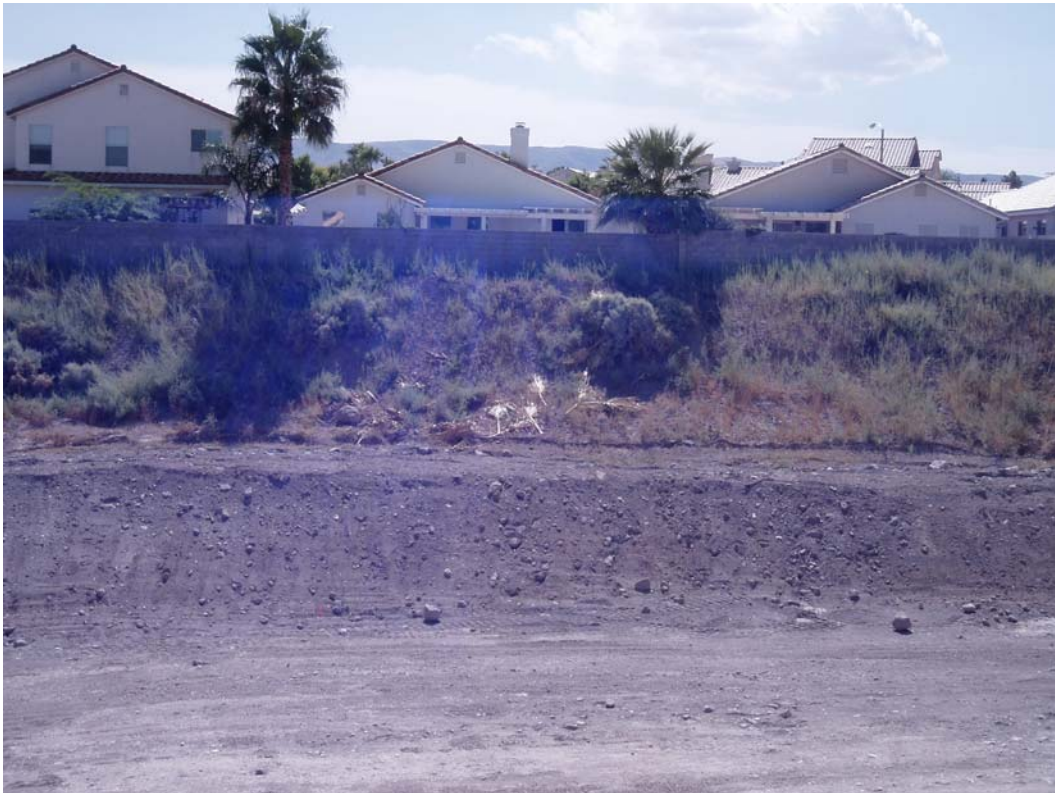
Photo 11. Palm fronds dumped in Upper Pittman Wash (photo center).

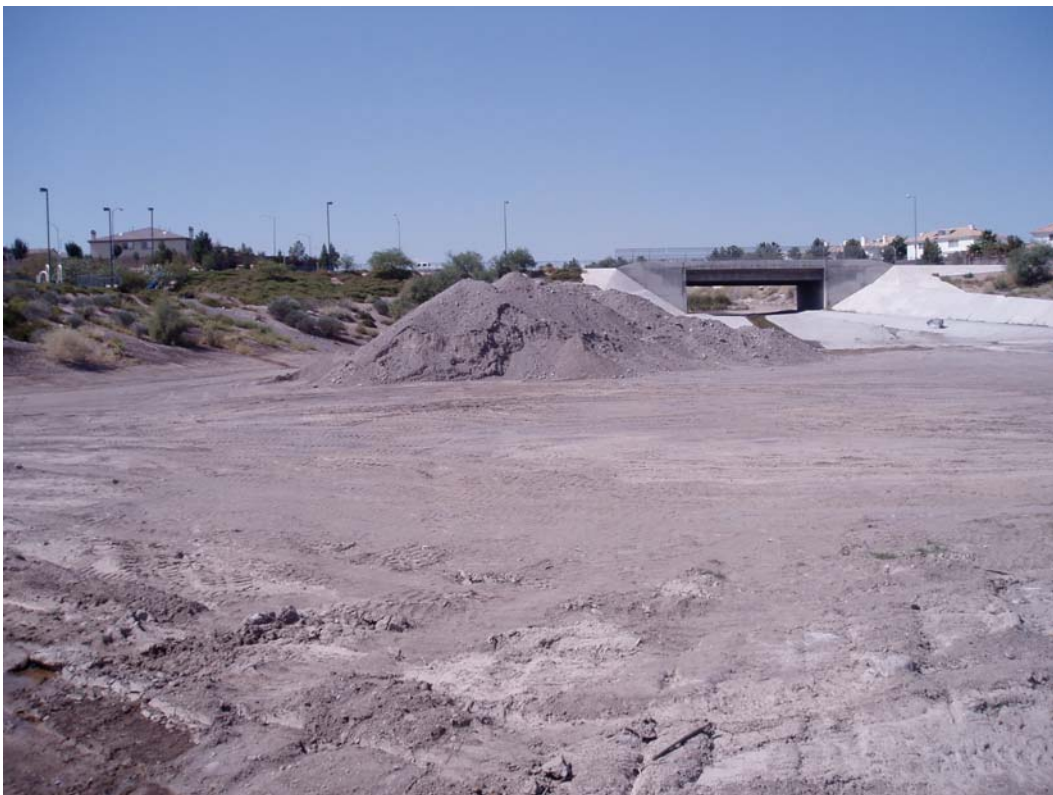
Photo 14. Sediment pile in Pittman Wash.

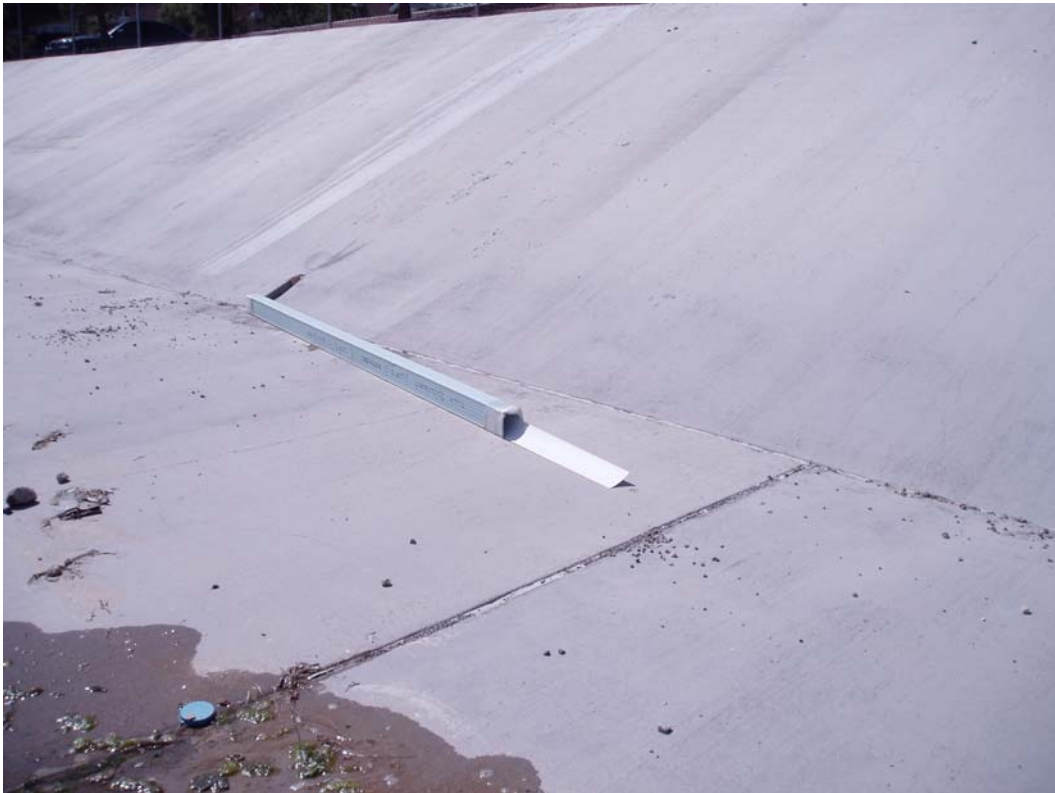
Photo 21. Empty box dumped in channel.

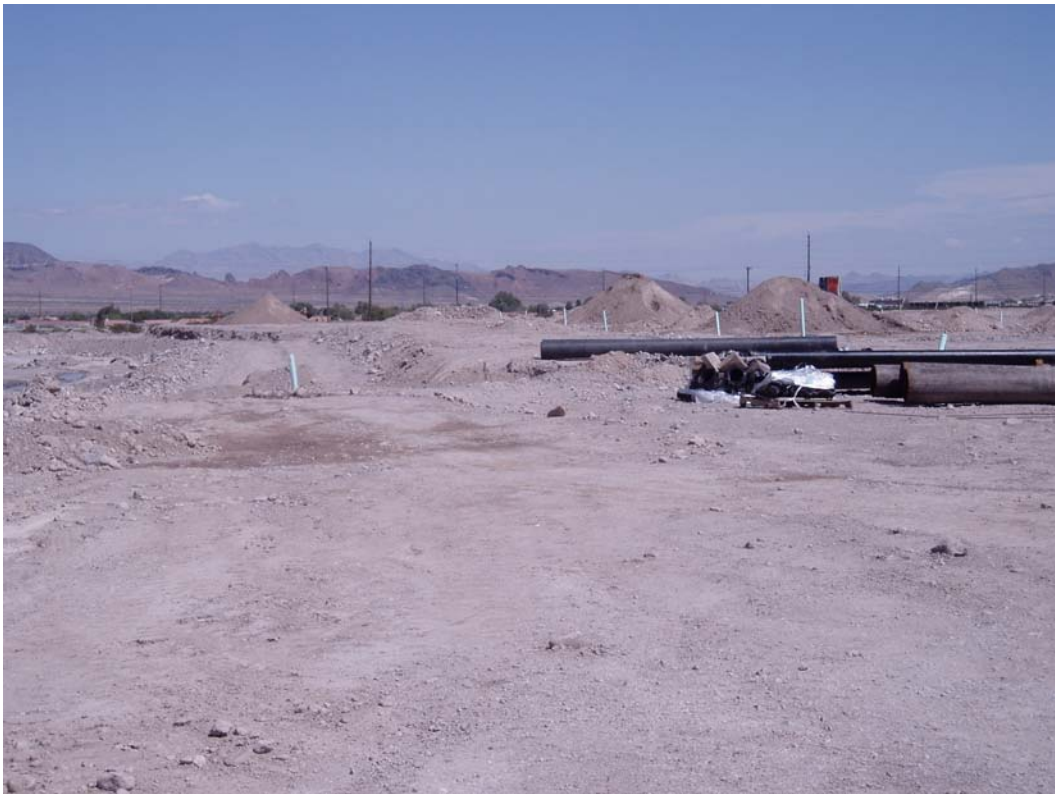
4. An industrial storage area and a residential construction site adjacent to Gibson Channel were not using Best Management Practices (BMPs) to minimize the potential for pollution to runoff into the channel.

Photo 26. Construction and sediment piles (photo right) adjacent to Gibson Channel (photo left).

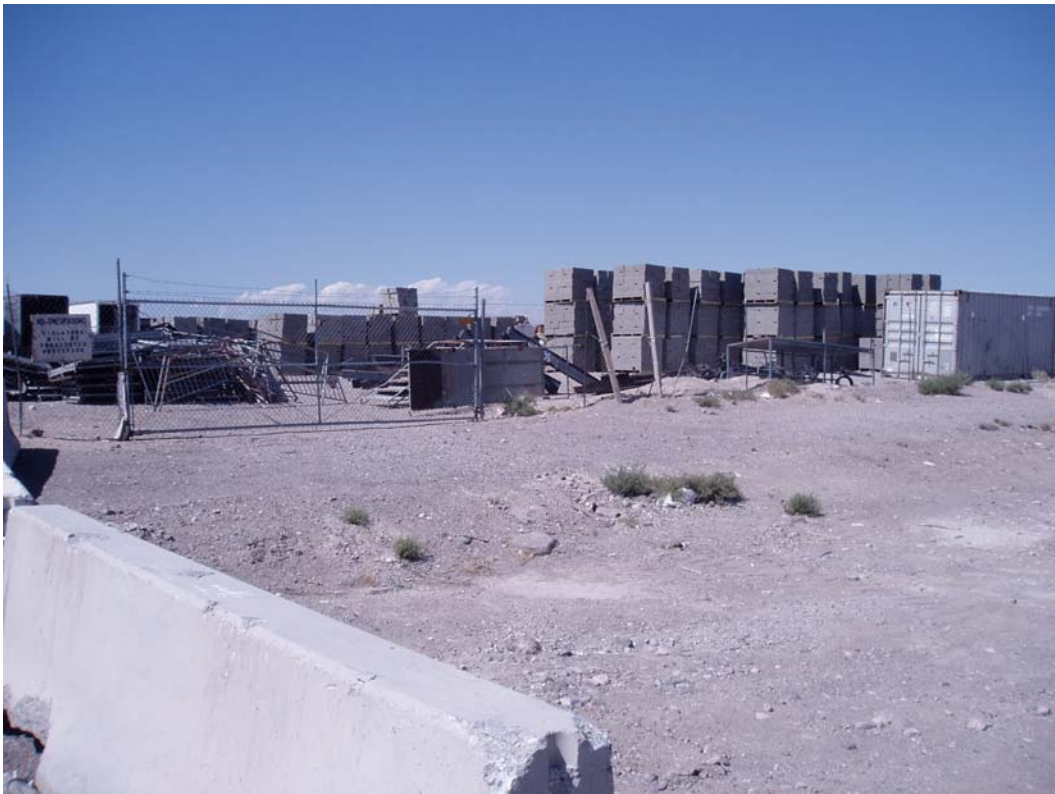
Photo 28. Storage along Gibson Channel.

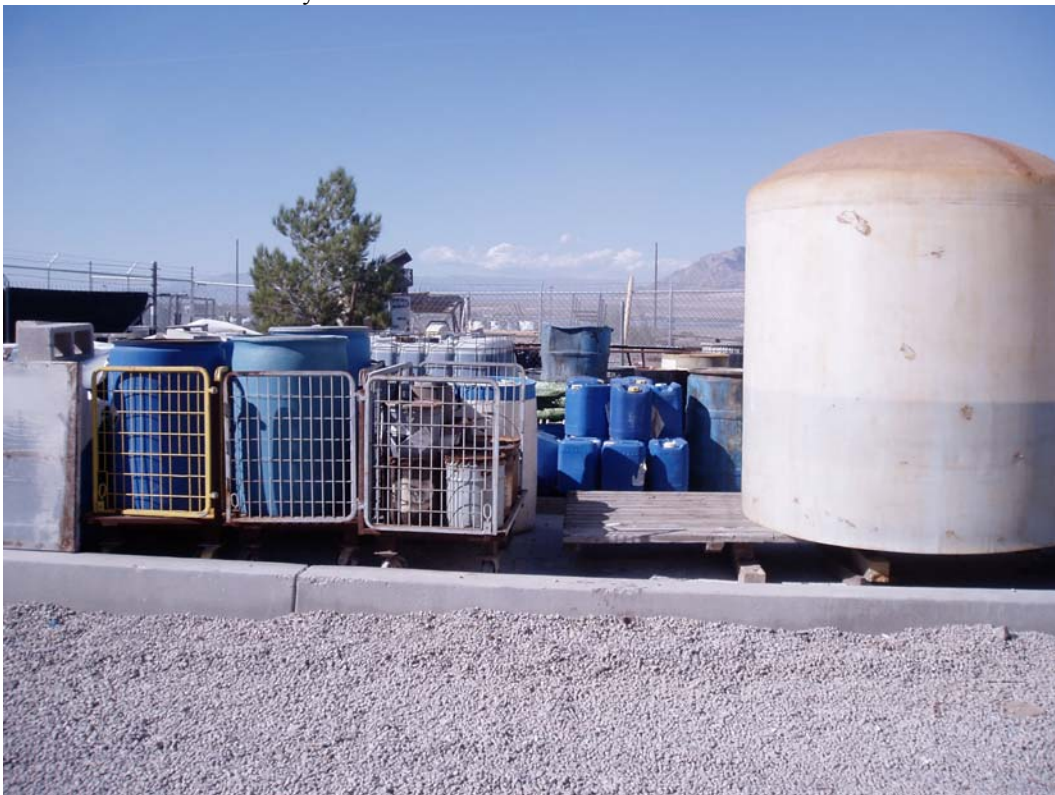
Photo 2. Bermed area for chemical storage.

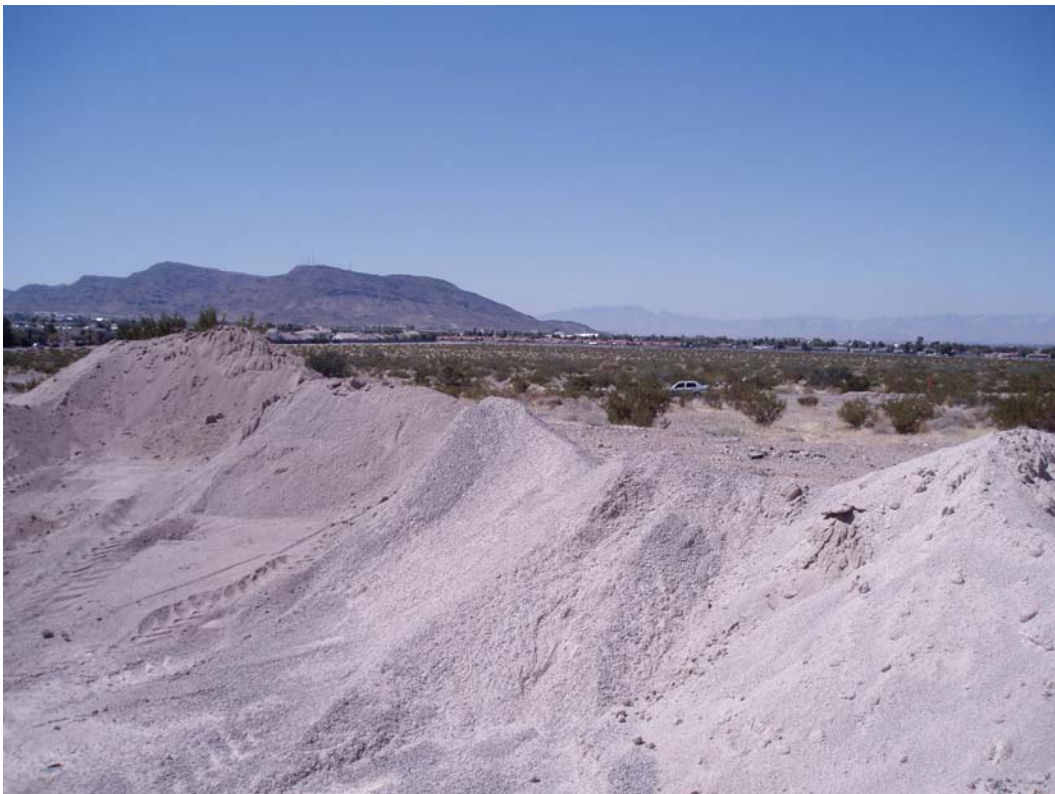
1. Mr. Ogle noted the debris at the construction site entrance.
2. Mr. Ogle noted that the soil stockpiles had the potential to runoff to the road. He said that he would ask the site superintendent to install a berm.
3. Mr. Ogle noted other construction debris throughout the site.
4. Mr. Ogle said that the site would be failed and a Notice of Violation (NOV) sent to the developer to install the berm and clean up the debris.

Photo 2. Sediment stockpiles. Note the ground slopes towards the road in the background.
